**TECHNICAL REPORT ON A SUBSIDENCE CLAIM**

**33 Langbourne Avenue  
London  
N6 6PS**

**SUBSIDENCE CLAIM**

DATE 25 September 2018

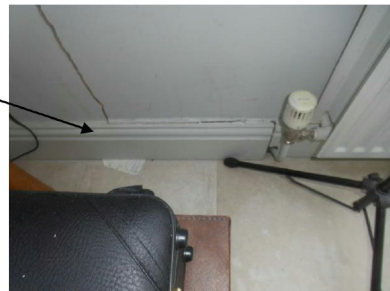
Study – separation to skirting board and crack

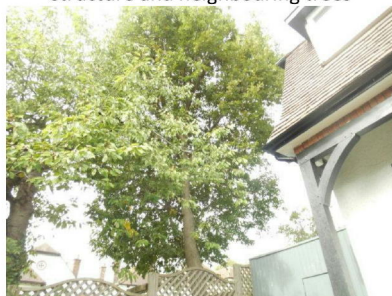
Neighbouring trees to front left of property

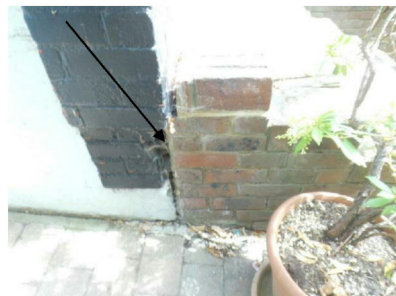
Separation crack to front steps
