## Arboricultural Appraisal Report

### Subsidence Damage Investigation at:

33 Langbourne Avenue  
London  
N6 6PS

CLIENT: Crawford & Company  
CLIENT REF: [REDACTED]  
MWA REF: 000136487-1121  
MWA CONSULTANT: Steve Swinburne  
REPORT DATE: 17-05-2019

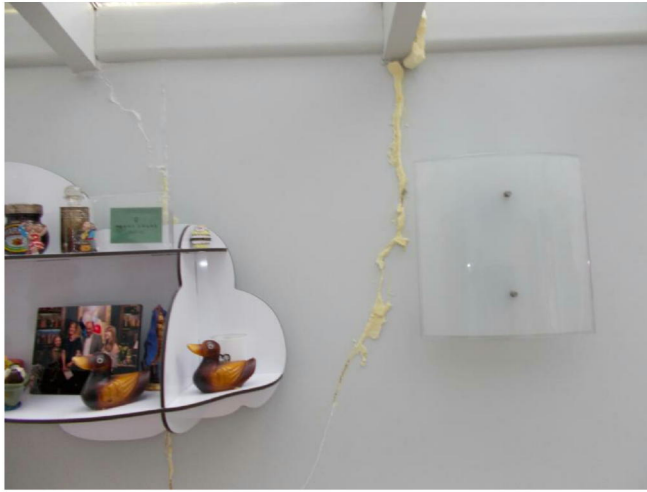
At the time of the building surveyor's inspection the structural significance of the damage was found to fall within Category 5 (very severe) of Table 1 of BRE Digest 251.

View of cracking to internal walls on left hand side of property

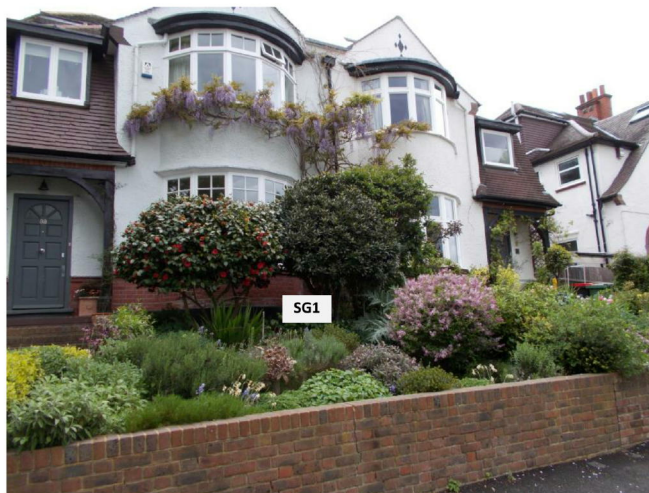
View of SG1

| Tree No. | Species | Ht (m) | Dia (mm) | Crown Spread (m) | Dist. to building (m) | Age Classification | Ownership |
|---|---|---|---|---|---|---|---|
| Recommendation | | Do not allow to exceed current dimensions. | | | | | |
