**TECHNICAL REPORT ON A SUBSIDENCE CLAIM**

**33 Langbourne Avenue  
London  
N6 6PS**

**SUBSIDENCE CLAIM**

DATE 25 September 2018

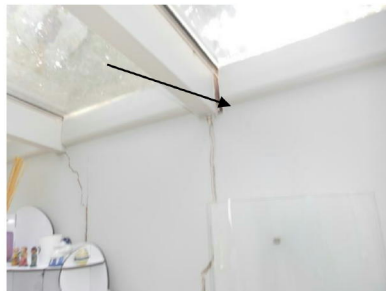
Study – vertical crack and separation of the roof structure

Separation along doorway to utility room floor tiles 2mm  
Crack above door to side exit door 5mm  
Series of cracks to left flank wall 2 to 10mm  
Vertical crack above door to kitchen with separation along frame work 1 to 3mm  
Separation crack around front door frame 2mm  
Vertical separation top right corner to roof line 4mm  
Separation to floor tiles along door way to kitchen  
Separation to skirting board along left flank wall behind radiator

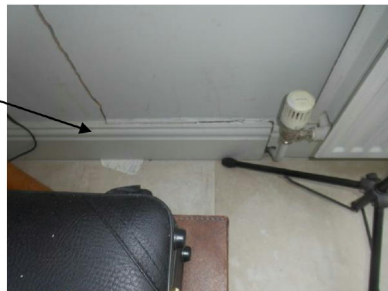
Study – separation to skirting board and crack

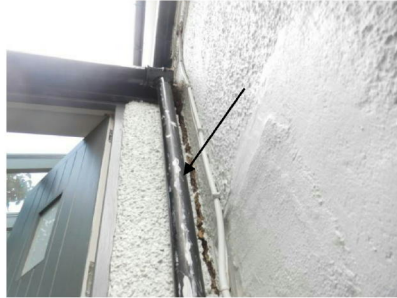
Front - vertical separation crack at junction of single storey structure and main building

Upward tapering vertical separation 5 to 45mm at junction to main building

In structural terms the damage falls into Category 5 of Table 1, Building Research Establishment<sup>7</sup> Digest 251, which describes it as "very severe".

The pattern and nature of the cracks is indicative of subsidence. The cause of movement appears to be clay shrinkage.

The timing of the event, the presence of shrinkable clay beneath the foundations and the proximity of vegetation where there is damage indicates the shrinkage to be root induced. This is a commonly encountered problem and probably accounts for around 70% of subsidence claims notified to insurers.

Although the cause of the movement needs to be dealt with, we note the nearby vegetation's is subject to a Preservation Order. Unfortunately, current legislation requires certain investigations to be carried out to support an application for the tree works.

Typically, these investigations would involve trial pit(s) to determine the depth and type of footings, boreholes to determine the nature of the subsoil/influence of any roots and monitoring to establish the rate and pattern of movement. The monitoring data provided must be sufficient to show a pattern of movement consistent with the influence of the vegetation and therefore it may be necessary to carry out the monitoring for up to a 12 month period.

It will also be necessary to obtain a specialist Arboricultural Report.

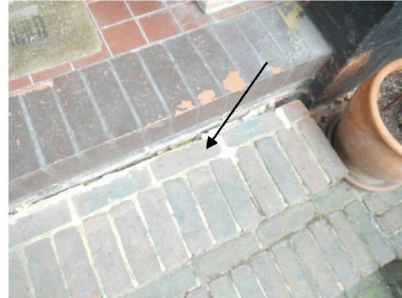
Cracks to front steps

Dropping towards the front with several fractures

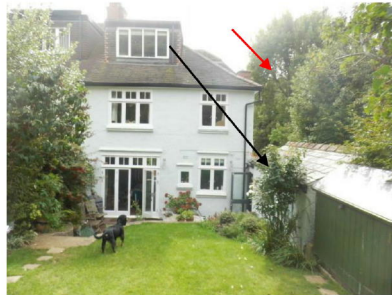
Rear of property showing single storey structure and neighbouring trees

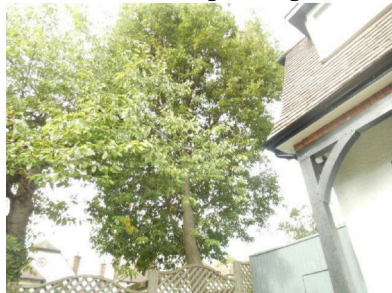
Neighbouring trees to front left of property

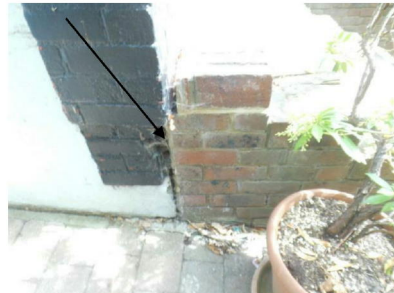
Separation crack to front steps
