# **Decay Detection Investigation**

Bedford Square  
Fitzrovia  
London  
WC1B 3DR

**April 2019**

**160523-DID-02**

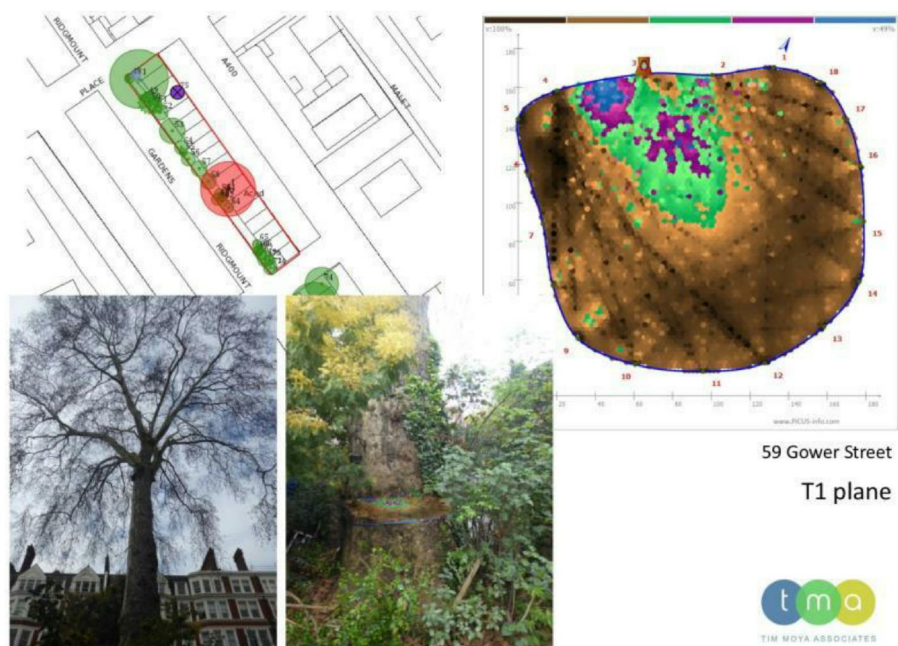
Decay detection investigation: Clockwise from the top left, map, tomogram, tomogram superimposed on the tree, the tree

- 3.7 The tomogram reveals a small area of decay (blue, pink) which is slowly developing (green, yellow) across the stem at the test height. The results indicate that the consistency of the wood at the test height is slightly compromised (light brown mixed with darker brown), however this is currently unlikely to be structurally significant.
- 3.8 The wood within the decayed area is still intact and not obviously degraded, so additional testing was undertaken using the RESI PD.

- 4.1 Some remedial tree work is required to reduce the risk of branch failure to acceptable levels and establish a smaller crown. Please see Appendix A for details. The tree should be re-inspected within 2 years or after storm force events which may weaken its condition.

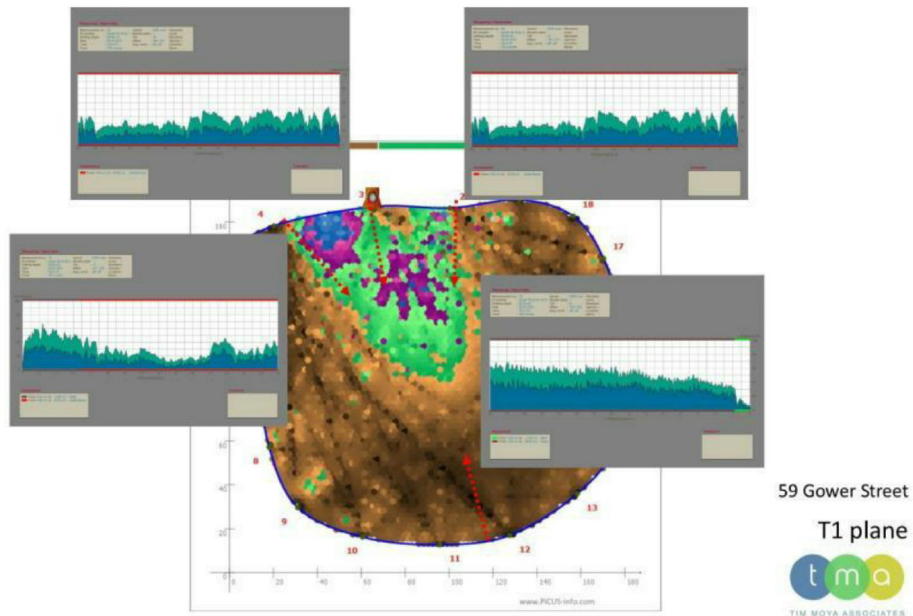
*RESI PD traces superimposed on tomogram for reference: RESI PD traces at measuring points 4, 3, and 2 (clockwise from the left) with the reference trace for comparison on the right*

- 3.9 The RESI PD traces by measuring points (mp) 4 (read from left to right) and mp's 3 and 2 (read from right to left) all show decayed and damaged wood. The reference trace from the south (read from right to left) shows intact wood throughout.
- 3.10 The decay revealed by the above testing does not currently present an unacceptable risk of tree failure. The development of decay will need to be monitored in the future.
- 3.11 Recommendations have been made to reduce the tree height and branch length for good arboricultural management purposes.
