# Marcus Foster Arboricultural Design & Consultancy

#### Arboricultural Survey & Impact Assessment (BS5837:2012)

12 Lyndhurst Gardens London NW3 5NR

AIA/MF/036/19

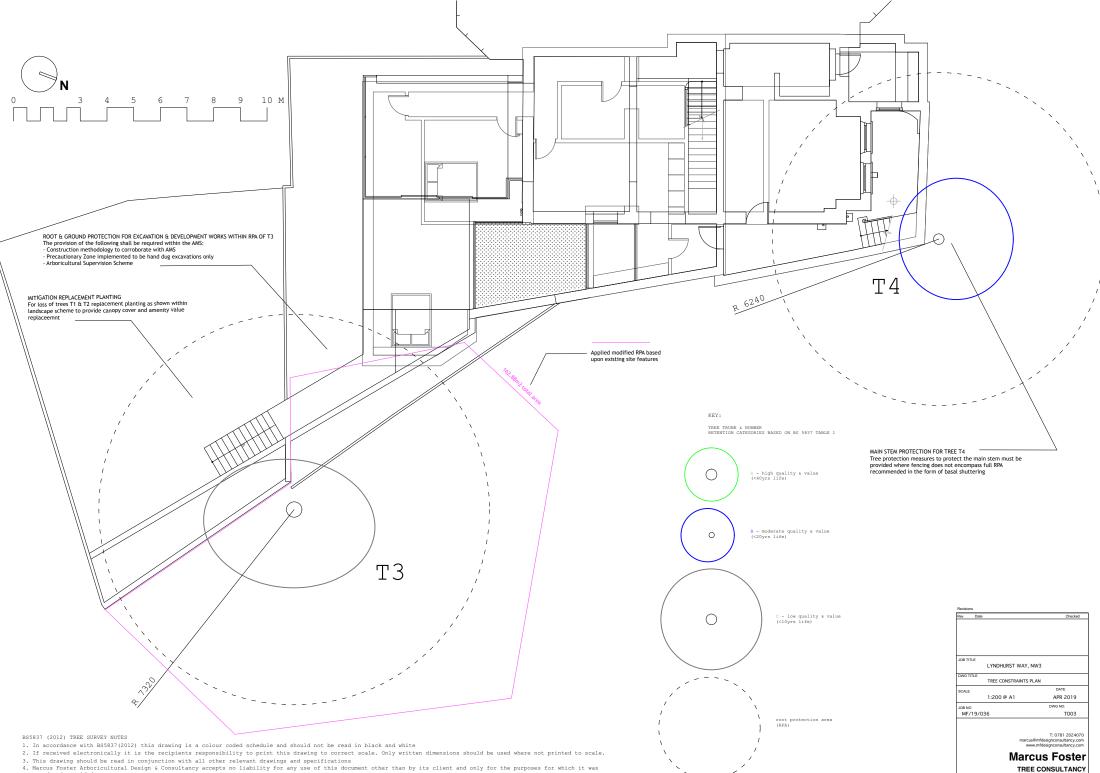
For this tree a modified RPA has been applied as shown within drawing T003 - Tree Constraints Plan (TCP) based upon the following site features

- 1.6m height retaining wall directly adjacent
- Historic existence of tree T2 to north within site of proposed development
- Level changes from north to south downwards

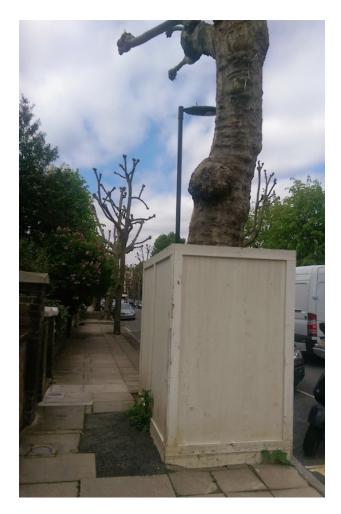
Basal shuttering offers immediate protection for the lower main stem and initial root plate of a tree where exposed with a porous surface. This method of tree protection does not offer protection to the root plate of a tree where surfaces are exposed / development works are being undertaken within the Root Protection Area of a tree. however, it does offer immediate protection to the main stem and provides vital clearance between the tree and construction site activities such as storage of materials, ad hoc toilet usage and compaction of exposed soft landscaped ground (in addition to many other additional construction site activities.

Tree protection measures to protect the main stem must be provided where fencing does not encompass full RPA recommended in the form of basal shuttering
