22 Froggnal Way - Curtilage Wall and Outbuilding

Structural Inspection Report

Job Number: 23261

Date	Version	Notes/Amendments/Issue Purpose
June, 2018	2	For Information

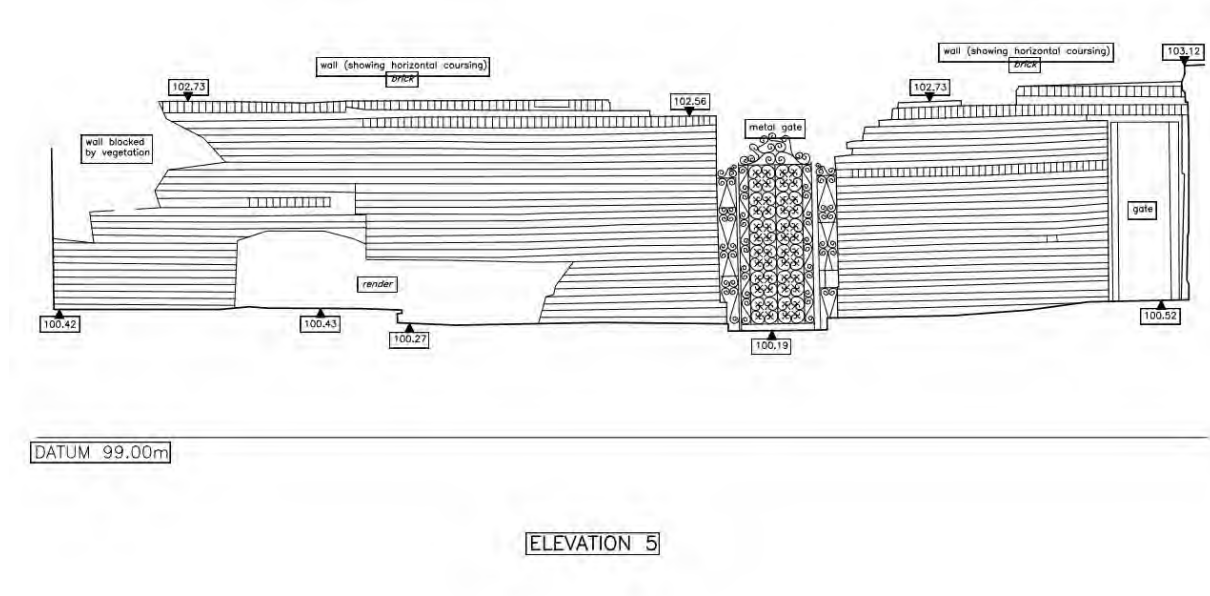
Elevation 5, Matrix Surveys

Elevation 5 depicts the initial straight-line boundary wall with two openings. The left-hand side section, behind the existing shed, has notable previous remedial works to the lower part of the wall. Photograph 2 shows the extent of the concrete render applied to the lower section of the wall. Above the concrete render the brickwork is in poor condition with the corbel portion no longer insitu.

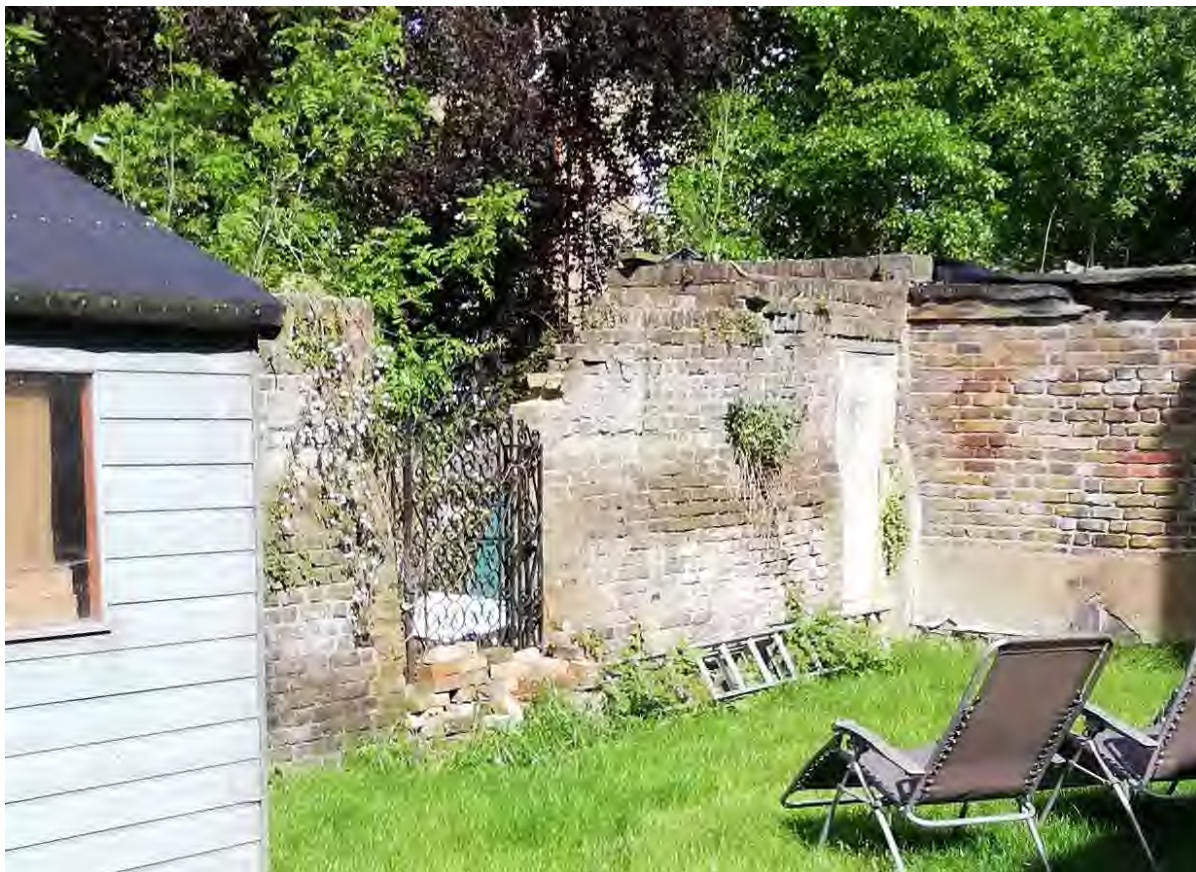
Photo 1, View from 20 Perrins Cottage

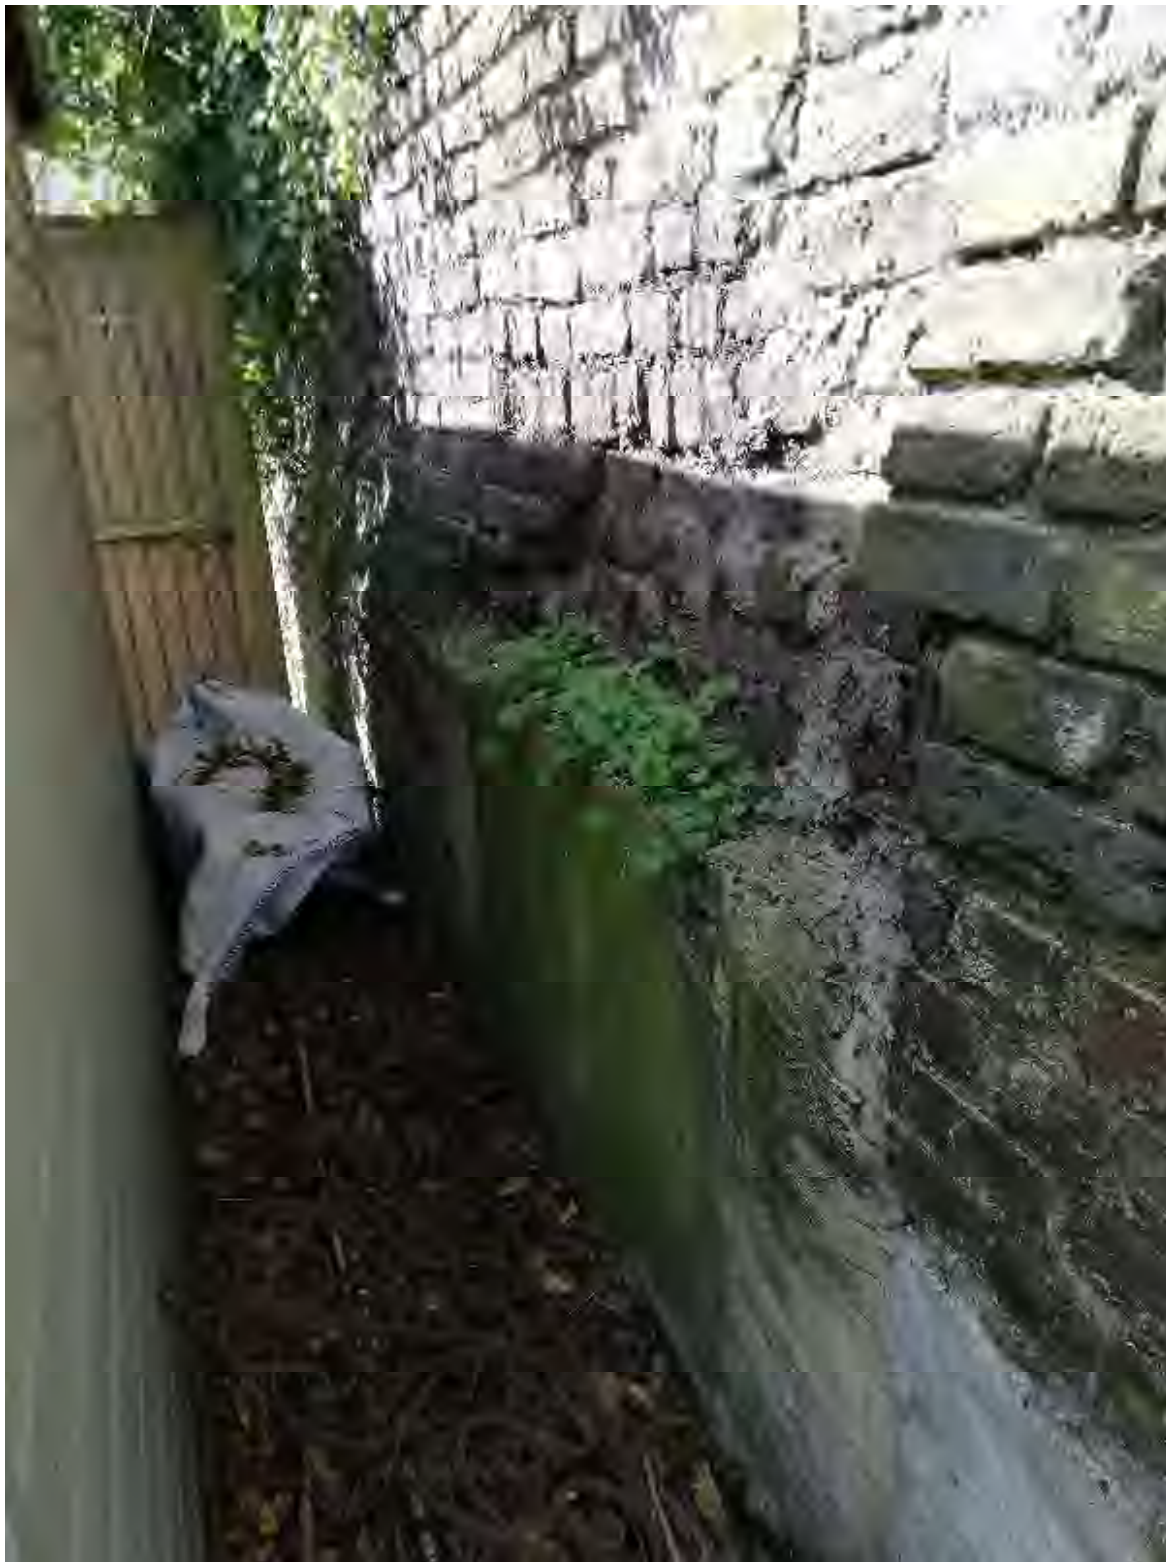
Photo 2, Southern section of wall behind existing shed

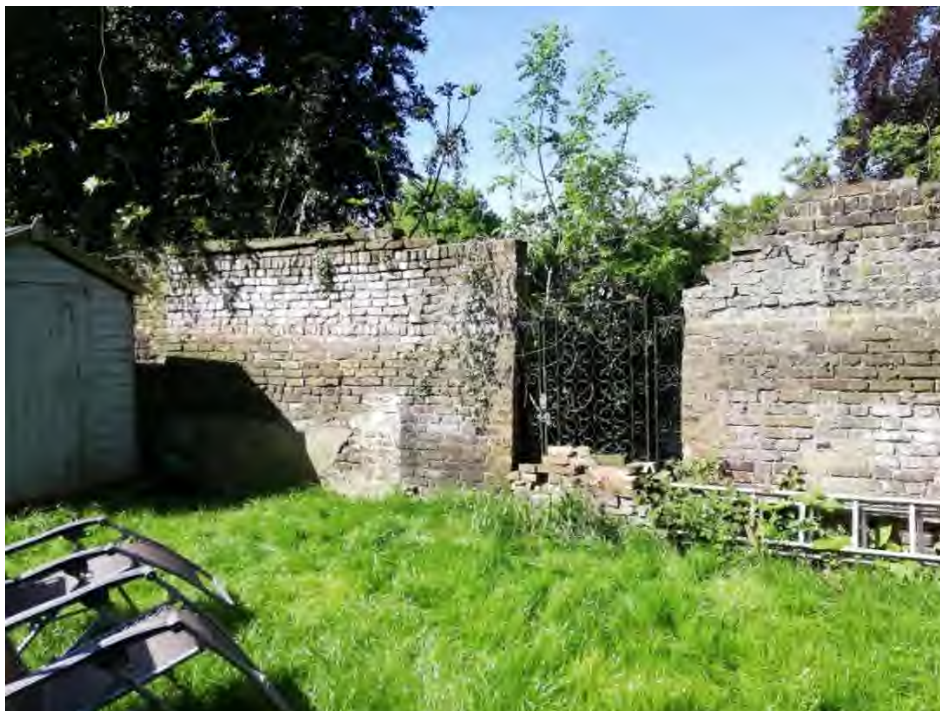
Photo 3, Opening 1, Full height

The right-hand section of the wall on this elevation has two openings (refer to Photograph 3 & 4). These openings provide access between the two properties. On review the openings do not look to be of a similar age as the wall construction as new brickwork and cement mortar is visible, refer to photograph 5.

The brickwork at high level surrounding the openings is in poor condition and a number of courses are missing locally from the upper section of the wall.

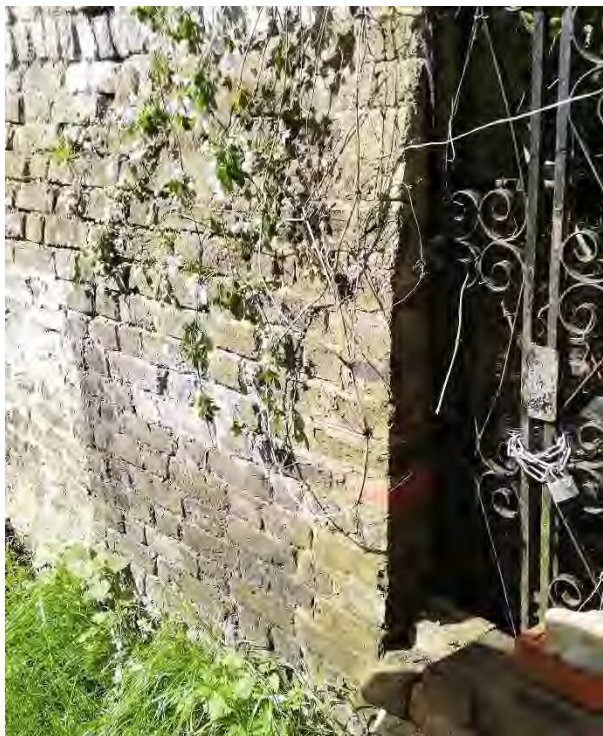
Photo 5, new/old brickwork at opening reveal

Photographs 5 & 6 show the composition of the wall itself. At its base it is a brick & a half thick reducing to one brick thick for the upper section. To achieve the change in thickness the wall corbels at approximately 1000mm above the current ground level. The Wall is approximately 2.3m high from 20 Perrins Walk side.

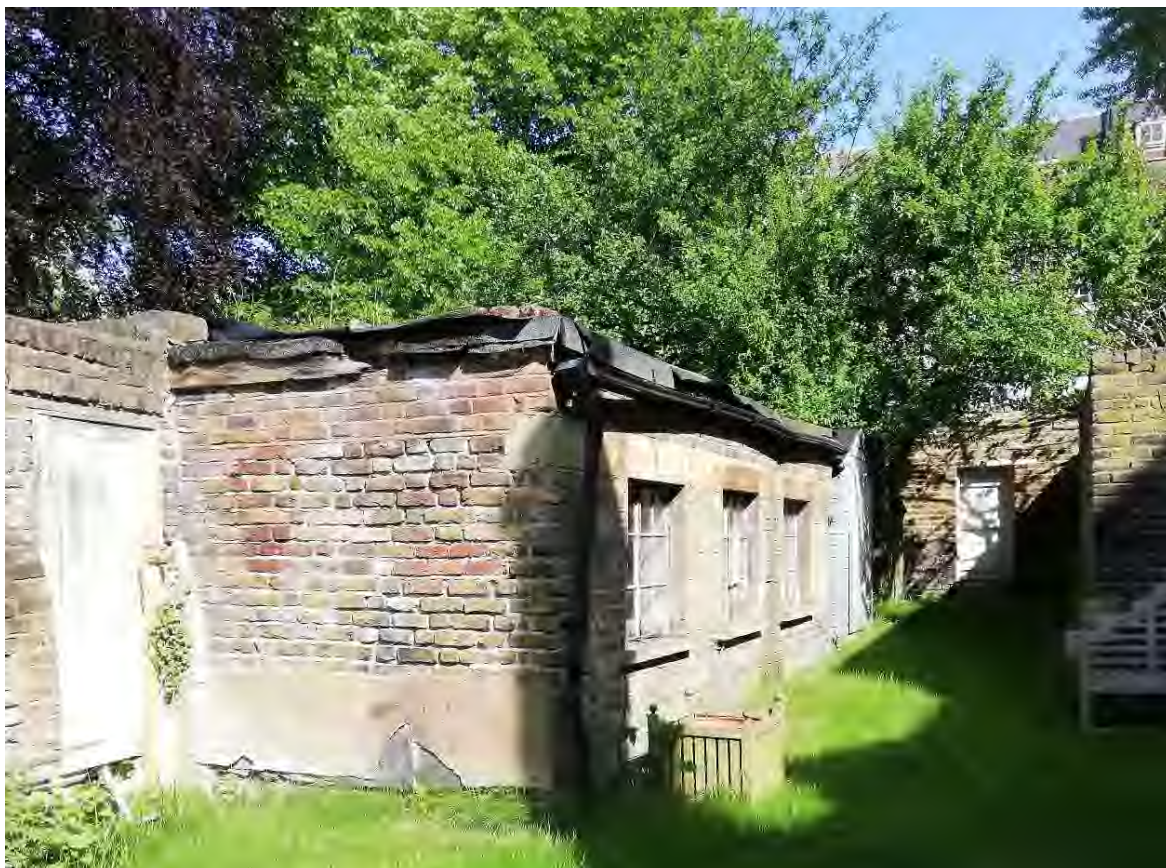
Photo 7, Outbuilding on 20 Perrins Cottage Side

The outbuilding is centrally located along the length of the wall and steps its footprint straddles the two properties. The construction of the outbuilding looks to be of London stock brick and no structural defects of concern in the masonry were seen during the site visit on the 11th May, although sections do require re-pointing. An anchor plate is evident on the top right-hand side corner of its east elevation.

The roof to the outbuilding was noted to be in disrepair.

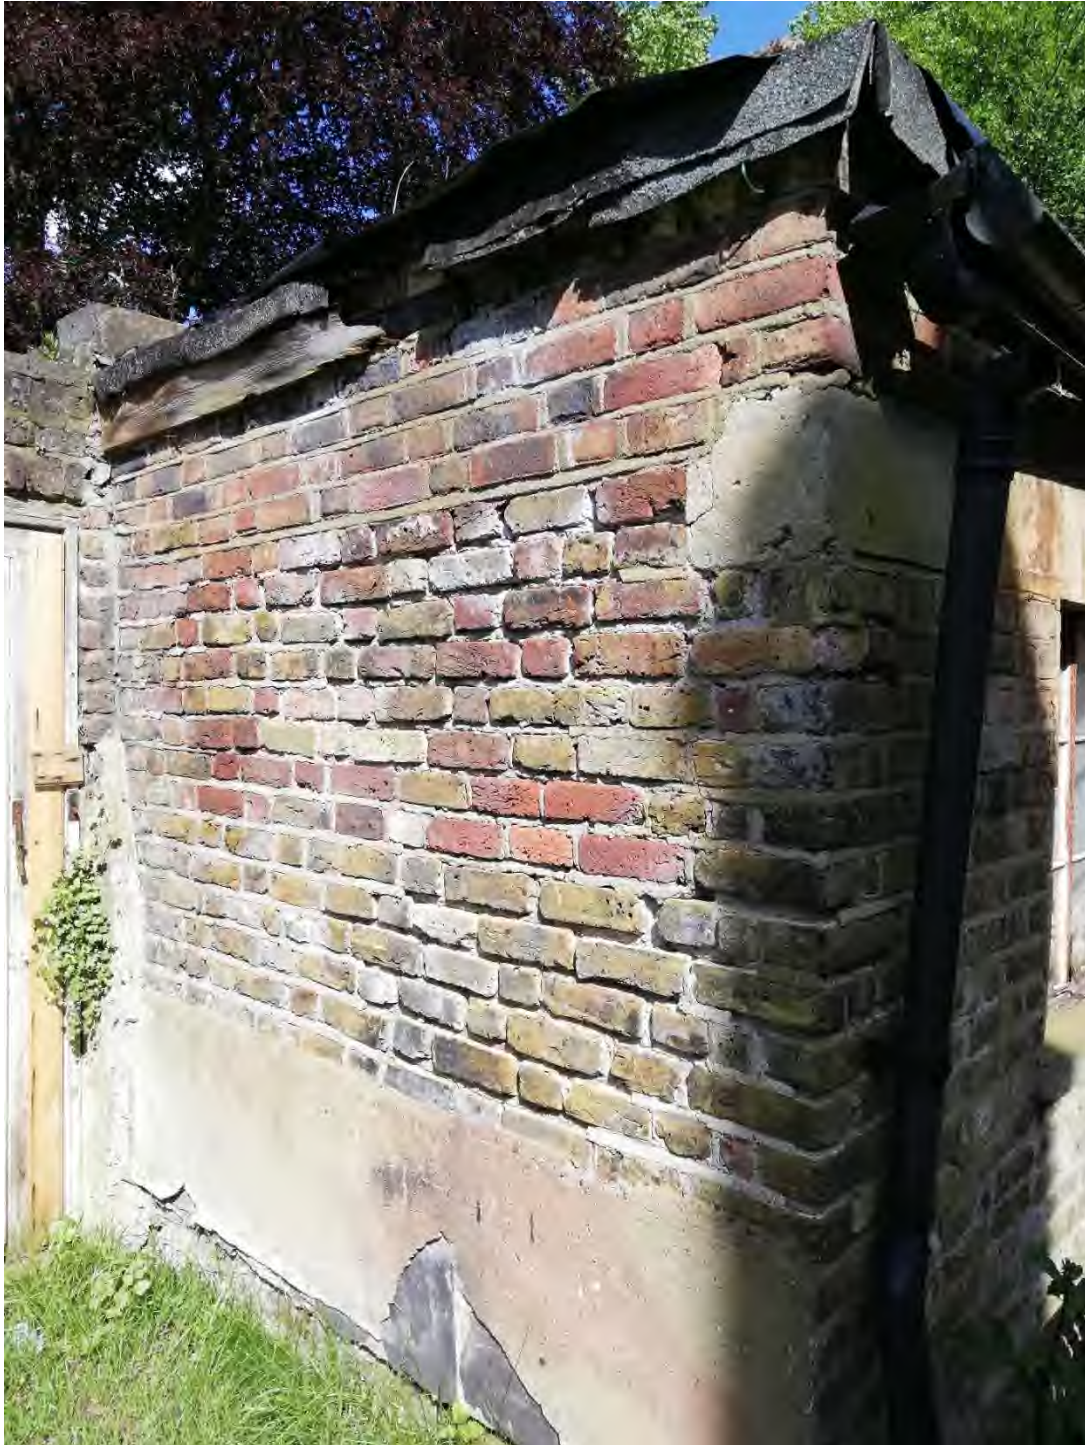
Photo 8, View of Outbuilding Masonry

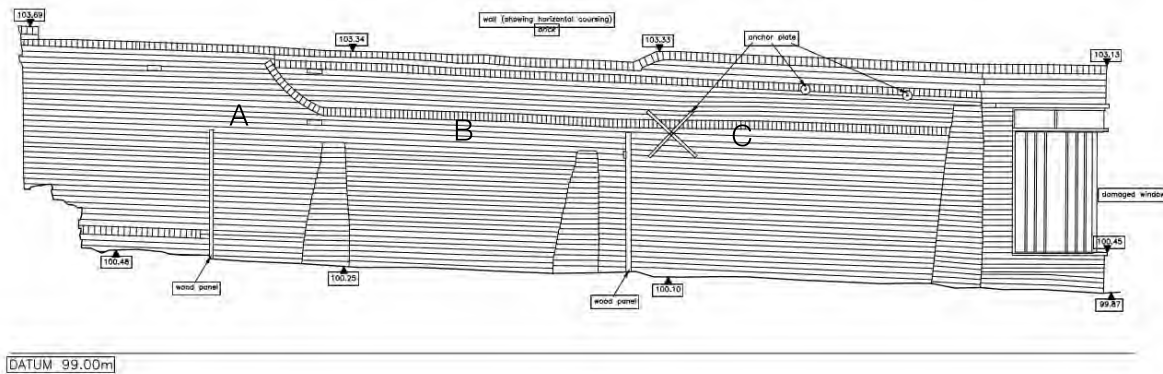
ELEVATION 2

Elevation 2, below, shows the northern part of the curtilage wall. This elevation forms part of the outbuilding façade (from its right-hand extent to the crossed anchor plate).

There are buttresses located on this elevation which are all of a raked masonry brickwork construction and taper towards their top. The right-hand side, taller pier looks to be constructed in the same brick as the remainder of the wall. The two smaller piers, to the left-hand side and centre, are obviously of recent construction and are likely to be an attempt to strengthen the wall against the obvious bow at approximately 2.3m above ground level. The bonding of the new buttresses does not match that of the wall, and they do not look to be properly keyed into the existing wall.

It should be noted that there is an level change between the two properties along this wall, with a retained height of approximately 860mm to the 20 Perrins Walk side the neighbouring property.

Measurements taken on site of the lean to the wall were measured at 48mm, 131mm and 144mm and correspond to the locations A, B & C in Elevation 2, above.

Location A on Elevation 2 & D on Elevation 4 have a centre of gravity that still falls within the middle third of the wall base and no added stability measures are required. However, at locations B and C on Elevation 2, and location E on Elevation 4, the wall is potentially unstable in the long term.

Separately, we have also investigated the structural capacity of the retaining section of the wall, Elevation 2. This wall is not satisfactory to support the required applied wind loads and retaining forces from the neighbouring property when checked using current codes of practice.

Finally, we have investigated the structural design of the 2.3m high freestanding wall with piers at a maximum of 5.0m centres as a standalone item. Location C on Elevation 2, where the wall spans 5.0m between piers is not satisfactory. The maximum allowable spacing of piers for the wall to be compliant with current codes is 4.6m. This is achieved at Locations A and B on Elevation 2, although as noted earlier, this section of wall fails once the retaining forces are taken into account in any event.

We would therefore recommend that Elevation 2 & 4 are either strengthened or taken down and rebuilt to modern codes of practice.

Three new buttresses would be introduced to Elevation 2 at central locations between the existing buttresses, and the existing buttresses should also be rebuilt. These piers will have new footings and be properly tied into the existing wall to ensure they work together structurally.

The existing masonry would be carefully taken down and a new concrete retaining wall built to the base of Elevation 2. This retaining wall will be faced with existing bricks so that it matched the current visual appearance of the wall.

Elevation 4 & the upper section of Elevation 2 would then be reinstated with concealed wind posts to provide the required structural capacity.

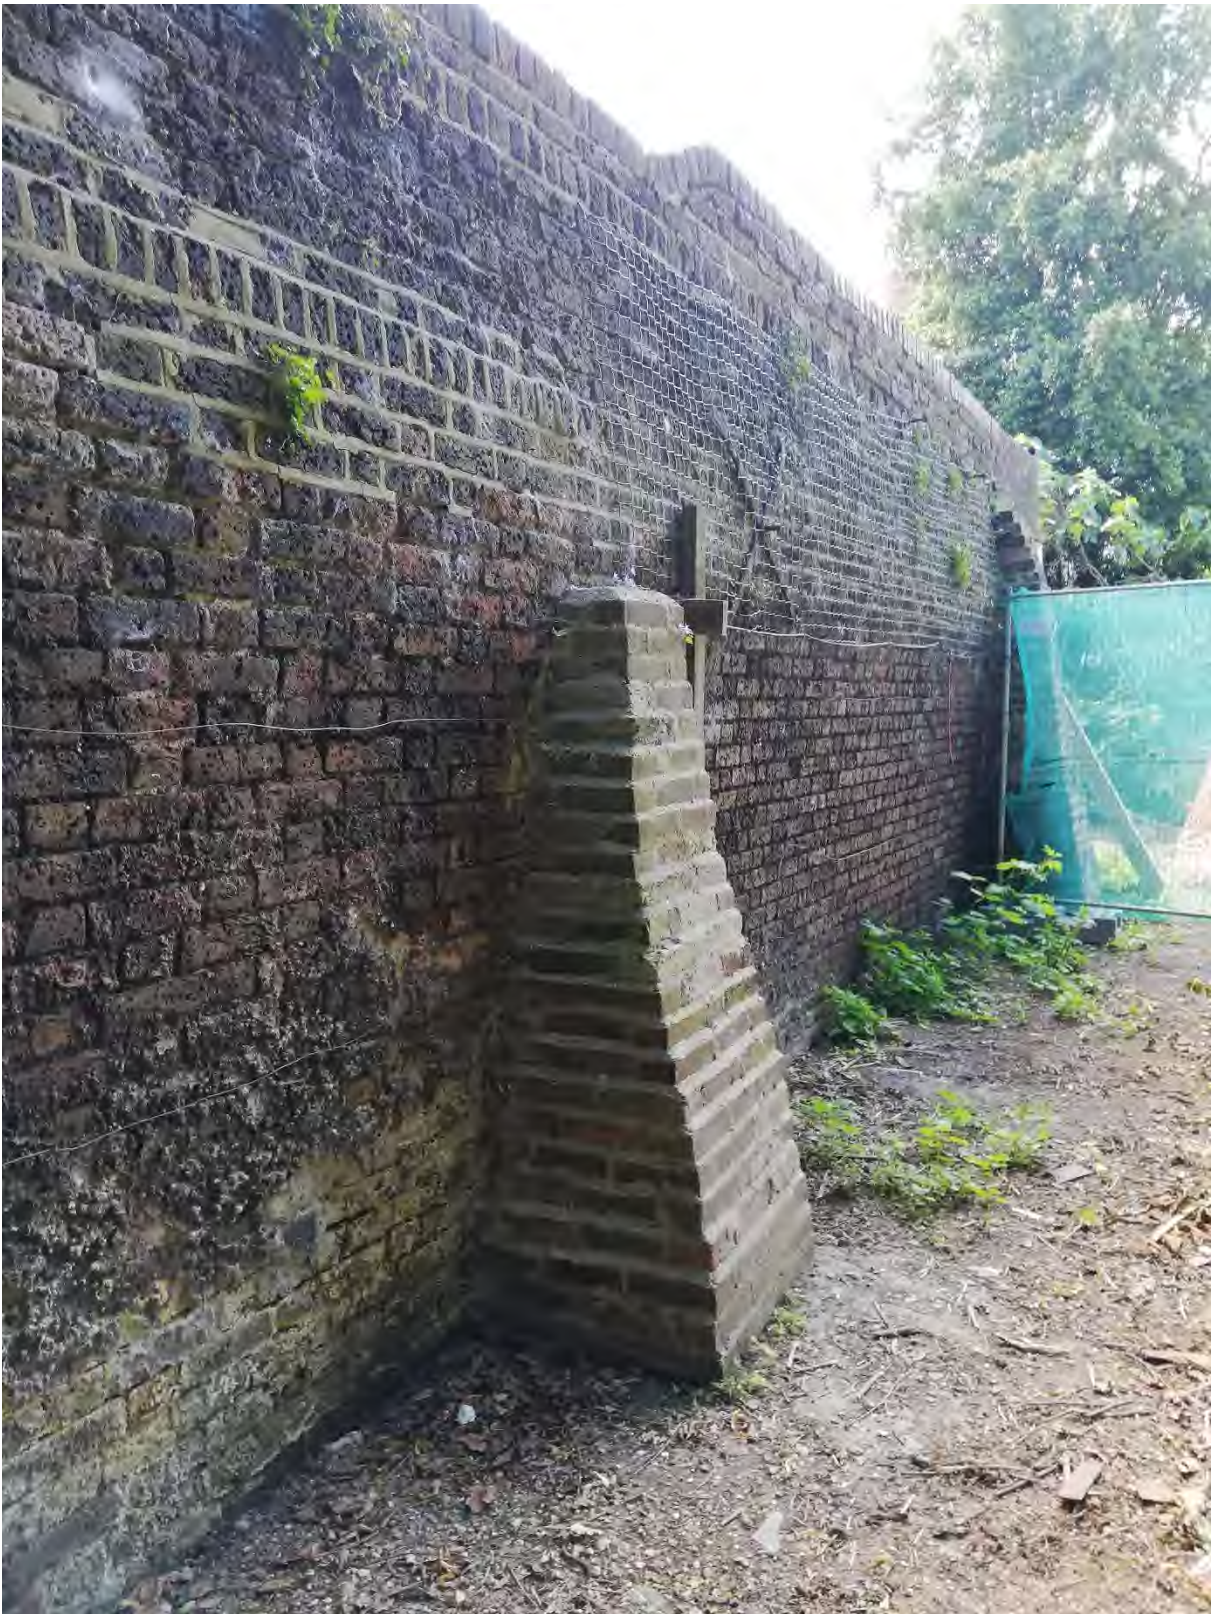
Photo 9, North section of wall and viewing toward the into Outbuilding entrance

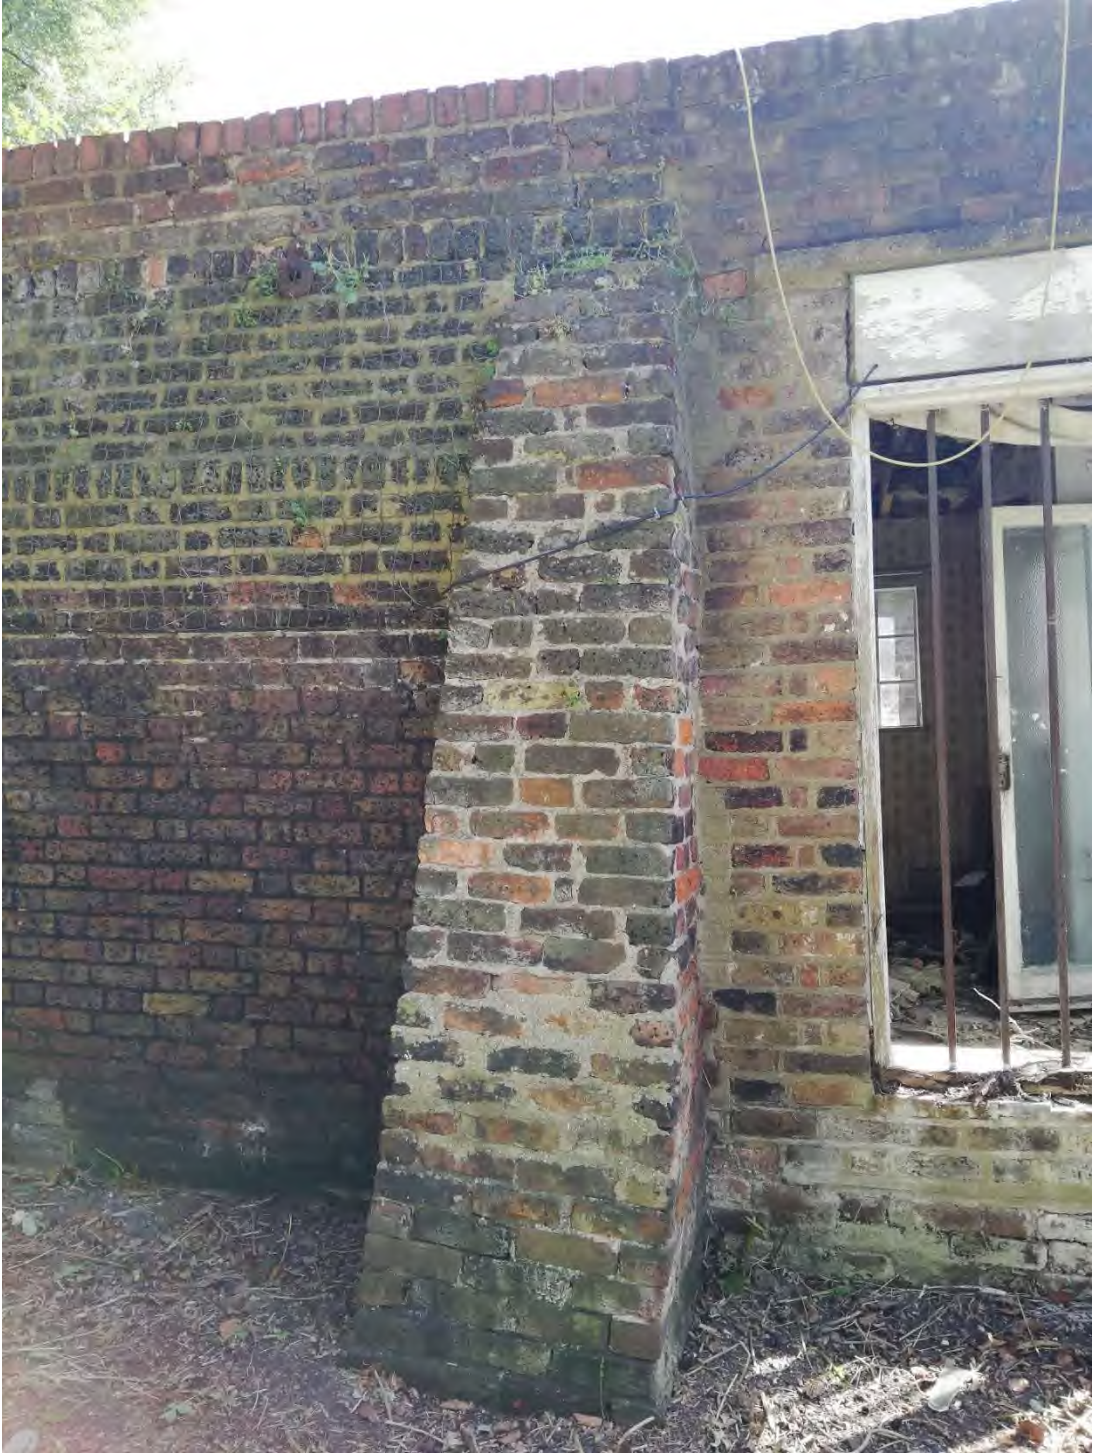
Photo 10, Right-hand side masonry pier to Outbuilding

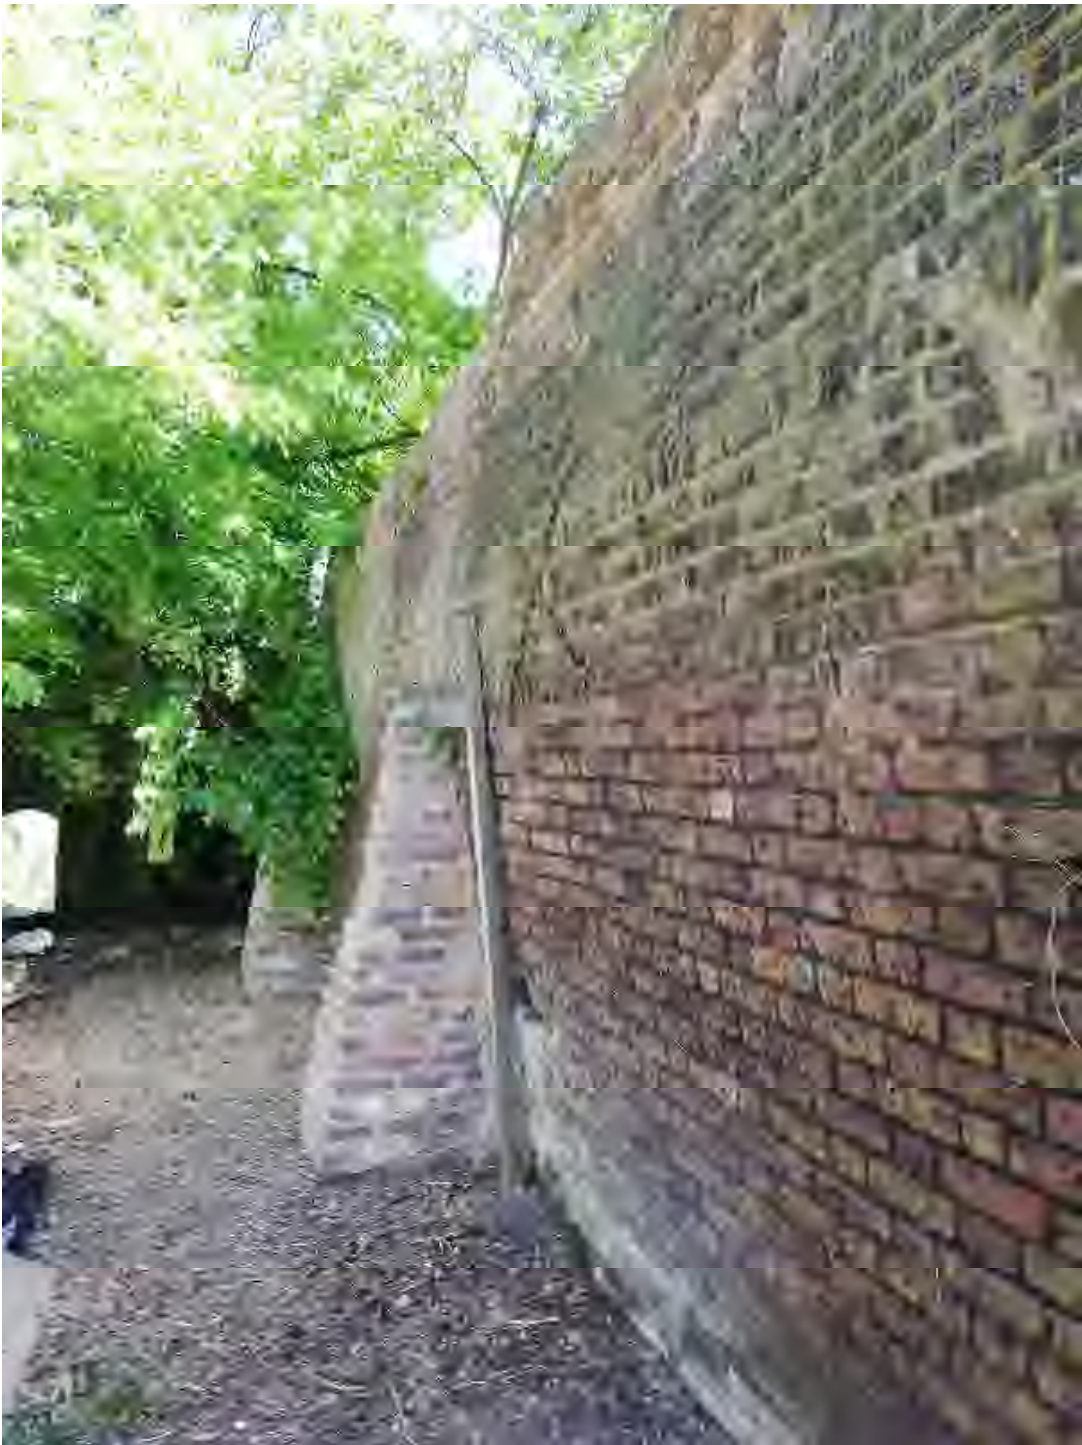
Photo 11, North Section of Wall showing newer piers and bow at the top of the elevation. Also evident is the anchor plate situated in front of the nearest pier.

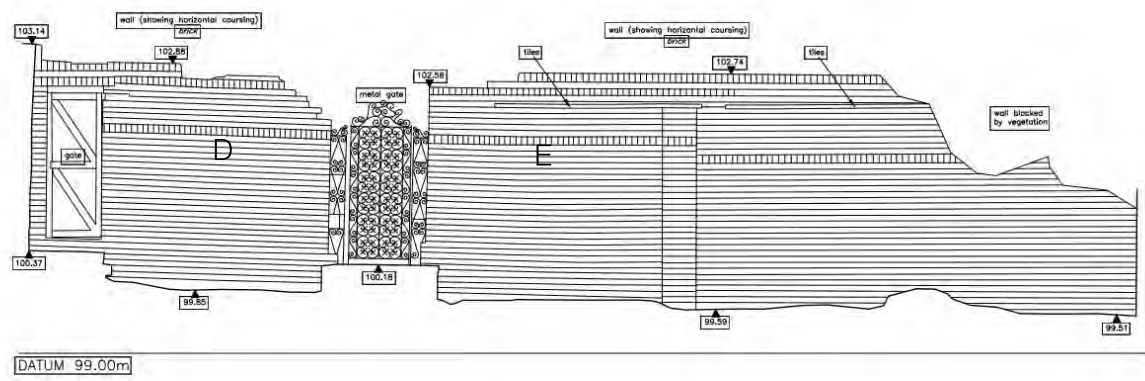
ELEVATION 4

Once the vegetation had been removed from this section of the wall we were able to see the condition of the masonry. The new brickwork and cement mortar is more visible on this side of the wall and, similar to the northern section, there is a slight bow to the wall at approximately 2.3m above ground level.

Measurements taken on site of the lean to the wall were measured at 51mm and 110mm which correspond to the locations D & E on Elevation 4.

There is also a level change of approximately 400mm between the two properties in this location. Unlike the northern section of wall, due to its thickness of 325mm at its base, the wall is not acting as a retaining wall as the spread of load at 45 degrees will transfer directly into the soil on the lower side.

We also recommend introducing two new piers either side of Opening 1 to strength this wall panel and repair the upper courses of masonry.

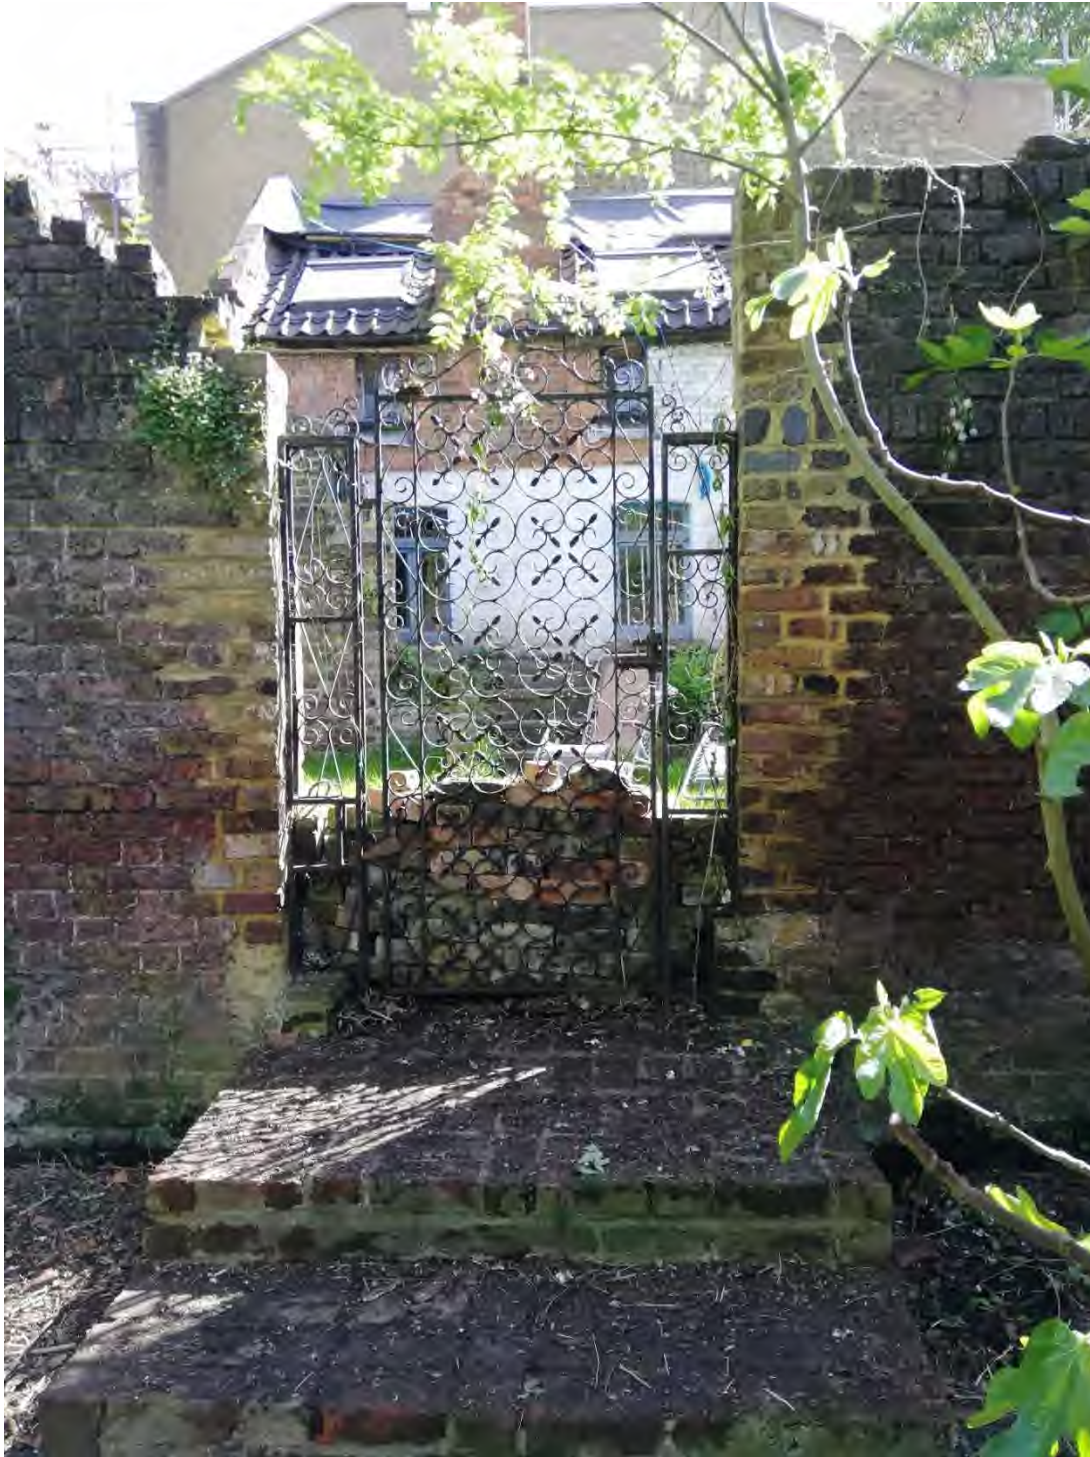
Photo 15, Opening 1 with new brickwork evident

As with observations from the 20 Perrins Walk side, the top masonry courses are noted to be in poor condition.

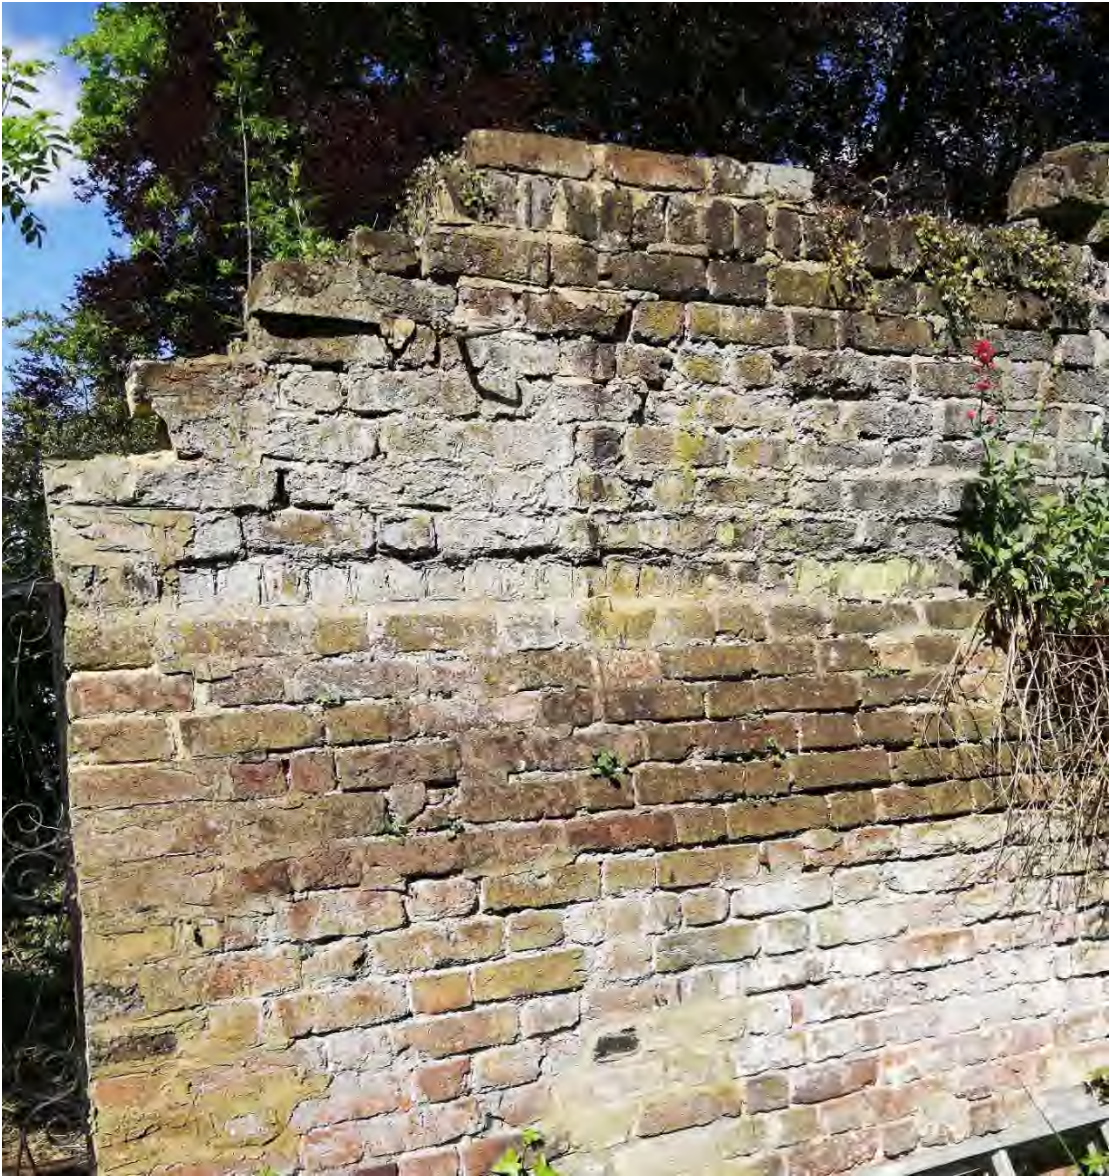
Generally the masonry on the 20 Perrins Cottage elevation looks to be in worst condition. This is probably due to increased exposure from its orientation. If the wall is strengthened rather than rebuilt, both elevations would require repointing.

Photo 16, Disrepair at the top of the wall adjacent to Opening 1

Where possible all masonry should be reused or new to match existing, and any re-pointing should be done with a suitable lime mortar by Limetec or similar in accordance with our specification.
