Arboricultural Appraisal Report

Subsidence Damage Investigation at:

Flat 18, Holmefield Court
 Belsize Grove
 London
 NW3 4TT

CLIENT:	Crawford & Company
CLIENT REF:	[REDACTED]
MWA REF:	
MWA CONSULTANT:	George Peters BSc. (Hons)
REPORT DATE:	14/05/2019

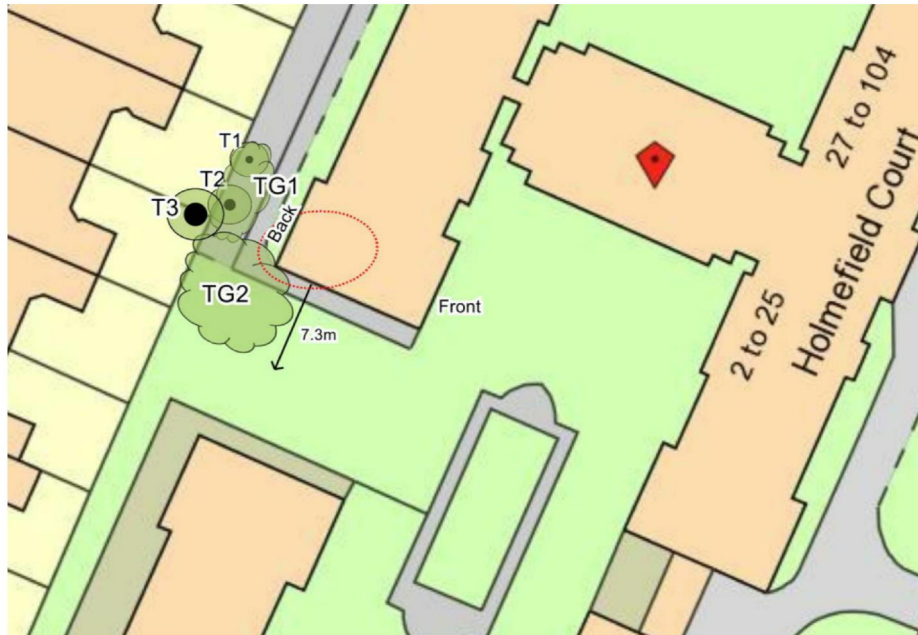
Site Plan

Approximate areas of damage

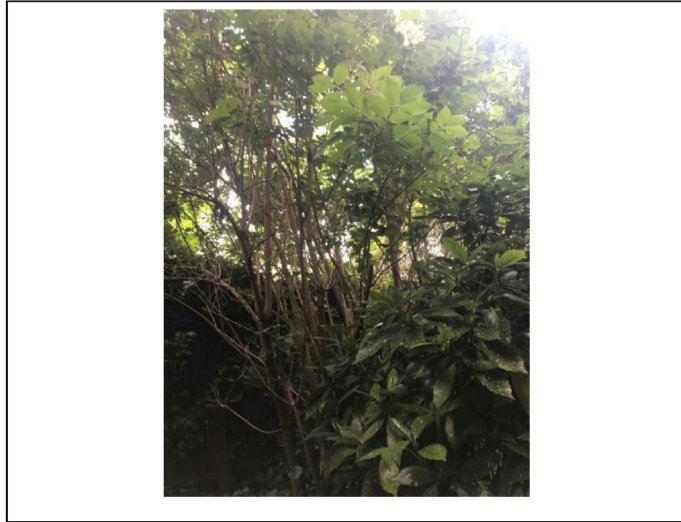
The vegetation likely to be most significant in relation to the current damage is T1 (Elder), T2 (Blackthorn), TG1 (Blackthorn and Laurel) and TG2 (mixed species, inc. Blackthorn). Other vegetation recorded represents a future risk.

Based on the information currently available, engineering opinion and our own site assessment we conclude the damage appears consistent with shrinkage of the clay fraction due to the soil drying effects of vegetation.

View of T1 Elder, current claim.

If an arboricultural solution is to be implemented to mitigate the influence of the trees/shrubs considered to be responsible for the damage we recommend that T1, T2, TG1 and TG2 are removed.

Tree No.	Species	Ht (m)	Dia (mm)	Crown Spread (m)	Dist. to building (m)	Age Classification	Ownership
T1	Elder	3.8 *	60 Ms *	3	3	Younger than Property	Policy Holder
Management history		No recent management noted.					
Recommendation		Remove (fell) to near ground level and treat stumps to inhibit regrowth.					
T2	Blackthorn	4	130 *	3	3	Younger than Property	Policy Holder
Management history		No recent management noted.					
Recommendation		Remove (fell) to near ground level and treat stumps to inhibit regrowth.					
TG1	Mixed species group	2.4	40 Ms *	4	2	Younger than Property	Policy Holder
Management history		Species include Blackthorn, and Laurel. No recent management noted.					
Recommendation		Remove (fell) to near ground level and treat stumps to inhibit regrowth.					
TG2	Mixed species group	4.5 *	100 Ms *	5	1	Younger than Property	Policy Holder
Management history		Species include blackthorn. No recent management noted.

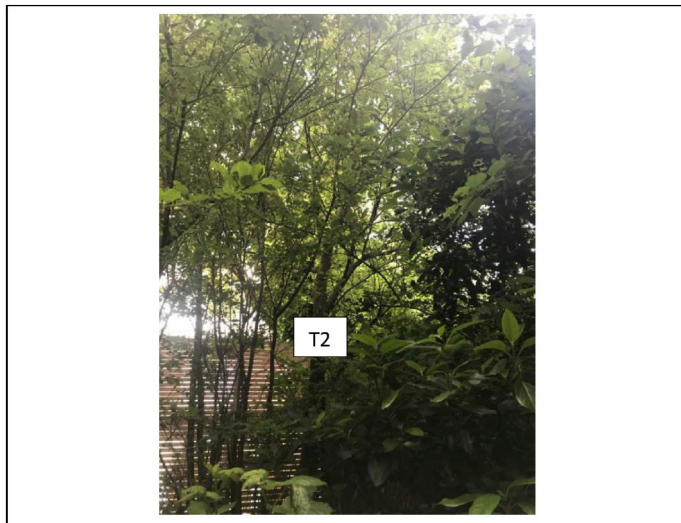
View of T2 Blackthorn, current claim.

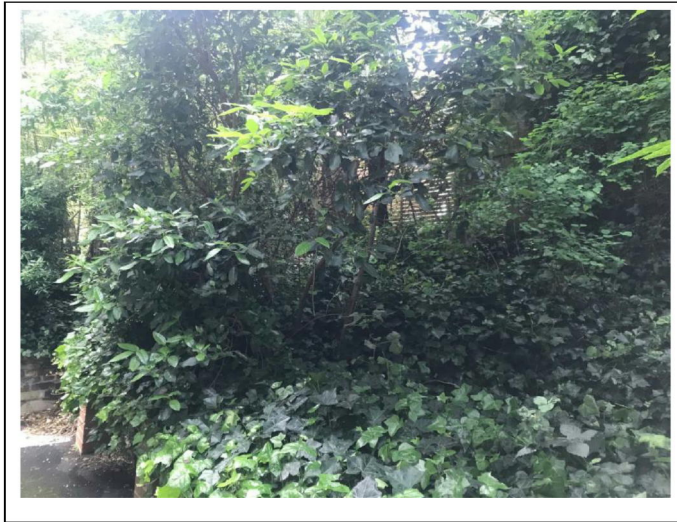
View of TG1 mixed species, current claim.

Recommendation		Remove (fell) to near ground level and treat stumps to inhibit regrowth.

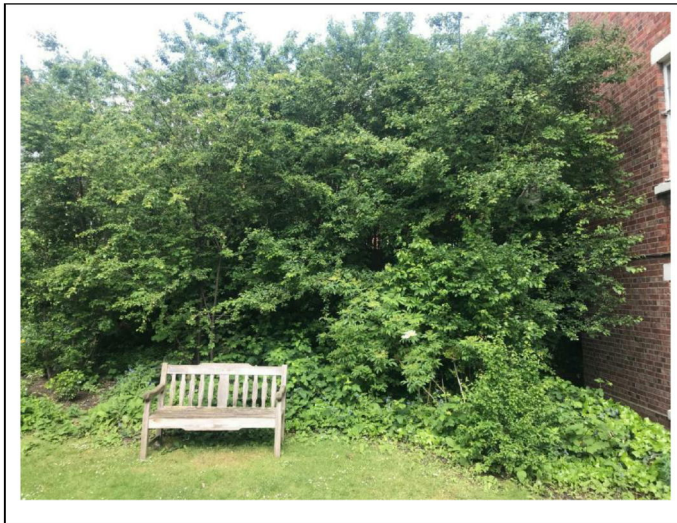
View of TG2 mixed species, current claim.
