TECHNICAL REPORT ON A SUBSIDENCE CLAIM

**Flat 18
Holmefield Court
Belsize Grove
London
NW3 4TT**

SUBSIDENCE CLAIM

21st January 2019

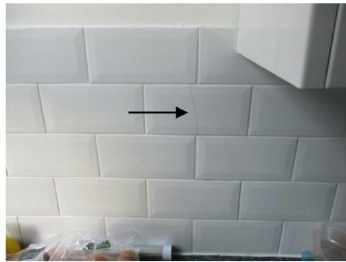
Cracking to tiles in flat 18 kitchen

Flat 18 - Kitchen - Hairline vertical crack in wall and tiles above worktop level to bedroom partition, 3mm vertical crack to bedroom partition below worktop level.

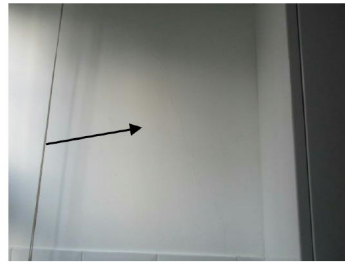
Cracking to bedroom partition in flat 18 kitchen

Bedroom - Hairline diagonal crack to kitchen partition.

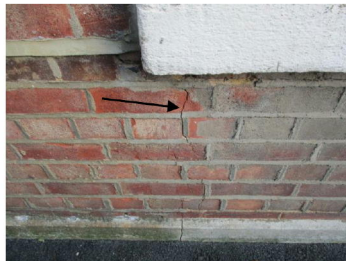
Cracking below kitchen window on left hand flank

Left Hand Flank - 2mm vertical crack below left hand side of flat 18 kitchen window, 2mm stepped crack below right hand side of flat 18 kitchen window, unrelated diagonal cracking to render above left hand side of top floor left hand window.

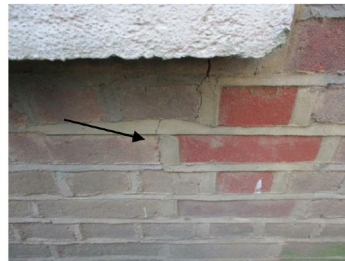
Cracking below bedroom window on rear elevation

Rear Elevation - 1mm vertical crack below left hand side of flat 18 bedroom window.

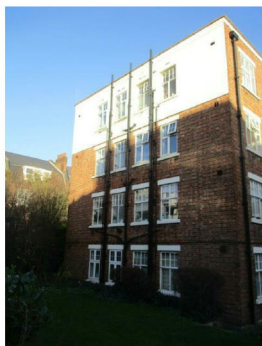
The pattern and nature of the cracking is indicative of an episode of subsidence. The cause of movement appears to be clay shrinkage.

View of general area of damage

Subject to a valid claim arising, the cause of the movement needs to be dealt with first. We have completed a soil risk analysis (VISCAT Assessment) and we are satisfied that your trees and shrubs growing around the area of the rear left hand corner of flat 18 can be removed.

Following completion of the tree management works, we will undertake a suitable period of monitoring to confirm stability has been achieved before undertaking repairs to the property.

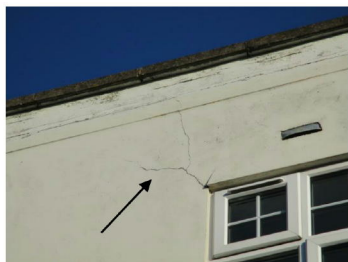
At the time of our visit we noted some cracking to the rendered section of the left hand flank at high level. The location and pattern of this particular isolated section of cracking was not indicative of that associated with foundation movement. We consider this cracking to be wear and tear related, the repair of which will fall outside the scope of this claim.

Unrelated high level render damage to left hand flank
