Arboricultural Survey
& Report

35a Buckland Crescent
London
NW3 5DJ

25th June 2019

AR/MF/062/19

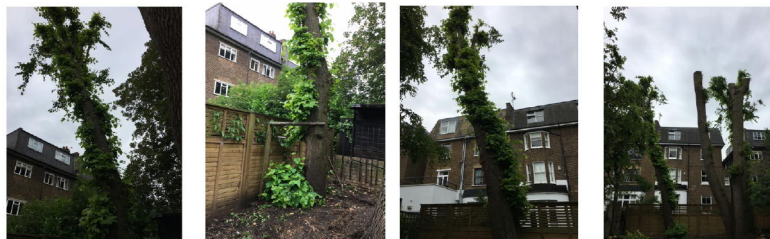
- Significant cavities within original pollard points - up to 1m depth as reported by climbing arborist with significant water collection - see photo of example of extent of cavity within tree T1 - taken 12th March 2019

- Unbalanced and inappropriate within the rear garden location very close to properties on Adamson Road to the south, taking account of structural defects and significant and cyclical management required to manage. Photos below show the trees incongruous form within the current garden landscape

4.8 Therefore the trees are recommended for removal in order to provide appropriate replacement plantings for the long term. The removal of the tree will not impact upon amenity value or canopy cover within the rear garden and wider landscape and proposed planting is recommended* with the following species to provide direct replacement:
