Simon Pryce Arboriculture

Date: 16 June 2019
Your ref:
My ref 19/032
FAO Brian Kernahan
By e mail

51 Belsize Park Gardens - site for new bin store at the front

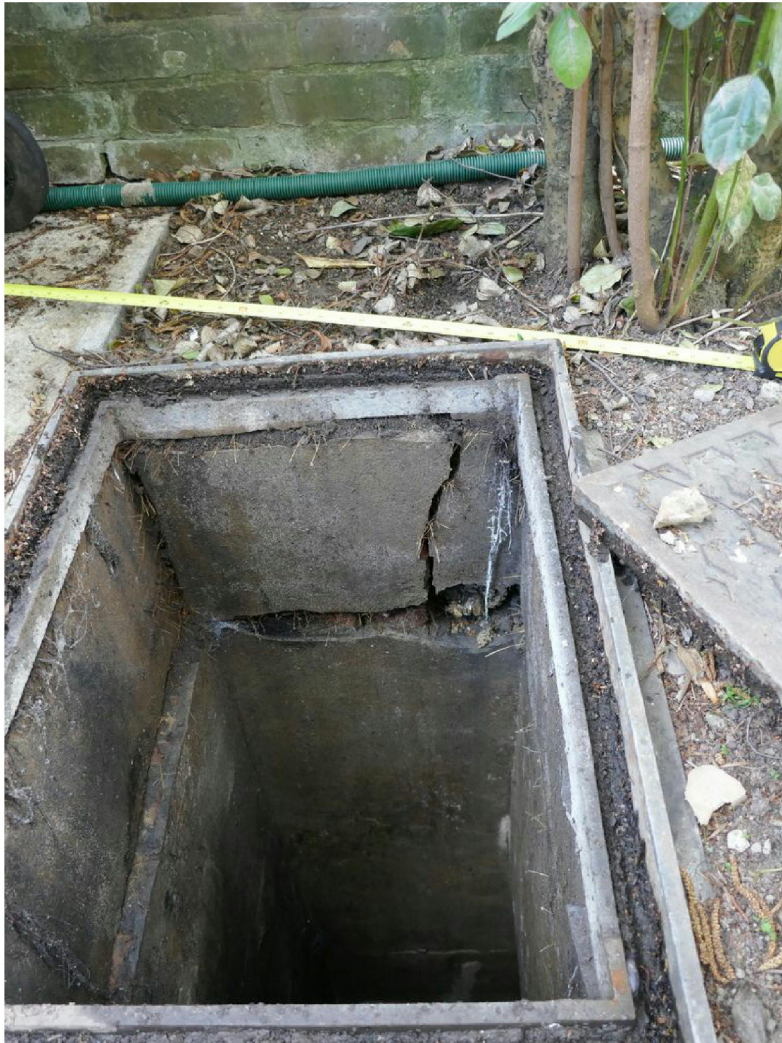
Photograph

4. We lifted the cover to inspect the drain, which is about 3m deep. The shaft has severe cracking showing that it was built with bricks and lined with concrete. The uppermost section has vertical cracks in each of the shorter sides and has displaced about 30mm laterally towards the front wall, i.e. away from the shrub. The joints between the sections and the shaft and cover base have opened and there are numerous roots growing through them and the cracks. I did not take samples of these, there is a small pink flowered thorn in front of no.53, but that is the other side of the boundary wall and the only likely source of these roots is the viburnum.

5. The local subsoil is London clay, which creates a potential for subsidence where roots dry the soil beneath structures, so that it shrinks. However the damage here is clearly due to direct pressure from the main roots of the viburnum pushing the uppermost section of the inspection shaft. It appears that the forward side is now being restrained by the concrete slab, but the other side of the shaft is still under pressure from the roots and the distortion and cracking is particularly severe in the rear left hand corner near the base of the shrub. The cover frame is heavy duty so has not distorted, which makes the damage less obvious than it might otherwise be.

View into the drain, showing severe cracking and the base of the viburnum to the far right, as seen from this direction.

6. The viburnum is mature, but healthy and capable of some more growth, so the problem will worsen if it is left. Pruning can address indirect clay shrinkage problems, but is not effective where the problem is due to direct pressure from the main roots of the tree or shrub. The upper section of the shaft would need to be rebuilt and the cover base refitted, which would inevitably involve major damage to the shrub. It is unlikely to survive that, so the only practical option is to remove it.
