Wheatsheaf Yard

Structural Appraisal of Front Façade to 50c Red Lion Street

Document: 1742.R03.P1
Date: 10.06.2019

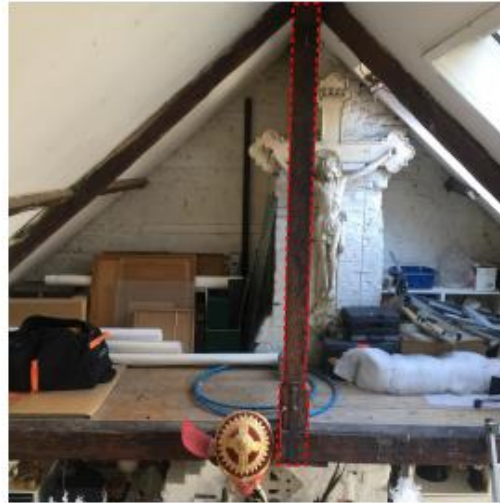
Figure 2a: Truss Four

B: Reconfigured Trusses

T4 has maintained the most original features of the four timber trusses supporting the roof (see figure 2a). The timber rafters, king post and bottom chord remain largely untouched. The steel plate connection also follows a similar style to the connections found on the timber post inset from the front façade on the ground floor (see figure 2b). T1, T2 and T3 have been altered, this is most clear on T2 where the rafter to the front façade has been removed and a timber purlin added to support the cut rafter and transfer loads to T1 and T3 (see figure 2c). These alterations prevent the truss from working as it was originally designed. Additional timbers have also been added to T1 and T3 to support a large dormer window (see figure 2d). These alterations are evidence that the front façade has been modified significantly at this level.

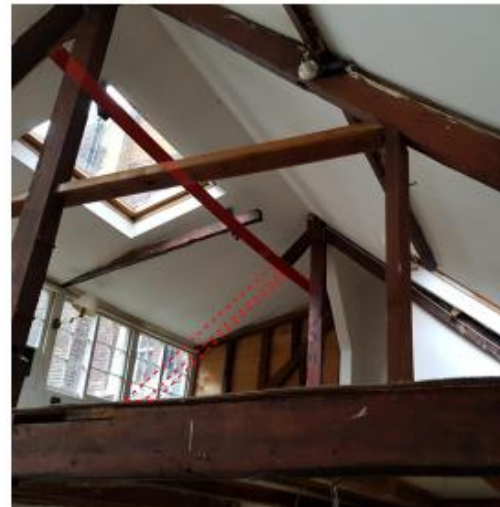
Figure 2c: Reconfigured Truss Two

We believe the installation of the dormer has significantly compromised two of the timber trusses (T2 and T3) as well as altered the original appearance of the roof and front façade.

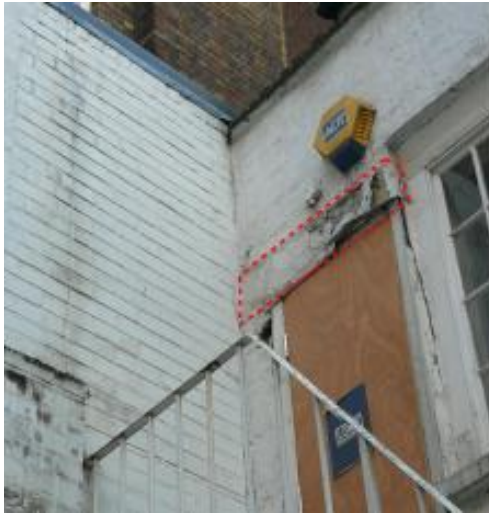
Figure 3: Decaying Timber Lintel

C: Decaying Timber Lintel

The timber lintel supporting masonry above the entrance from the top of external stair shows signs of water ingress (see figure 3). The lintel looks to have been painted white, which is peeling away from the timber, this could be a sign of decay to the timber.

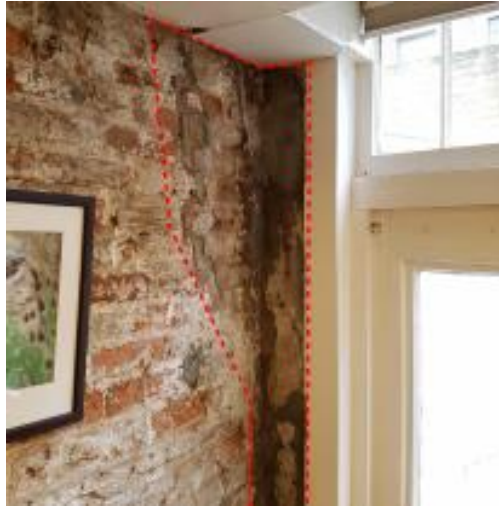
Figure 4a: Bed Joint – 7a Lambs Conduit

David Kohn Architects (DKA) drawing 218-PL02-01 shows a 300mm thick masonry wall to the north side of 50c Red Lion Street (see 'Site Schematic Plan' on 1742.SK05), the 300mm thick wall is likely to resemble the original external wall to 7a Lambs Conduit Passage. The masonry wall to the front façade of 50c Red Lion Street is stack bonded to the south wall of 7a Lambs Conduit Passage with a vertical joint (see figure 4a). Large cracks can be seen in the spandrel panel near the junction of these two walls that would suggest the wall to 50c Red Lion Street has pulled away from 7a Lambs Conduit Passage (see figure 7). Similarly, large cracks can be seen internally where the two walls meet at ground floor level (see figure 4a). The same bonded junction exists between the front wall and 18 Princeton Street (see figure 4b). Based on this information, we believe it reasonable to assume the current rear and front walls to 50c Red Lion Street were constructed after both 7a Lambs Conduit Passage and 18 Princeton Street were complete.

The brickwork is concealed behind decaying fascia board, internally the brickwork shows signs of severe cracking along the vertical joint adjoining the front façade of 50c Red Lion Street to 7a Lambs Conduit Passage (see figure 4a). Due to the bearing of the first floor bressummer beam, a large portion of load is concentrated through this narrow panel. When combined with the poor condition of the brickwork and the decaying first floor bressummer beam which has been exposed to water from the leaking drainpipe, there is a risk that the beam may pull away from the brickwork, or the masonry pier may fail, resulting in a partial failure of the front façade.

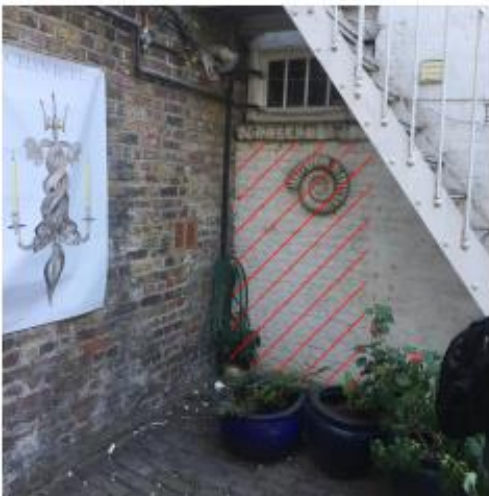
Figure 5: Infill Panel

E: Brick Infill

Fresh paintwork and pronounced mortar suggest this section of brickwork is a more recent addition to the brickwork surrounding it (see figure 5). This implies a previous entrance to the building would have been located here. The infill brickwork panel is another indication that the front façade seen presently does not match that of the original façade and further alters the original load paths.

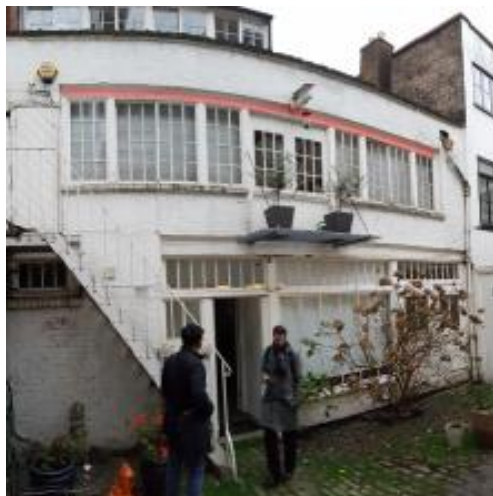
Figure 6: Second Floor Bressummer beam

F: Second Floor Bressummer Beam

Three of the four trusses are supported on a shallow bressummer beam at the front of the building (see figure 6), this beam is supported on a series of timber posts also acting as mullions to frame the second-floor windows. The structure of the roof is largely dependent on this beam. The lintel complicates the load paths by directing roof loads through timber posts onto the masonry spandrel panel and down onto the first-floor lintel, resulting in an indirect load path to the ground. Signs of cracking to the spandrel panel above and decay to the timber beam due to exposure to moisture show the beam is in poor condition.

To conclude, the existing timber bressummer beams are in poor condition and we would recommend they are removed and replaced with new timber or galvanised steel beams. These lintels play a crucial structural role to the front facade and to facilitate their replacement would require significant temporary works to support the spandrel panel, parapet and three of the four timber trusses.

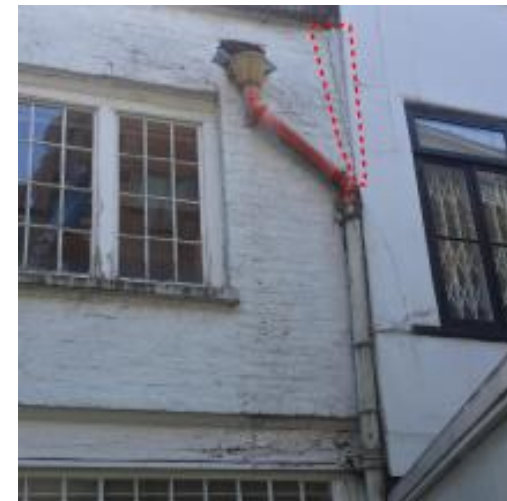
Figure 7: Drainpipe

G: Drainpipe

The downpipe on the front façade shows signs of recent renovation. Fixing bracket details for the vertical element appear to be from steel whereas the angled section of pipe and its fixing brackets appear to be from PVC (or a similar plastic) (see figure 7). This suggests the upper part of the pipe has been replaced and may have previously continued vertically instead of being orientated on the angle, resulting in the creation of a new opening in the brickwork parapet. In the drainpipe's latest arrangement, a blockage or failure to the pipe would likely cause water ingress to either the second floor bressummer beam or the large vertical crack between the front façade and the external wall to 7a Lambs Conduit Passage. There is also evidence of water damage to the first floor bressummer beam due to water leaking from the drainpipe (see figure 7). The brickwork is also stained over the first floor lintel due to water from the hopper.

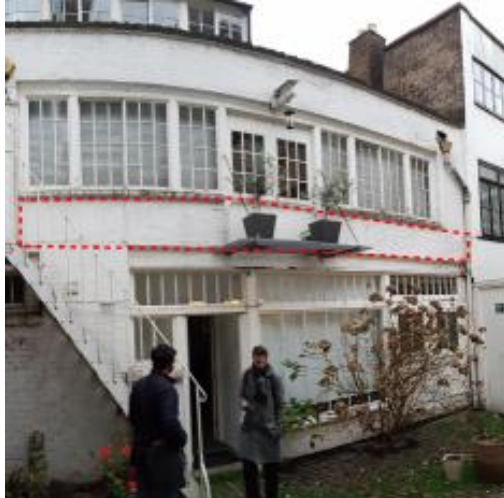
Figure 9: Spandrel Brick Panel

H: Spandrel Brick Panel

The spandrel panel is supported on a deep bressummer beam below and looks to be in reasonable condition (see image 9). The panel transfers point loads from the timber posts above to the timber bressummer beam below. There appear to be no concerning signs of cracking or wear to the brickwork.

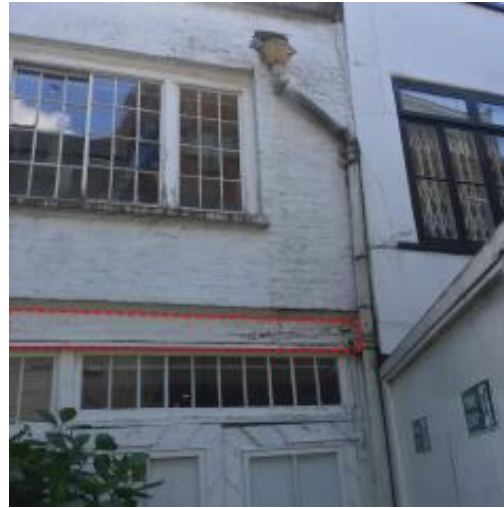
Figure 10: First Floor Lintel

I: First Floor Bressummer Beam

This exposed timber element supports brickwork from the spandrel panel above. It's depth and frequent supports show the original design intent to support wall, truss and therefore roof loads from above. The near equidistant timber post supports create rational load paths for loads to reach the ground (see figure 10). Based on visual information, we believe the beam to be original. The 7a Lambs Conduit Passage end of the lintel appears to show signs of warping and general decay due to the leakage from the drainpipe. With the beam also continuously exposed to the elements, it would be prudent to suggest it were to be replaced.

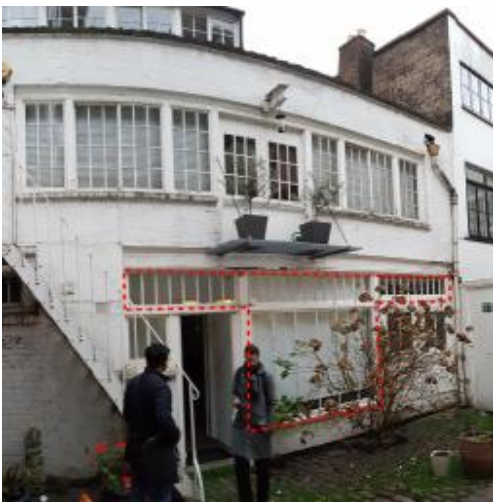
Figure 11: Ground Floor Windows

J: Ground Floor Windows

Based on conversations with the client and neighbours on previous site visits, it is understood that the fenestration windows in place on the ground floor are dated back to the 1970s (see figure 11). Whilst the openings to the façade on the ground floor may match that of the original facade, the windows and framing that now remain are not original.

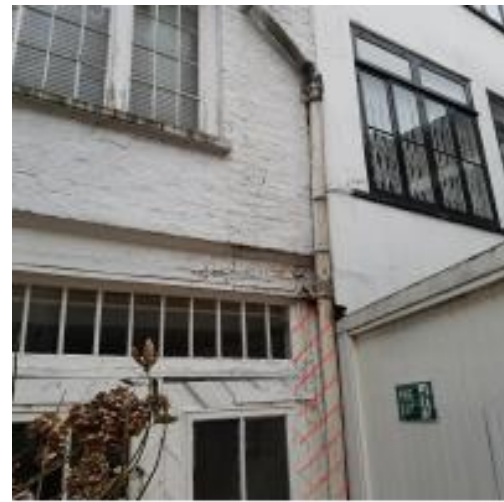
Figure 12: Brick Panel

K: Brick Panel

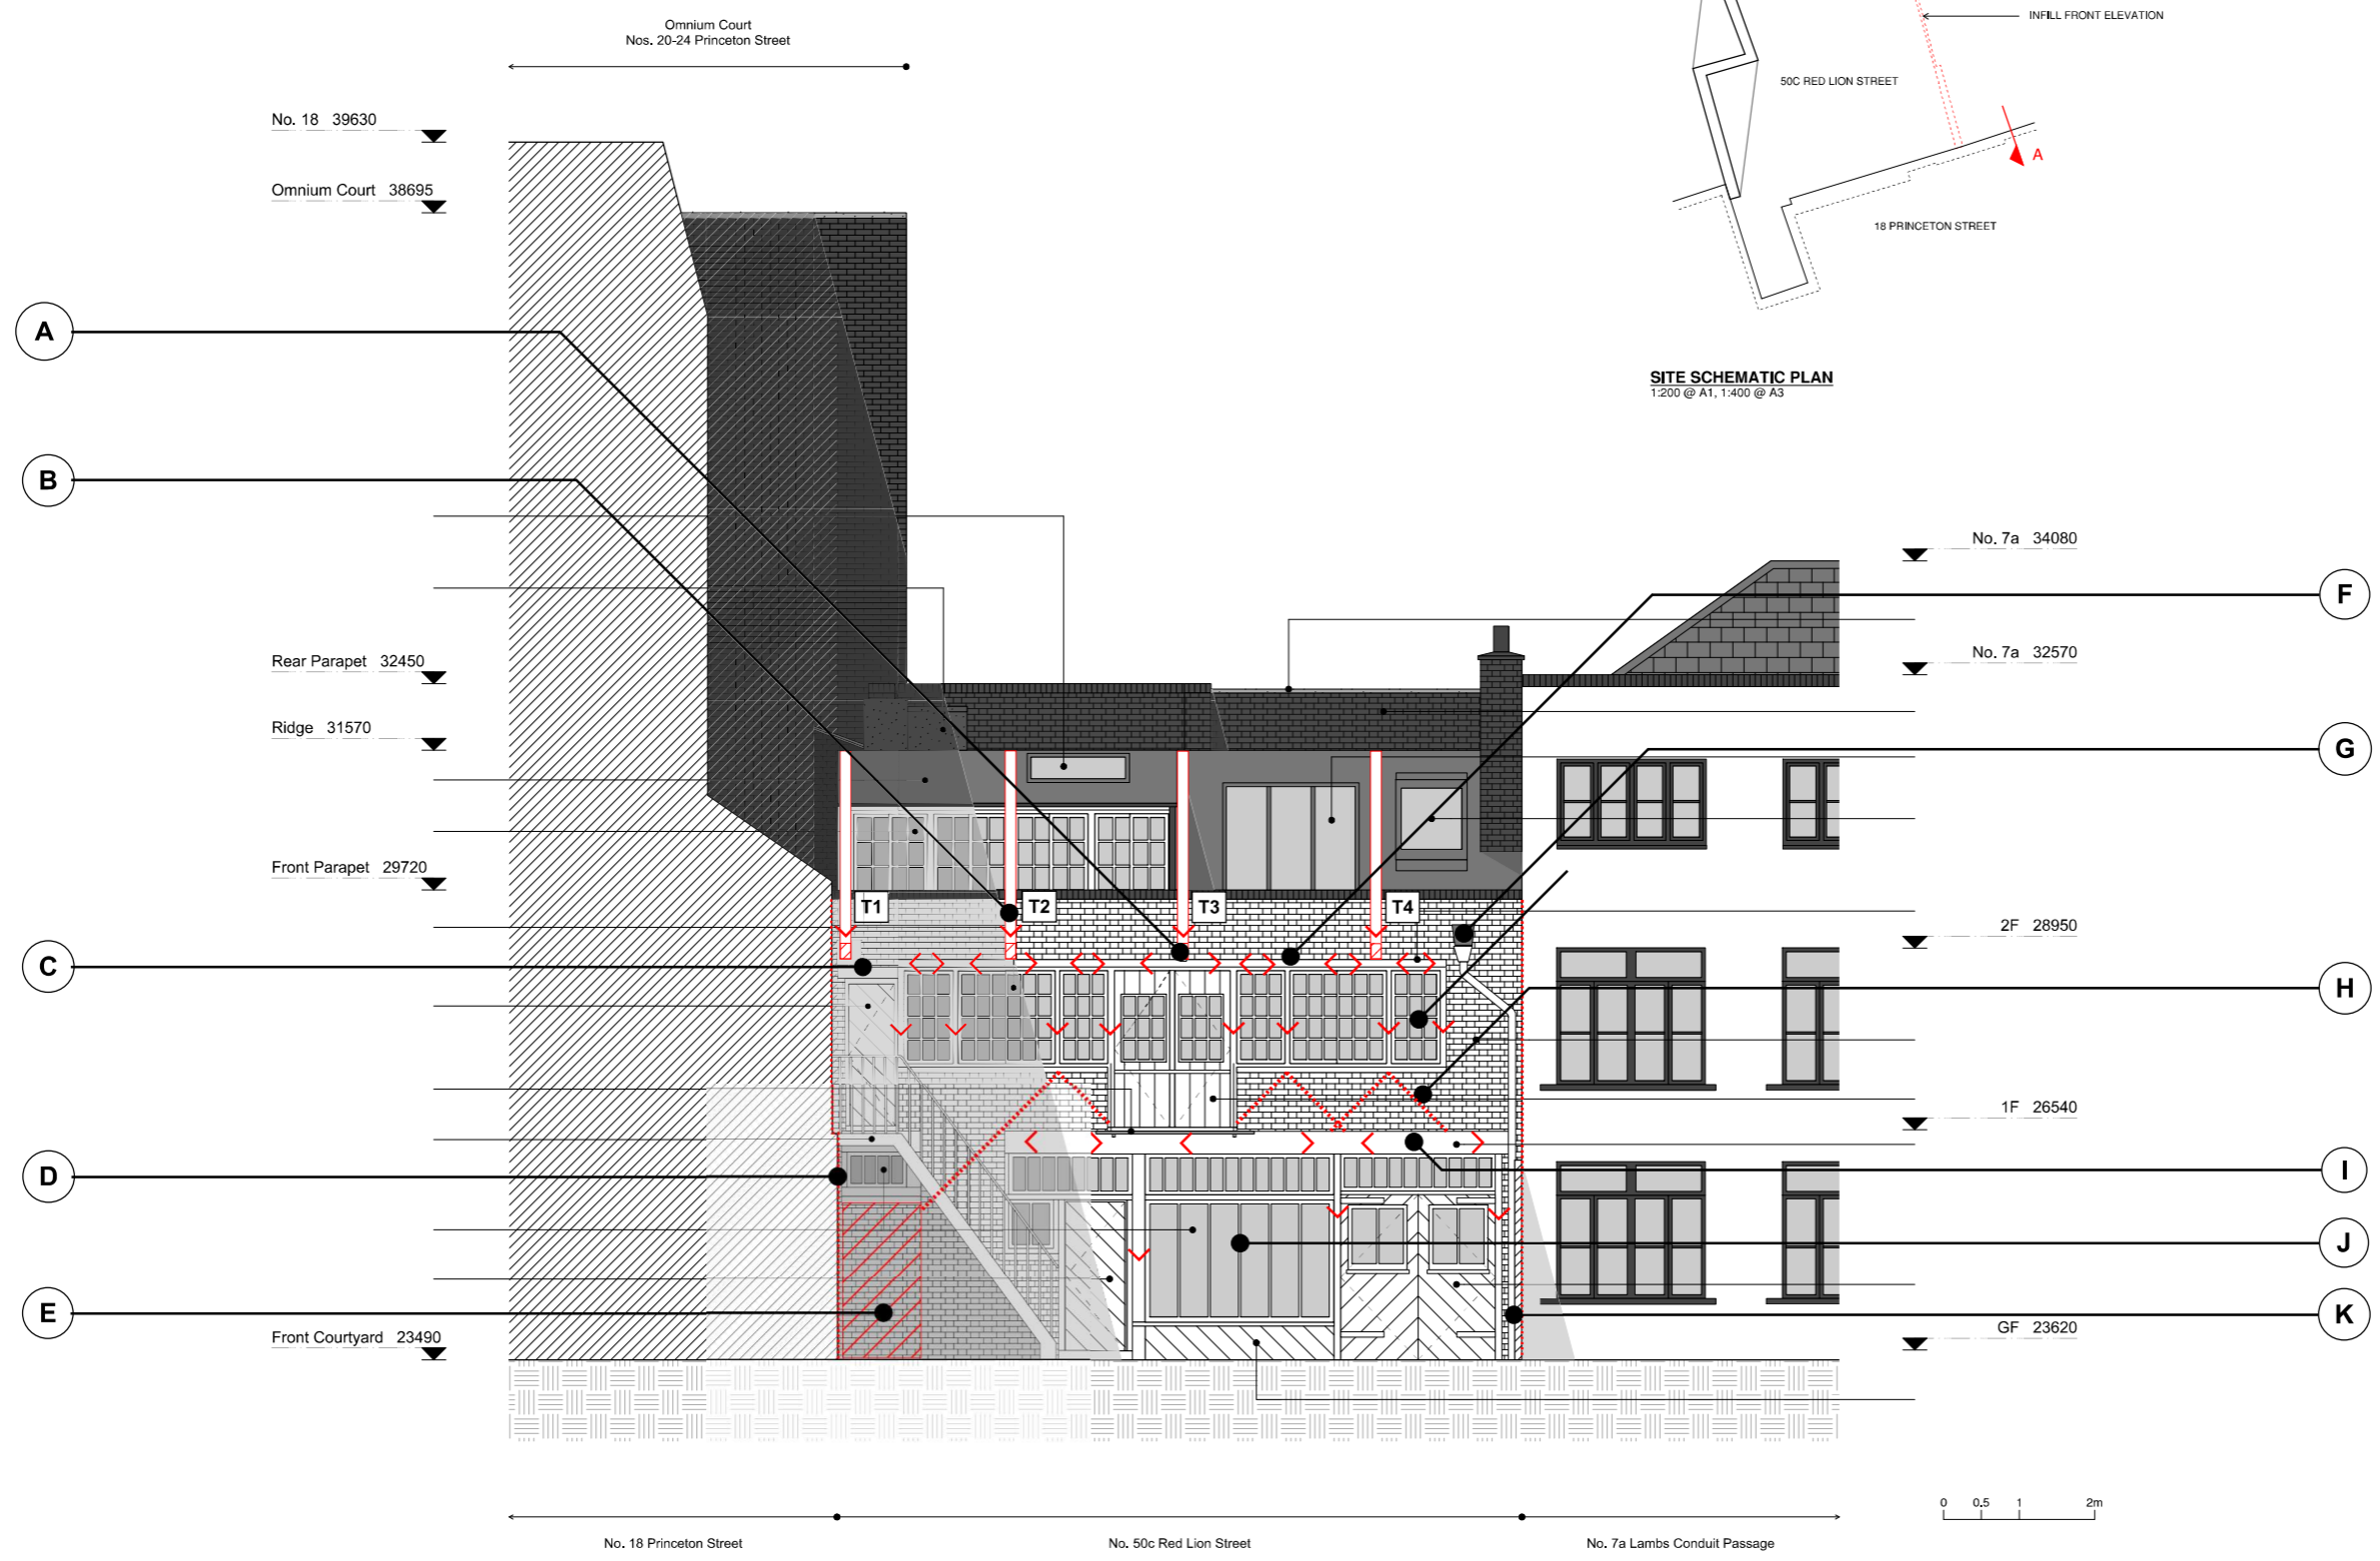
ELEVATION A-A
 1:50 @ A1, 1:100 @ A3

Appendix A – Structure Workshop drawing 1742.SK05.I1 highlighting all structural defects
