Asbestos Survey Report
Project Ref. No: 133483
Highgate Newtown The Cottage
Demolition survey

Highgate Newtown The Cottage

Survey Type: Demolition survey

Project Reference Number: 133483

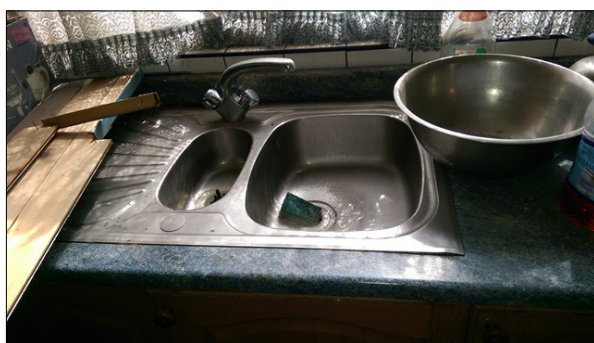
Non asbestos bitumen sink pad (1 off)

Action required:	None		
Next action due date:	N/A	Approx cost:

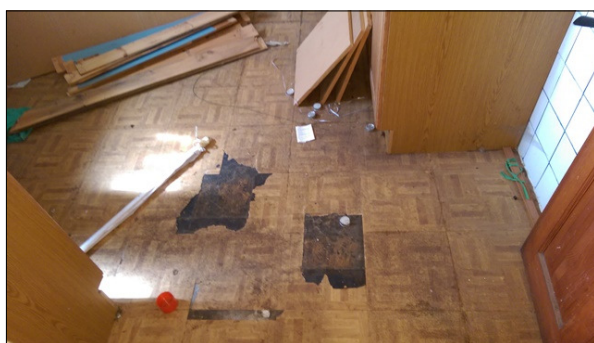
Condition:	Low damage	Accessibility:	Occasional disturbance likely (1)
Friability:	Low	Exposure:	Public
Surface:	Composite materials: reinf plastics	Amount:	>10 sq m < 50 sq m (2)
Position:	Room up to 100 sq m (2)	RISK:	VERY LOW (3)

Thermoplastic brown floor tile with bitumen adhesive. Asbestos in tile and bitumen (12m2)

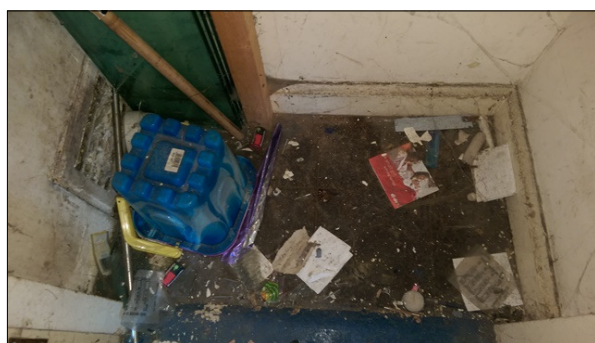
Condition:	Good condition	Accessibility:	Occasional disturbance likely (1)
Friability:	Low	Exposure:	Public
Surface:	Composite materials: reinf plastics	Amount:	<= 10 sq m (1)
Position:	Room up to 100 sq m (2)	RISK:	VERY LOW (2)

Thermoplastic brown floor tile with bitumen adhesive. Strongly presumed asbestos in tile and bitumen (1m2)

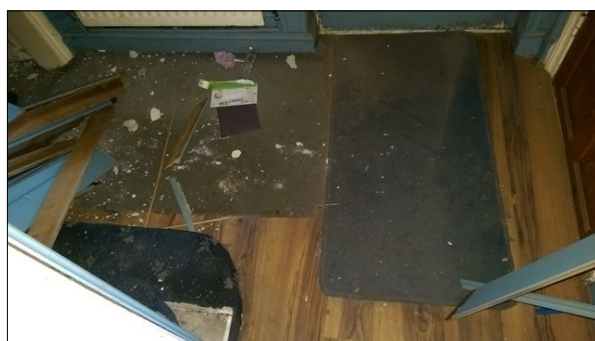
Condition:	Good condition	Accessibility:	Occasional disturbance likely (1)
Friability:	Low	Exposure:	Public
Surface:	Composite materials: reinf plastics	Amount:	<= 10 sq m (1)
Position:	Room up to 100 sq m (2)	RISK:	VERY LOW (2)

Thermoplastic brown floor tile with bitumen adhesive. Strongly presumed asbestos in tile and bitumen (4m2)

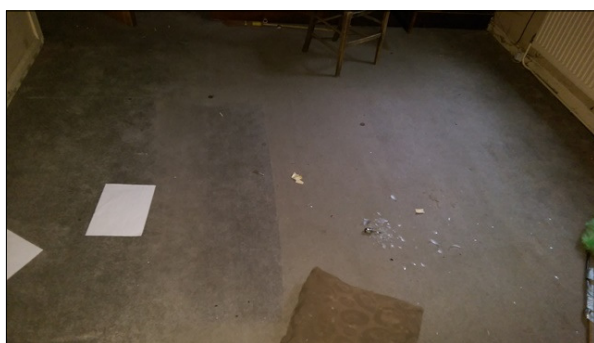
Condition:	Good condition	Accessibility:	Occasional disturbance likely (1)
Friability:	Low	Exposure:	Public
Surface:	Composite materials: reinf plastics	Amount:	>10 sq m < 50 sq m (2)
Position:	Room up to 100 sq m (2)	RISK:	VERY LOW (2)

Thermoplastic brown floor tile with bitumen adhesive. Strongly presumed asbestos in tile and bitumen (12m2)

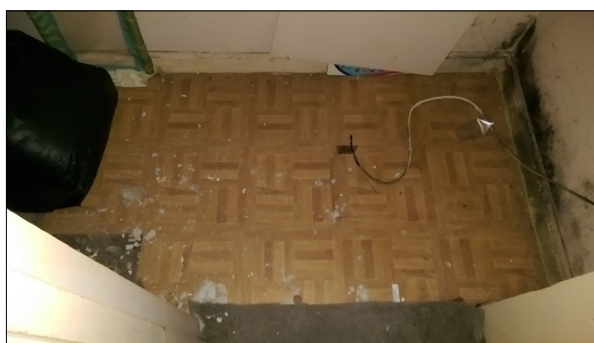
Condition:	Good condition	Accessibility:	Occasional disturbance likely (1)
Friability:	Low	Exposure:	Public
Surface:	Composite materials: reinf plastics	Amount:	<= 10 sq m (1)
Position:	Room up to 100 sq m (2)	RISK:	VERY LOW (2)

Thermoplastic brown floor tile with bitumen adhesive. Strongly presumed asbestos in tile and bitumen (2m2)

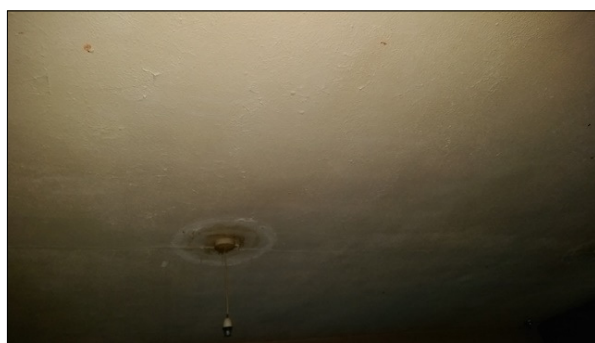
Non asbestos textured coating to ceiling (12m2)

Action required:	None		
Next action due date:	N/A	Approx cost:

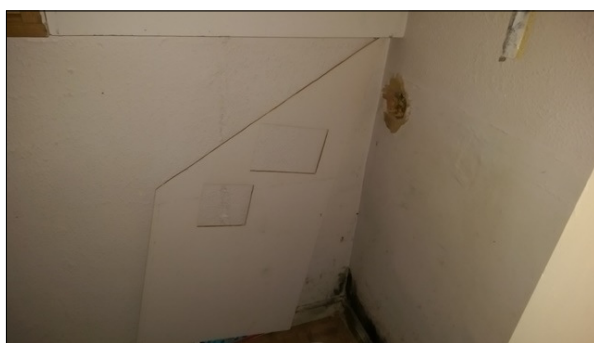
Non asbestos textured coating to wall (2m2)

Action required:	None		
Next action due date:	N/A	Approx cost:

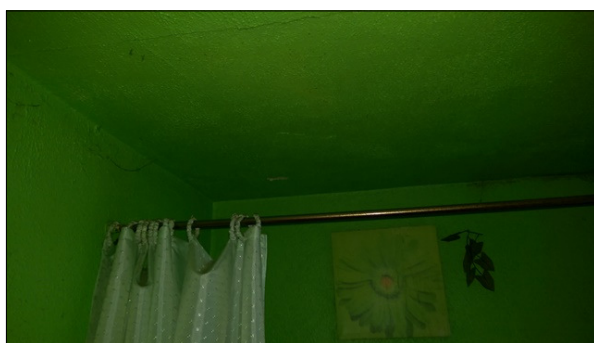
Non asbestos textured coating to walls and ceiling (6m2)

Action required:	None		
Next action due date:	N/A	Approx cost:

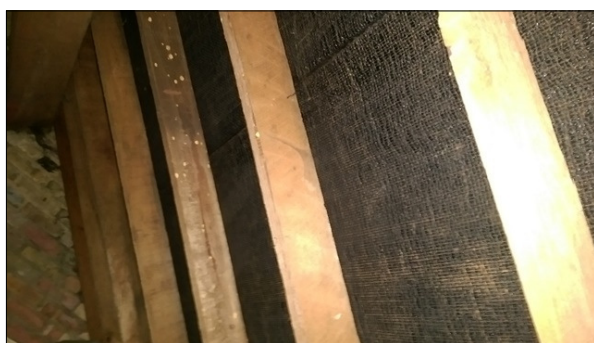
Non asbestos bitumen roof felt (40m2)

Action required:	None		
Next action due date:	N/A	Approx cost:
