Asbestos Survey Report
Project Ref. No: 133483
Highgate Newtown Fresh Youth Academy
Demolition survey

Survey Type: Demolition survey

Project Reference Number: 133483

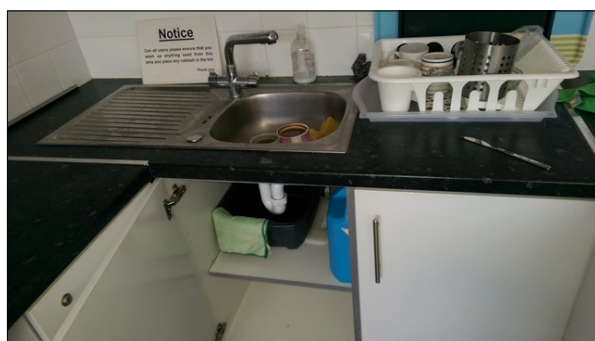
Non asbestos bitumen to sink pad (1 no.)

Action required:	None		
Next action due date:	N/A	Approx cost:

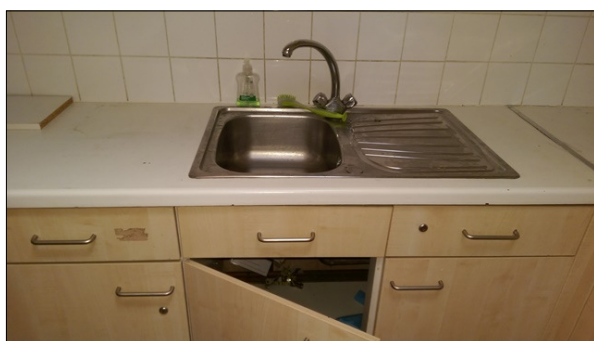
Non asbestos bitumen to sink pad (1 no.)

Action required:	None		
Next action due date:	N/A	Approx cost:

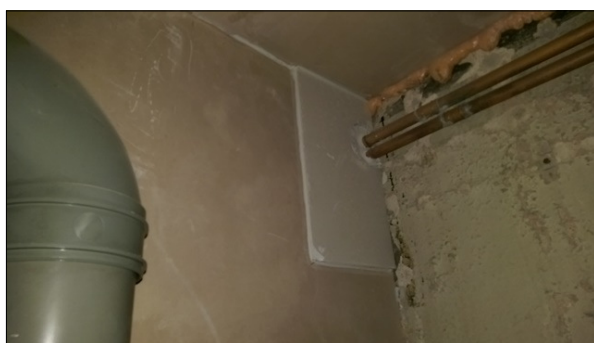
Non asbestos insulating board panel to wall surrounding pipe work (<1sqm)

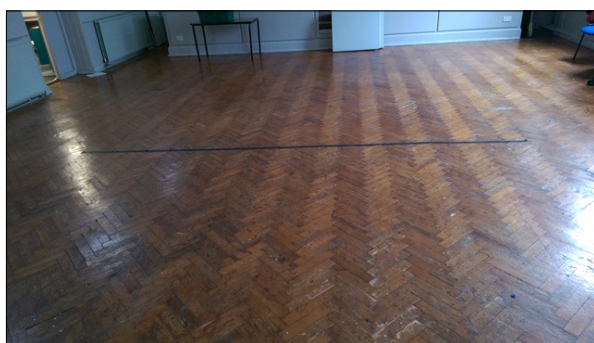
Non asbestos bitumen adhesive to concrete floor under parque (60sqm)

Action required:	None		
Next action due date:	N/A	Approx cost:

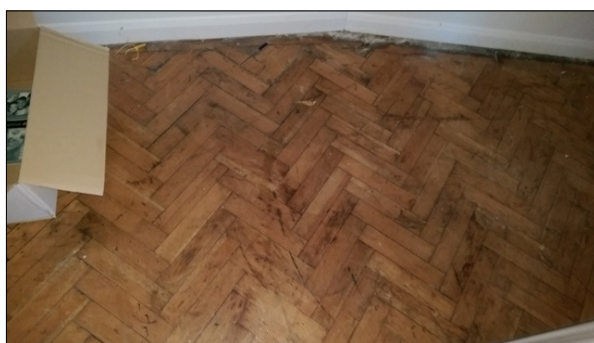
Non asbestos bitumen adhesive to concrete floor under parque (3sqm)

Action required:	None		
Next action due date:	N/A	Approx cost:

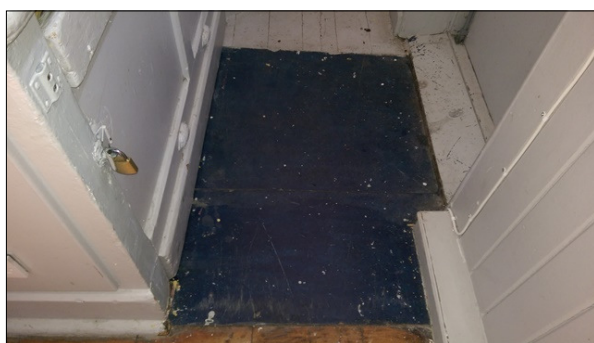
Non asbestos lino (blue) to floor with textile back (2sqm)

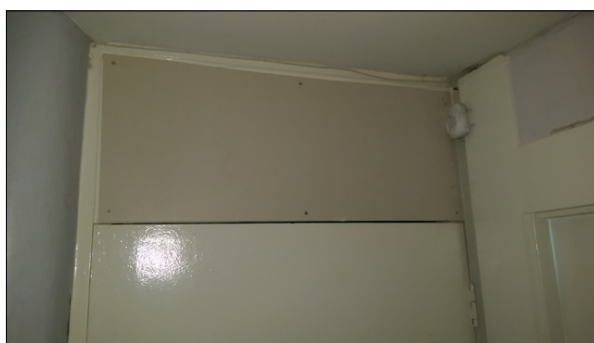
Non asbestos insulating board infill panel above door (<1sqm)

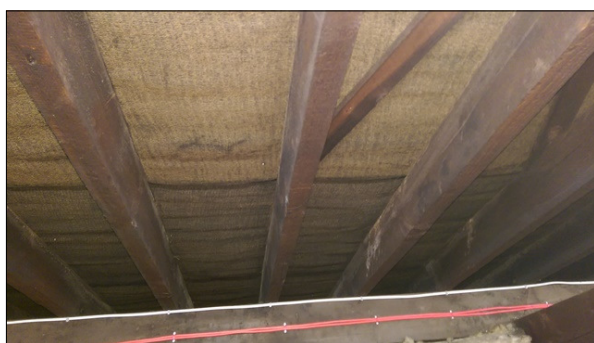
Non asbestos bitumen roof felt (<50sqm)

Action required:	None		
Next action due date:	N/A	Approx cost:

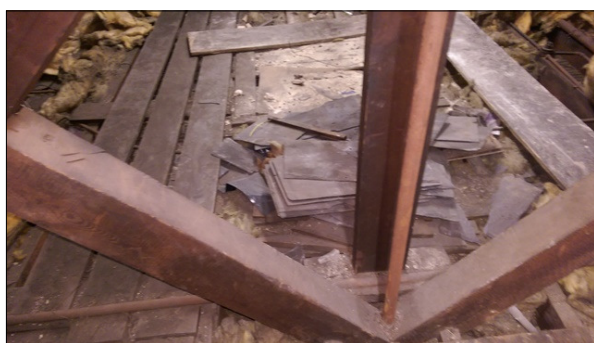
Non asbestos cement slate debris throughout loft (<1sqm)

Action required:	None		
Next action due date:	N/A	Approx cost:

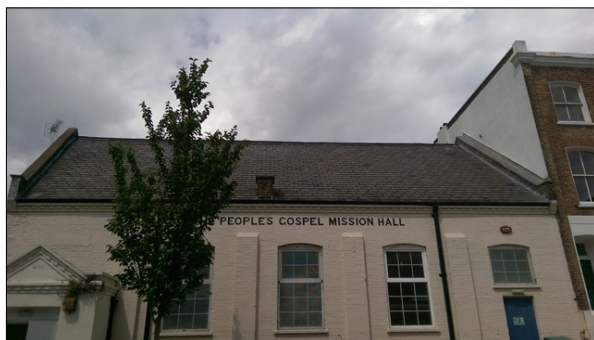
Non asbestos cement slate roof tiles (<50sqm)

Action required:	None		
Next action due date:	N/A	Approx cost:

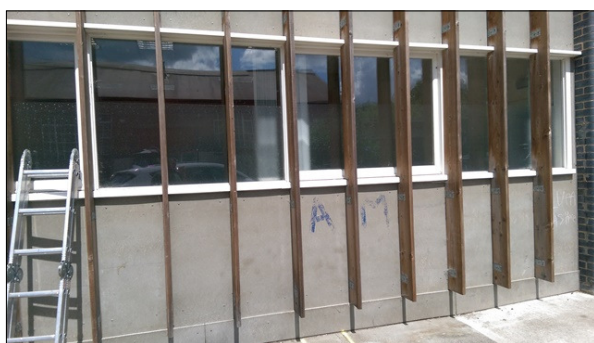
Non asbestos cement panel forming external wall (25sqm)

Action required:	None		
Next action due date:	N/A	Approx cost:
