Asbestos Survey Report
Project Ref. No: 133483
Highgate Newtown Workshop
Demolition survey

Highgate Newtown Workshop

Survey Type: Demolition survey

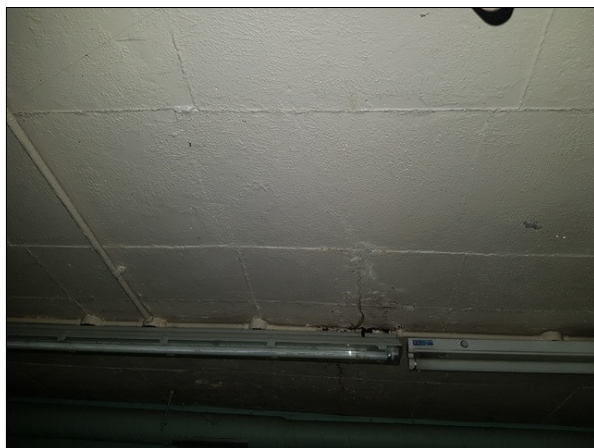
Non asbestos textured coating to ceiling (8m2)

| Action required: | None | | |

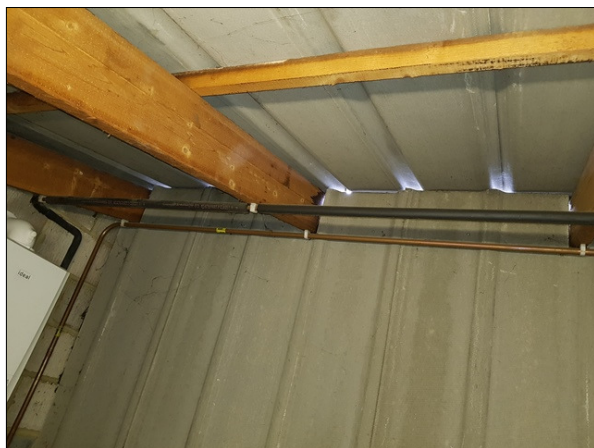
Non asbestos cement panel forming ceiling and back wall (12m2)

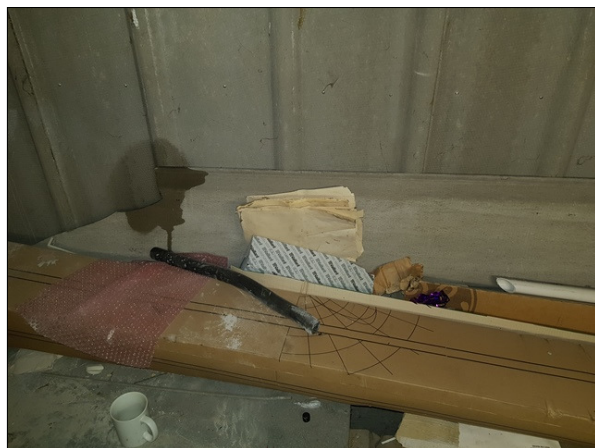
Non asbestos cement debris to floor (2m2)

| Action required: | None | | |

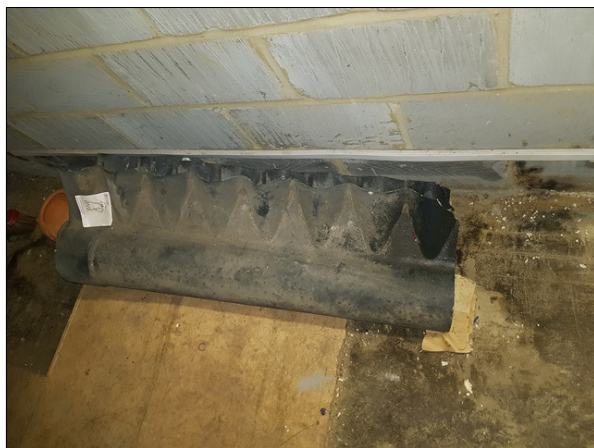
Non asbestos cement debris to floor (2m2)

| Action required: | None | | |

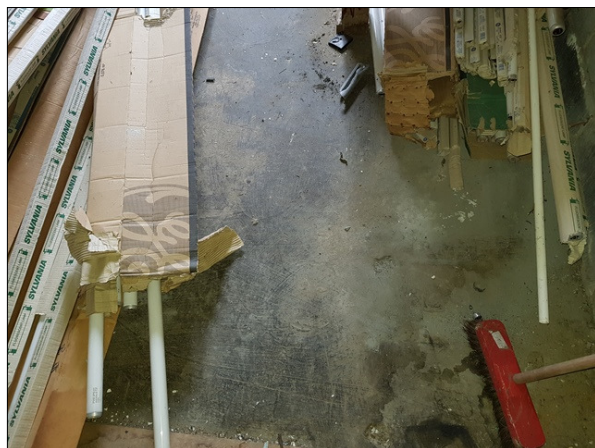
Non asbestos bitumen felt to floor (2m2)

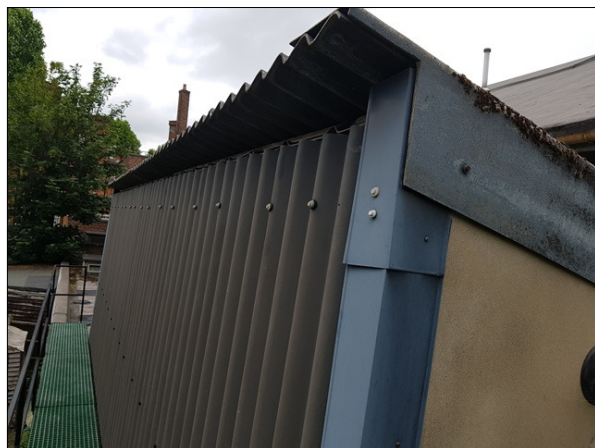
Non asbestos cement corrugated roof (12m2)

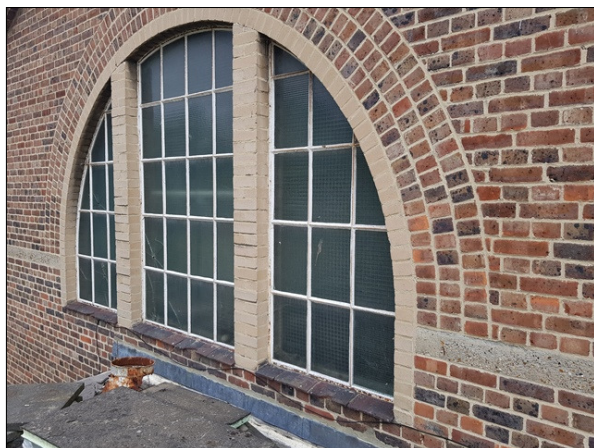
Non asbestos putty seal to windows throughout external (10m2)

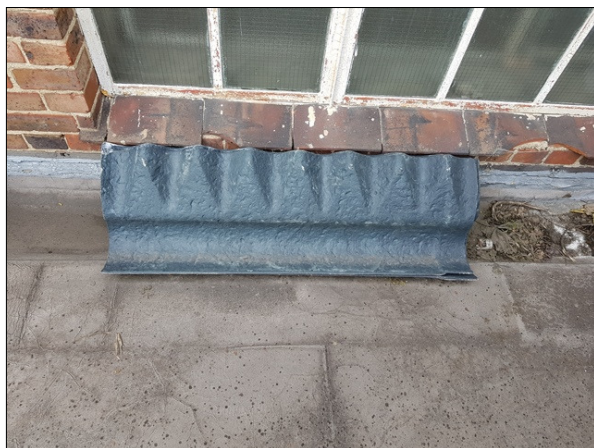
Non asbestos cement debris to floor against wall (10m2)

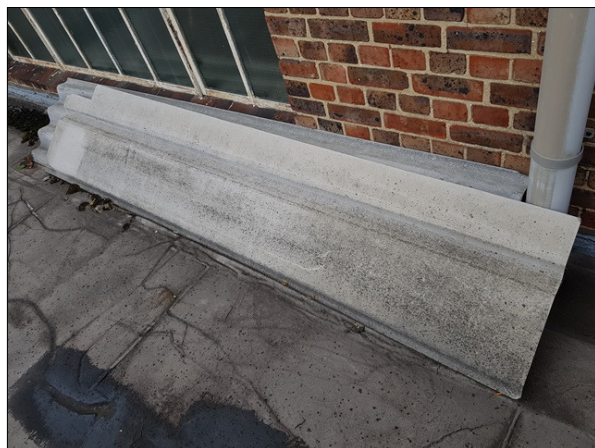
Non asbestos cement debris to floor against wall (10m2)

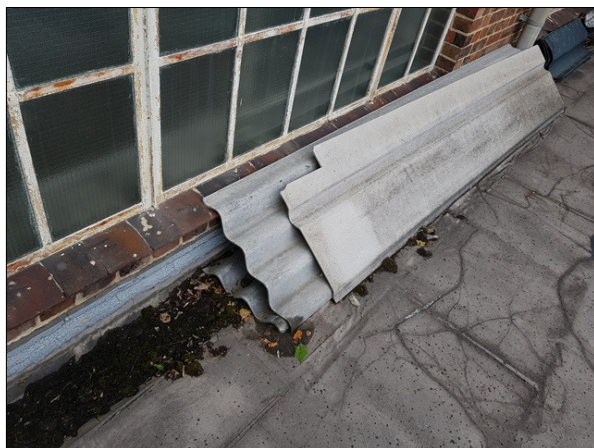
Non asbestos cement debris to floor against wall (10m2)

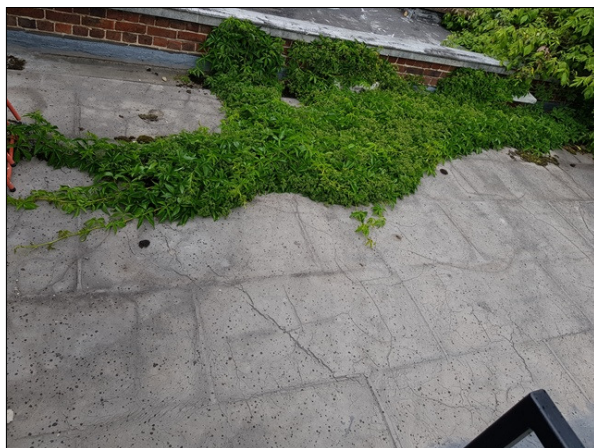
Non asbestos bitumen ashfelt to roof throughout (130m2)

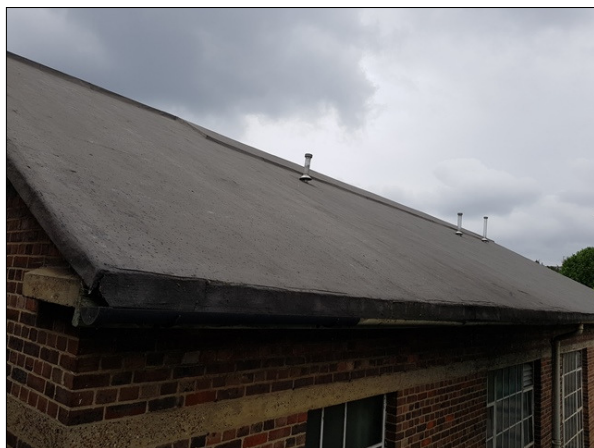
Non asbestos bitumen ashfelt to roof throughout (300m2)

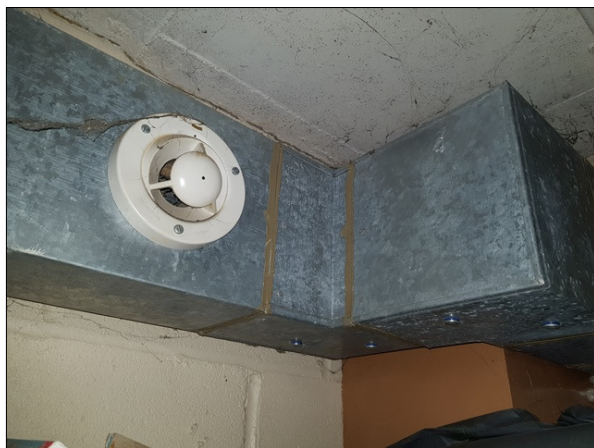
Non asbestos mastic seal to pipe work units throughout (10m2)

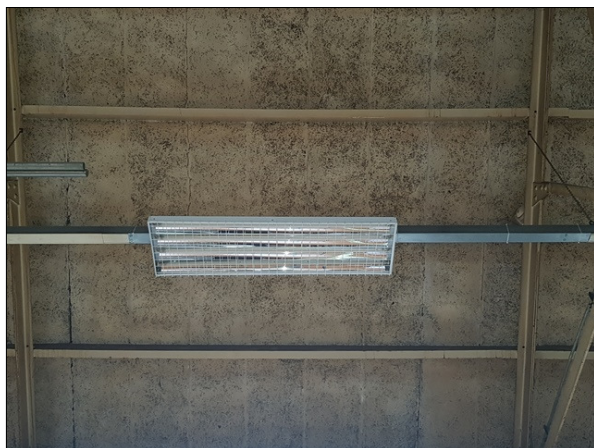
Non asbestos straw boards to ceiling (300m2)

| Action required: | None | | |

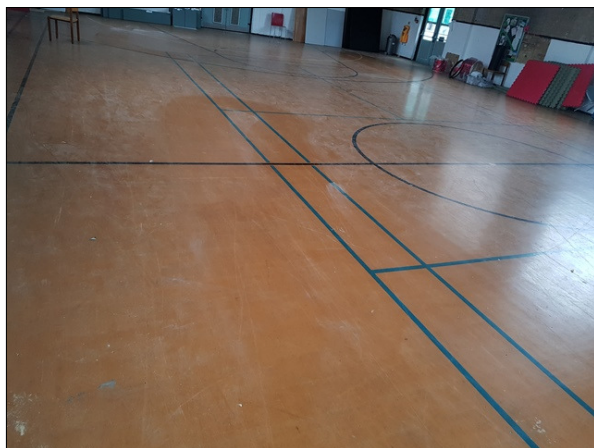
Non asbestos vinyl floor tile with non asbestos bitumen adhesive (300m2)
