**Asbestos Survey Report**  
**Project Ref. No: 133483**  
**Highgate Newtown Community Centre**  
**Demolition survey**

## **Highgate Newtown Community Centre**

**Survey Type:** Demolition survey

**Project Reference Number:** 133483

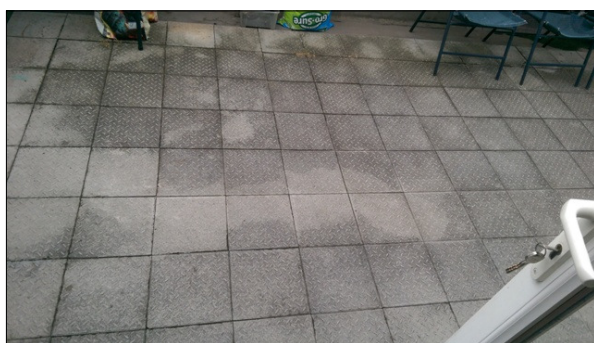
Non asbestos cement floor tiles. (18m2)

| <b>Action required:</b> | None | | |

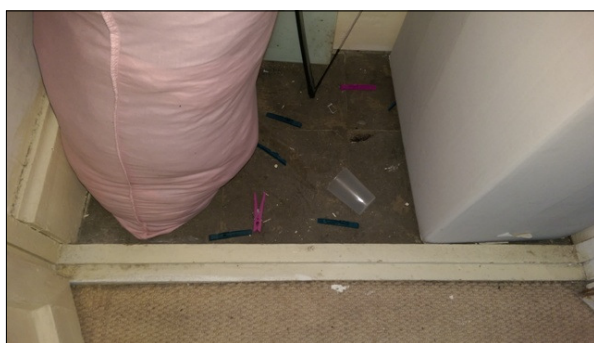
Asbestos thermoplastic floor tiles grey and non asbestos bitumen (Asbestos in tile only) (1m2)

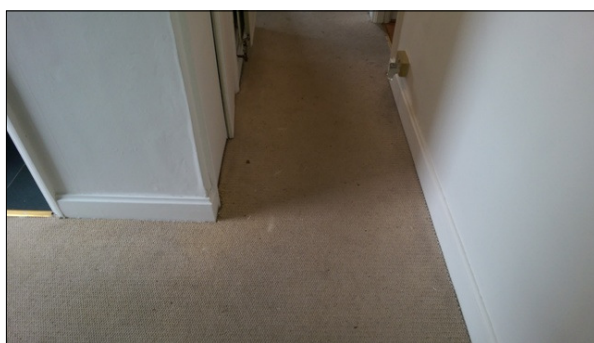
Strongly presumed asbestos thermoplastic floor tiles grey and non asbestos bitumen (Asbestos in tile only) (8m2)

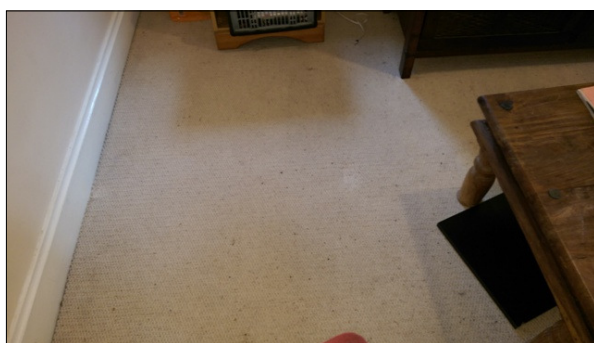
Asbestos thermoplastic floor tiles brown and non asbestos bitumen (Asbestos in tile only) (15m2)

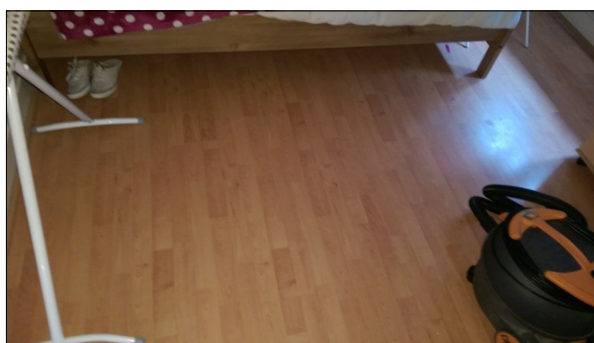
Strongly presumed asbestos thermoplastic floor tiles brown and non asbestos bitumen (Asbestos in tile only) (12m2)

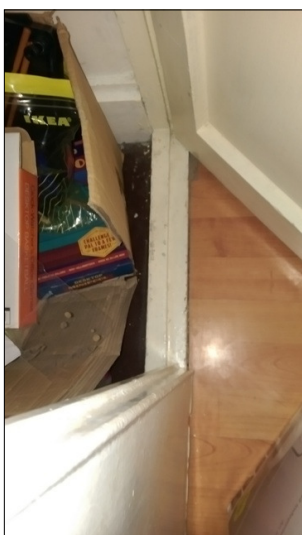
Strongly presumed asbestos thermoplastic floor tiles brown and non asbestos bitumen (Asbestos in tile only) (1m2)

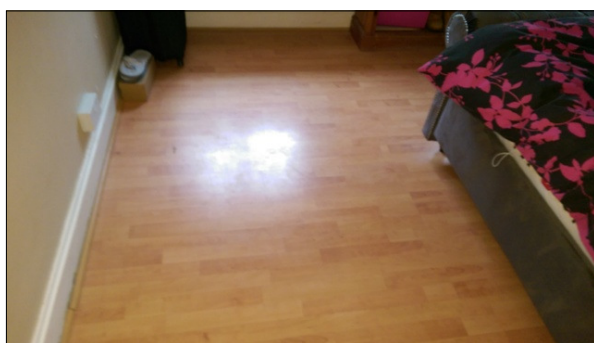
Strongly presumed asbestos thermoplastic floor tiles brown and non asbestos bitumen (Asbestos in tile only) (14m2)

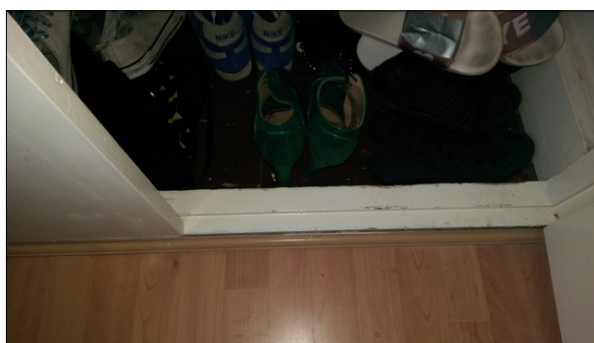
Strongly presumed asbestos thermoplastic floor tiles brown and non asbestos bitumen (Asbestos in tile only) (1m2)

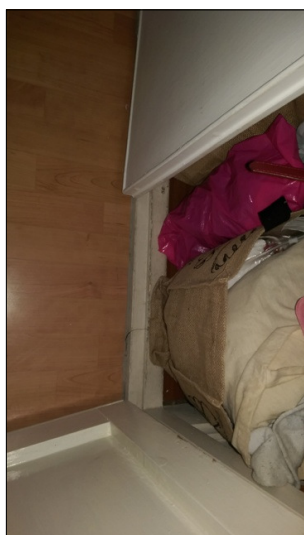
Strongly presumed asbestos thermoplastic floor tiles brown and non asbestos bitumen (Asbestos in tile only) (1m2)

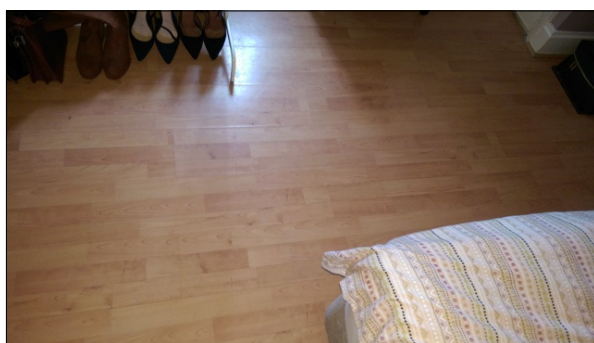
Strongly presumed asbestos thermoplastic floor tiles brown and non asbestos bitumen (Asbestos in tile only) (8m2)

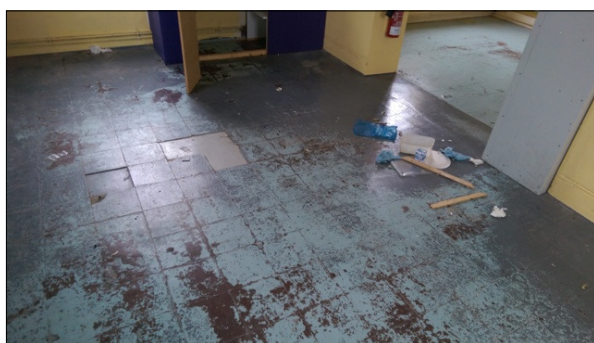
Asbestos thermoplastic floor tiles brown and bitumen (Asbestos was found in both the bitumen and tile) (30m2)

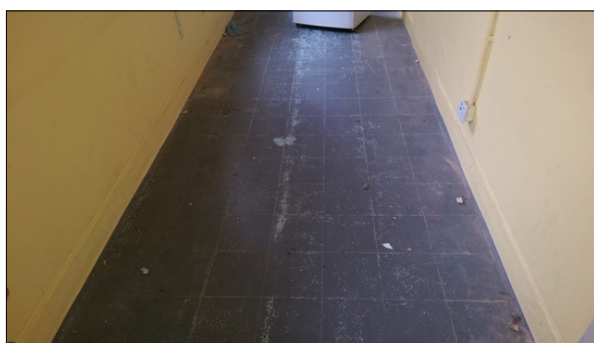
Strongly presumed asbestos thermoplastic floor tiles brown and bitumen (Asbestos was found in both the bitumen and tile) (6m2)

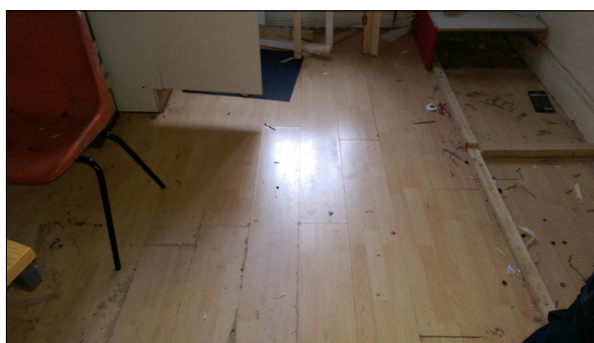
Strongly presumed asbestos thermoplastic floor tiles brown and bitumen (Asbestos was found in both the bitumen and tile) (12m2)

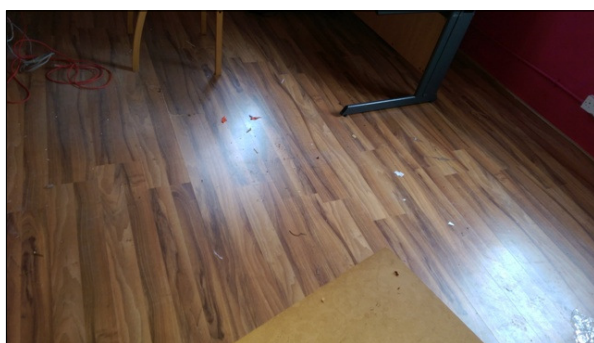
Strongly presumed asbestos thermoplastic floor tiles brown and bitumen (Asbestos was found in both the bitumen and tile) (16m2)

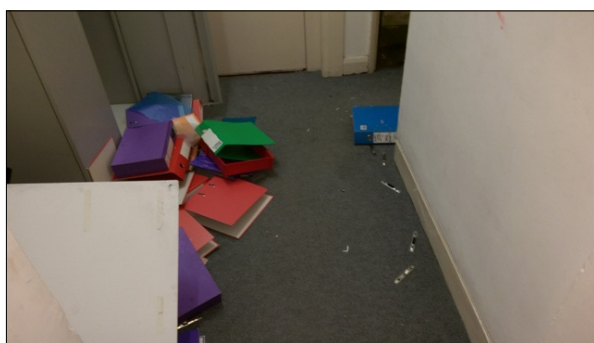
Strongly presumed asbestos thermoplastic floor tiles brown and bitumen (Asbestos was found in both the bitumen and tile) (6m2)

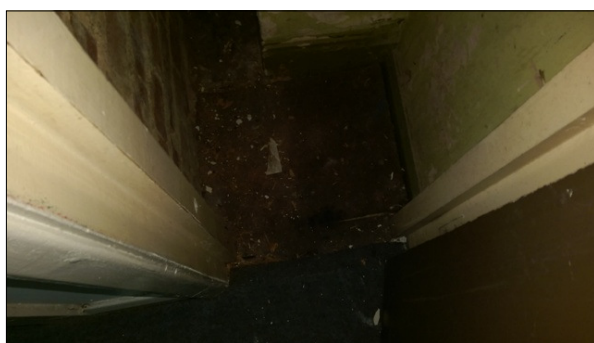
Strongly presumed asbestos thermoplastic floor tiles brown and bitumen (Asbestos was found in both the bitumen and tile) (1m2)

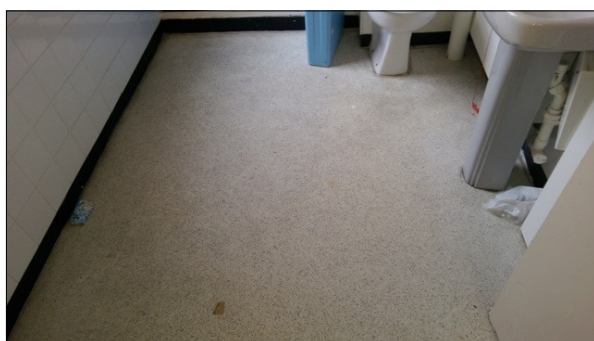
Strongly presumed asbestos thermoplastic floor tiles brown and bitumen (Asbestos was found in both the bitumen and tile) (5m2)

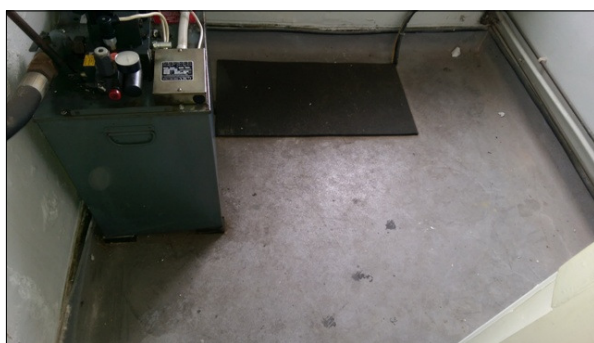
Strongly presumed asbestos thermoplastic floor tiles brown and bitumen (Asbestos was found in both the bitumen and tile) (4m2)

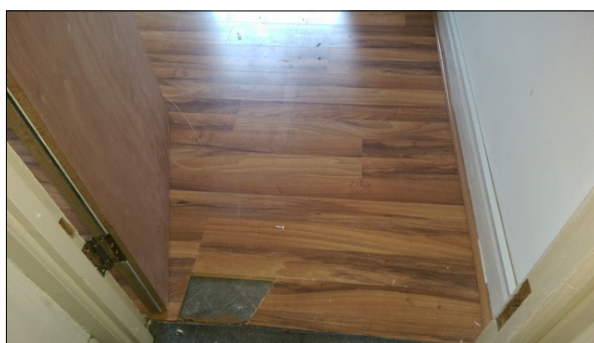
Strongly presumed asbestos thermoplastic floor tiles brown and bitumen (Asbestos was found in both the bitumen and tile) (15m2)

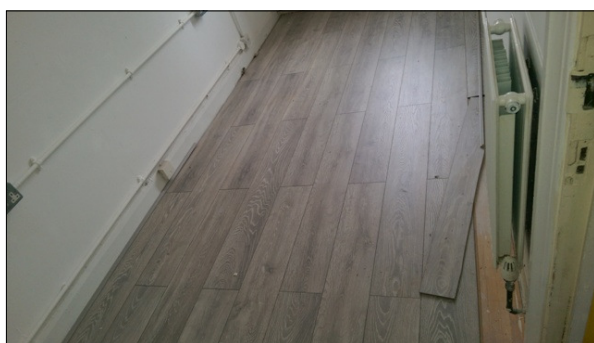
Strongly presumed asbestos thermoplastic floor tiles brown and bitumen (Asbestos was found in both the bitumen and tile) (8m2)

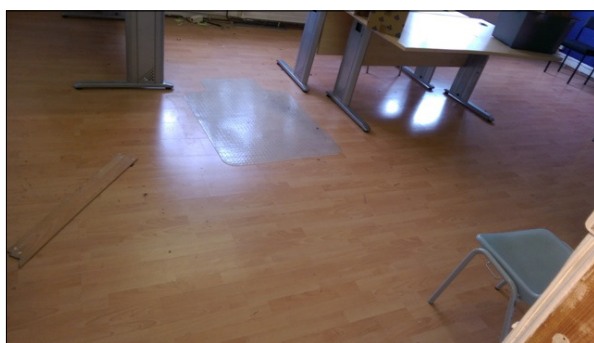
Strongly presumed asbestos thermoplastic floor tiles brown and bitumen (Asbestos was found in both the bitumen and tile) (18m2)

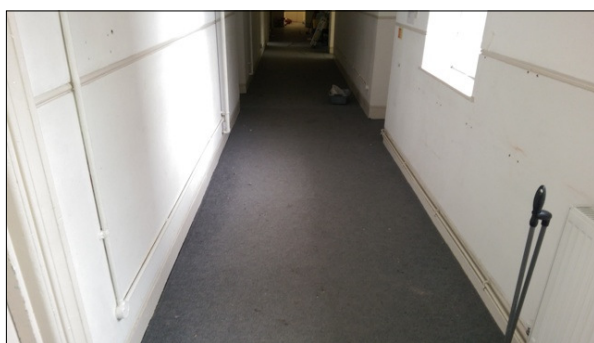
Asbestos thermoplastic floor tiles grey and bitumen (Asbestos was found in both the bitumen and tile) (14m2)

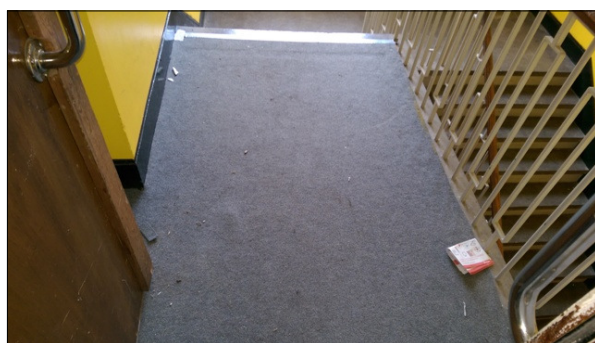
Strongly presumed asbestos thermoplastic floor tiles grey and bitumen (Asbestos was found in both the bitumen and tile) (2m2)

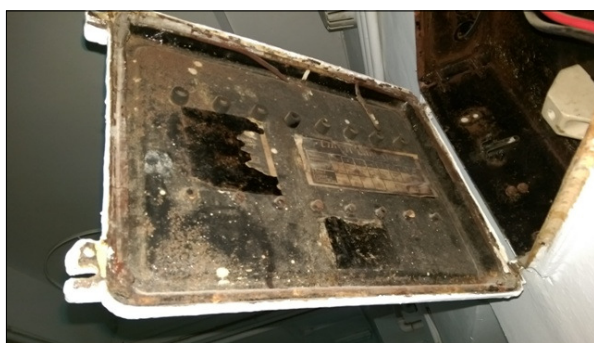
Asbestos gasket seal to electrics intake cover.  
(<1m2)

| <b>Action required:</b> | Remove | | |

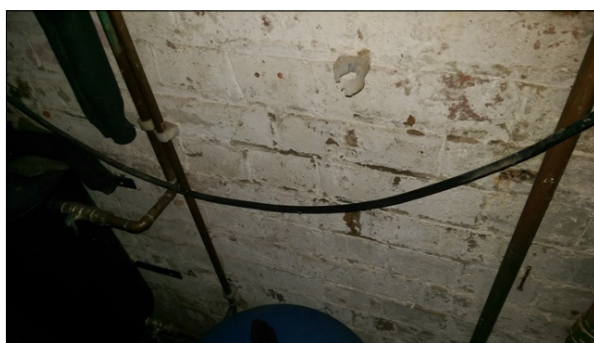
Asbestos residue to walls throughout. (<1m2)

| <b>Action required:</b> | Remove | | |

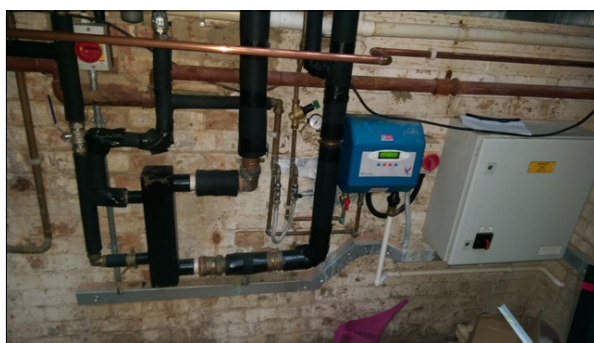
Asbestos residue to walls throughout. (<1m2)

| <b>Action required:</b> | Remove | | |

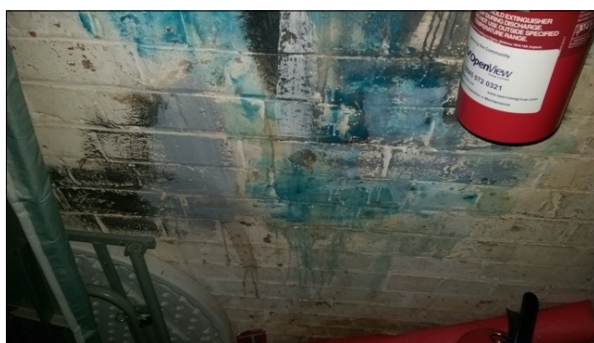
Asbestos residue to walls. (<1m2)

| <b>Action required:</b> | Remove | | |

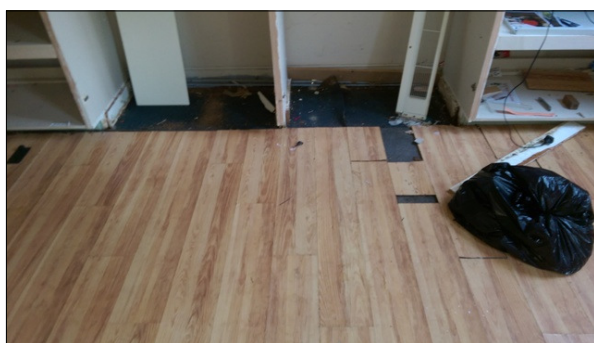
Asbestos thermoplastic floor tiles brown and bitumen (Asbestos was found in both the bitumen and tile) (16m2)

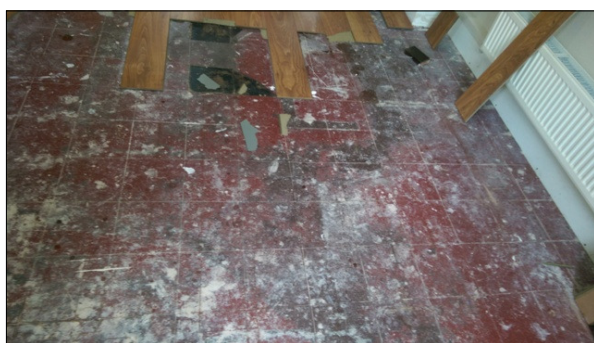
Strongly presumed asbestos thermoplastic floor tiles brown and bitumen (Asbestos was found in both the bitumen and tile) (16m2)

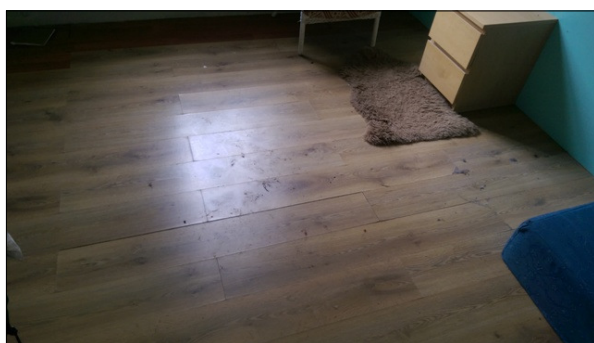
Strongly presumed asbestos thermoplastic floor tiles brown and bitumen (Asbestos was found in both the bitumen and tile) (9m2)

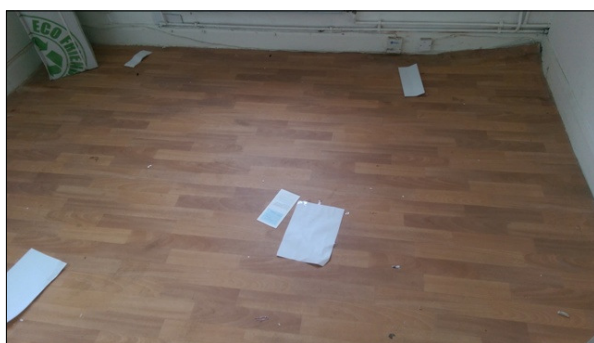
Strongly presumed asbestos thermoplastic floor tiles brown and bitumen (Asbestos was found in both the bitumen and tile) (6m2)

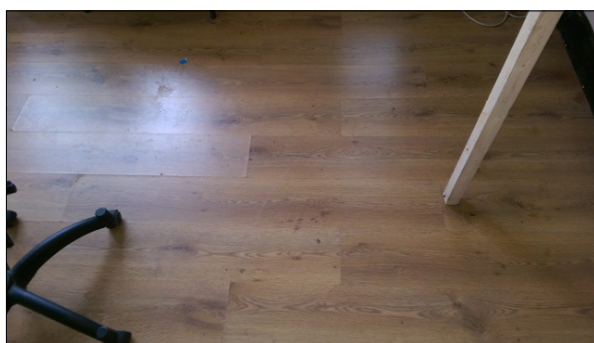
Strongly presumed asbestos thermoplastic floor tiles brown and bitumen (Asbestos was found in both the bitumen and tile) (8m2)

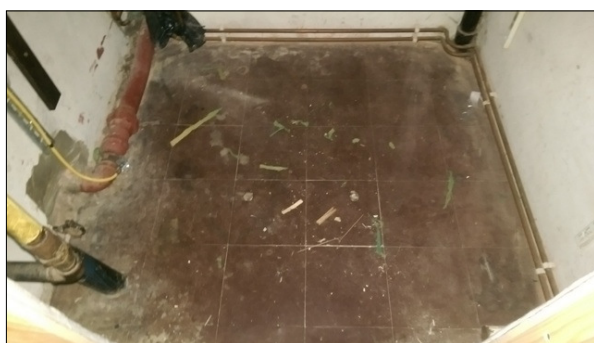
Strongly presumed asbestos thermoplastic floor tiles brown and bitumen (Asbestos was found in both the bitumen and tile) (1m2)

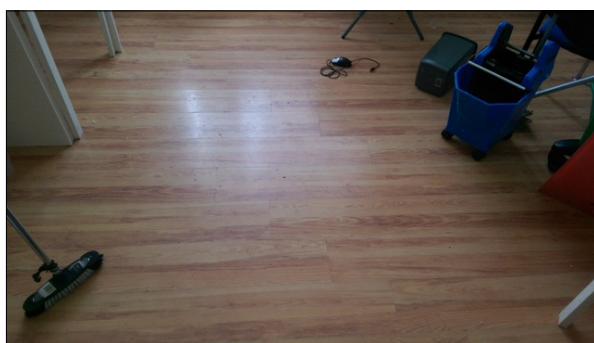
Strongly presumed asbestos thermoplastic floor tiles brown and bitumen (Asbestos was found in both the bitumen and tile) (6m2)

| <b>Action required:</b> | Remove | | |

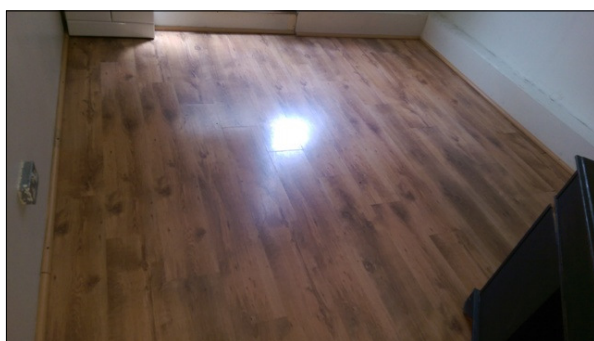
Strongly presumed asbestos thermoplastic floor tiles brown and bitumen (Asbestos was found in both the bitumen and tile) (5m2)

| <b>Action required:</b> | Remove | | |

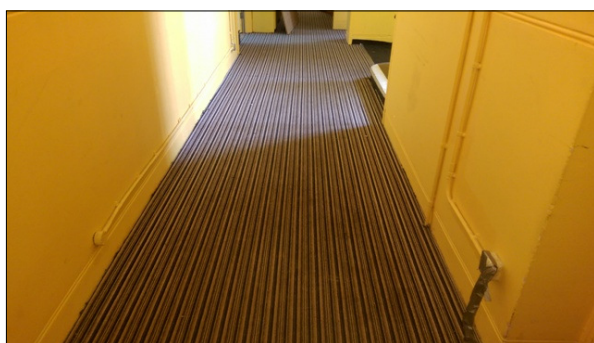
Asbestos bitumen adhesive to non-asbestos thermoplastic floor tiles grey. (18m2)

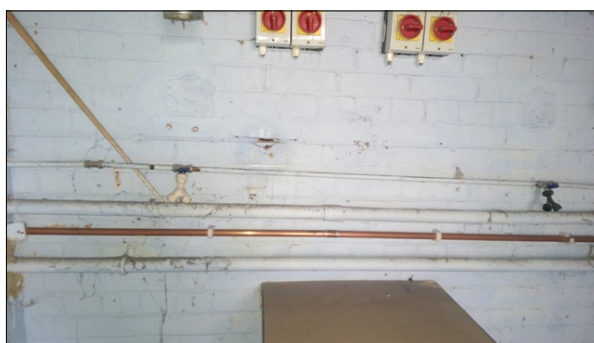
Asbestos residue to wall. (<1m2)

| <b>Action required:</b> | Remove | | |

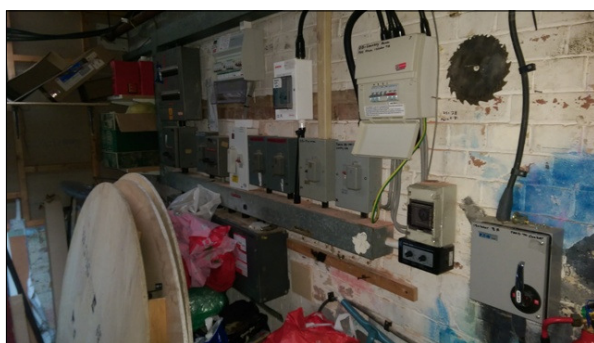
No access within live electrics.

| <b>Action required:</b> | Investigate further | | |

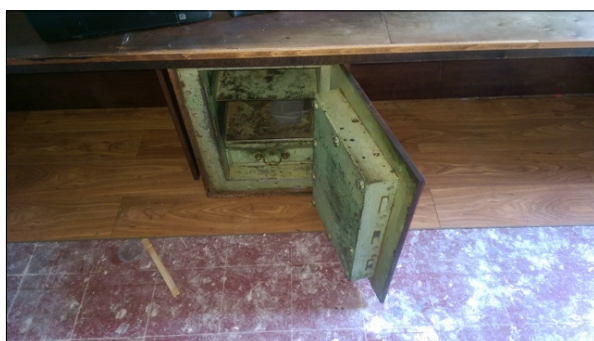
No access due to fully sealed metal safe.

| <b>Action required:</b> | Investigate further | | |

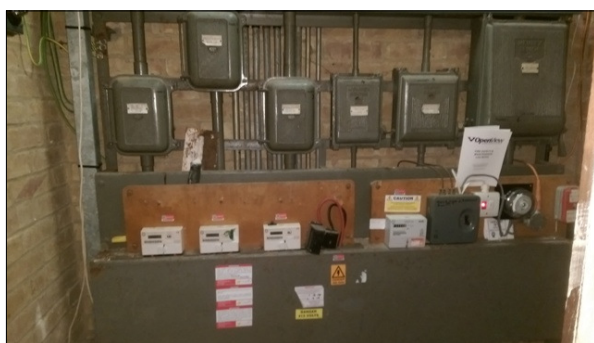
No access within live electrics.

| <b>Action required:</b> | Investigate further | | |
