# Subsidence Report

## For Westways

**12 Greville Road, London, NW6 5JA**

<b>Insured:</b>	TBC
<b>Insurer:</b>	TBC
<b>Our Reference:</b>	02929Rv2
<b>Client Ref:</b>	NA
<b>Consultant:</b>	Keiron Hart (BSc Hons, C.Env, F.Arbor.A, MICFor, MEWI)
<b>Report Date:</b>	18.7.2019

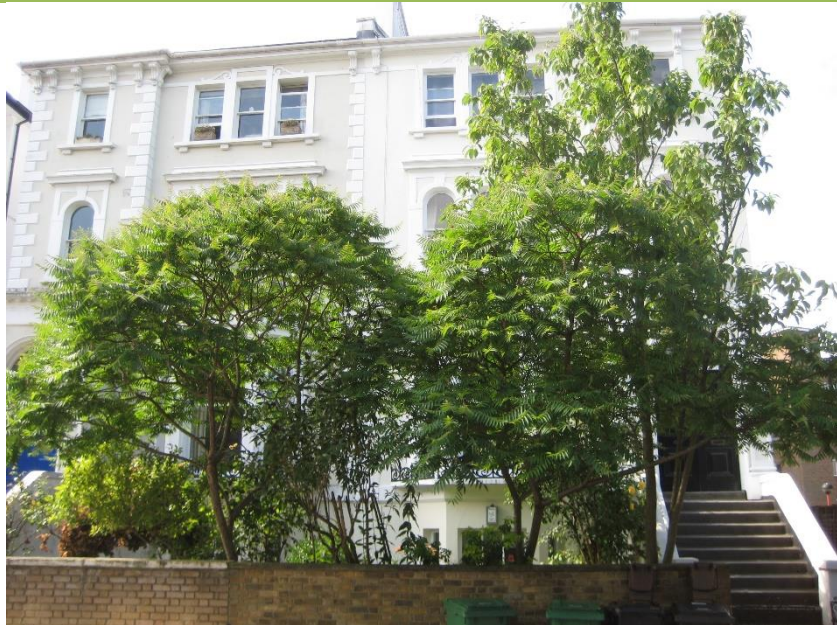
In the event that underpinning was not for the whole of the building then the main elements of potential risk vegetation would be T3 (Cherry) as it relates to the front steps (as these tend to have a shallower footing than the building itself) and T4 (Lime) to the rear.

It is noted that the pruning works to T4 (Lime) and implementation of cyclical management to trees T1 – T3, & T5 have not been initiated following advice in 2018. These recommendations remain.

**The property with T1, T2 & T3 visible**

Tree No.	Species	Age Cat	Approx. Height (m)*	Distance to Building (m)	Ownership	Observations	Subsidence Risk Action	Recommended Tree Work
T1	Rhus	A	4.7	7.1	No 12/ 14 TBC	Established tree with low growth potential.	Action to Avoid Future Risk	Do not allow to exceed current dimensions
T2	Rhus	A	4.5	6	No 12	Established tree with low growth potential. Distance to building but only 2.8m to steps.	Action to Avoid Future Risk	Do not allow to exceed current dimensions
T3	Cherry	A	6.2	2	No 12	Distance to steps. 6.2m to building. Tight v Union.	Action to Avoid Future Risk	Do not allow to exceed current dimensions
T4	Lime	A	18.5	10	No 12	No sign of previous management.	Action to Avoid Future Risk	Crown reduce by 2m, reshape and then maintain at reduced dimensions. Clear basal undergrowth for future inspections
T5	Lime	A	8	12	No 12	Establishing tree with some deadwood evident.	Action to Avoid Future Risk	Do not allow to exceed current dimensions. Clear basal undergrowth for future inspections.

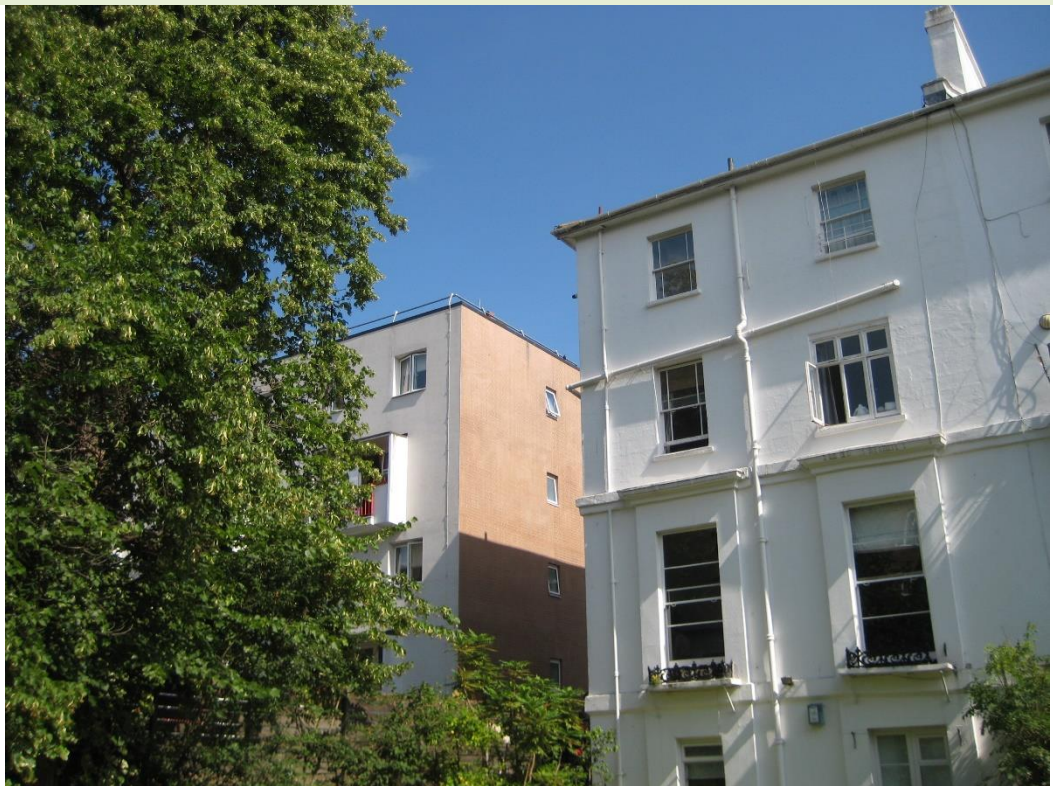
T4 is located 10m from the property. Cutler & Richardson (1997) indicate that in 75% of subsidence claims Lime will be closer to the property than 8m. This suggests a lower risk (as the 75% level is often referenced when assessing potential risk). However the tree is large enough and close enough to have a zone of potential influence extending to and below the property.

It should also be noted that the presence of a Conservation Area means notification for tree works to T3 & T4 would be required. In our experience without evidence to demonstrate their role in any movement there is a real risk that a notification seeking to remove T4 (Lime) would result in a TPO being served on this tree.

**T4 & & TG1 also visible**

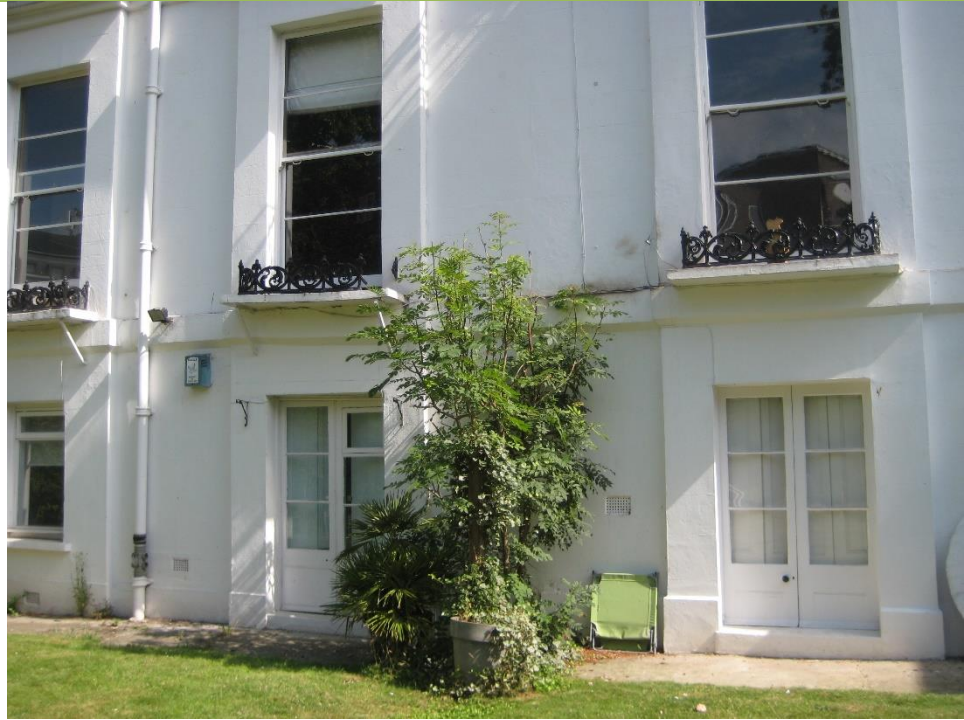
In addition to the above TG1 is a small self-set group of Ash saplings which have significant growth potential. At their current size they pose little risk but action now would remove the risk. In addition the trees within TG1 are below the size threshold for any Conservation Area notification.

TG1	Ash	A	2.3	0.5	No 12	Self-set trees poorly located for longer term retention.	Action to Avoid Future Risk	Previously reduced but removal recommended given location and growth potential.
TG2	Elder x 2	A	4.9	20	No 12	Established trees with low growth potential.	Action to Avoid Future Risk	No works
S1	Cornus (TBC)	A	2.3	0.9	No 12	Established multi stemmed shrub possibly Cornus spp.	Action to Avoid Future Risk	No works
SG1	Rose & Mahonia	A	2.2	1.3	No 12	Established shrubs.	Action to Avoid Future Risk	No works
<b>Tree Age Category: A = Younger than property; B = Similar age to the property; C = Significantly older than property</b>

**TG1 Ash has been pruned but should be removed**

TG1 (Ash) has been reduced but we would recommend complete removal given location and proximity to the building.

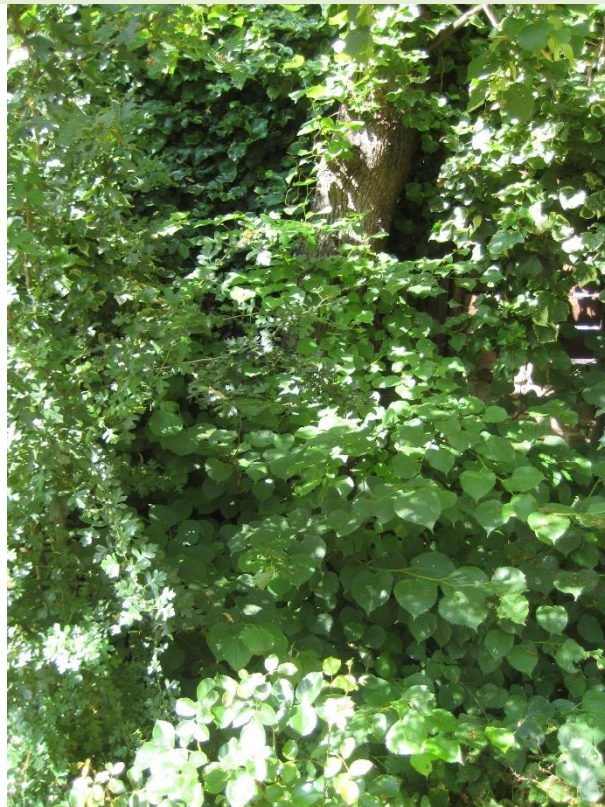
**Clearing around the base of T4 & T5 will assist future inspections.**

To aid future inspections we would recommend the removal of undergrowth from around the base of T4 & T5 (Lime).
