12-22 Theobalds Road
London WC1X 8PF

**Heritage Assessment
of the 3rd Floor Ceilings**

July 2019

12-18 Theobalds Road Offices – 3rd Floor

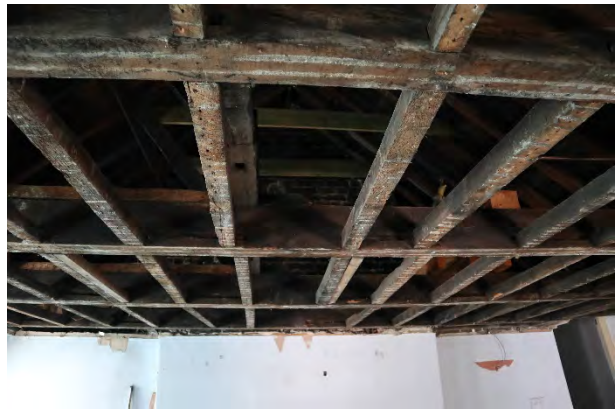
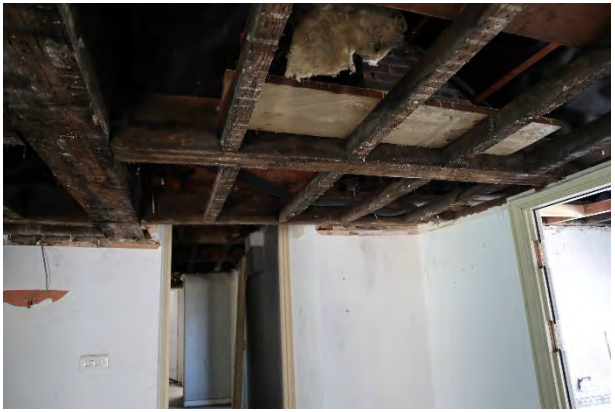
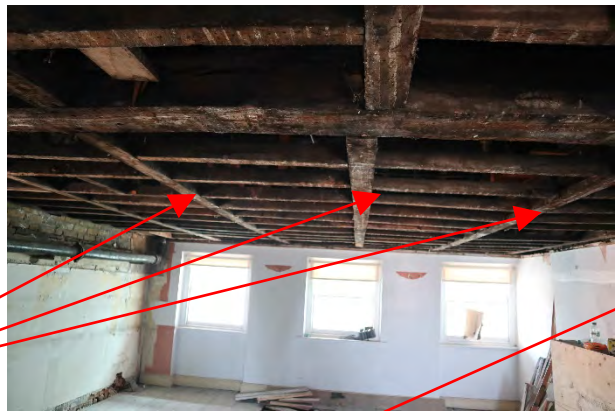
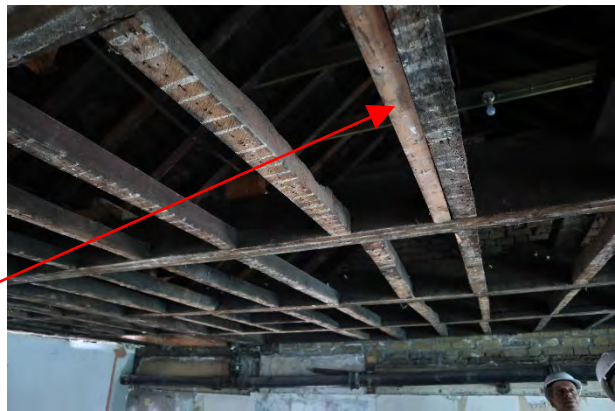
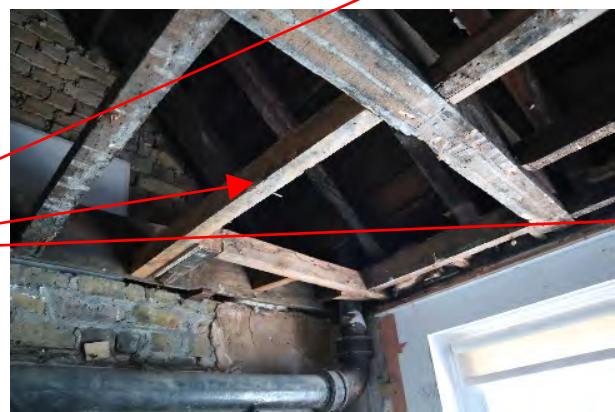
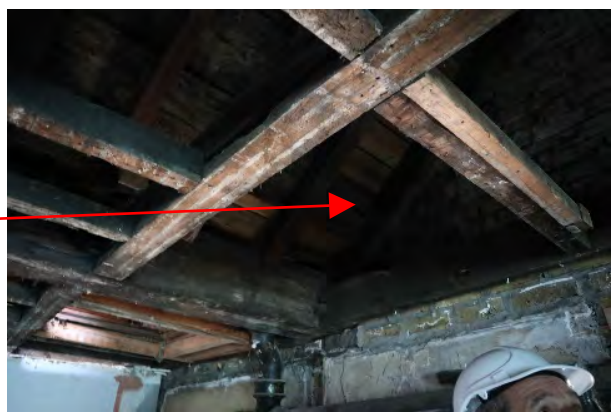
No 12

- **Roof rafters and boards:** modern fabric (95%) + historic (5%)
- **Primary ceiling beams:** historic (100%)
- **Ceiling joists:** historic (80%) + modern repairs; replacements; missing joists (20%)
- **Ceiling finish:** modern plasterboard (100%) – removed

Modern repairs and missing joists

Primary ceiling beams to be retained

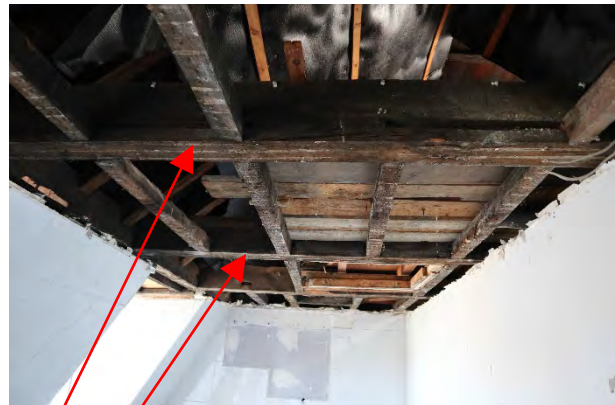
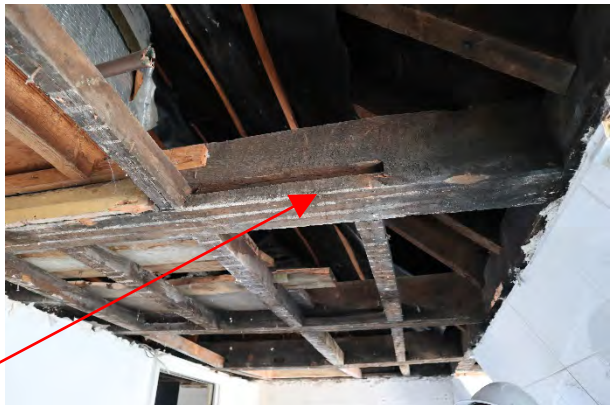
No 12

- **Roof rafters and boards:** modern fabric (95%) + historic (5%)
- **Primary ceiling beams:** historic (100%)
- **Ceiling joists:** historic (50%) + modern repairs; replacements; missing joists (50%)
- **Ceiling finish:** modern plasterboard (100%) – removed

Modern reinforcement for the water tank above and damage to historic fabric

Modern repairs and missing joists

Primary ceiling beams to be retained

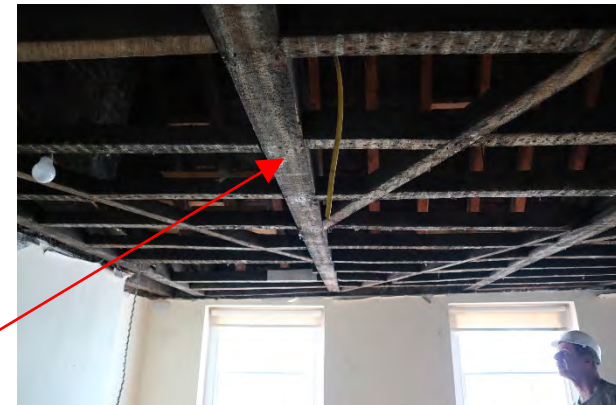
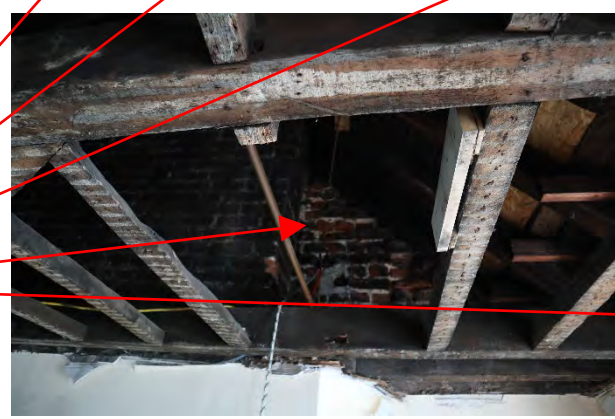
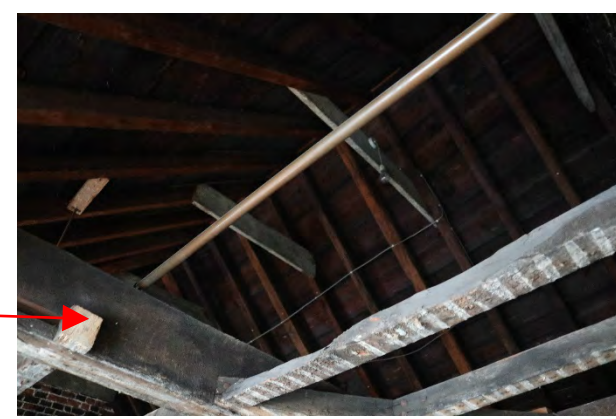
No 14

- **Roof rafters and boards:** modern fabric (95%) + historic (5%)
- **Primary ceiling beams:** historic (100%)
- **Ceiling joists:** historic (70%) + modern repairs/insert; replacements; missing joists (30%)
- **Ceiling finish:** modern plasterboard (100%) – removed

Modern insert/damage to historic joists and missing joists

Primary ceiling beams to be retained

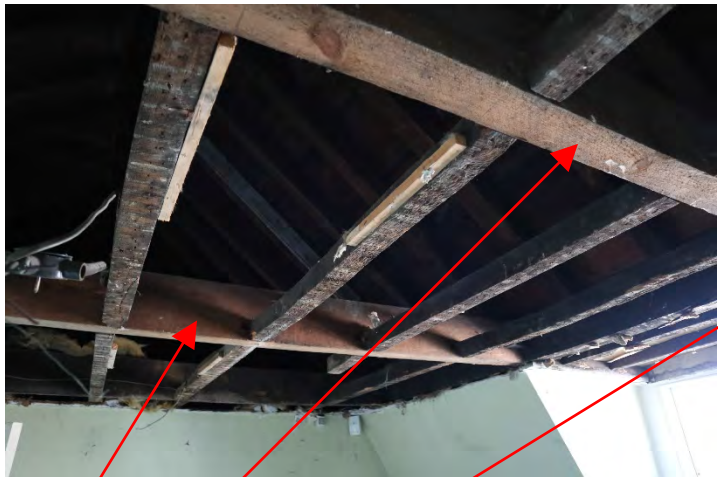
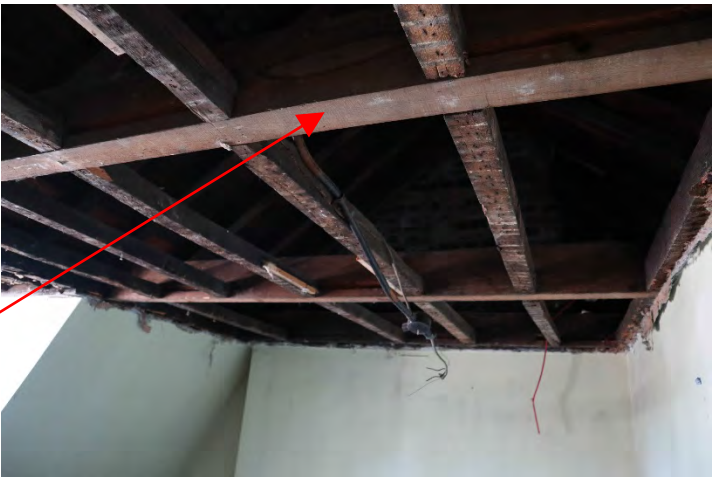
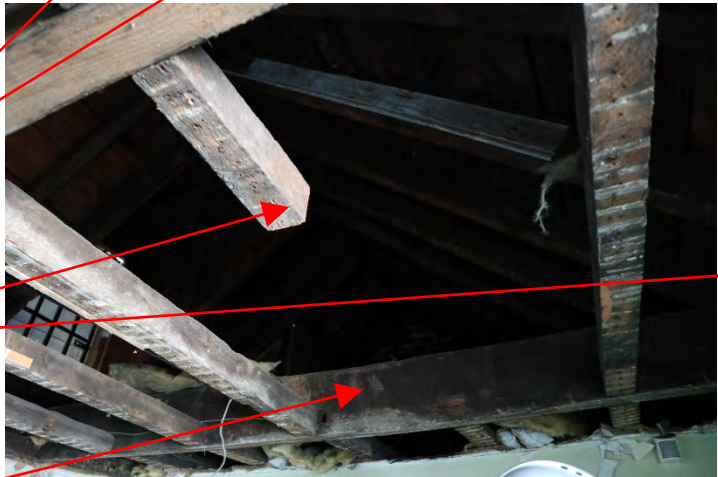
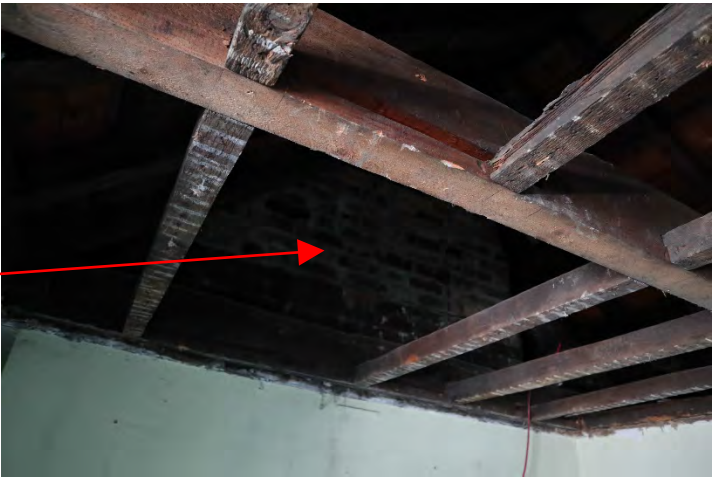
No 14

- **Roof rafters and boards:** modern fabric (95%) + historic (5%)
- **Primary ceiling beams:** historic (50%) + modern replacement (50%)
- **Ceiling joists:** historic (50%) + modern repairs/insert; replacements; missing joists (50%)
- **Ceiling finish:** modern plasterboard (100%) – removed

Primary ceiling beams – modern replacements

Modern damage to historic joists and missing joists

Primary ceiling beams - historic

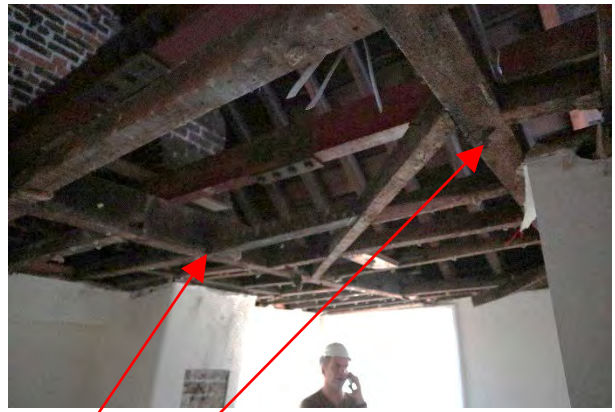
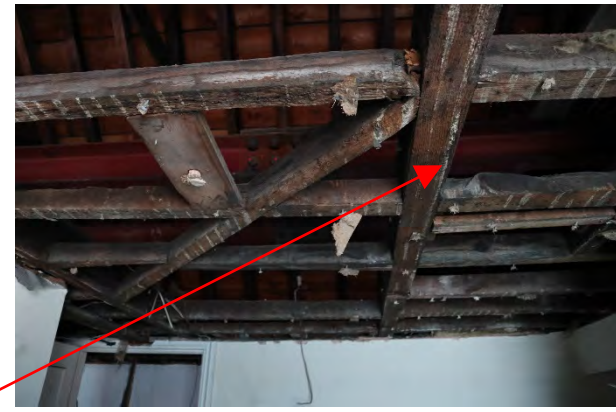
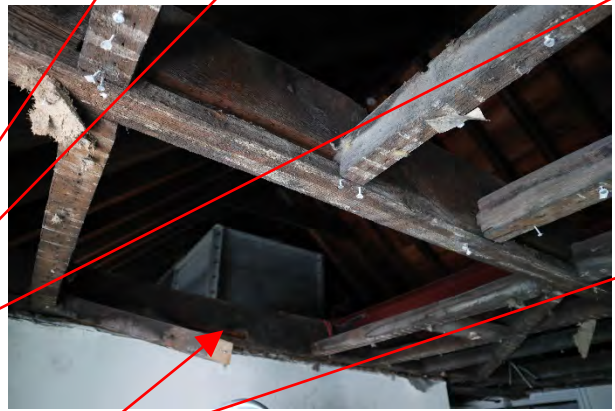
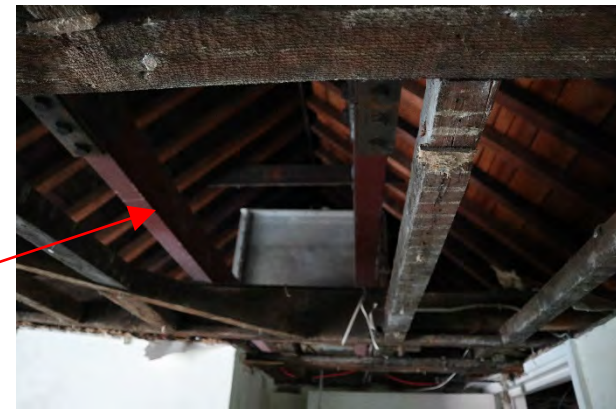
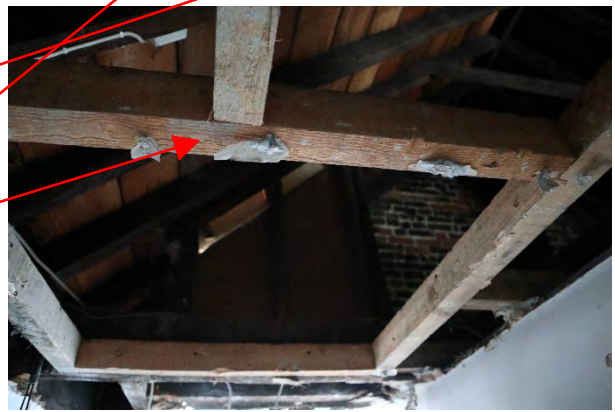
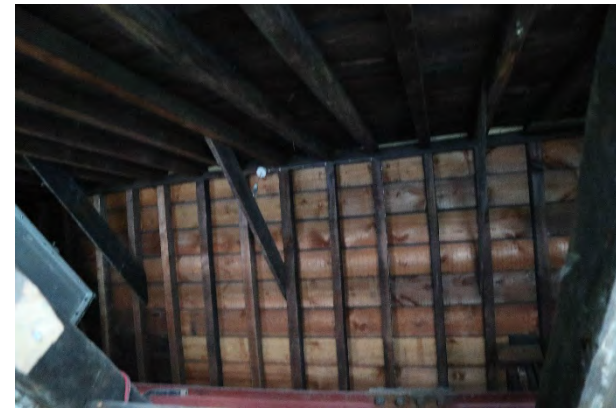
No 16

- **Roof rafters and boards:** modern fabric (95%) + historic (5%)
- **Primary ceiling beams:** historic (100%)
- **Ceiling joists:** historic (60%) + modern repairs/insert; replacements; missing joists (40%)
- **Ceiling finish:** modern plasterboard (100%) – removed

Modern reinforcement steel beams for the water tank above and damage to historic fabric

Modern repairs and missing joists

Primary ceiling beams to be retained

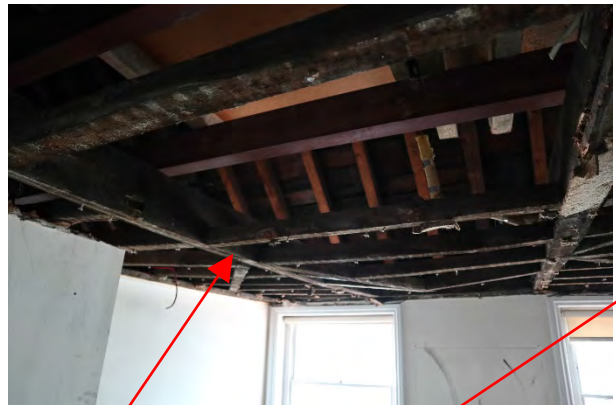
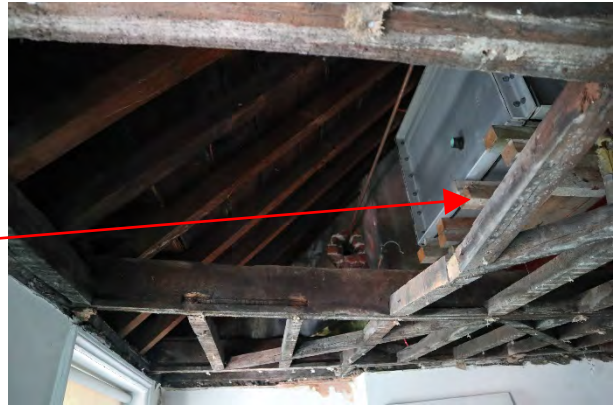
No 16

- **Roof rafters and boards:** modern fabric (95%) + historic (5%)
- **Primary ceiling beams:** historic (100%)
- **Ceiling joists:** historic (60%) + modern repairs/insert; replacements; missing joists (40%)
- **Ceiling finish:** modern plasterboard (100%) – removed

Modern reinforcement steel beams for the water tank above and damage to historic fabric

Modern damage and missing joists

Primary ceiling beams to be retained

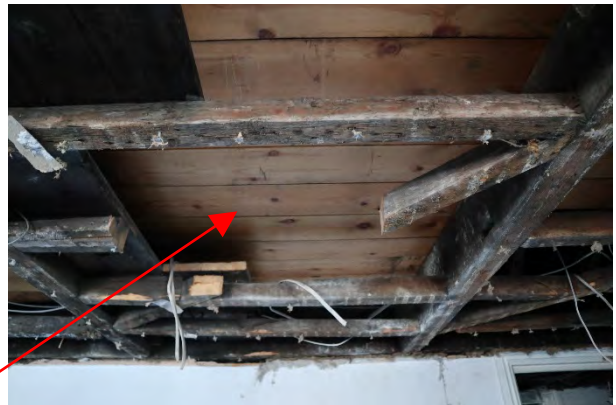
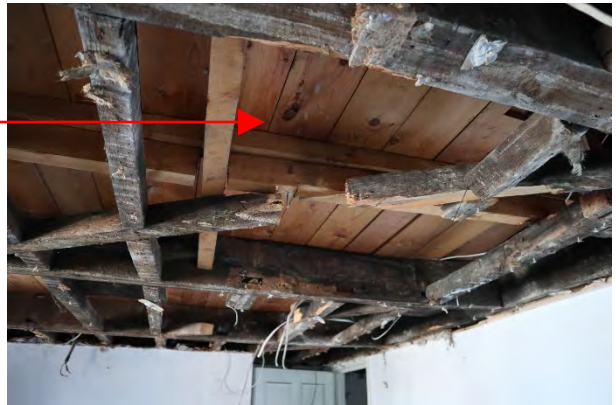
No 16

- **Roof rafters and boards:** modern fabric (95%) + historic (5%)
- **Primary ceiling beams:** historic (95%) + modern replacement (5%)
- **Ceiling joists:** historic (50%) + modern repairs/insert; replacements; missing joists (50%)
- **Ceiling finish:** modern plasterboard (100%) – removed

Modern reinforcement for the boarding/walkway above and damage to historic fabric

Primary ceiling beam – modern replacement

Primary ceiling beams to be retained

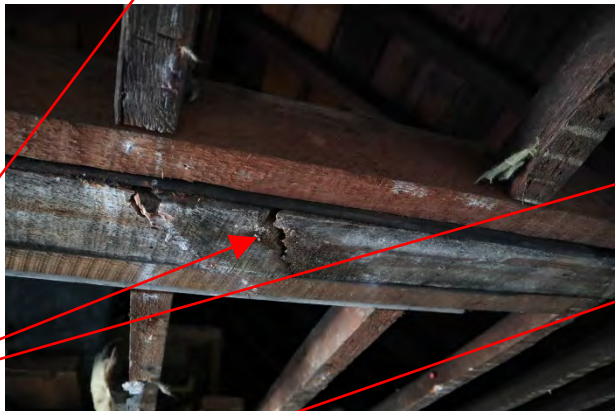
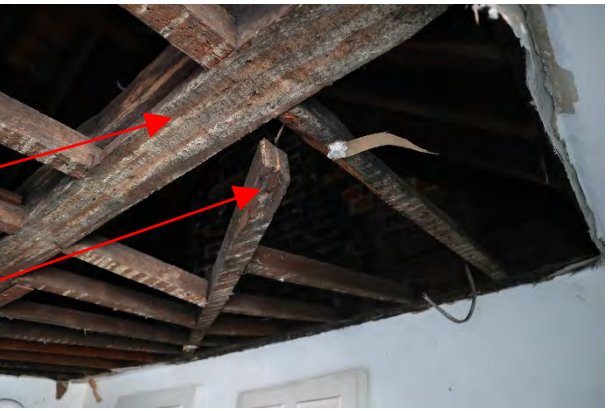
No 18

- **Roof rafters and boards:** modern fabric (95%) + historic (5%)
- **Primary ceiling beams:** historic (100%)
- **Ceiling joists:** historic (20%) + modern repairs/insert; replacements; missing joists (80%)
- **Ceiling finish:** modern plasterboard (100%) – removed

Modern damage and missing joists

Ceiling joists – modern replacement

Primary ceiling beams to be retained and repaired as needed

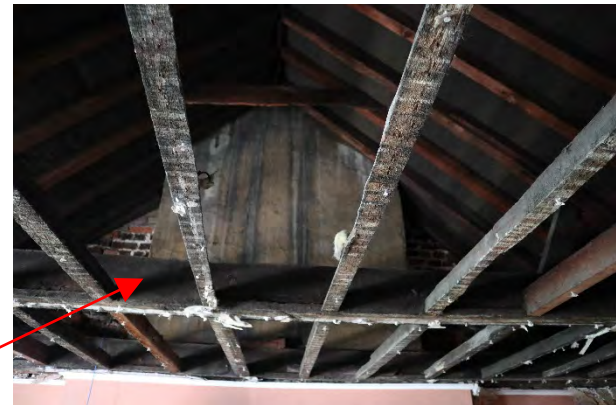
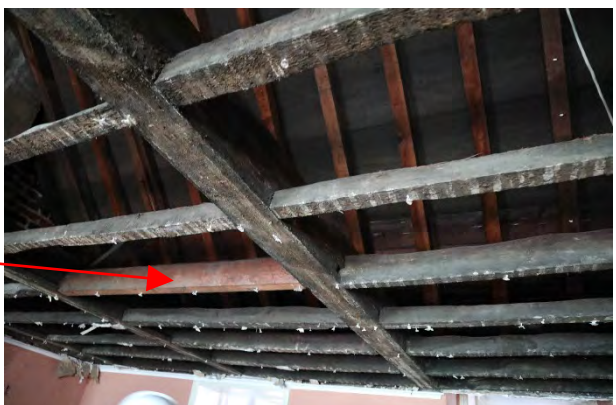
No 18

- **Roof rafters and boards:** modern fabric (95%) + historic (5%)
- **Primary ceiling beams:** historic (100%)
- **Ceiling joists:** historic (90%) + modern repairs/insert; replacements; missing joists (10%)
- **Ceiling finish:** modern plasterboard (100%) – removed

Ceiling joists – modern replacement

Primary ceiling beams to be retained

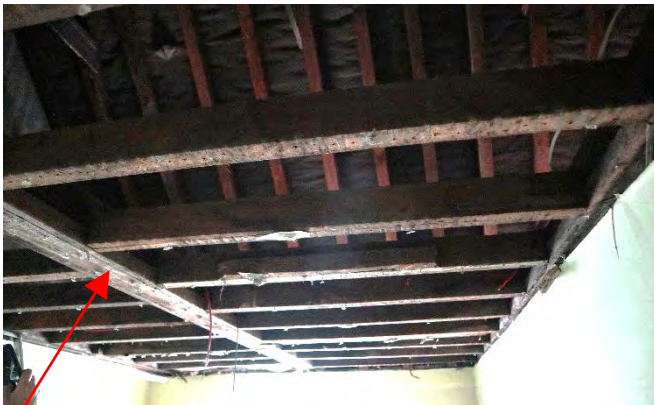
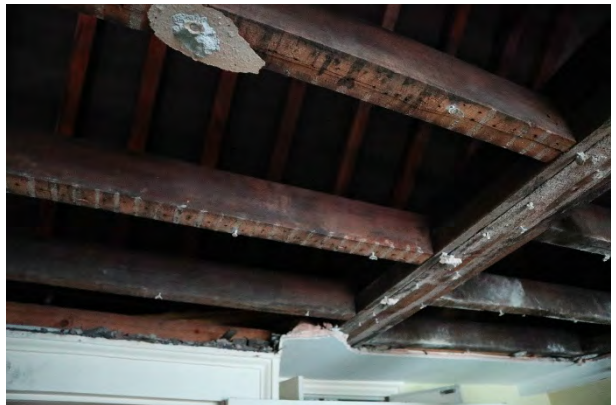
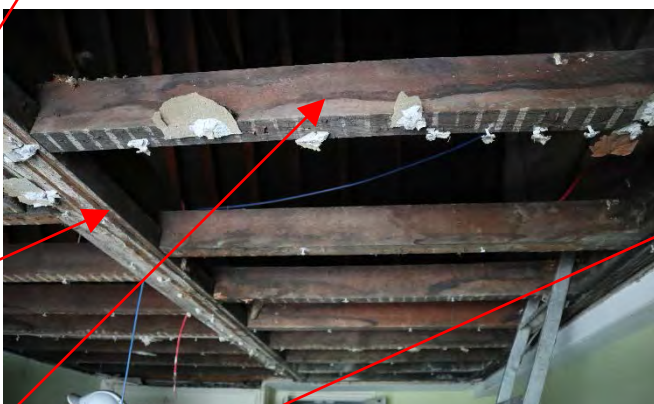
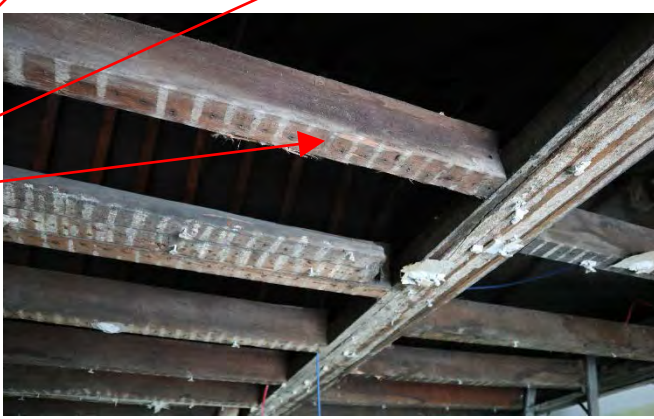
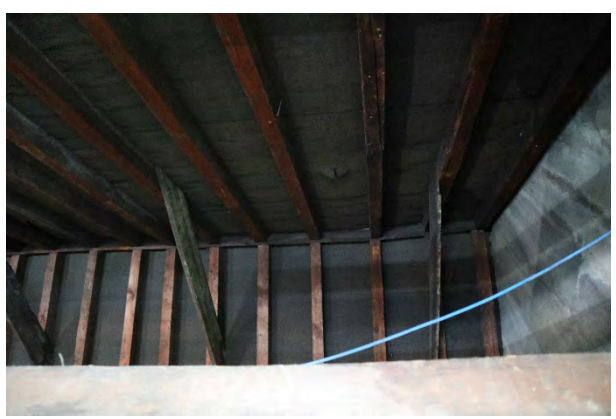
No 18

- **Roof rafters and boards:** modern fabric (95%) + historic (5%)
- **Primary ceiling beams:** historic (100%)
- **Ceiling joists:** modern replacements (100%)
- **Ceiling finish:** modern plasterboard (100%) – removed

Ceiling joists – modern replacement

Primary ceiling beams to be retained

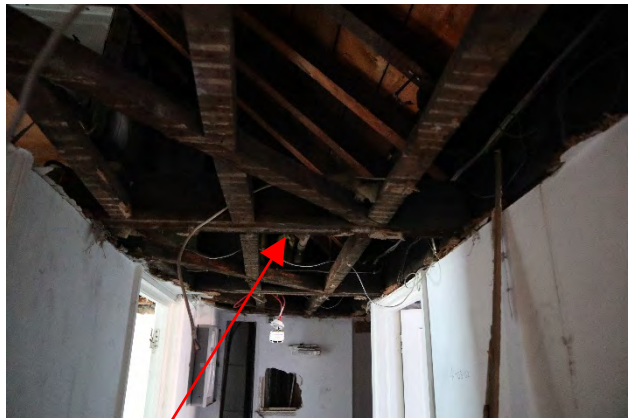
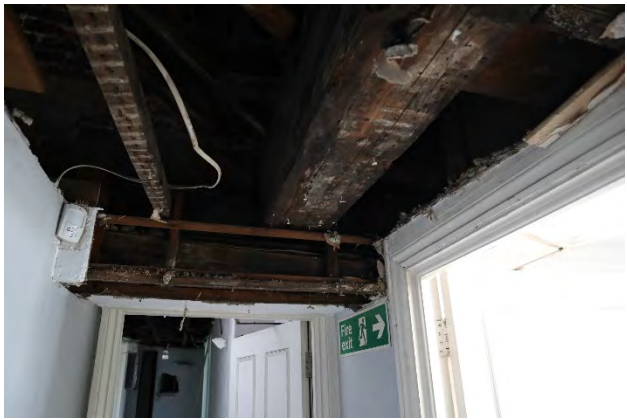
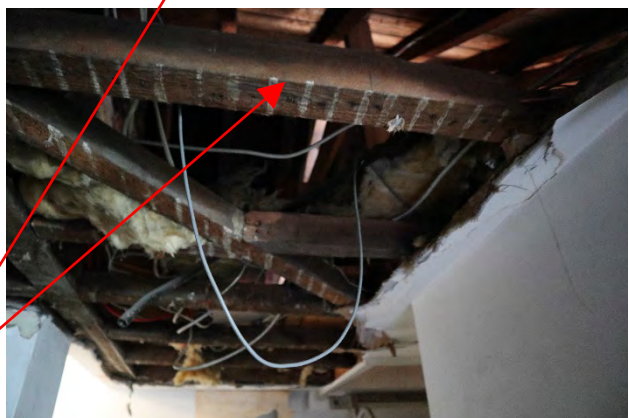
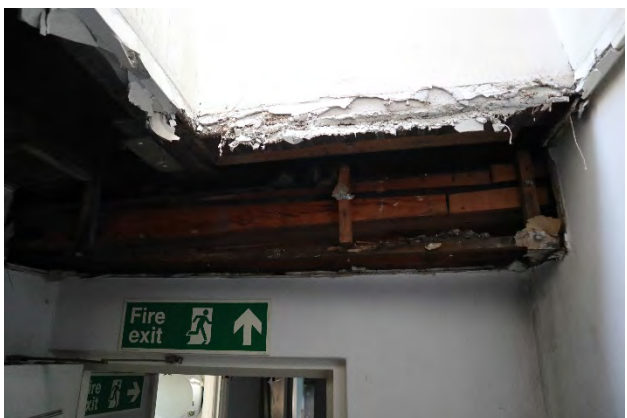
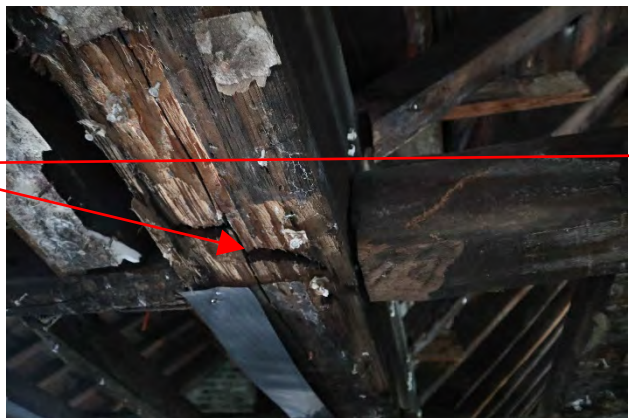
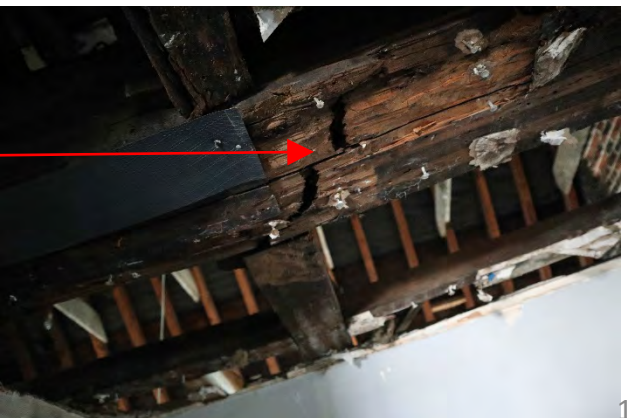
- **Roof rafters and boards:** modern fabric (95%) + historic (5%)
- **Primary ceiling beams:** historic (90%) + modern repairs/inserts (10%)
- **Ceiling joists:** historic (50%) + modern repairs/insert; replacements; missing joists (50%)
- **Ceiling finish:** modern plasterboard (100%) – removed

Primary ceiling beams to be retained and repaired as needed

Valley beam to be retained and repaired as needed

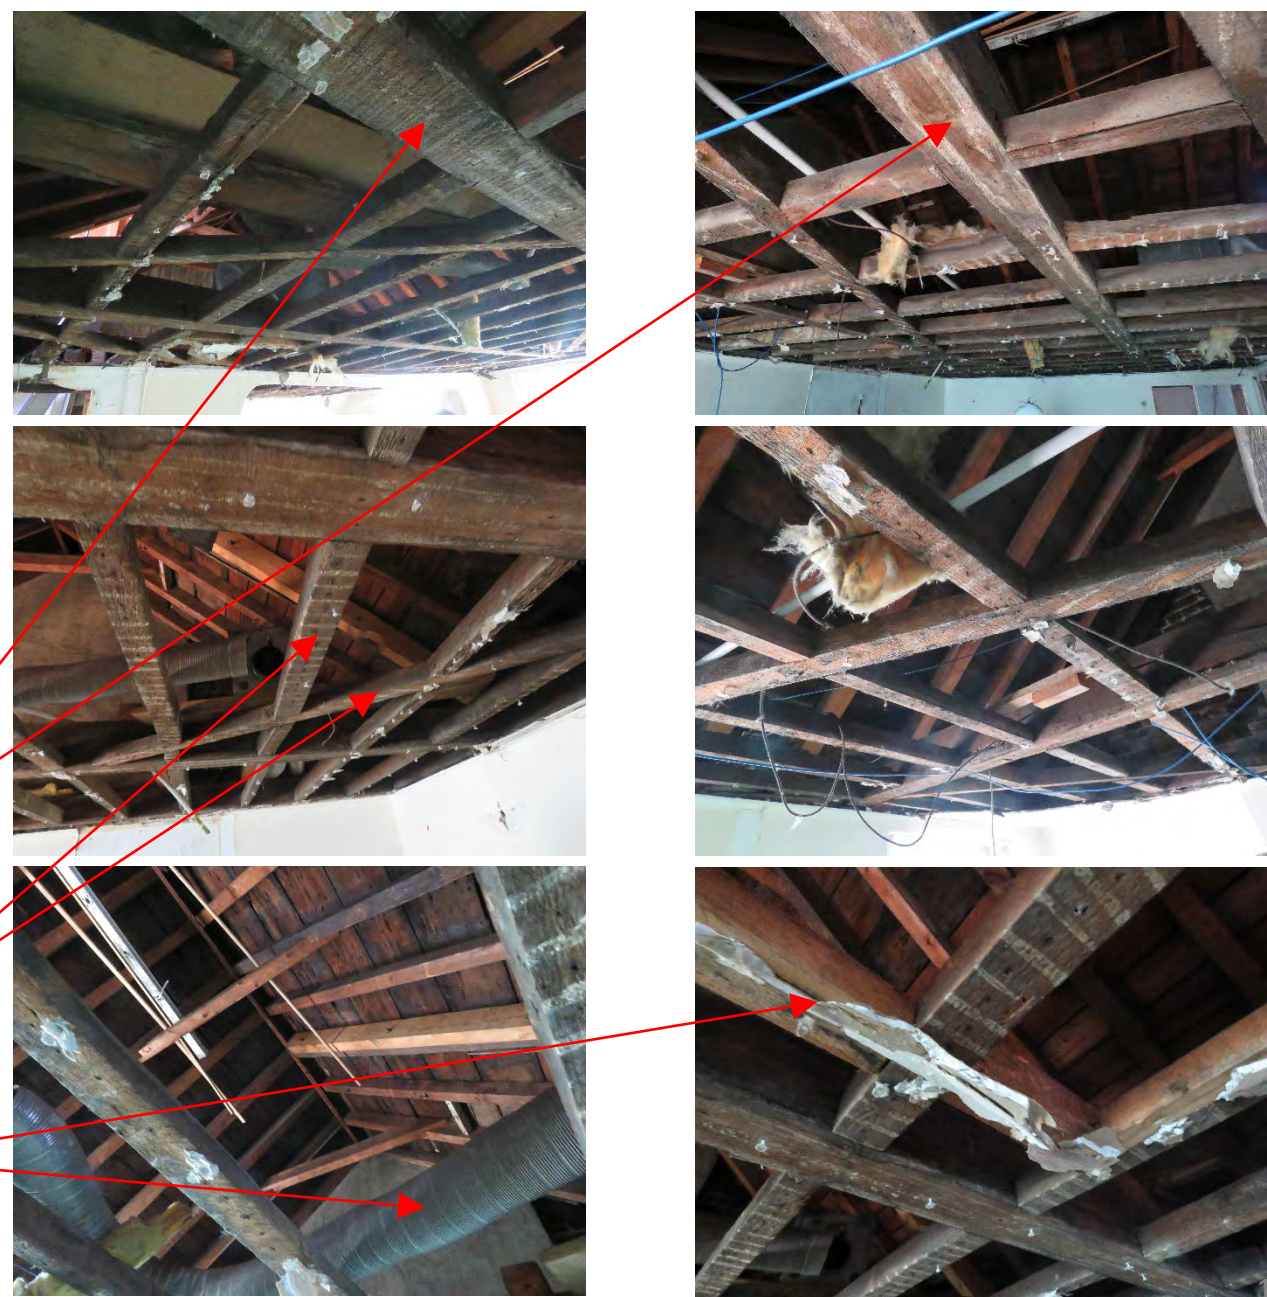
No 20

- **Roof rafters and boards:** modern fabric (95%) + historic (5%)
- **Primary ceiling beams:** historic (100%)
- **Ceiling joists:** historic (90%) + modern repairs/insert; replacements; missing joists (10%)
- **Ceiling finish:** modern plasterboard (100%) – removed

Modern repairs and services above the ceiling

Primary ceiling beams to be retained

Ceiling joists to be removed

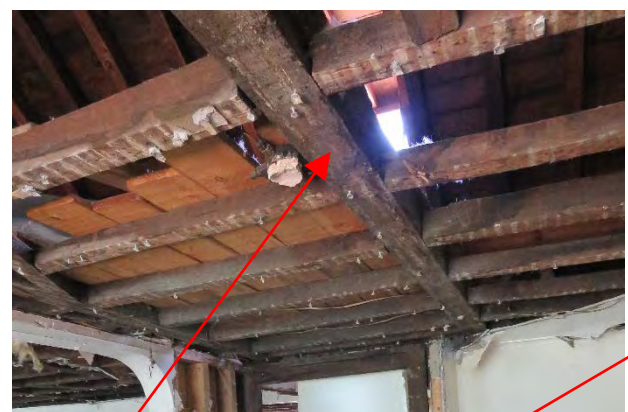
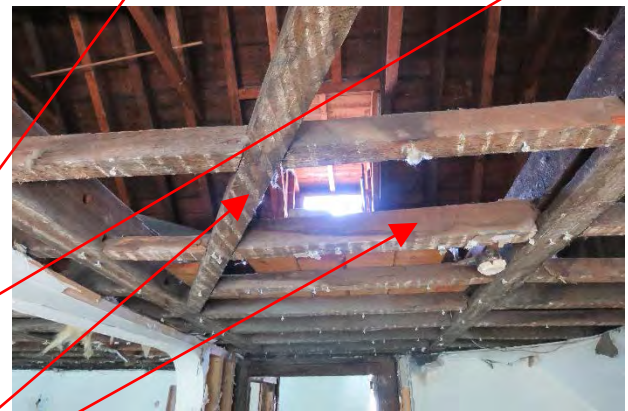
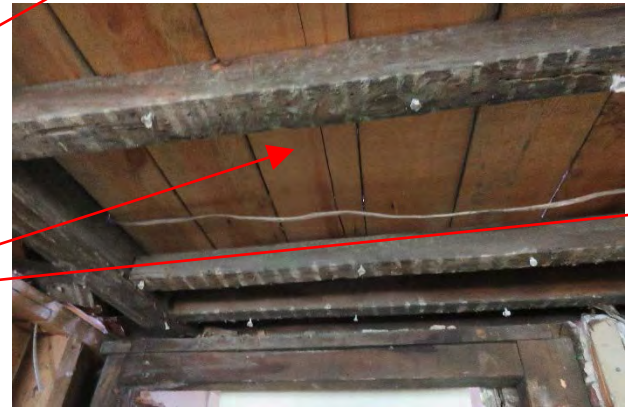
No 20

- **Roof rafters and boards:** modern fabric (95%) + historic (5%)
- **Primary ceiling beams:** historic (100%)
- **Ceiling joists:** historic (80%) + modern repairs/insert; replacements; missing joists (20%)
- **Ceiling finish:** modern plasterboard (100%) – removed

Modern repairs/missing joists and services above the ceiling

Primary ceiling beams to be retained

Ceiling joists to be removed

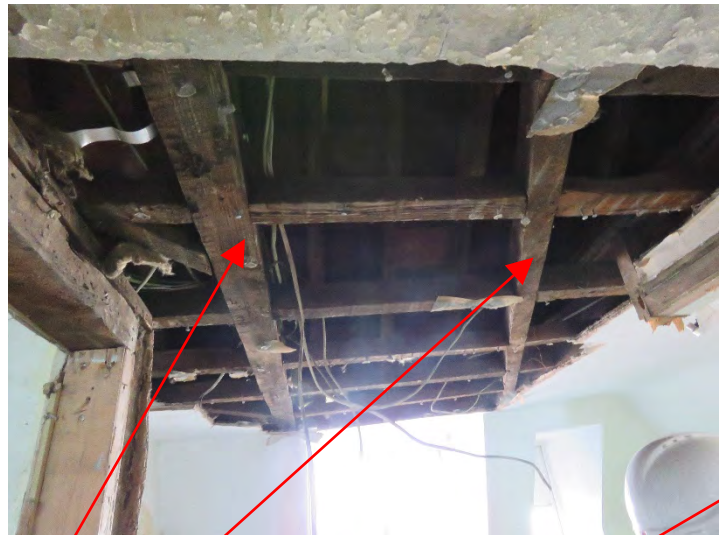
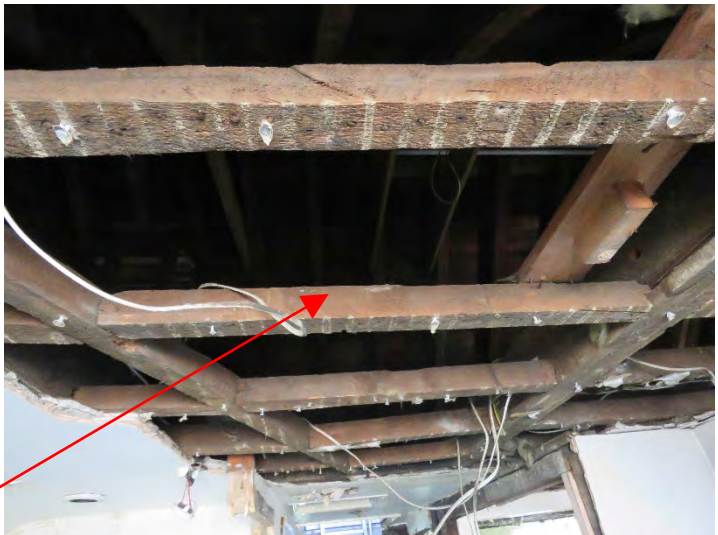
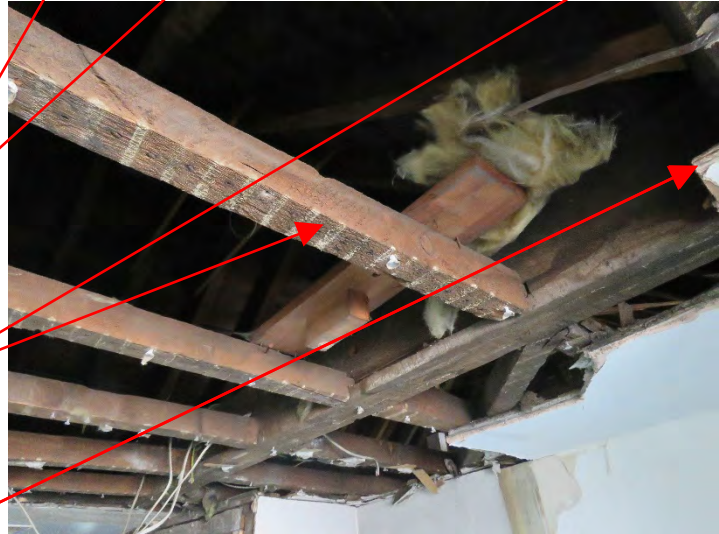
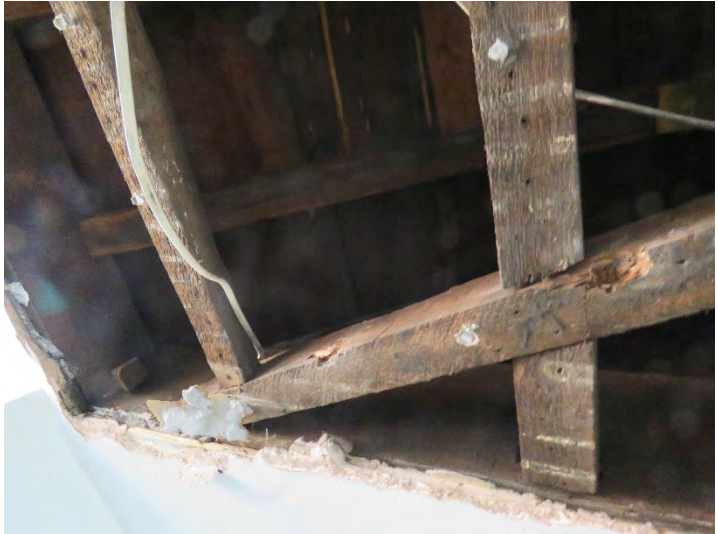
No 20

- **Roof rafters and boards:** modern fabric (95%) + historic (5%)
- **Primary ceiling beams:** historic (100%)
- **Ceiling joists:** historic (90%) + modern repairs/insert; replacements; missing joists (10%)
- **Ceiling finish:** modern plasterboard (100%) – removed

Modern repairs/missing joists and services above the ceiling

Primary ceiling beams to be retained

Ceiling joists to be removed

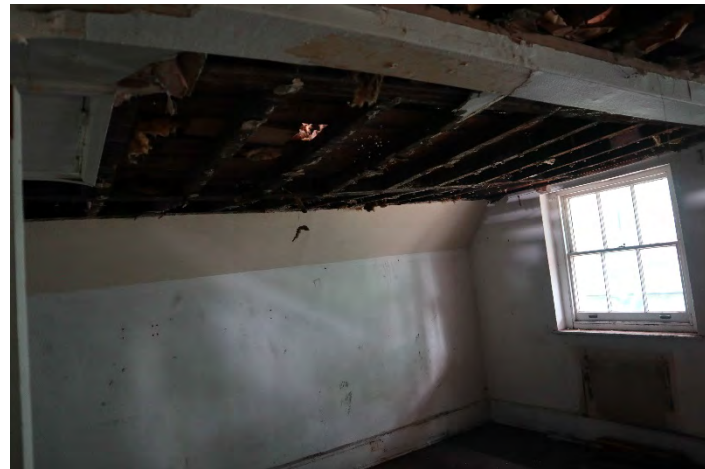
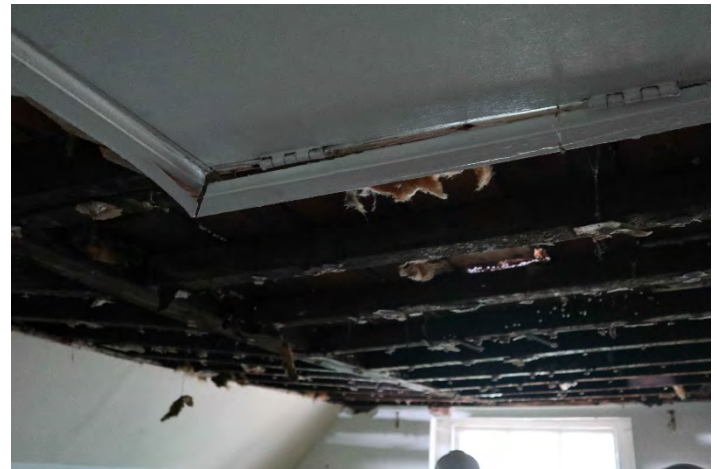
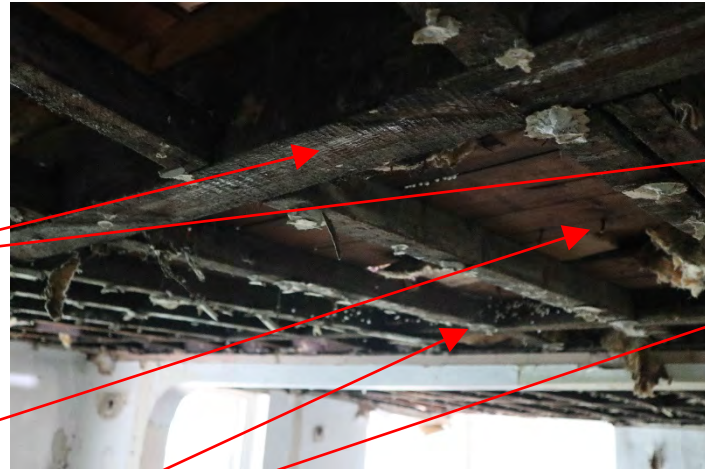
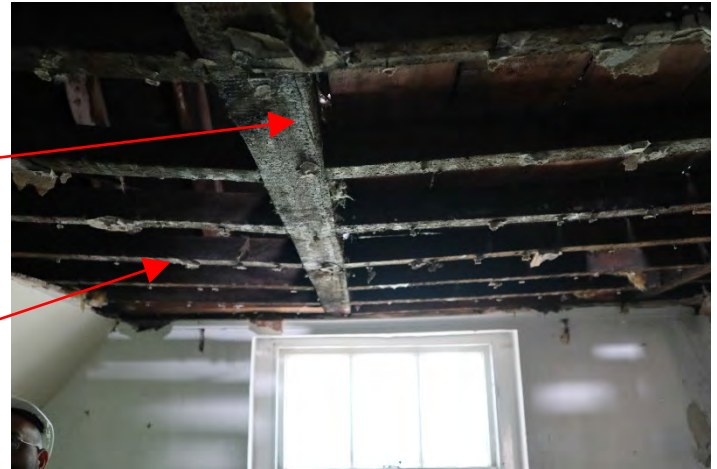
No 22

- **Roof rafters and boards:** modern fabric (95%) + historic (5%)
- **Primary ceiling beams:** historic (100%)
- **Ceiling joists:** historic (90%) + modern repairs/insert; replacements; missing joists (10%)
- **Ceiling finish:** modern plasterboard (100%) – removed

Modern reinforcement/addition for the water tanks above caused damage to historic fabric

Primary ceiling beams to be replaced due to structural damage – see Structural Investigation of Roof Structure by GDC Partnership

Ceiling joists to be removed

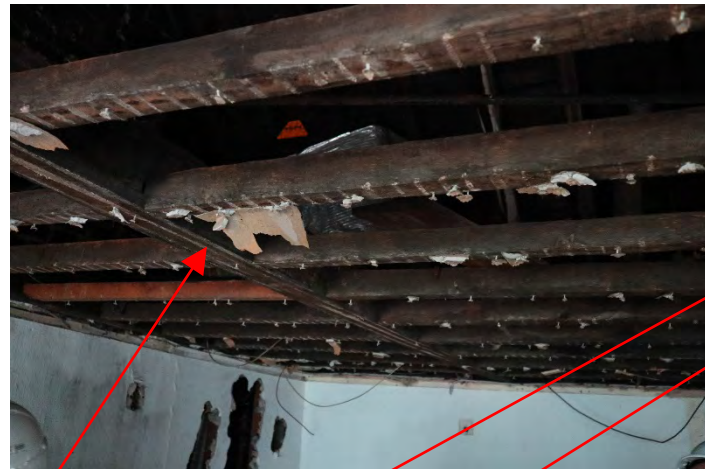
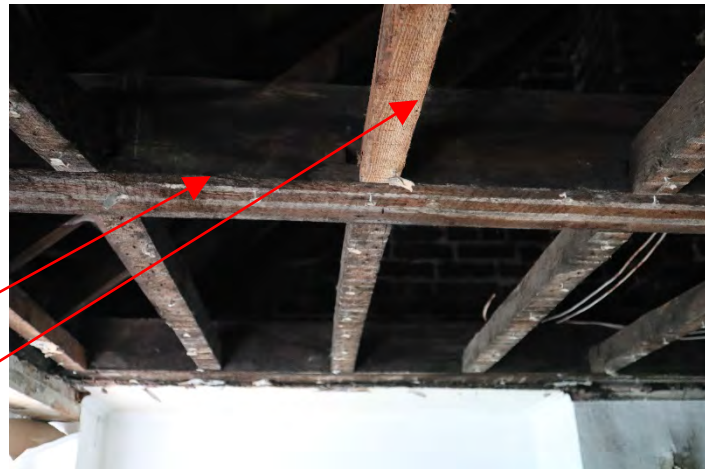
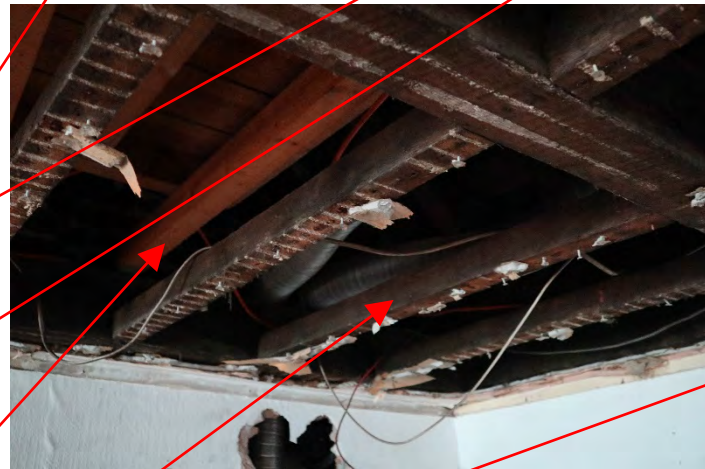
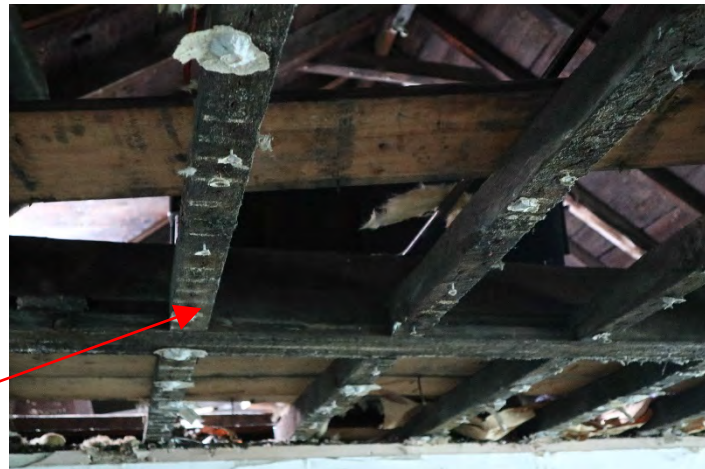
No 22

- **Roof rafters and boards:** modern fabric (95%) + historic (5%)
- **Primary ceiling beams:** historic (100%)
- **Ceiling joists:** historic (90%) + modern repairs/insert; replacements; missing joists (10%)
- **Ceiling finish:** modern plasterboard (100%) – removed

Modern repairs/replacements

Modern reinforcement/addition for the water tanks above caused damage to historic fabric

Primary ceiling beams to be retained

Ceiling joists to be removed

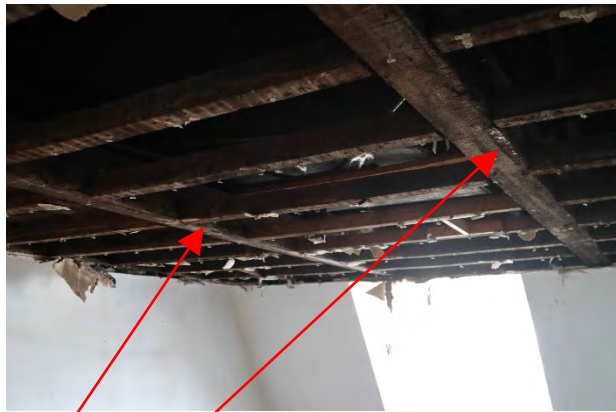
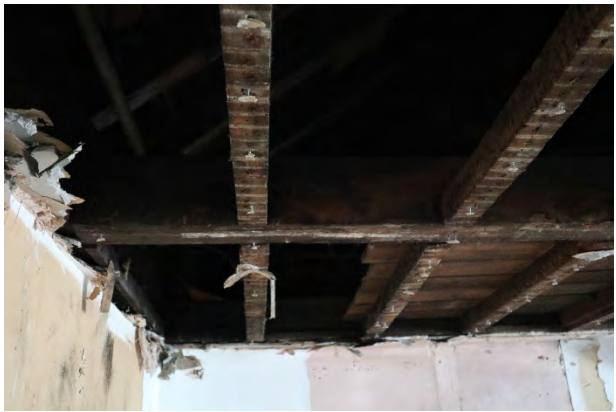
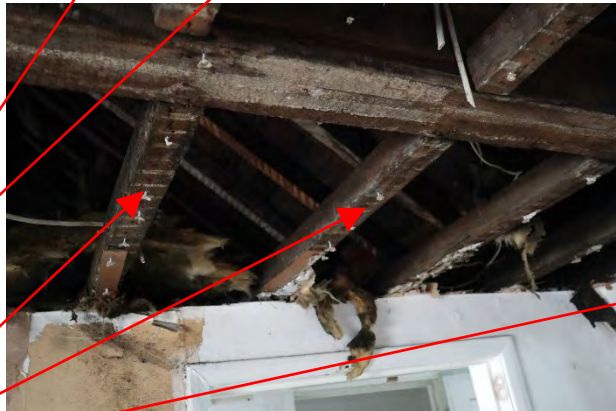
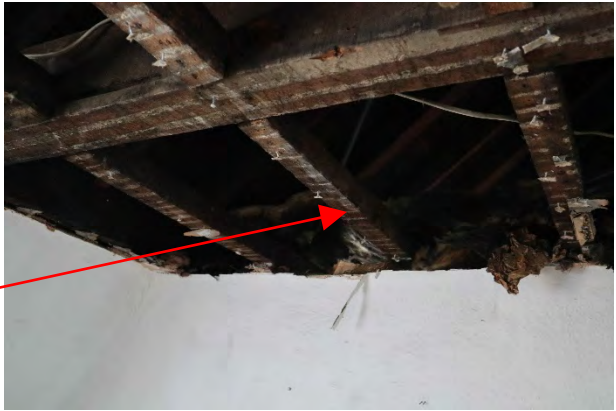
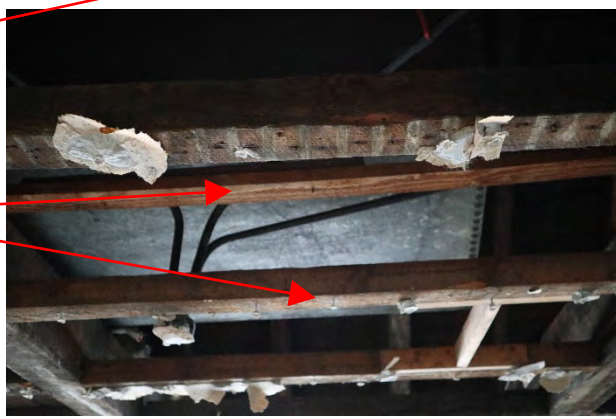
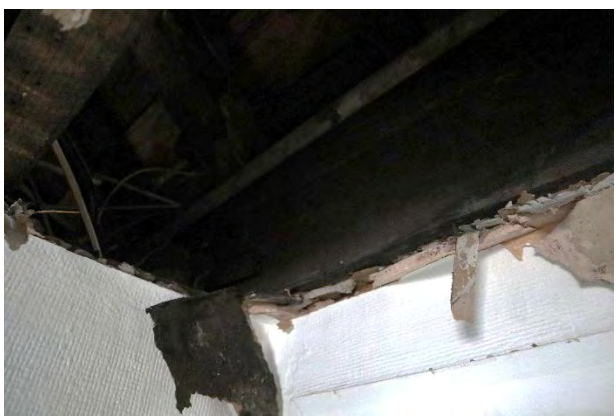
No 22

- **Roof rafters and boards:** modern fabric (95%) + historic (5%)
- **Primary ceiling beams:** historic (100%)
- **Ceiling joists:** historic (90%) + modern repairs/insert; replacements; missing joists (10%)
- **Ceiling finish:** modern plasterboard (100%) – removed

Modern reinforcement/addition for the water tanks above caused damage to historic fabric

Primary ceiling beams to be retained

Ceiling joists to be removed

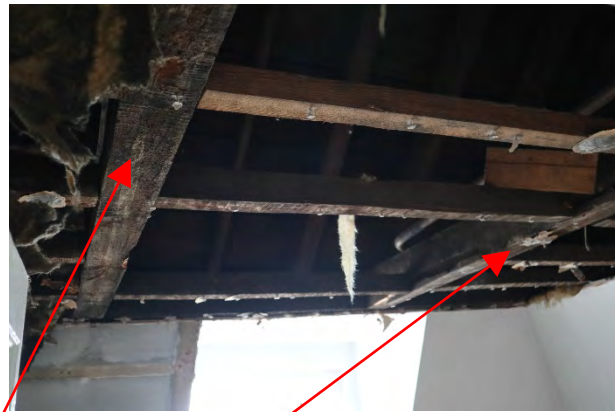
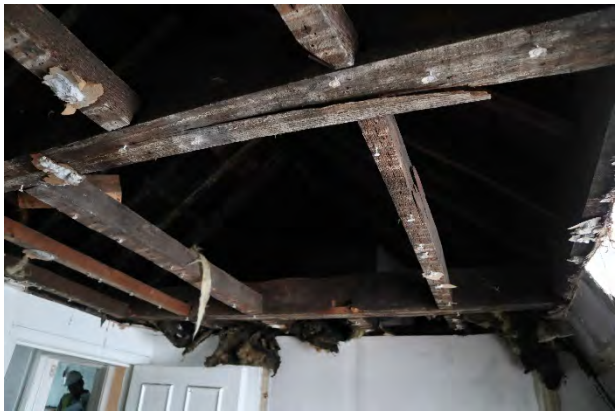
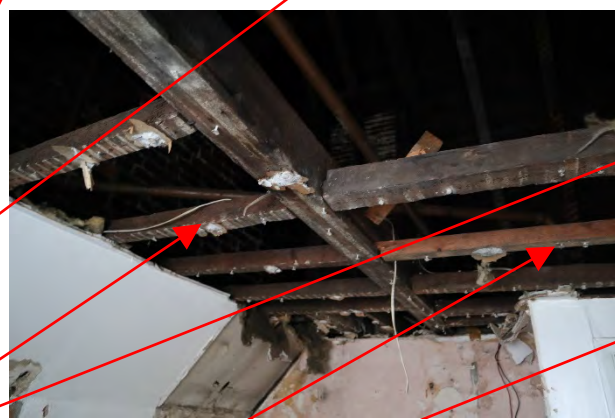
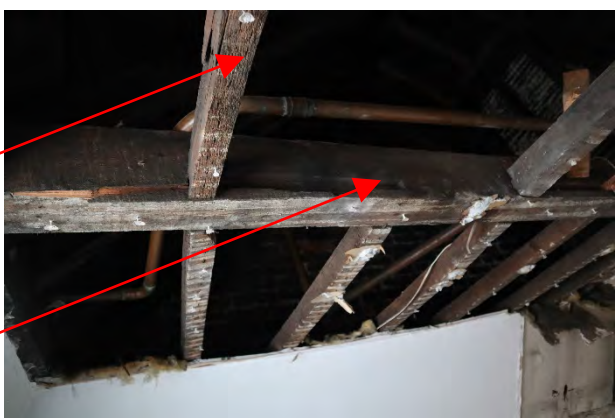
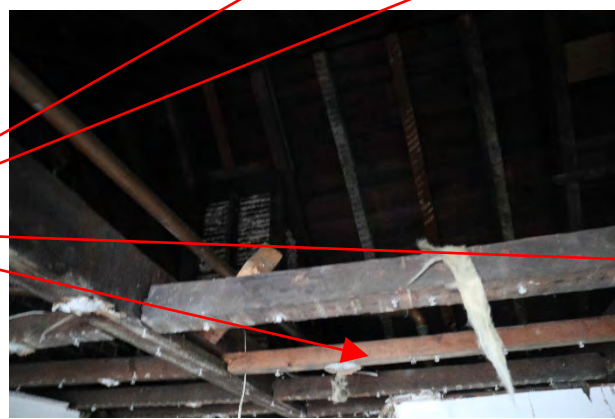
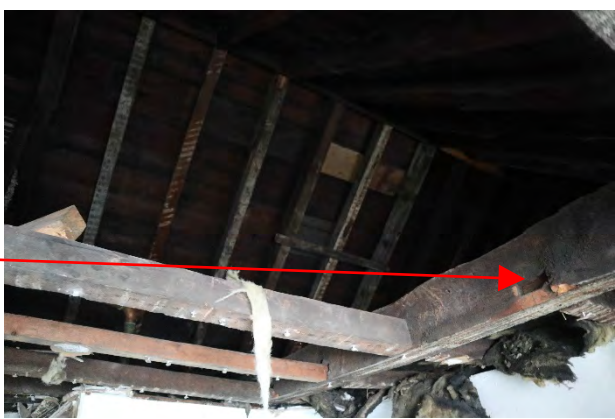
No 22

- **Roof rafters and boards:** modern fabric (95%) + historic (5%)
- **Primary ceiling beams:** historic (100%)
- **Ceiling joists:** historic (60%) + modern repairs/insert; replacements; missing joists (40%)
- **Ceiling finish:** modern plasterboard (100%) – removed

Modern repairs/replacements and missing joists

Primary ceiling beams to be retained

Ceiling joists to be removed
