Arboricultural Consultancy for Aviva

Insured		Address	54 Hillway, London, N6 6EP		
Client	Subsidence Management Services	Contact	Benon Flemons	Claim No.	
ES Ref		Consultant	Lewis Fraser	Contact No.	0330 380 1036
Report Date	18/12/2018 Revised: 07/03/2019

Scope of Report: To survey the property and determine significant vegetation contributing to subsidence damage, make recommendation for remedial action and assess initial mitigation and recovery prospects. The survey does not make an assessment for decay or hazard evaluation. Please note: this is a revised report to include the results of root analysis.

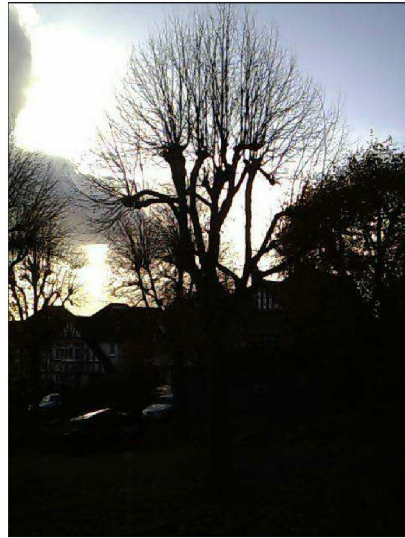
T1 - Lime

Please note that the footing of the insured property fall within the anticipated rooting distance of additional vegetation which we believe presents a foreseeable risk of future damage and accordingly we have made recommendations in respect of this.

Tree No.	Species	Age Cat	Approx. Height (m)	Distance to Building (m) *	Ownership	Action	Requirement
T1	Lime	1	12.5	16.7	B - Local Authority	Action to avoid future risk	Note: Pruning works scheduled for November 2018. Re-pollard back to points of previous reduction and repeat at 3 year (max) intervals.
T3	Lime	1	14.5	16.7	B - Local Authority	Action to avoid future risk	Note: Pruning works scheduled for November 2018. Re-pollard back to points of previous reduction and repeat at 3 year (max) intervals.
T4	Birch (Silver)	1	6.5	9.8	A - Third Party	Action to avoid future risk	Do not allow to exceed current dimensions by way of regular pruning.
T5	Cedar (Blue Atlas)	1	4.9	5.2	C - Insured	Action to avoid future risk	Do not allow to exceed current dimensions by way of regular pruning.

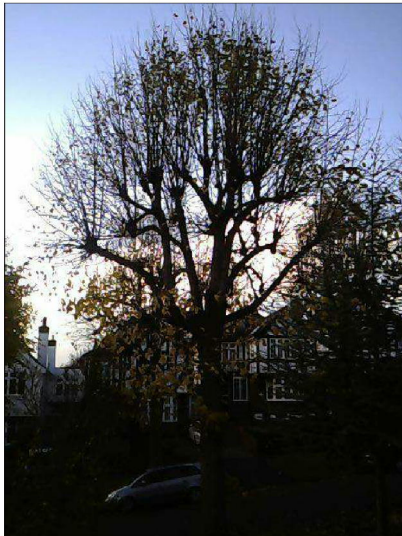
T2 - Lime

Site Investigations revealed the presence of roots in TP/BH1 and TP/BH2 as having emanated from the genus *Tilia* spp. (Lime) and Pomoideae group spp. (Includes; Quince and Cotoneaster).

Our survey of the site identified T2 (Lime) and SG1 (Mixed Species Shrubs Including; Quince and Cotoneaster), given their position relative to the damage it is in our opinion that the roots identified within TP/BH1 and TP/BH2 will emanate from this vegetation.

In assessing the extent of damage and the potential drying influence of the vegetation on site, T2 (Lime) is judged to be the dominant feature and accordingly we have identified it as the principal cause of the subsidence.

However, the above tree is scheduled for robust pruning works (full pollard); this work will accord with pruning parameters as advised by published research and as such a meaningful reduction in soil drying from T2 should be expected.

Removal of T2 (Lime) and SG1 (Mixed Species Shrubs) will offer the most certain and reliable arboricultural solution likely to restore long-term stability.

Where movement persists, removal of T2 (Lime) would offer the most certain and reliable arboricultural solution likely to restore long-term stability; our management prescriptions assume movement persists despite the recent pruning work.

Tree No.	Species	Age Cat	Approx. Height (m)	Distance to Building (m) *	Ownership	Action	Requirement
SG1	Mixed species shrubs: Includes: Quince, Lavender, Cotoneaster & Jasmin.	1	1.9	0.1	C - Insured	Remove	Note: Revised recommendation. Remove close to ground level and treat stumps to inhibit regrowth.
T2	Lime	1	14	14.5	B - Local Authority	Remove	Note: Pruning works scheduled for November 2018. Remove close to ground level; do not treat stump due to translocation risk. Where such a risk exists, we advise that any emergent regrowth is removed annually.

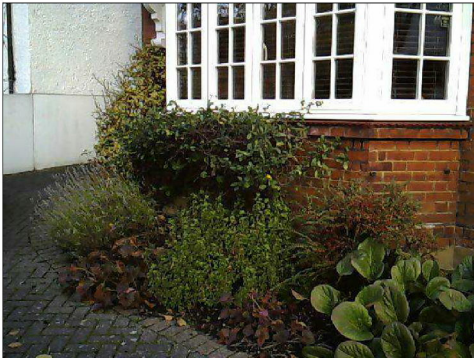
SG1 - Mixed species shrubs

SG1 (Mixed Species Shrubs) cannot be discounted as contributing to the overall level of soil drying proximate to the area of damage and is therefore also considered to retain a contributory influence, albeit in a limited / secondary capacity when compared to T2.
