114 Albert Street, Camden Town, NW1 7NE

Short Report on the Failure of a Balcony Stone

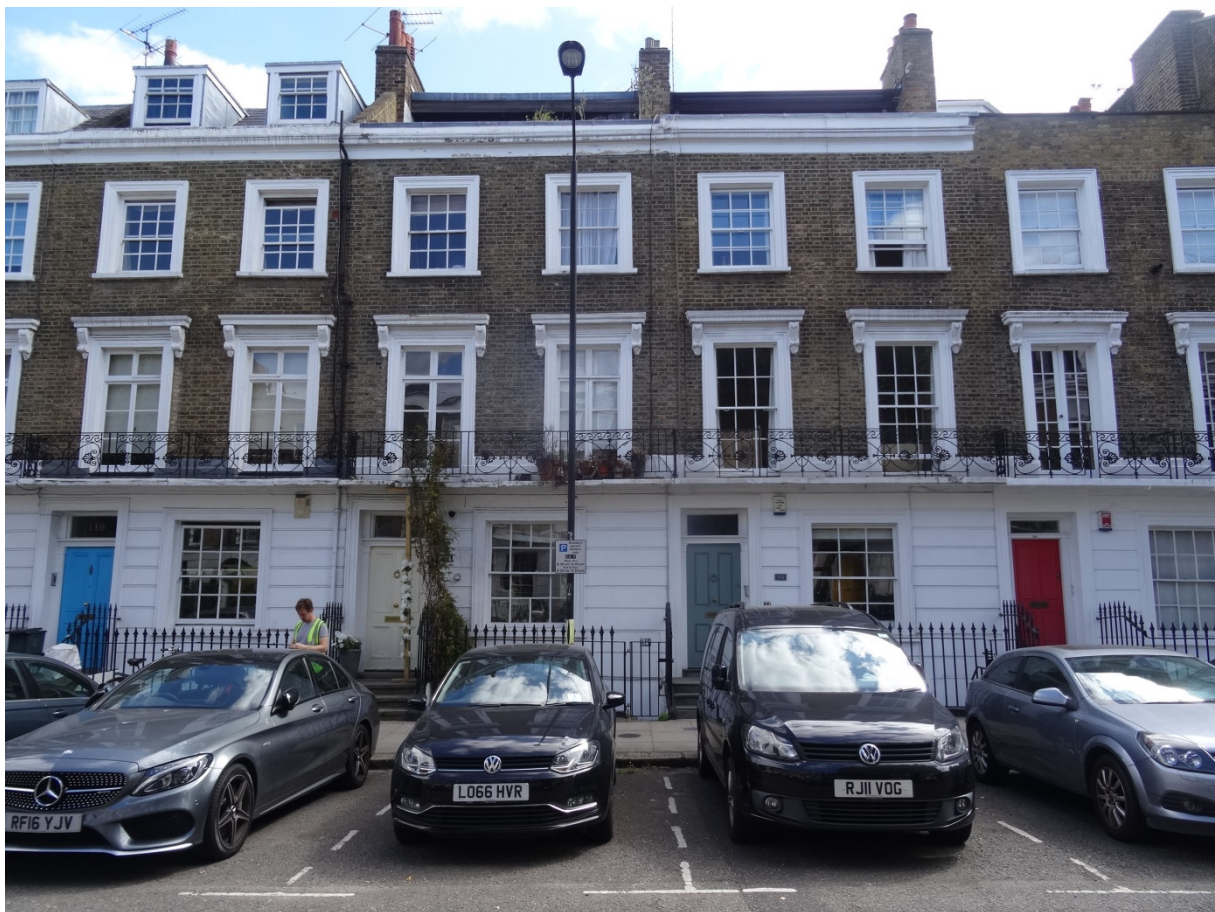
General view of the North side of Albert Street. No.114 has a prop to the balcony slab

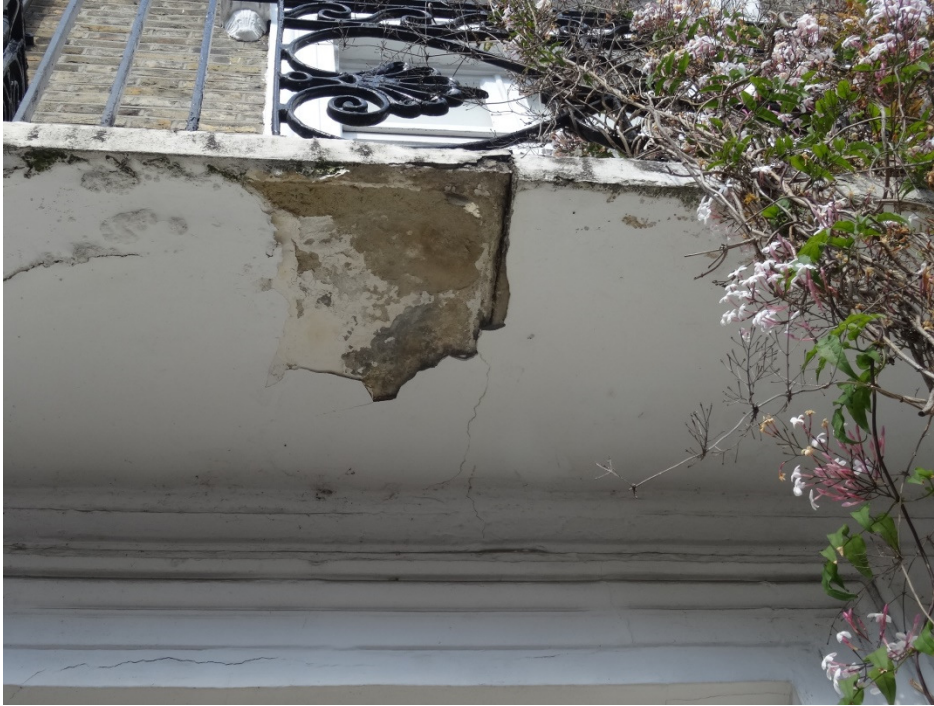
The right hand stone has dropped relative to its neighbour and a piece of stone and possibly some plaster has spalled off the bottom of the stones. Photograph taken before the prop was put in

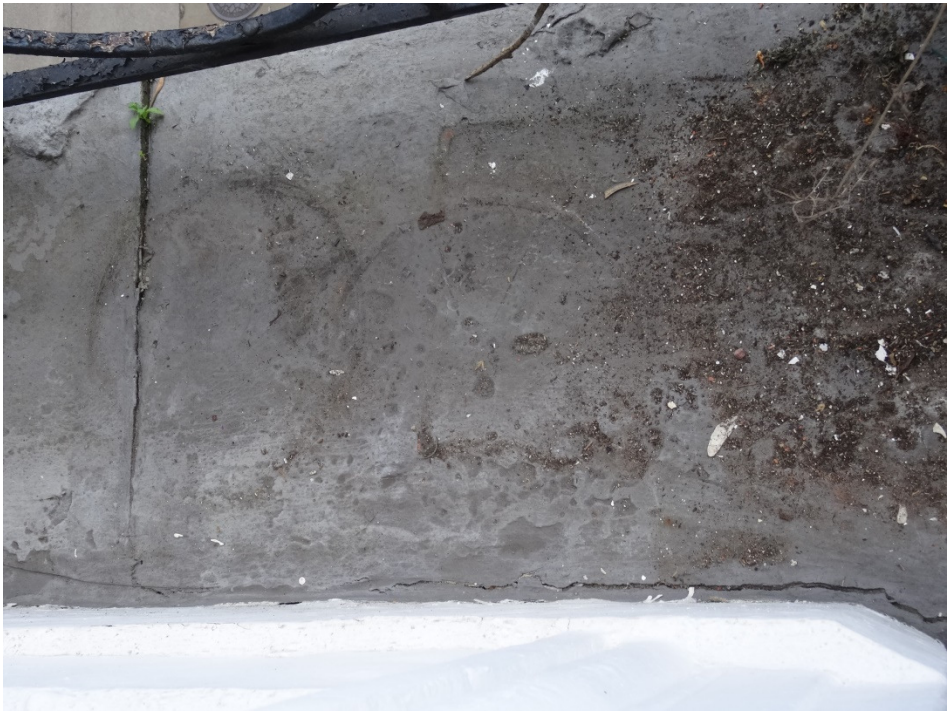
Looking down onto the balcony from the French window. There is a crack in the bituminous waterproofing of the balcony slab at the face of the wall. This may indicate that the slab has broken at the face of the wall.

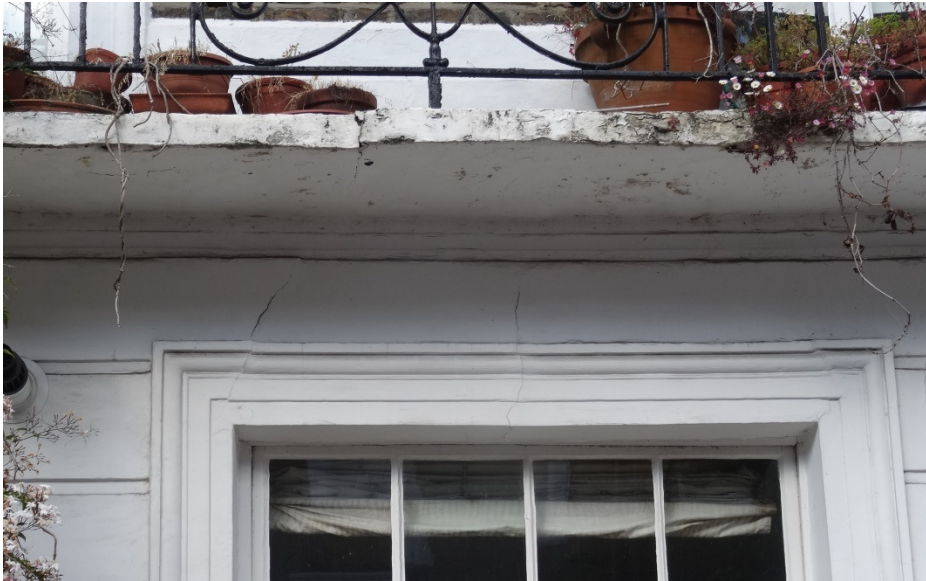
Cracks in the stucco over the Ground Floor window
