OVERVIEW

St Giles Circus Zone 2

20 DMS Vault Options 12.02.2019 ISH

029-Z2-SK156

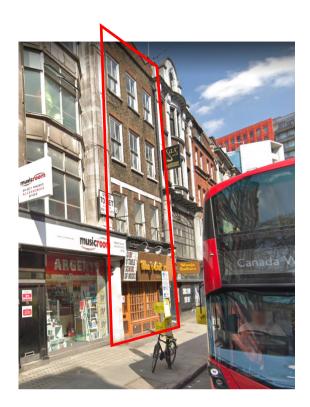
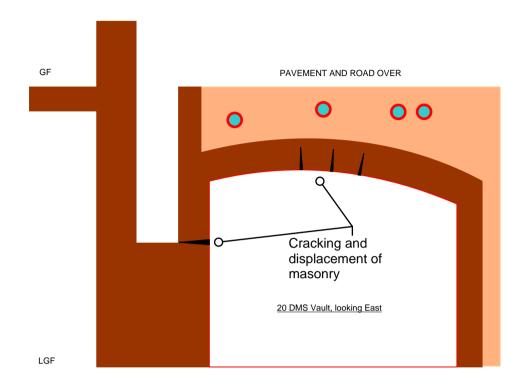
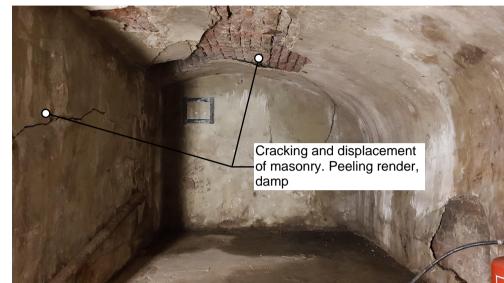
20 Denmark Street has a vault at lower ground floor that extends under the pavement The vault is formed from a masonry arch spanning between the frontage of the property and a retaining wall beneath street level.

Multiple structural defects have been identified at 20 Denmark Street and 16 Denmark Place. Most can be resolved through careful repair and replacement methods that are sympathetic to the existing historic structure. For example, an overview of areas found of concern in lower ground floor shown overleaf. At lower ground floor there is an existing vault which is showing indications of masonry failure. The structural arrangement of the vault is not appropriate for supporting the loads over, and cannot be rectified without intrusive structural works being undertaken. Ultimately, there is a risk of structural failure and eventual collapse of the vault if left unchecked.

At the springing point of the arch, immediately under the shop front, there is a cavity. The cavity prevents the thrust line of the arch from being resolved within the masonry, and with no dead weight of facade (open shop front) and the cavity, there is little in the way of dead weight to restrain the masonry.

The vault is showing signs of failing with cracks opening up at the apex of the arch and at the springing point. The vault is in need of urgent attention to restore a robust load path, noting that the vault supports the pavement and road edge over.
