Simon Pryce Arboriculture

Report

Site: 3 Greville Place, London, NW3 5JS

Subject: Trees and other vegetation near the building and their effects on it. Specification for necessary or appropriate work.

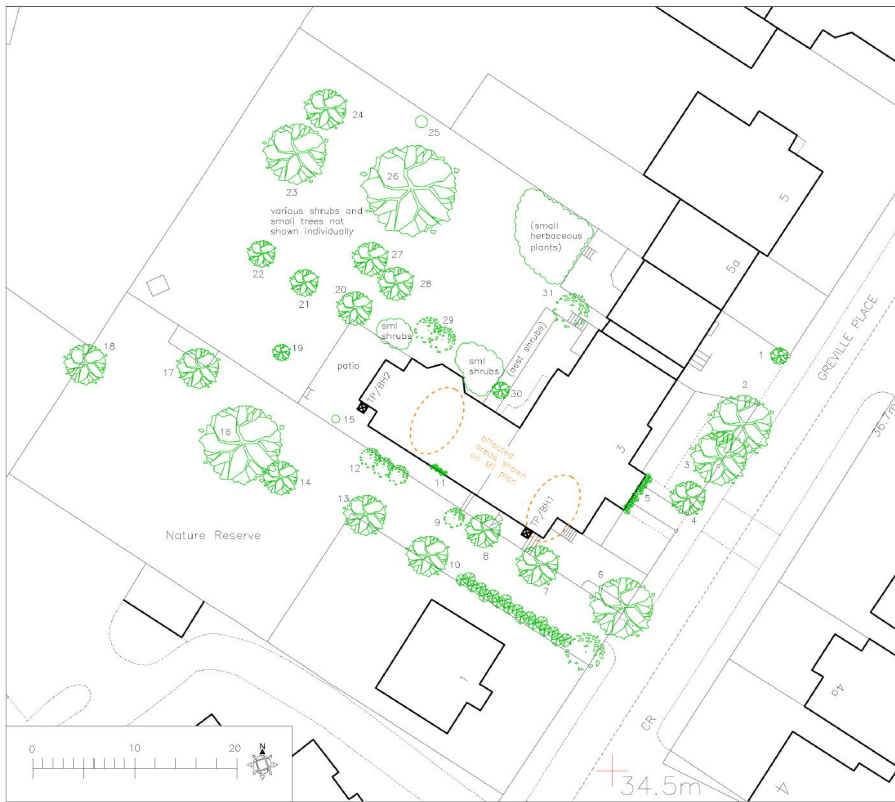
- 4.2 These are described individually in the schedule forming the second part of this report, with preliminary recommendations for any necessary or appropriate work. Some are also listed in the MT report and their numbers are also shown as well. They are numbered on the attached site plan.
