Arboricultural Consultancy for Aviva

Insured	Mr Marios Stergides	Address	55 Albert Street, London, NW1 7LX		
Client	Subsidence Management Services	Contact	Mark Studley	Claim No.	
ES Ref		Consultant	Andrew Cayley	Contact No.	0330 380 1036
Report Date	05/02/2019

2. Property and Damage Description

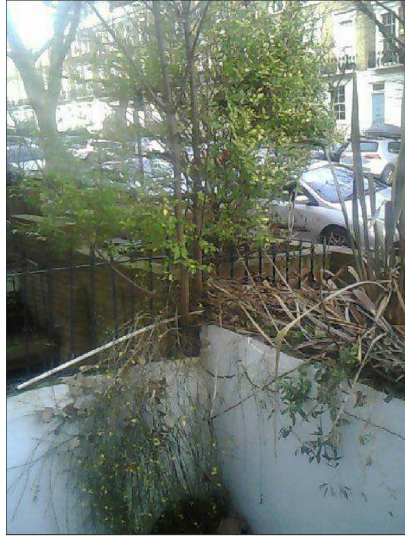
T7 - Acer

T7	Acer	1	3.4	3.7	E - Boundary Veg (ownership to be confirmed)	Action to avoid future risk	Remove close to ground level and treat stump to inhibit regrowth. Appears to be damaging front retaining wall.
