Arboricultural Consultancy for Aviva

1. Case Details

Insured	Mr Marios Stergides	Address	55 Albert Street, London, NW1 7LX		
Client	Subsidence Management Services	Contact	Mark Studley	Claim No.	[REDACTED]
ES Ref	[REDACTED]	Consultant	Andrew Cayley	Contact No.	0330 380 1036
Report Date	05/02/2019

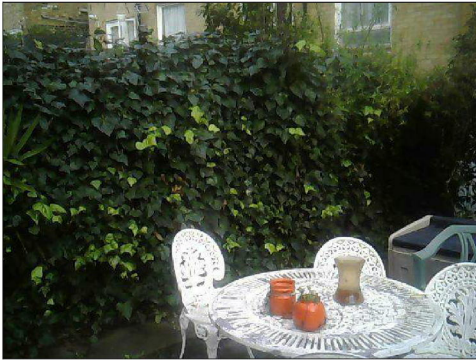
CG1 - Mixed species climbers

Tree No.	Species	Age Cat	Approx. Height (m)	Distance to Building (m) *	Ownership	Action	Requirement
CG1	Mixed species climbers	1	3	2.3	E - Boundary Veg (ownership to be confirmed)	Action to avoid future risk	Maintain at current dimensions by way of regular pruning.
SG1	Mixed Species Group: Camelia & Rose.	1	2.7	0.7	C - Insured	Action to avoid future risk	Maintain Camelia at current dimensions by way of regular pruning. No works required to rose.
T1	Fig	1	3.1	3.2	C - Insured	Action to avoid future risk	Subject to regular management; maintain at current dimensions by way of regular pruning.
T2	Fig	1	8.2	5.7	A - Third Party	Action to avoid future risk	Do not allow to exceed current dimensions by way of regular pruning.
T5	Lime	2	13.5	12	A - Third Party	Action to avoid future risk	Do not allow to exceed current dimensions by way of regular pruning.
T6	Plane (London)	1	13	9.3	B - Local Authority	Action to avoid future risk	Subject to regular management; maintain at current dimensions by way of regular pruning.

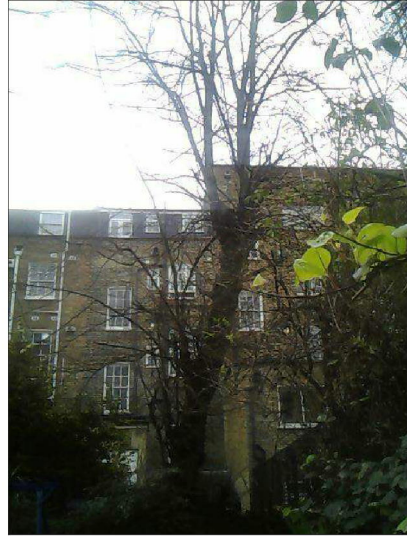
T3 - Lime

Based on our observations on site and with due regards to species profile, T3 (Lime) and T4 (Lime) are considered the dominant features and accordingly we have identified them as the principal cause of the subsidence damage.

The size and proximity of this vegetation is consistent with the location of damage and advised mechanism of movement; it is our opinion on balance of probability that roots from the above vegetation will be in proximity to the footings of the insured property.

Tree No.	Species	Age Cat	Approx. Height (m)	Distance to Building (m) *	Ownership	Action	Requirement
T3	Lime	2	13	9.6	A - Third Party	Remove	Remove close to ground level; do not treat stump due to translocation risk. Where such a risk exists, we advise that any emergent regrowth is removed annually.
T4	Lime	2	13.5	9.6	A - Third Party	Remove	Remove close to ground level; do not treat stump due to translocation risk. Where such a risk exists, we advise that any emergent regrowth is removed annually.

Removal of T3 (Lime) and T4 (Lime) will offer the most certain and reliable arboricultural solution likely to restore long-term stability.

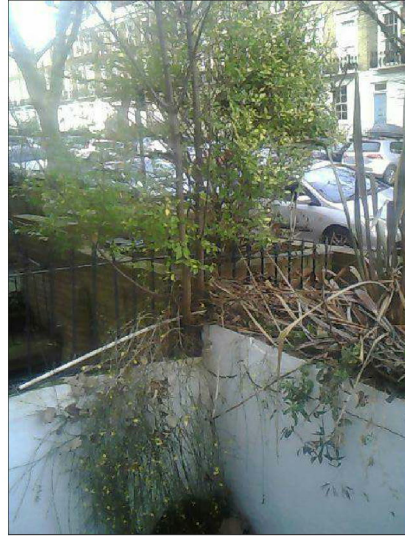
T7 - Acer

T7	Acer	1	3.4	3.7	E - Boundary Veg (ownership to be confirmed)	Action to avoid future risk	Remove close to ground level and treat stump to inhibit regrowth. Appears to be damaging front retaining wall.
