Woodstock Priory Court Management Ltd
83 Priory Road, London, NW6 3NL
Subsidence

REPORT

on trees in relation to
83 Priory Road, London NW6 3NL
for Redbourne Consultants

INSURED: Woodstock Priory Court
Management Ltd
(7th May 2019)

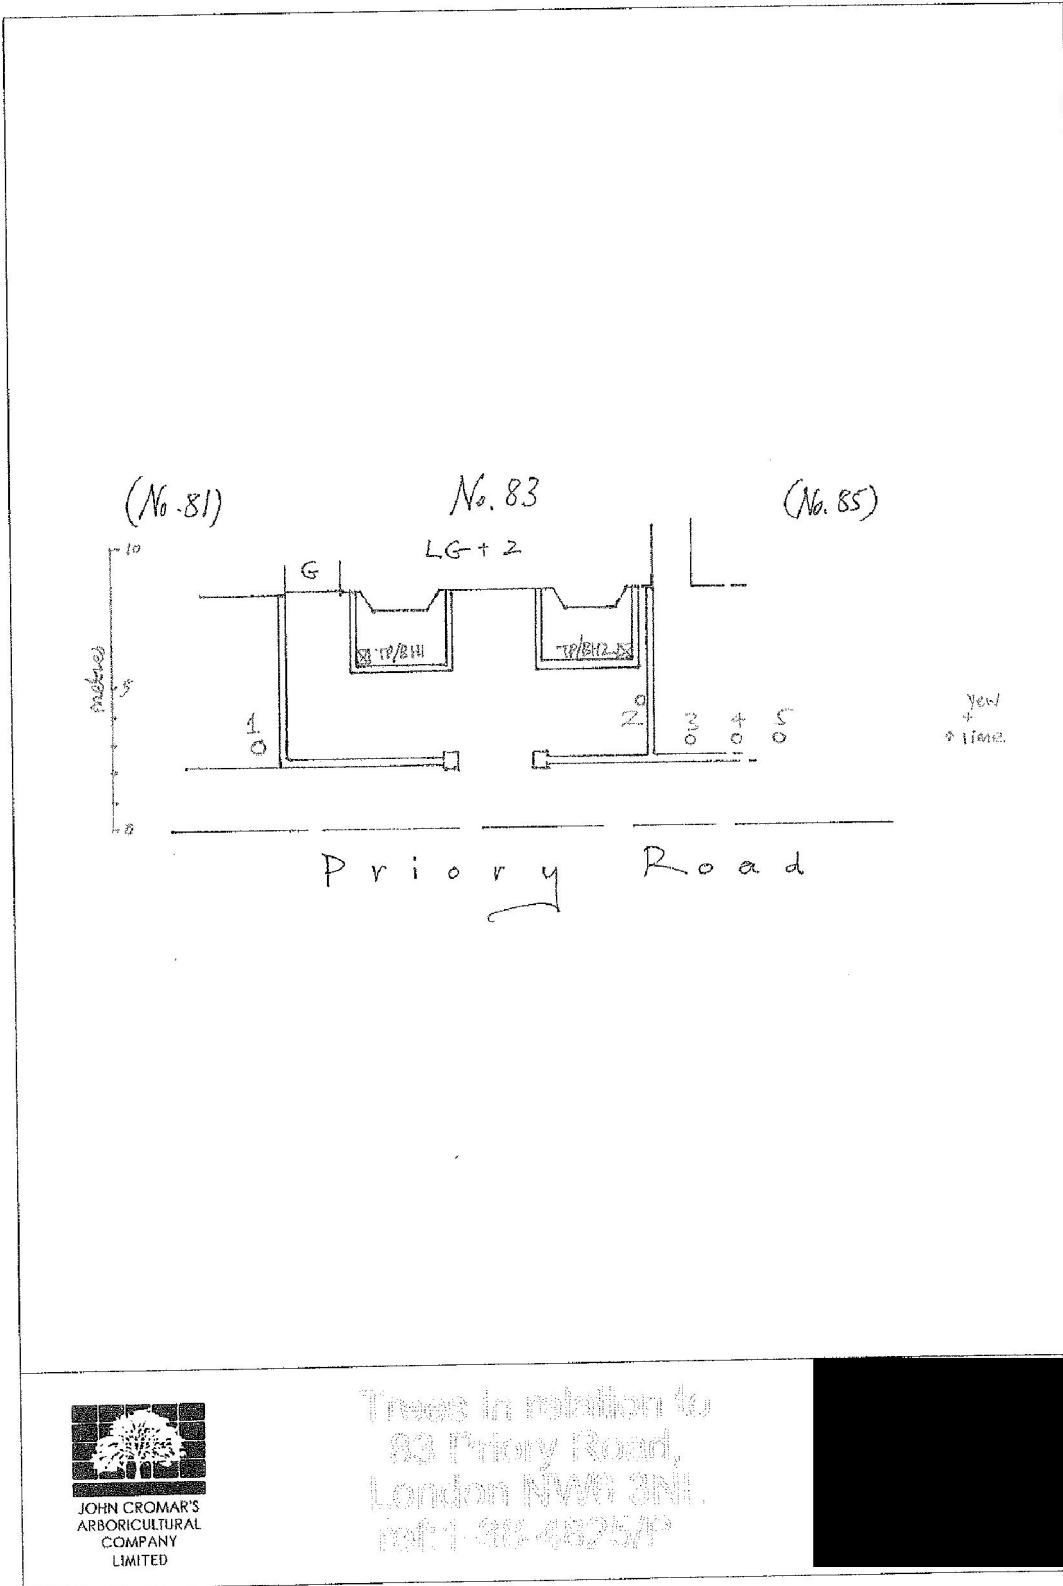
Trees in relation to
 83 Priory Road,
 London NW6 3NL.
 ref: 1 88 48257P

Tree number	Tree type	Height	Stem diameters	Proximity	Comments	Now	Repeat (Y/N +any repeat in years)	Reason	Cost - £
1	common lime	12	400	4.3	History of containment pruning to a reasonable standard. Pollarded to around 5.5m+GL last c.1995. Sited very close to dividing wall.	Y	2	Suspect	850
2	English yew	9.5	530	1.5	Noted to have been pruned to a good standard. Typically a very 'low risk' species with regard to cohesive soil drying and structures.				
3	common lime	11	<350	3.7	Pollarded to 3m last c.1995.	Y	2	Suspect	1250
4	common lime	11	<350	4.3		Y	2	Suspect	
5	common lime	11	<350	5.5		Y	2	Suspect

Tree number	Tree type	Height	Stem diameters	Proximity	Comments
1	common lime	12	400	4.3	Pollard to around 5.5m+GL.
3	common lime	11	<350	3.7	Pollard to 3m+GL.
4	common lime	11	<350	4.3	
5	common lime	11	<350	5.5
