ARBORICULTURAL ASSESSMENT REPORT

For:	Client:	Oriel Services Limited
	Insurer:	Zurich Personal Lines
Site:	Policyholder:	[REDACTED]
	Risk Address:	19 Willoughby Road, London, NW3 1RT
Refs:	PRI Ref:	[REDACTED]
	Client Ref:	[REDACTED]
	Insurer Ref:	[REDACTED]

Arborist Name:	Edward Clear	Date:	25/07/2019
QC:	Margaret MacQueen	Date:	26/07/2019

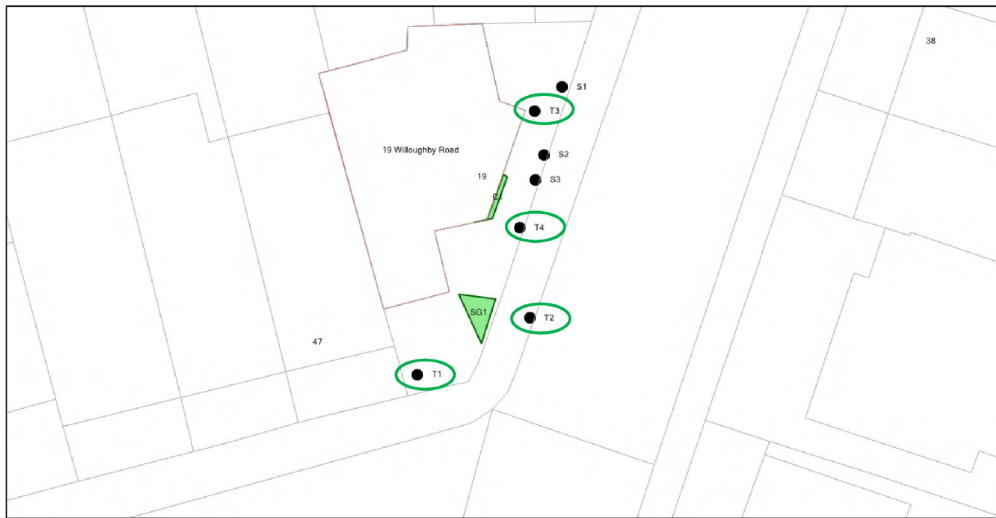
7.0 APPENDIX 2: SITE PLAN

Tree No:	Species	Works Required
T1	Cypress	Fell and treat stump.
T3	Thorn	Fell and treat stump.
