Commissioned Independent, Site inspection, Technical assessment & Report

Copper Dome installed on the roof of

Koko Building

1A Camden High Street,

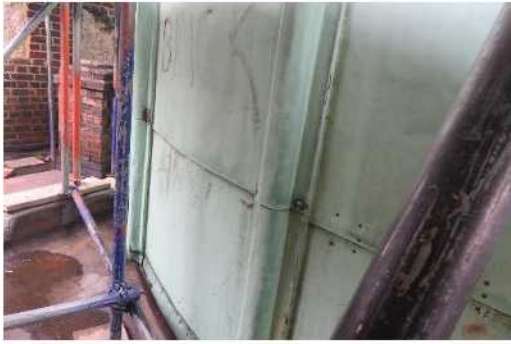
Photo A

- 3.2 The writer noted that the poor condition and lack of fixing within some of the lower copper panels at the base of the dome. There were severe panting and distortions, within these panel faces between the battens.

- 3.3 The writer noted that some of the panels were loose and flappy on cross joints. The repairs and the external nail fixing saw on the lower panelling was very poor. The would have certainly restricted thermal movement within the surface causing fracturing and distortions in the copper surface. The long-term effects would a breakdown in the metals weathering ability allowing water ingress.

- 3.4 The use of flash band and bituthene paint used as a weathering at the base presumably to whether the copper and felt roof covering should only be considered as a temporary short-term weathering solution.

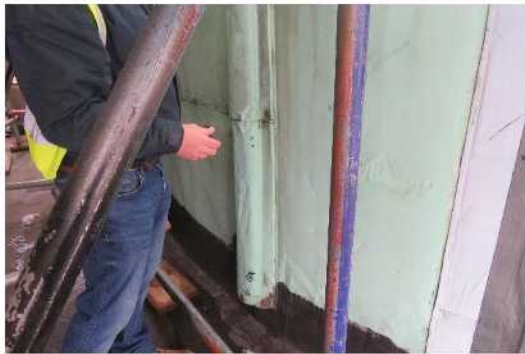
Photo C

3.5 Some of the hip detailing were showing signs of distress with brass screw fixing missing. **Photos C, D & E.** The writer's opinion is that the wooden substrate and hip carcass has degenerated over time probably due water ingress behind the metal weathering. The sealing (3.4) has only added to the issues by locking any ingress with lower sections of the dome.

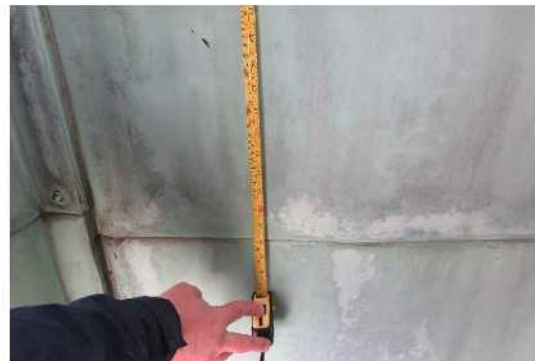
Photo F

3.6 It was noted that the size of the panels in the lower sections would exceed current trade good practice recommendations. **Photo F.**

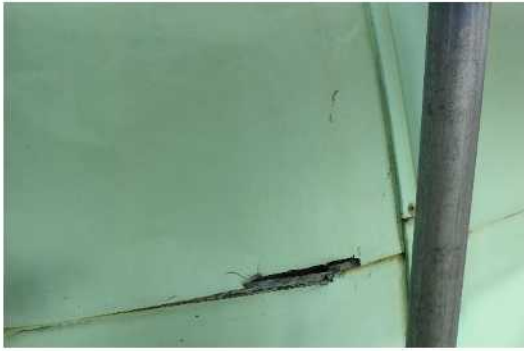
Photo G

3.7 The writer noted that several joints had fractured and were now failing. There could be several reasons or an accumulation of reasons for this within the installation. **Photos G, H, I & L. Photos K & L show early signs fatigue with the welted joint detailing.**

- (a) The gradual thinning of the copper over the installation period.
- (b) Thermal expansion and contraction.
- (c) Metal-induced embrittlement, causing a loss of ductility in the metal, making it brittle.
- (d) Failure of the metal fixing.
- (e) Failing and ageing of the substructure below the metal.

The writer's conclusions, therefore, are that due to the age and condition of the copper weathering it is not repairable and will need to be stripped and replaced. Once the copper has been removed, to expose the copper's immediate timber support decking, it will allow further investigations to assess the condition of the domes supporting substructures more effectively.

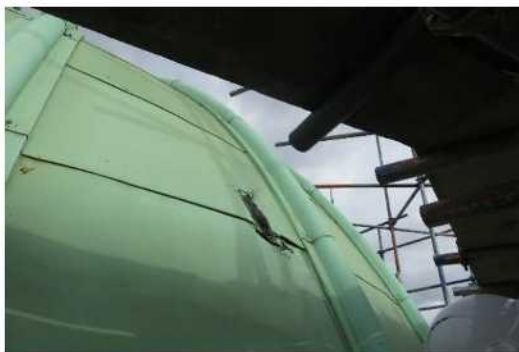
Photo M

3.8 Latten damage and further flash band repairs on the upper areas of the dome. **Photos M & N**

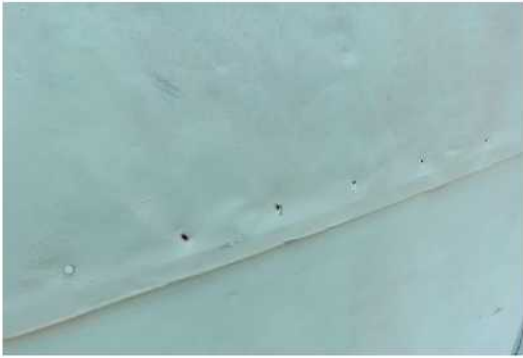
3.9 Photo O shows the nails in one of the upper panels and Photo P is from the lower panel cross joint. The writer believes that this is a poor repair for fixing back the joint where the actual original fixing had failed.

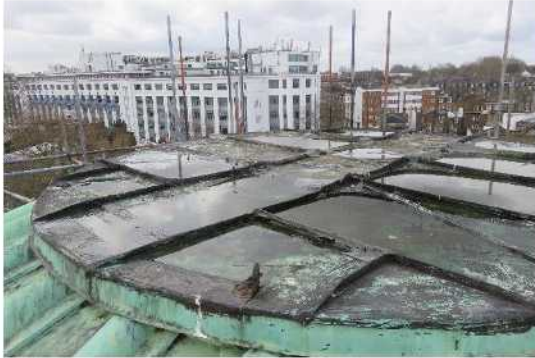
Photo Q

3.10 Photographs Q & R is of the weathering on top of the dome where bituthene paint felt repairs have been at some point in the past. The copper has been installed with the standing seam detail on what appears very flat area with very little pitch. This has resulted in the water ponding on the surface. A standing seam installed on such a low pitch is very susceptible to water ingress syphoning through the seam upstands. It is the writer's opinion that the standing water within the cover would be a major concern as ingress may distorting the copper supporting decking. **Photos Q & R**

* A cautionary note from the writer's experience, care must be taken if further investigation is required on the flat area, the surface distortions suggest that the flat substrate may not be capable of supporting heavy weights.

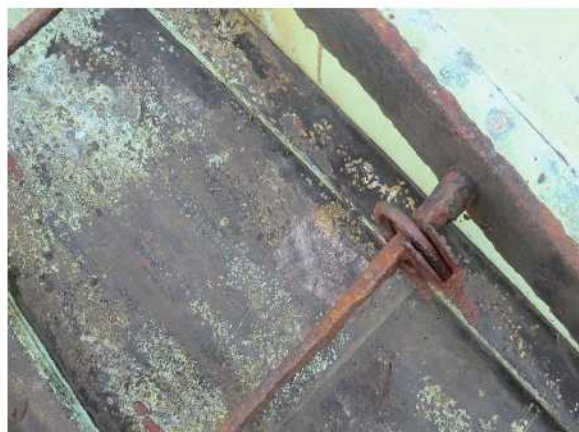
Photo S

3.11 The is final photograph below shows of a rung on one of the iron ladders. The picture shows the rust and decay that the ladder and dome have been exposed to since 1900. **Photo S**
