**Status:** Interim Report  
**Date:** 27/07/2018  
**Revision:** A  
**Job no:** 1444  
**Prepared by:** Harry Johnston  
**Approved by:** James Morgan

HTS undertook a site visit on the 12th June 2018 to inspect the steel truss which supports the dome and the western roof of Koko night club. The truss was found to have suffered from severe corrosion which was possibly caused by water ingress over the life of the building.

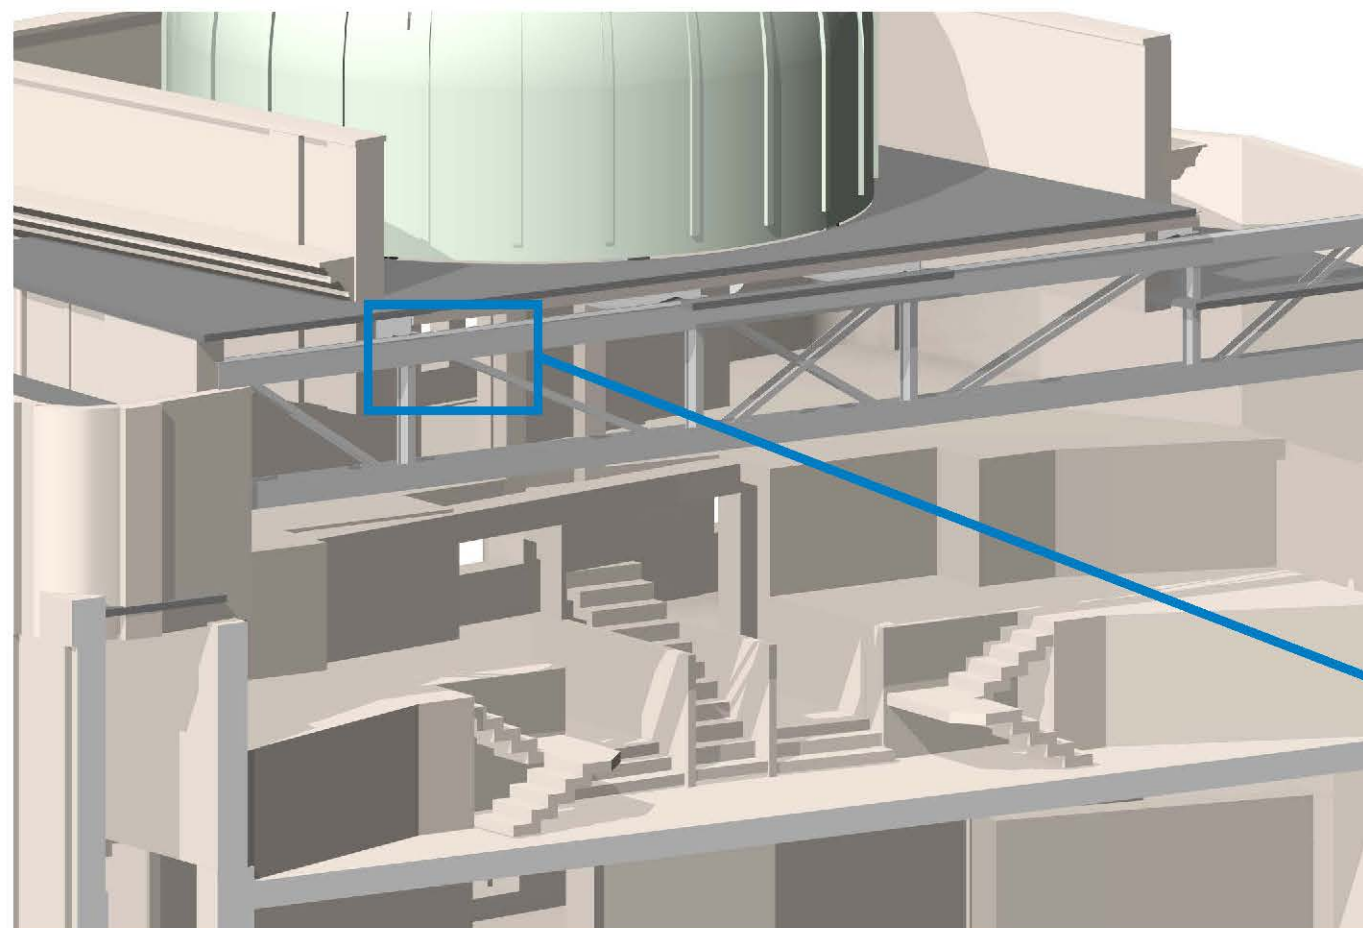
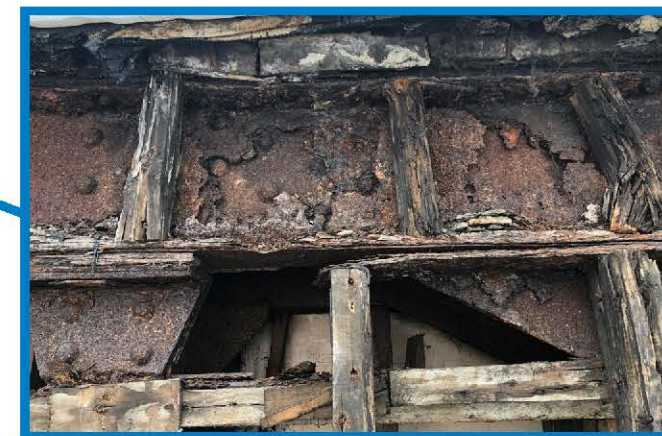
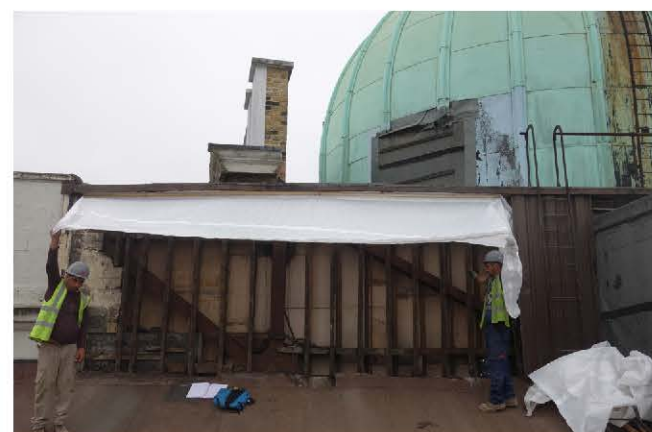
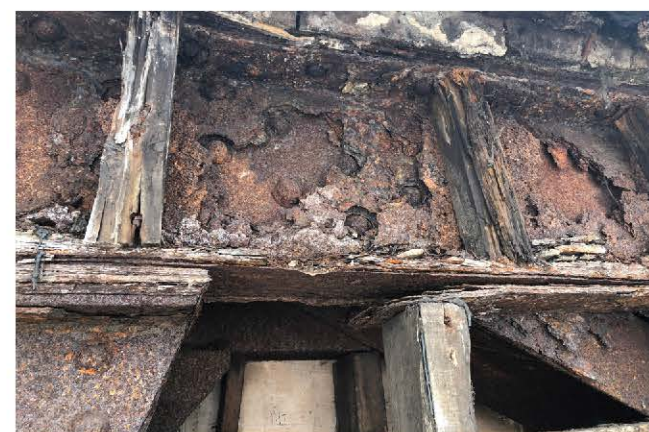
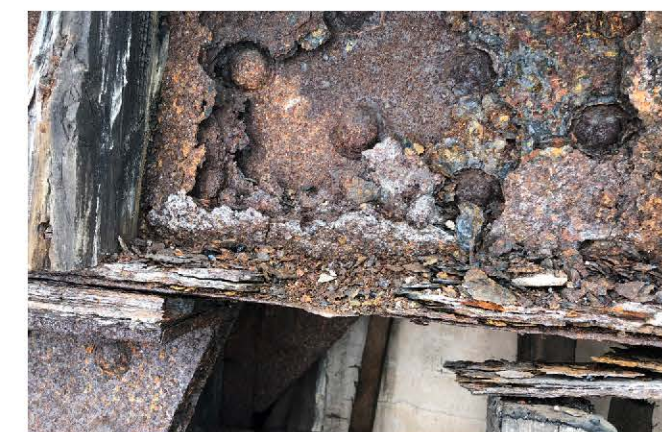
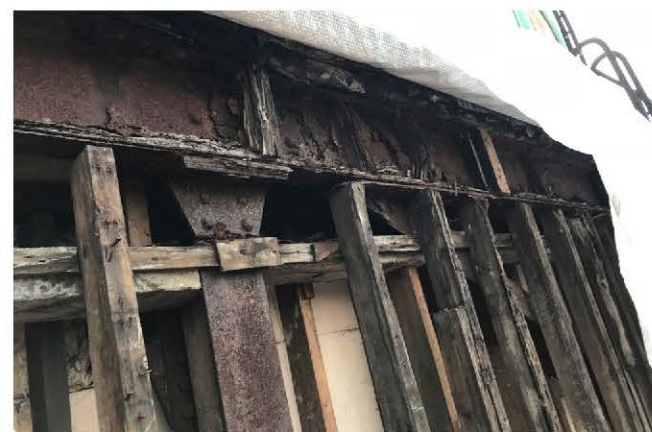
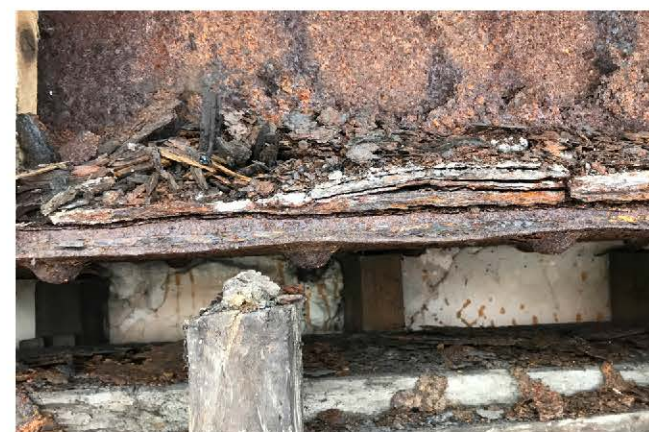
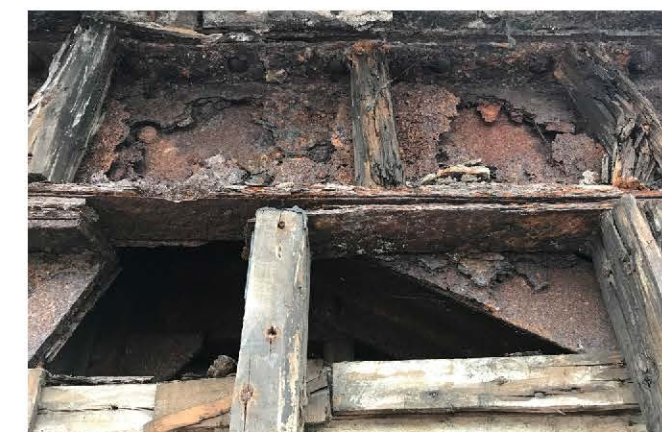
Severe deterioration/delamination of the truss top chord was observed, likely caused by water ingress during the life of the building. Delamination has caused a reduction in effective steel area which consequently reduce the capacity of the existing truss. In some areas it appears that a significant amount of steel area has been lost to the outer channel that forms the top chord.

A primary area of concern is the connection of the diagonal chord into the top chord. Analysis of the current condition indicates that the diagonal chord carries a tensile force approximately 1000kN (100 tonnes). To give this some context, the diagonal beam is trying to pull away from the corroded top chord with a weight equivalent to 85 VW Golfs.

The concern with this connection is that the section of the top chord that carries this force is very corroded and cannot withstand the applied force. There is also a risk that the corrosion of the connecting rivets may lead them fail under the applied load.

We recommend that the most simple option for works to the truss would be to retain the props in until the proposed works commence in March. Following this the most feasible option would be to replace the corroded truss with a new stronger and stiffer truss.

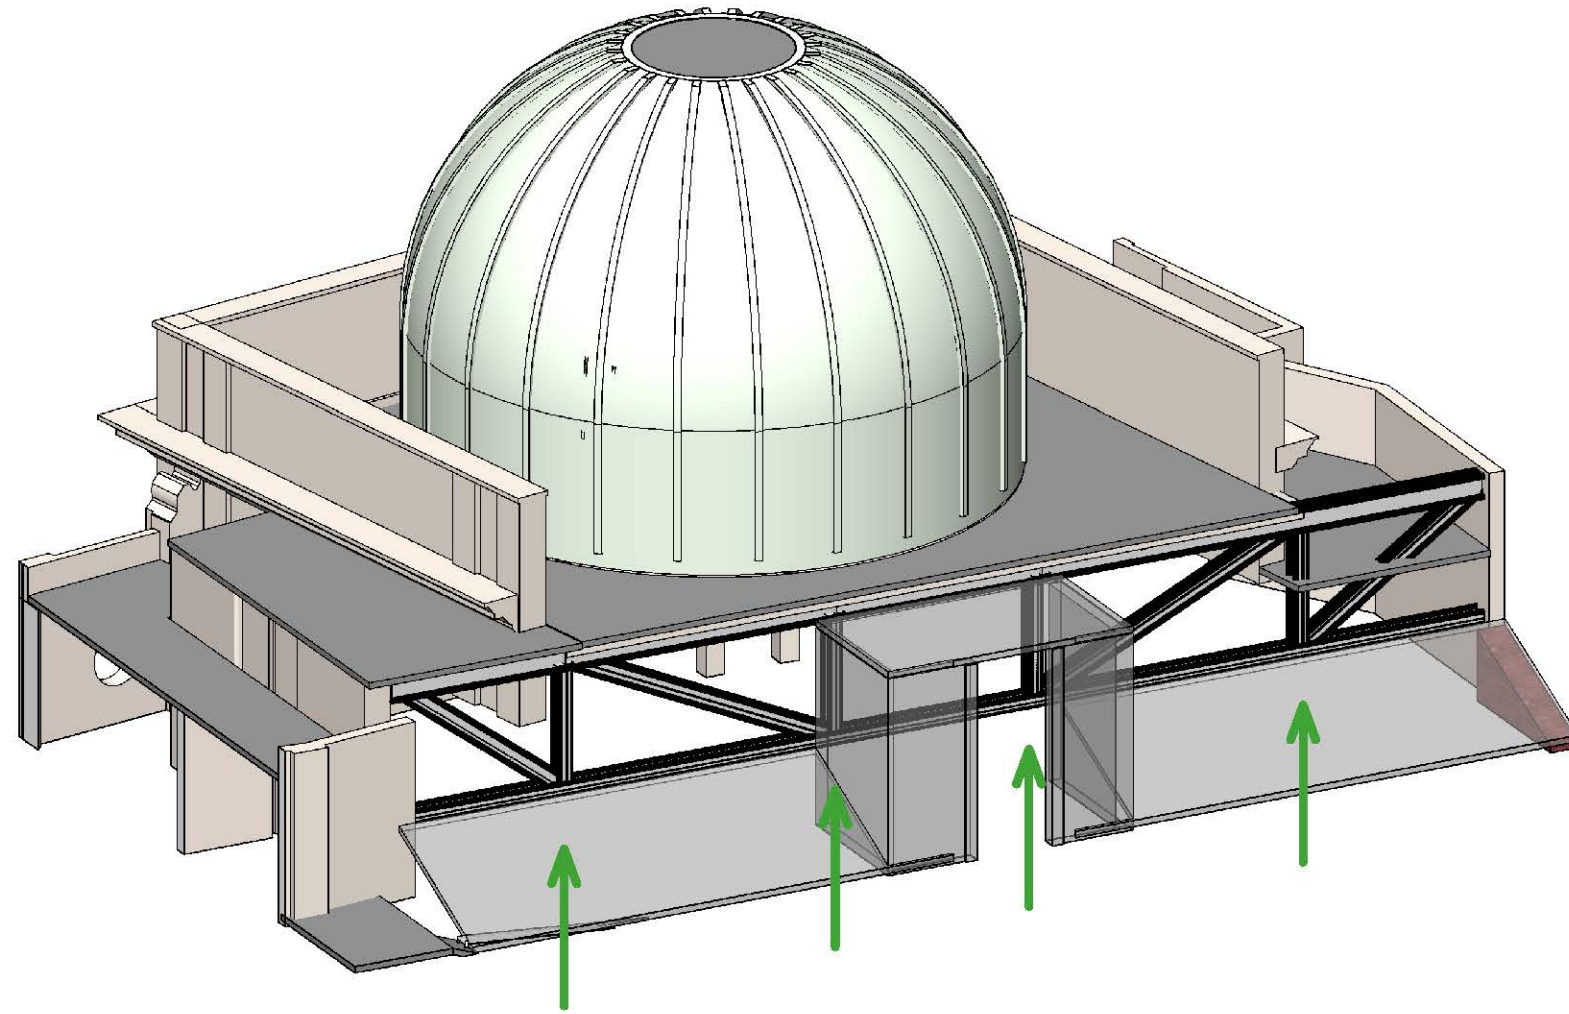
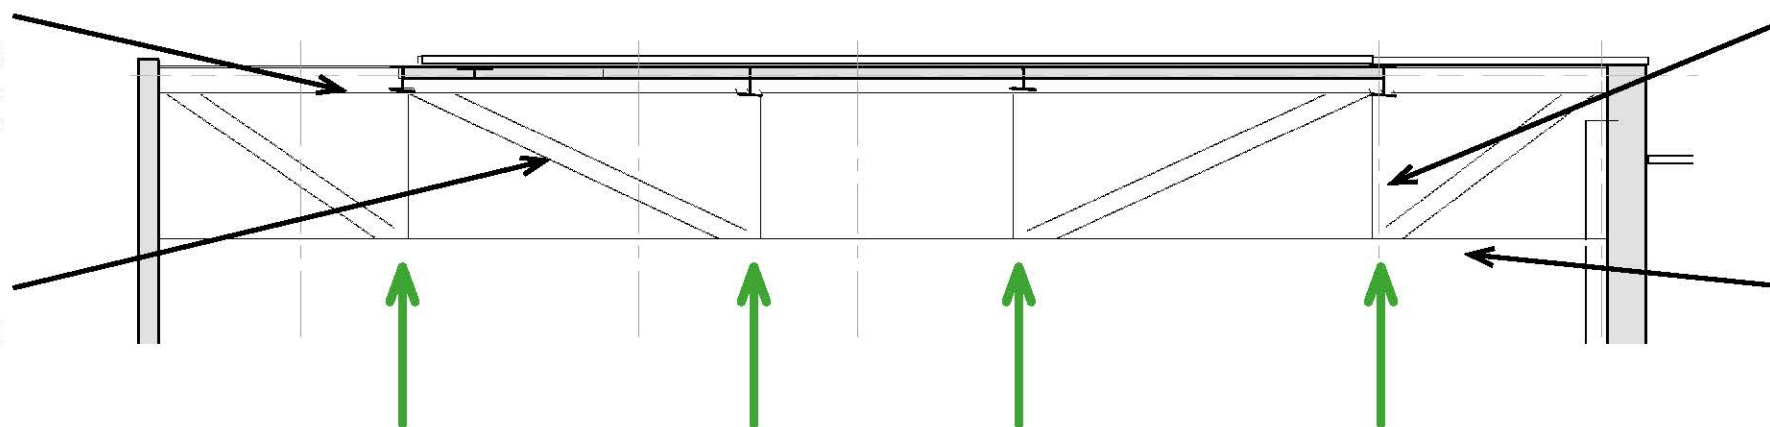
**Top chord:**  
Fabricated steel section from two 13"x3 1/2" PFC sections riveted with steel plates top and bottom. Extremely corroded in sections

**Diagonal members:**  
10"x6" steel I-sections riveted to top and bottom chords

**Vertical members:**  
9"x7" steel I-sections riveted to top and bottom chords

**Bottom chord:**  
10"x6" steel I-section on side. Appears to be supporting sloped filler-joist slab.

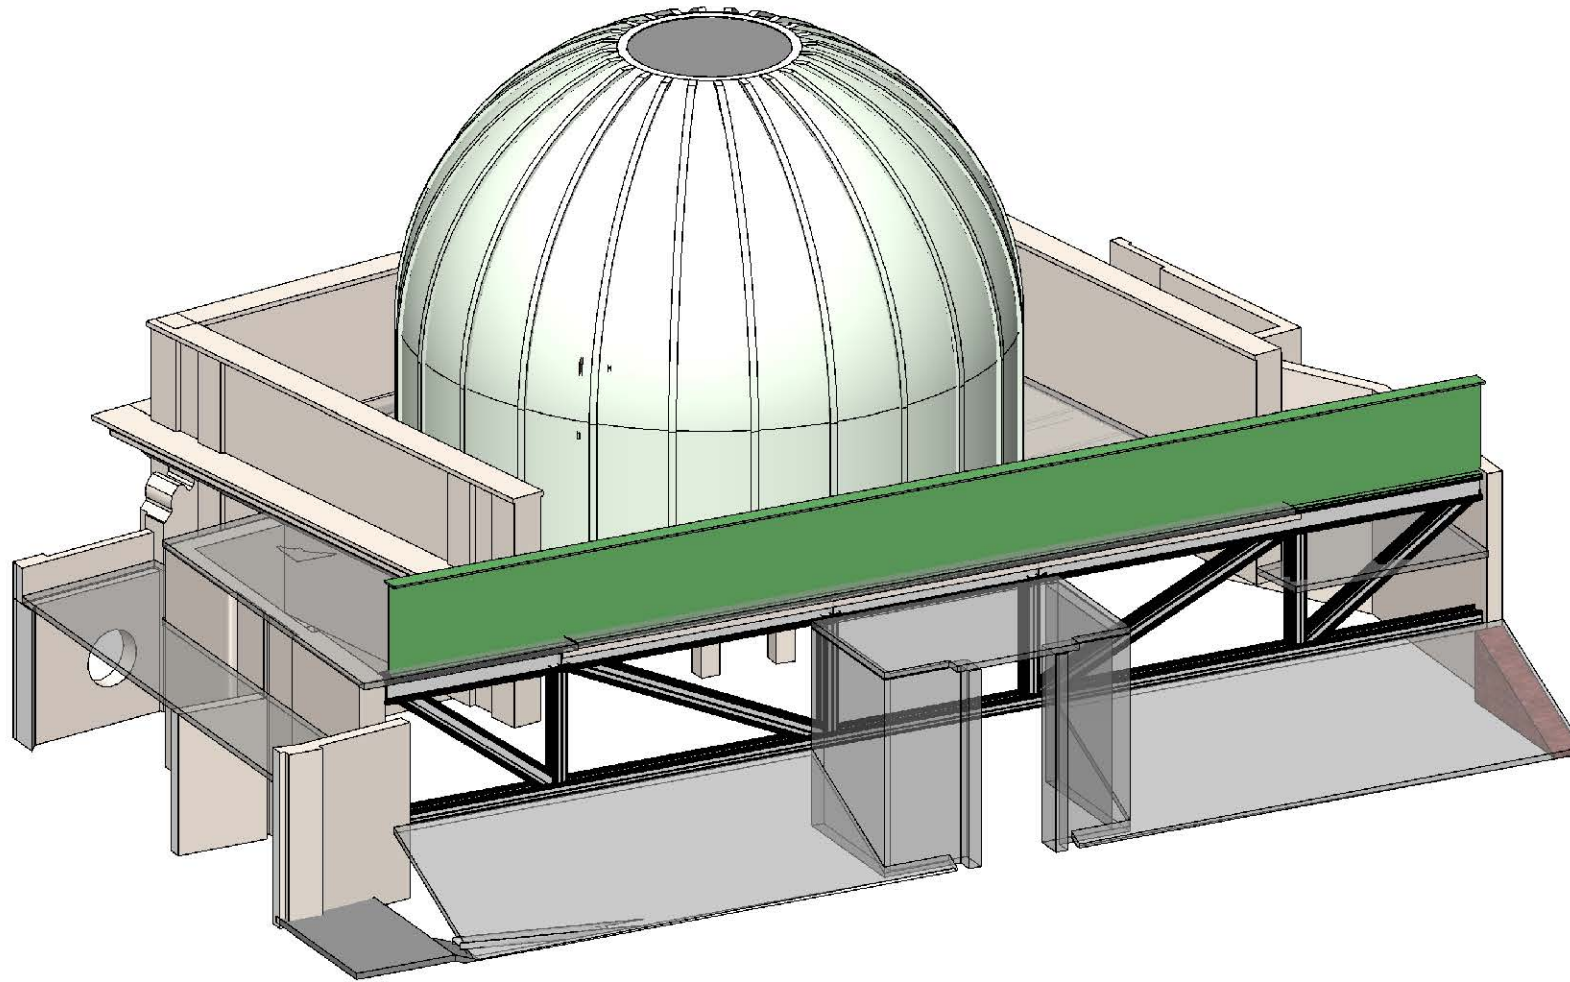
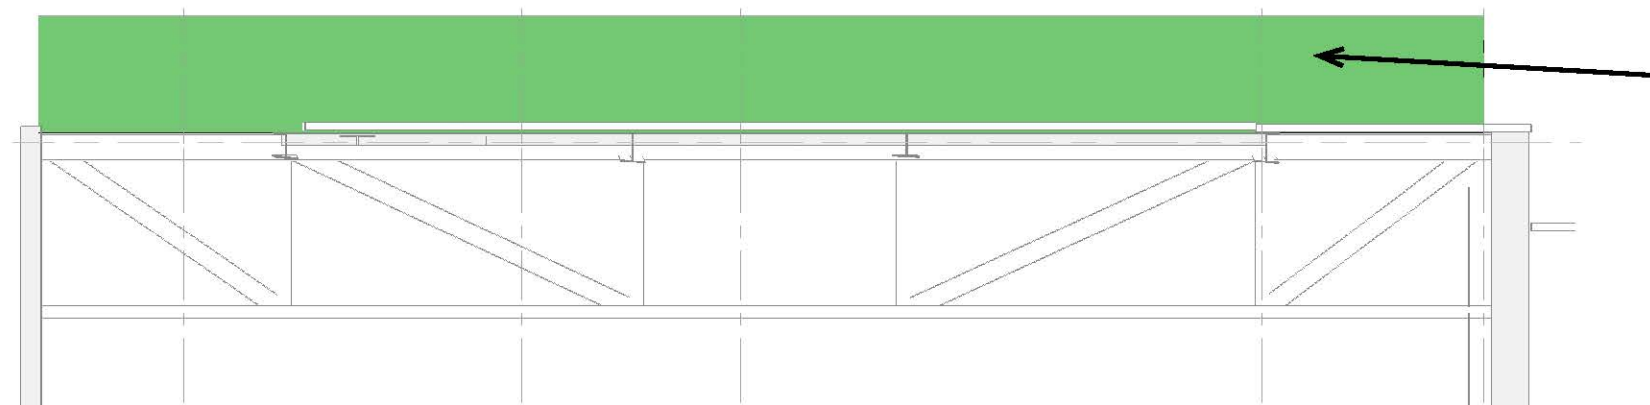
New 1500mm dp x 300mm wd steel beam.  
320kg/m

A new temporary steel beam can be installed to support the existing truss to allow removal of props. In this case, no works are done to the truss, which is assumed to have no structural function.

The beam would be a 18m long, 1500mm deep x 300mm wide steel section weight approx. 6.5 tonnes.

This option relies on reusing the existing supports of the truss at each end. The beam will require lateral support to the top flange by way of steel ties to the roof slab.

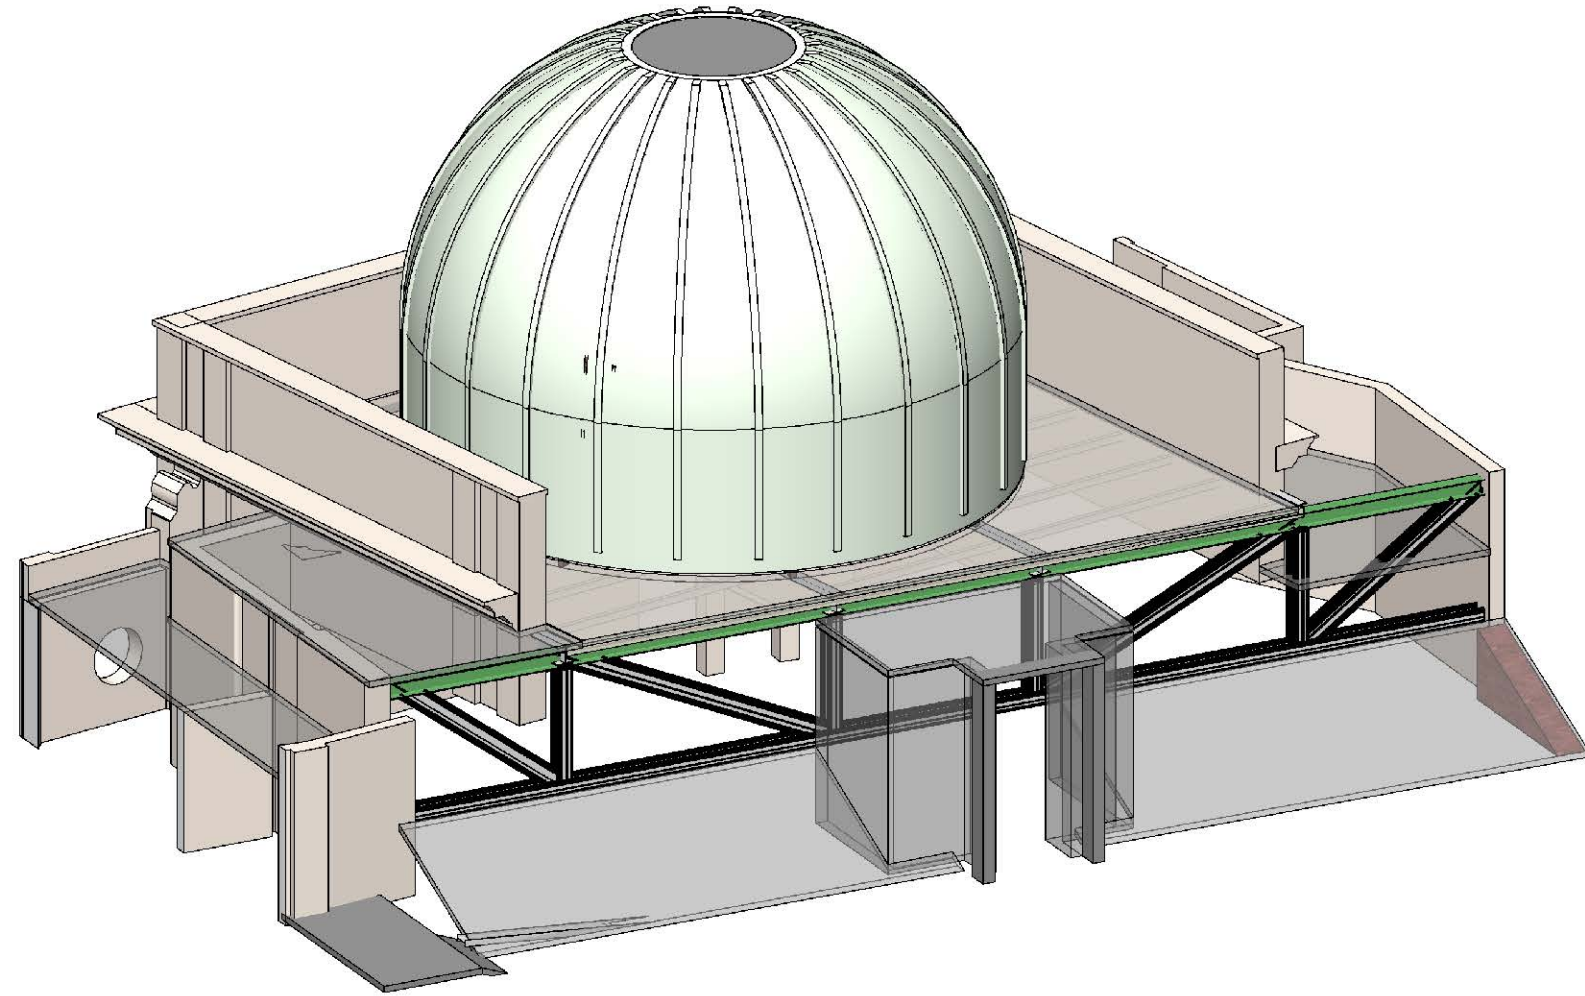
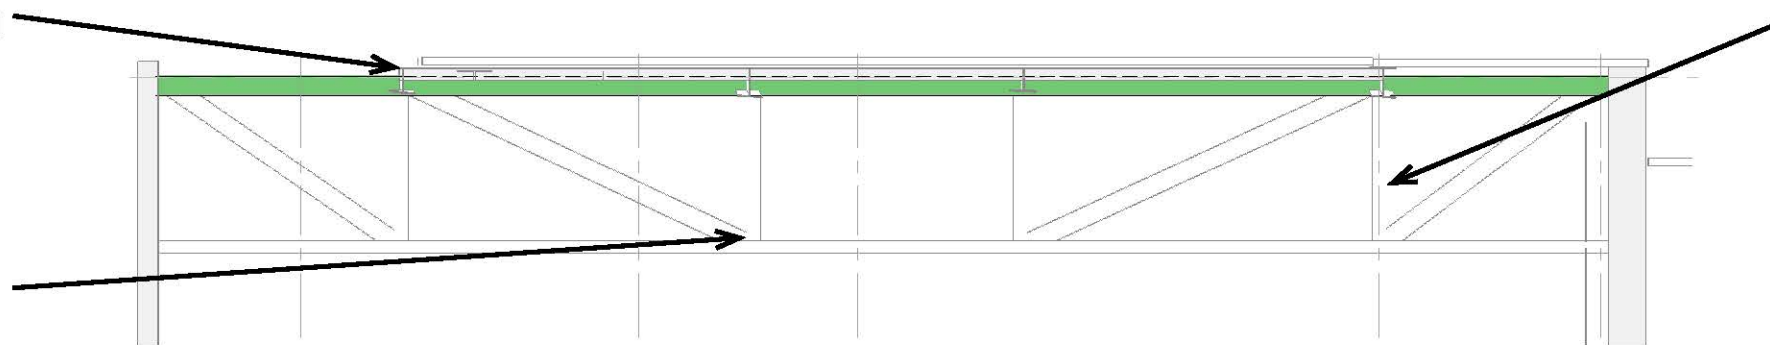
New connections between top chord and retained members

Existing riveted connections reused

New top chord 203UC60

Top chord of the existing truss is replaced with a new steel section. This option is subject to the condition of the bottom chord of the truss, which has not been exposed yet.

The new chord would require complex connections to fix the new sections in around the existing vertical and diagonal members. The steel of the truss would require metallurgy testing to verify whether it can be welded for new connections.
