London - The Court

Visual Structural Survey - Rev 1

Ref: G24167

Date: 21st January 2019

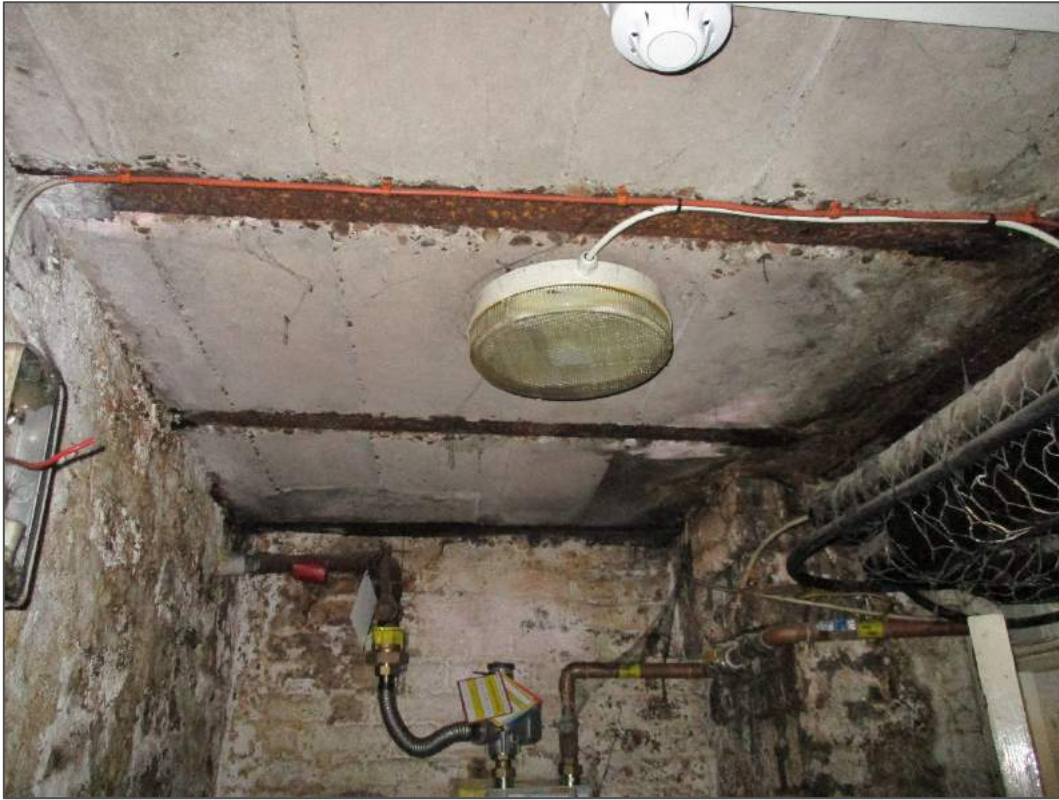
The external floor structure at ground floor level over the corridor consists of a various forms of construction along its length. At the west end, a length of approximately 2.2m of the ground floor is a filler joist floor of approximate thickness 250mm (Photo 9). The joists span approximately 1.6m and are supported by a masonry wall at the south end and a masonry wall or a steel beam at the north end (Photos 10-11). The filler joists are likely to be an historic 127x80mm I section. The bottom flanges of the filler joists are severely corroded and the steel is delaminating.

Photograph 9 – Filler joist floor in basement south

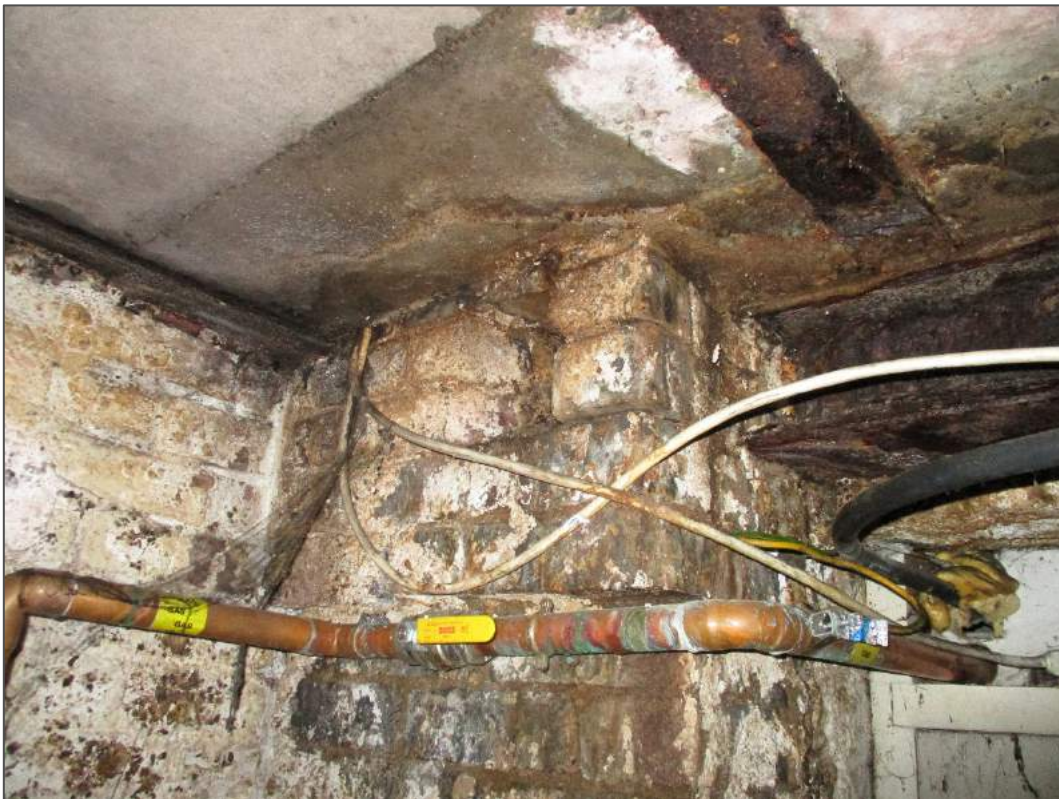
Photograph 10 – Masonry pier with missing bricks in basement south

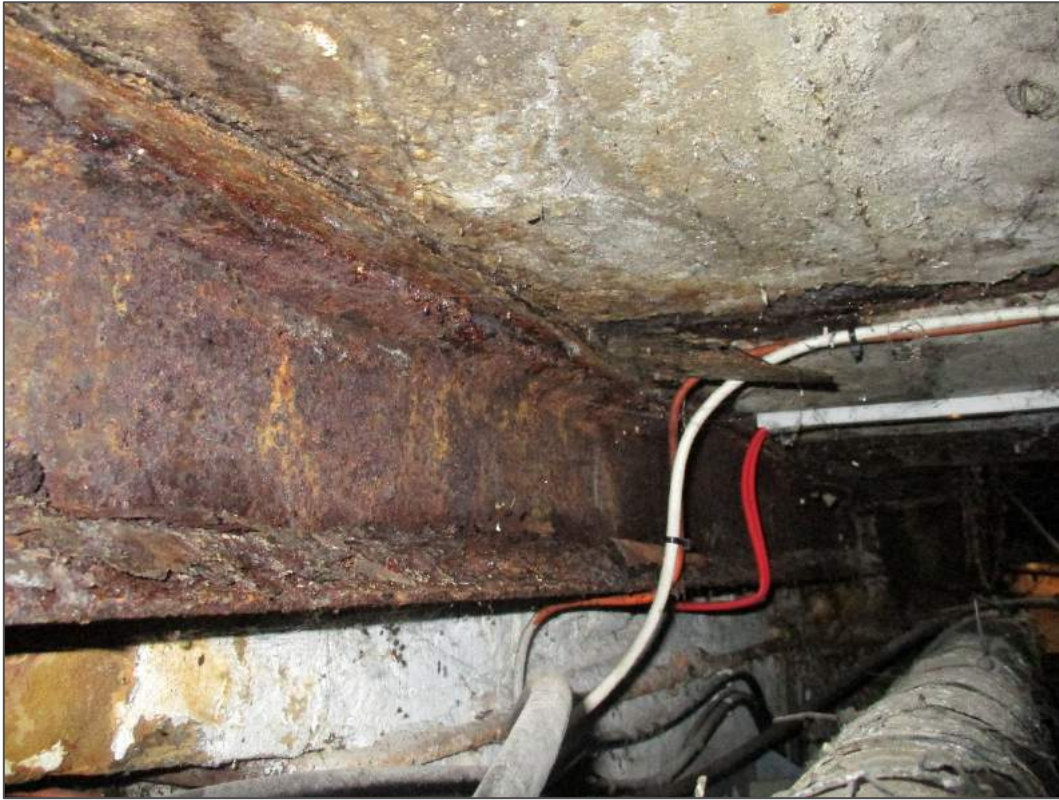
The steel beam supporting several filler joists, which spans approximately 2.4m between two masonry piers on either side of the side entrance, is most likely an historic steel 152x131mm I section. The beam is likely to also support a portion of the internal ground floor. The beam is severely corroded and the steel is delaminating.

The corrosion of the steelwork has occurred as a result of the damp environment. The corrosion of all of the steel beams is severe. The steel has delaminated and there has been significant loss of section. As a result, the load carrying capacity of the steelwork has effectively been reduced to below safe limits. The steel beams should therefore be replaced. For the most part, the external ground floor and steel beams are integral so the replacement of the steel beams will also necessitate the replacement of the external ground floor structure.

Photograph 11 – Corroded primary beam in basement south

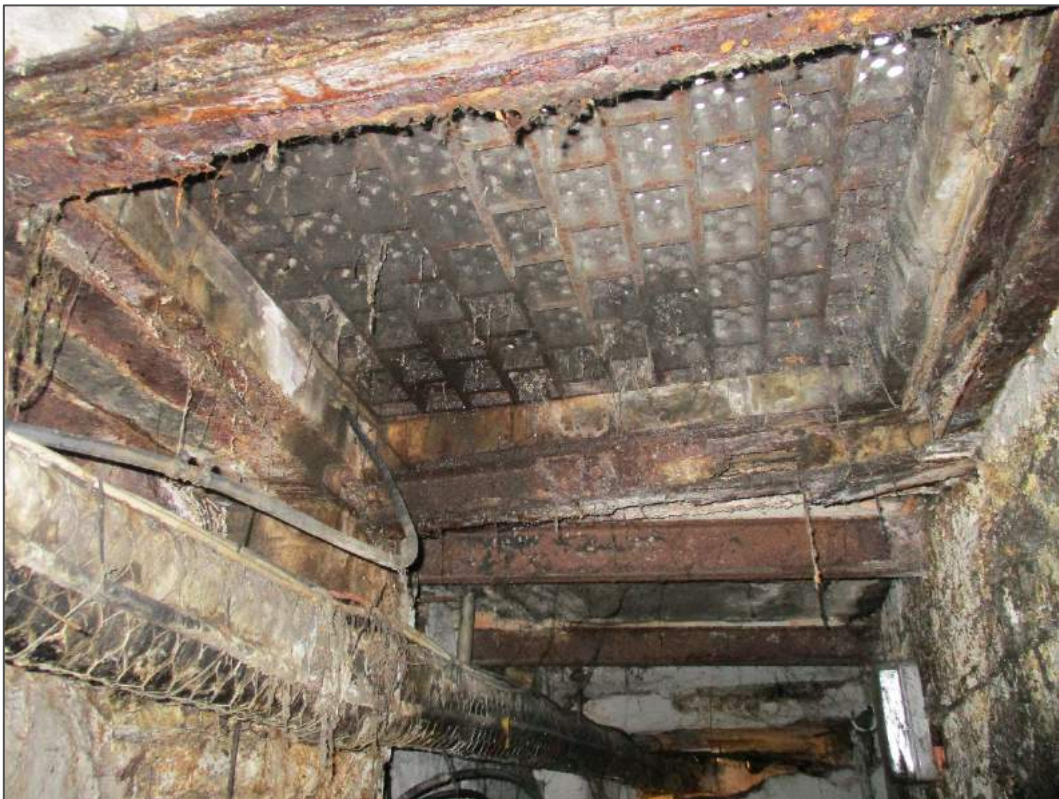
There is a steel pavement light supported on an arrangement of steel trimmer beams on the east side of the side entrance (Photos 12-14). The pavement light is approximately 1x1.1m on plan. The pavement light lattice has numerous small openings by design. The soffit of the pavement light has corroded (Photo 15). The trimmer beams supporting the pavement light are most likely an historic

Photograph 12 – Corroded beams in basement south

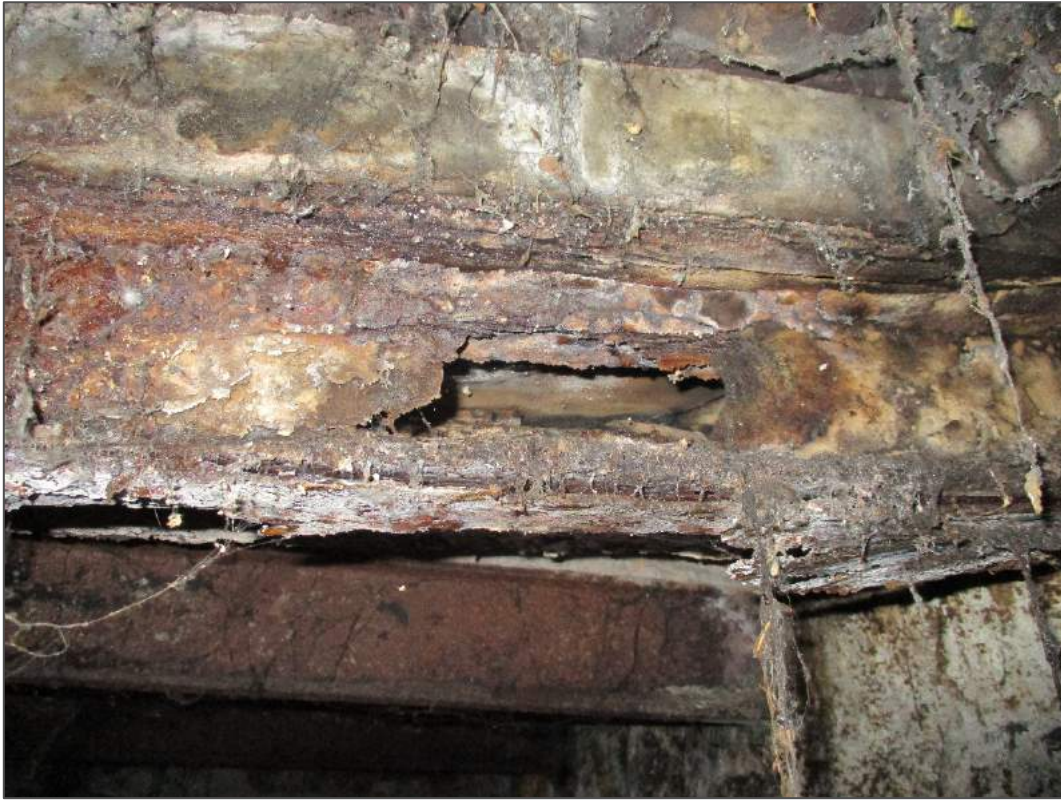
steel 127x80mm I section. The beams are severely corroded and the corrosion section loss is equal to the full thickness of the web for at least one of the beams (Photo 13).

Photograph 13 – Corroded pavement light trimmer beam in basement south (1)

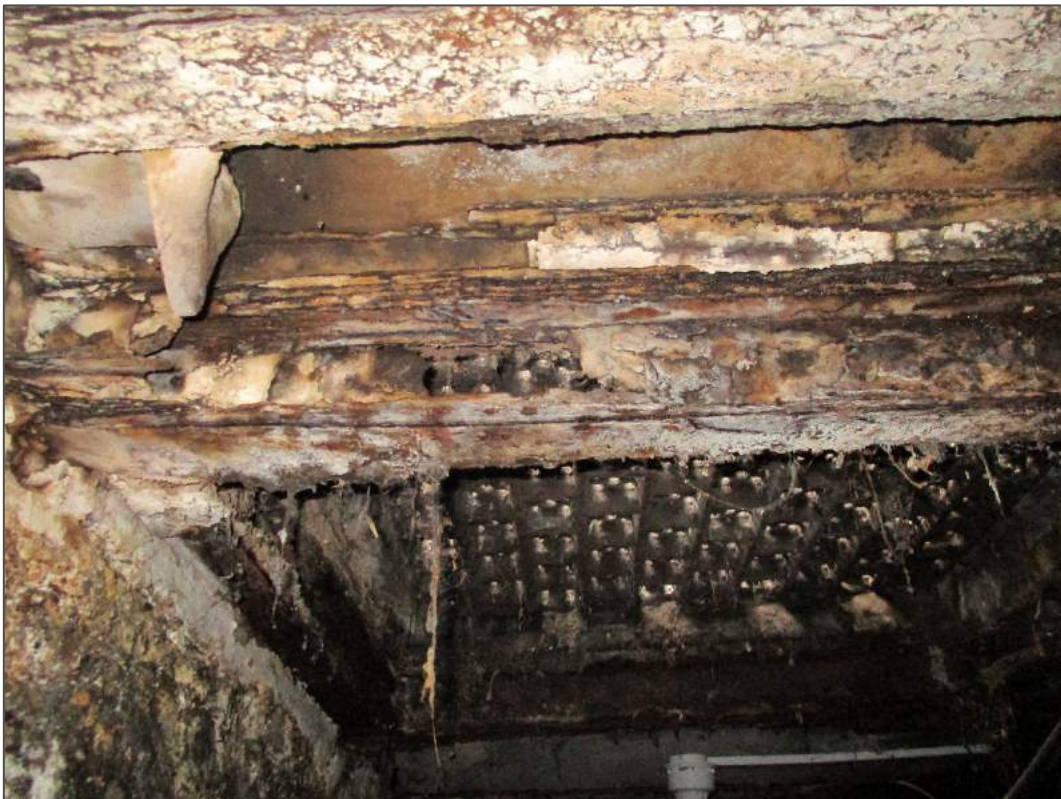
Photograph 14 – Corroded pavement light trimmer beam in basement south (2)

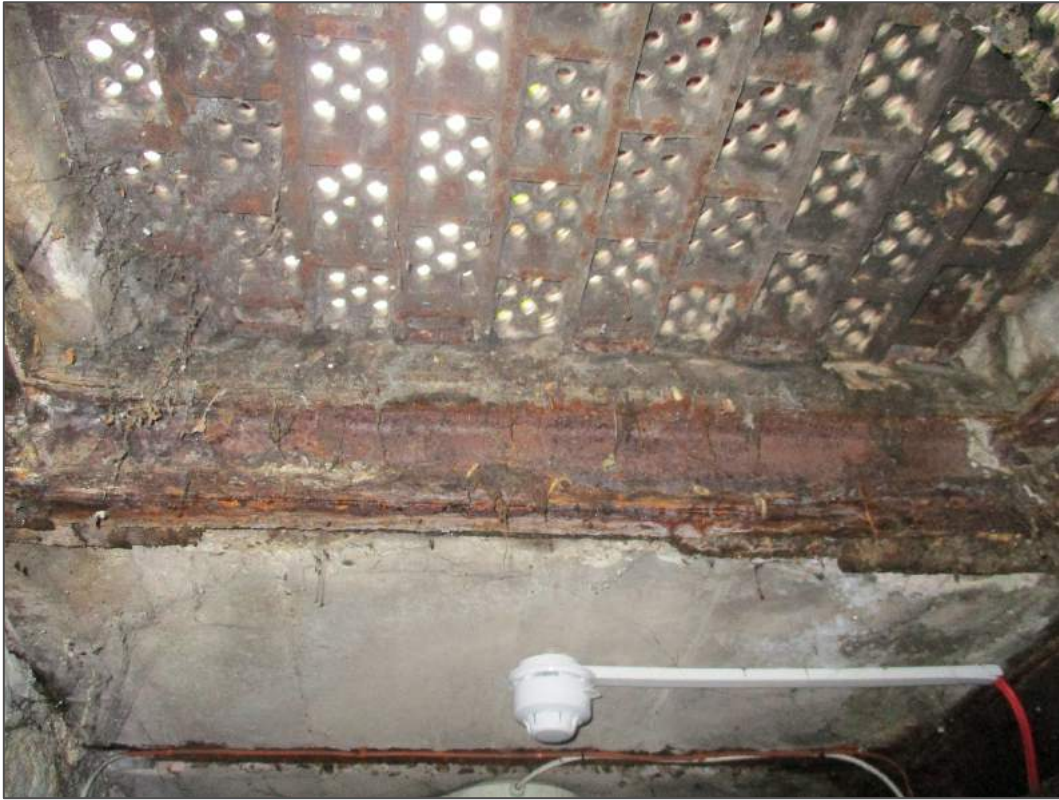
Photograph 15 – Corroded pavement light soffit

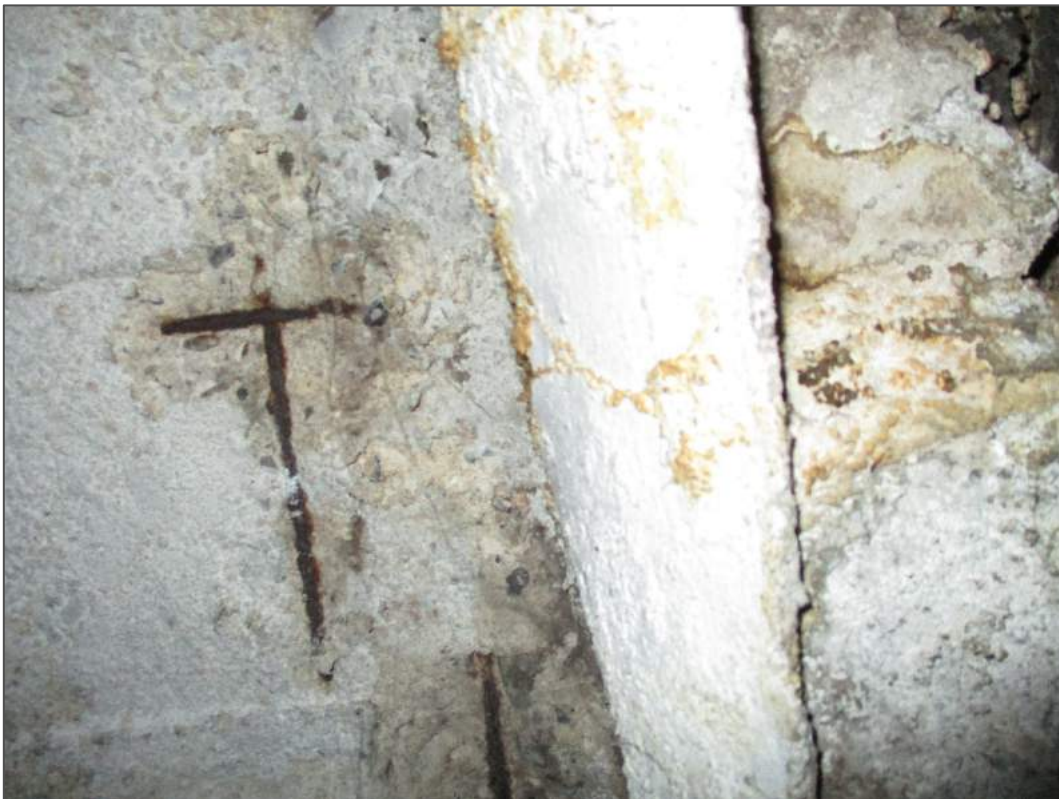
To the east of the pavement lights, over a length of approximately 2.9m the ground floor is typically a reinforced concrete (RC) slab, approximately 100mm deep, supported on the masonry walls and several downstand steel beams. The downstand beams are most likely an historic steel 121x46mm I section. The beams are severely corroded and the steel is delaminating. The RC slab has spalled at several locations and the reinforcement in the bottom of the slab is exposed and visibly corroded (Photo 16).

The RC slab is most likely to have spalled due to carbonation of the concrete leading to a reduction in pH. The depth of carbonation is likely to exceed the cover to the reinforcement and the lower pH, in combination with the presence of water, has caused it to corrode. This corrosion has led to swelling and expansive forces causing the concrete slab soffit to spall. Verification of the cause for the spalling would require carbonation testing to be undertaken.

Photograph 16 – Exposed and corroded reinforcement in RC slab in basement south

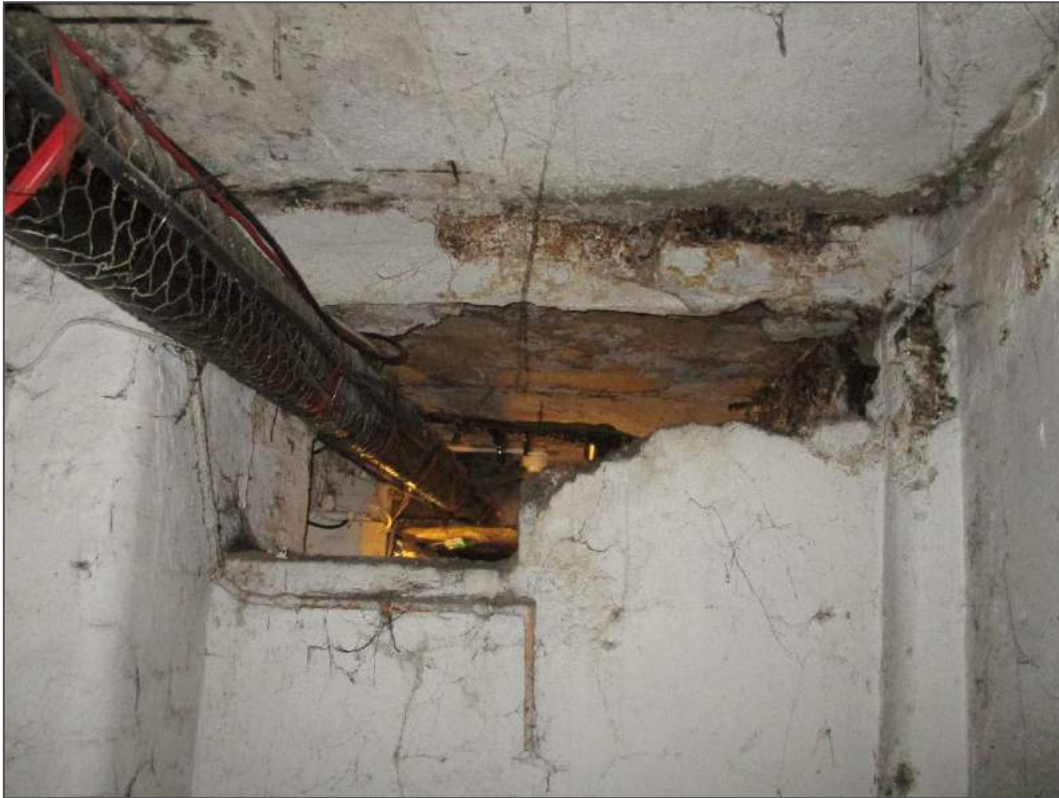
There is a one-brick thick masonry partition wall, in which an opening has been formed, approximately 3.1m to the east of the side entrance (Photo 17). A strip of brickwork, approximately 215mm wide over the top of the opening has been left unsupported (Photo 18).

Photograph 17 – Opening in masonry wall in basement south

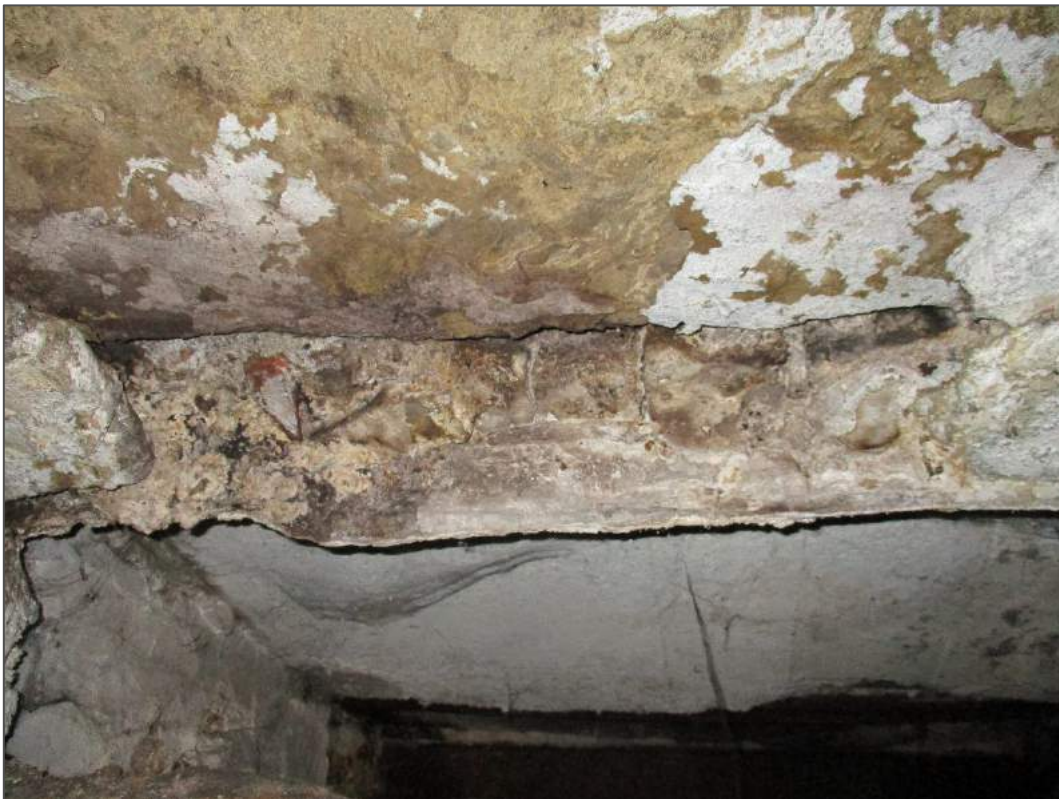
Photograph 18 – Unsupported brickwork over opening in basement south

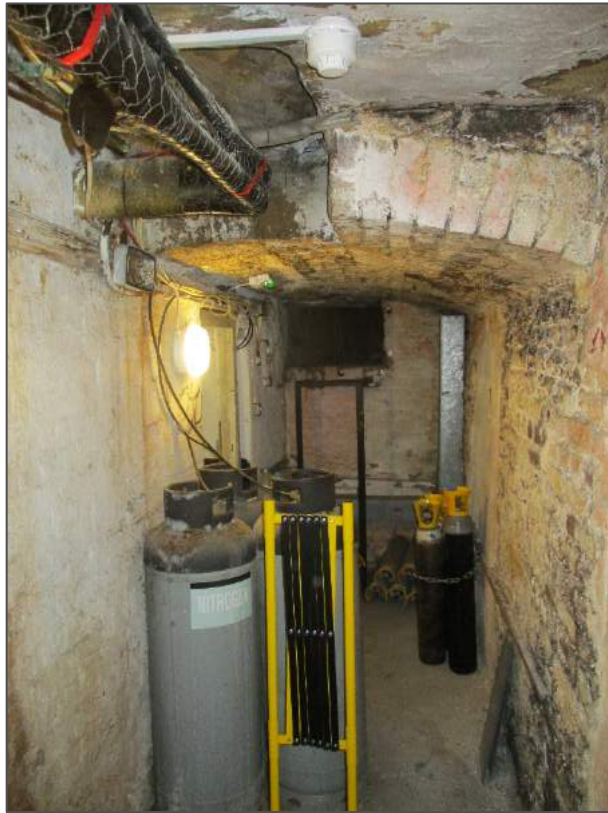
On the east side of the partition wall the basement corridor continues to the south east corner of the building. The ground floor is most likely a reinforced concrete slab spanning between the masonry walls, however it has a rendered soffit and as such could not be inspected. Approximately 2.8m to the east of the partition wall the ground floor is supported on a one-brick thick bonded masonry arch (Photo 19).

Photograph 19 – Masonry arch in basement south corridor

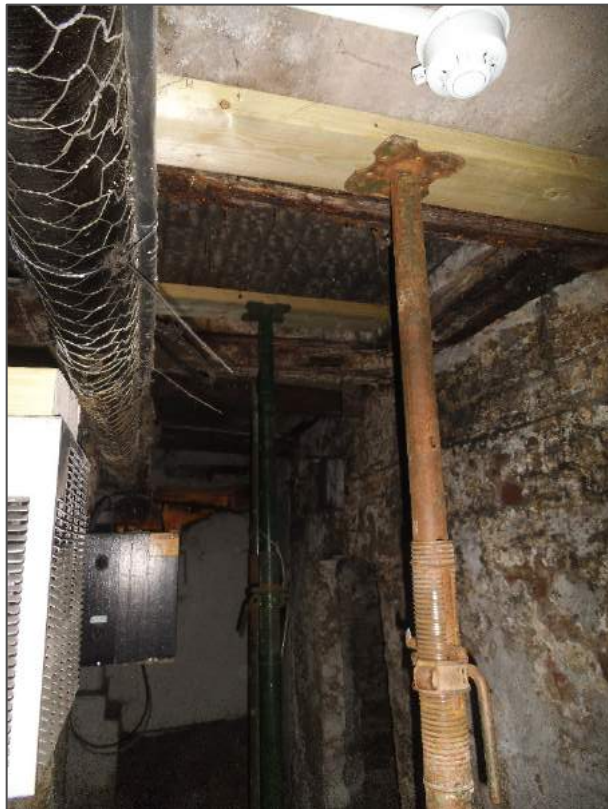
Temporary propping was provided to the ground floor slab in the basement south and west (Photos 20-28).

Photograph 20 – Temporary props installed in basement south

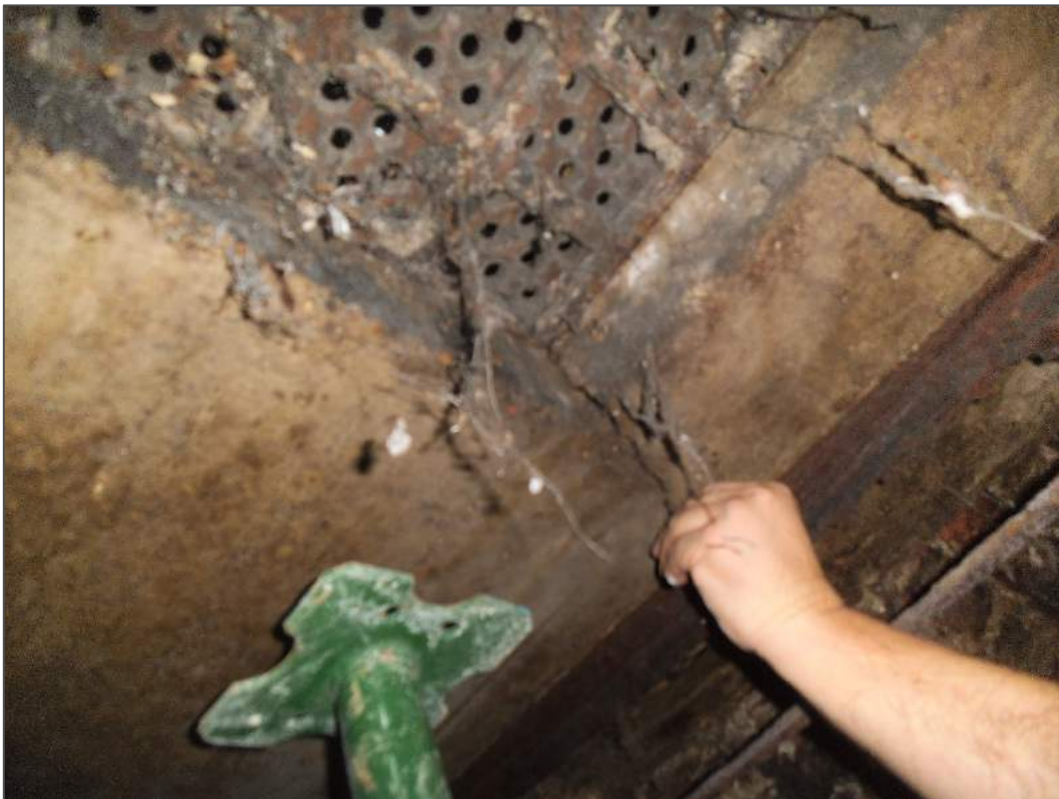
Photograph 24 – Crack in ground floor slab soffit, basement west

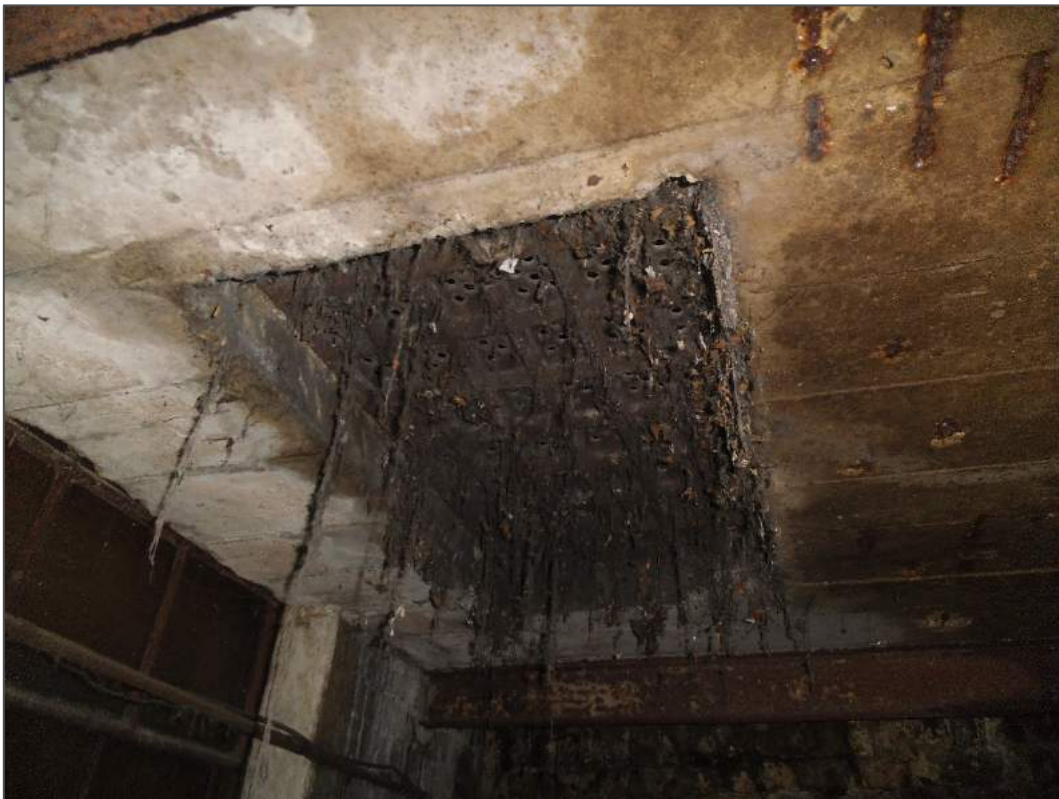
It is therefore considered sensible to replace the concrete slab particularly given the cost savings to be made by replicating the design and detailing and set-up works required for the basement south. The pavement lights are corroding, are not sufficient to take the highways agency point loads and allow the ingress of water. The pavement lights should therefore be replaced.

Photograph 26 – Pavement light in basement west

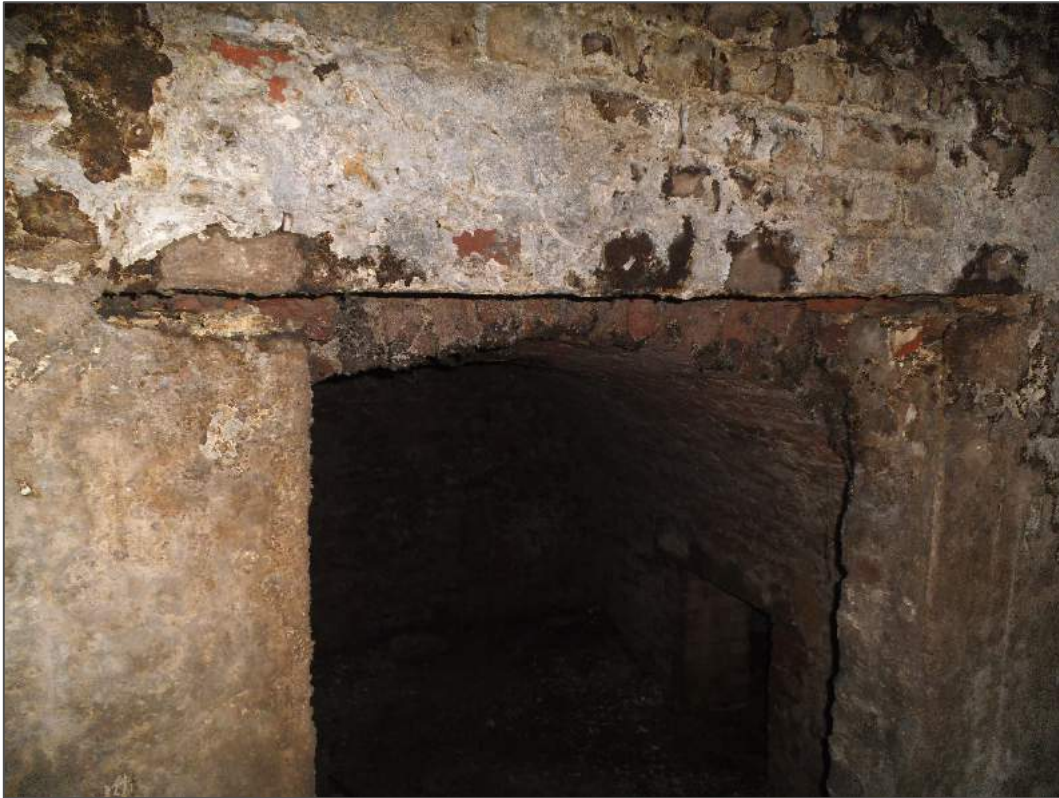
Photograph 27 – Missing lintel in basement west

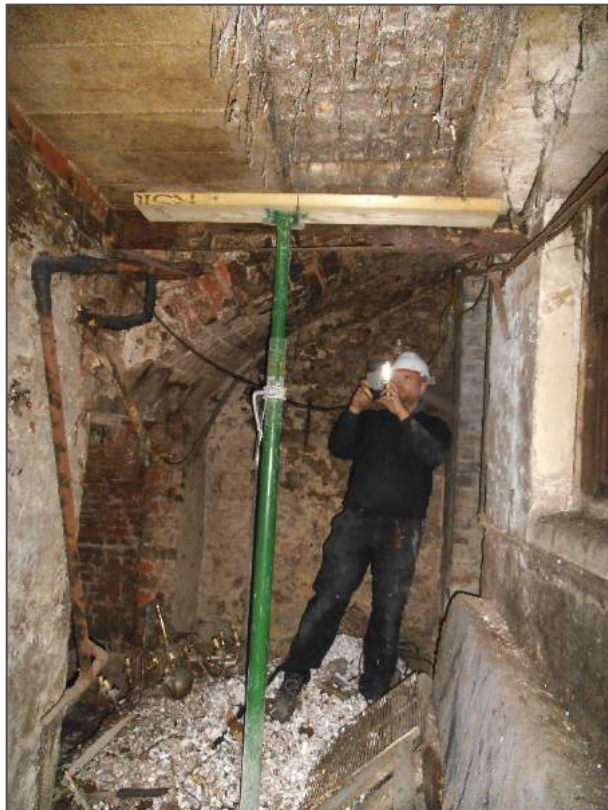
Photograph 28 – Temporary prop installed in basement west
