### Arboricultural Survey & Impact Assessment (BS5837:2012)

13 Woodchurch Road  
London  
NW6 3PL

7th May 2019

AIA/MF/044/19

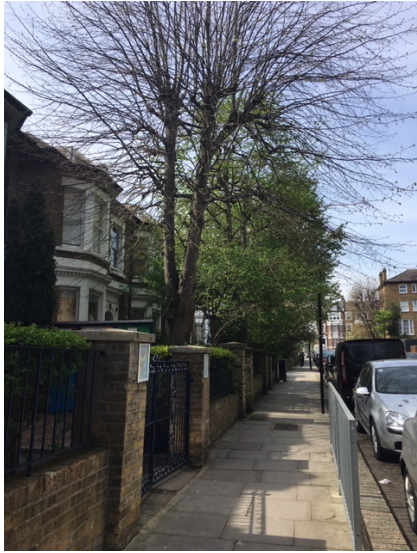
5.10 Tree T2 is a mature Lime sited on the western boundary adjacent to the public highway. The tree has the following main characteristics being rated as a 'B1' category specimen (BS5837:2012):

- Generally structurally sound
- Lapsed pollarded / crown reduced form last managed 3-4 years ago.
- Tree growing towards building with southern lower-mid crown growing directly against property

Tree T2, 13 Woodchurch Road, as viewed in a westerly direction from public highway

5.11 The Root Protection Area (RPA) for this tree - 4.8m RPA radius / 72.39m<sup>2</sup> area will not be affected by proposed development and general refurbishment works. However it is recommended that the following tree protection measures are carried out during development works:

- GROUND PROTECTION  
Retention of existing hard Standing within RPA area for tree T2 throughout development process

The cyclical management of the tree is recommended to be undertaken prior to commencement of works in order to continue management and also prevent encroachment of tree to property

Basal shuttering is recommended to enclose the main stem of tree T2 for the entire development process

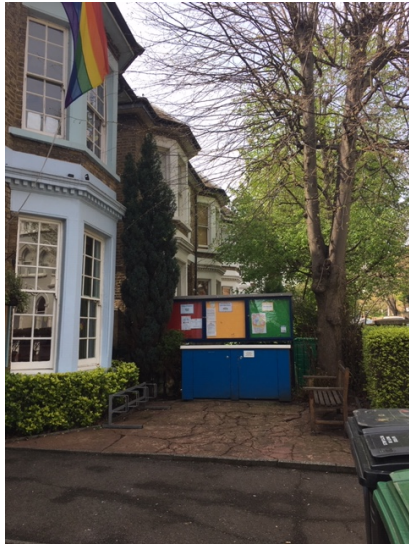
5.12 The small Cypress tree (T3) is an ornamental dwarf specimen growing directly against the building. The tree is inappropriately placed but is not a constraint to development or long term retention should its retention be required; the tree has very low amenity value and no protection measures are recommended.

Trees T2 & T3 as viewed in a westerly direction from within site

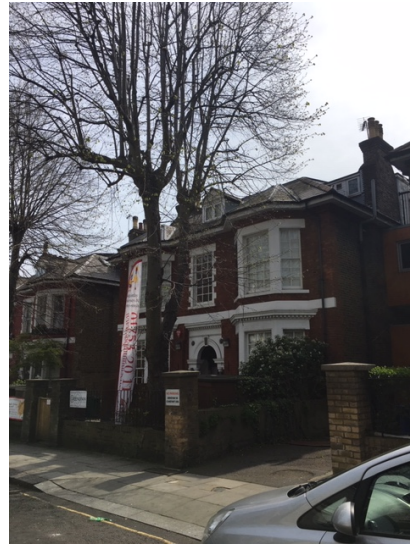
5.8 Tree T1 is a mature Lime sited off site on the front northern boundary with the public highway. The tree has the following main characteristics being rated as a 'B1' category specimen (BS5837:2012):

- Off site location to east of proposed development site
- Generally structurally sound with main union at 2.5m
- Overhanging western canopy growth at 5-8m over site by maximum 2m branch lengths

Neighbouring tree, T1 within 11 Woodchurch Road as viewed in a southeasterly direction

5.9 The Root Protection Area (RPA) for this tree - 5.4m RPA radius / 91.62m<sup>2</sup> area will not be affected by proposed development and general refurbishment works. However it is recommended that the following tree protection measures are carried out during development works:

- GROUND PROTECTION  
Retention of existing hard Standing within RPA area for tree T1 throughout development process
- TREE WORKS  
Crown lifting to 5m of western crown over site should low growth have developed when development commences / 6 months onwards from the date of this report

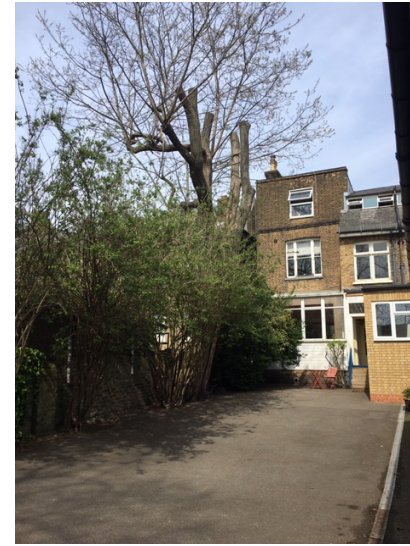
5.13 Tree T4 is an over-mature False Acacia within the rear playground area on the western boundary and with the following characteristics:

- Main stem decay at 0.5-2.5m to east - likely significant with tree leaning to east within site.
- Heavily reduced to 8-10m, with significant sections dead / no regenerative re-growth and overhanging playground - notably main leader 5-8m 350mm diameter dead stem.
- Regenerative growth where developing lapsed.
- Generally hazardous state for 'High' target location

False Acacia, T4 within rear playground as viewed in a northerly direction

5.14 Therefore the tree is rated as a 'U' category tree and is recommended for removal in order to remove the hazard which currently exists. The replacement of a small to medium sized tree would provide replacement canopy cover and wildlife attributes for this educational environment and be more appropriate in size for the setting.

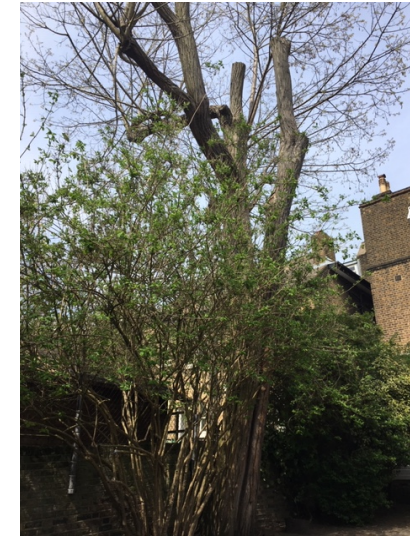
False Acacia, T4 within rear playground as viewed in a northerly direction showing decay on main stem / hazardous dead sections

*\* Note for Tree T4 (False Acacia) removal works these are unrelated to the development and are recommended in relation to hazard assessment and adherence to duty of care*

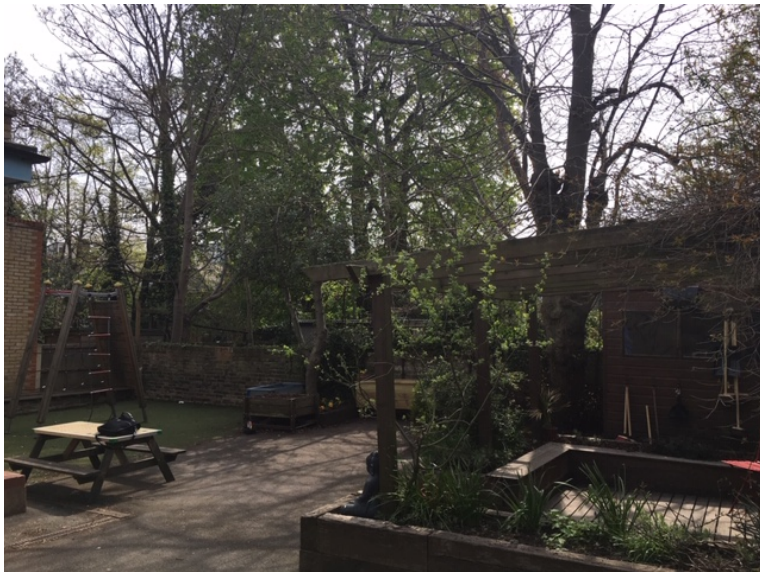
Trees T7 - T13 as viewed in a southerly direction from within rear playground area

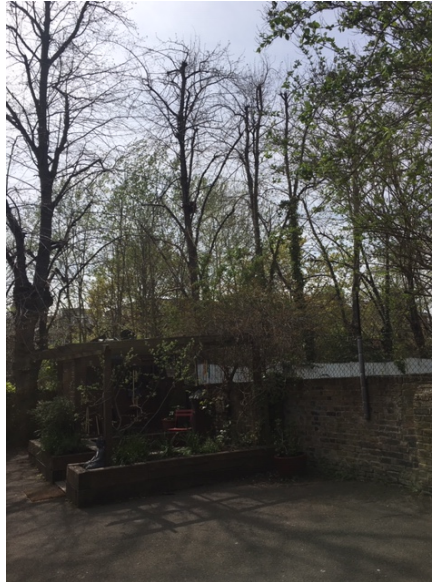
5.15 Trees T5 & T6 comprise 2 x mature Lime sited off site to the west. The trees are sited within a soft landscape verge to the southern boundary area of 15 Woodchurch Road and are in fair condition with relatively sparse canopy for species and major deadwood. The off site location with limited overhang of canopies and existing boundary wall means no tree protection measures are required.

Trees T5-T6, off site trees within rear of 15 Woodchurch Road

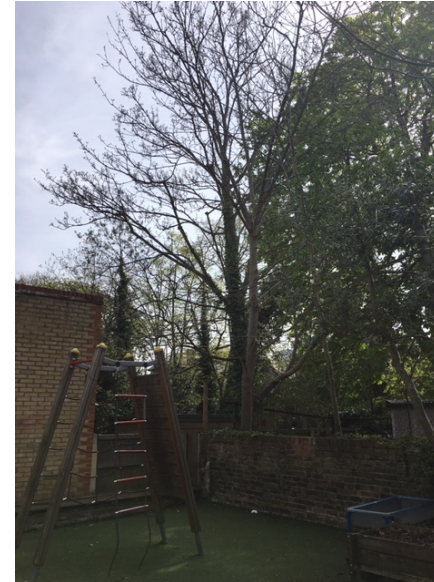
5.21 Holly tree T11 is required for removal within the scheme being within very close proximity and being a poor 'C' category specimen. Taking account of the BS5837 rating with limited amenity value and low vigour combined with reduced form the loss of tree T11 is not deemed significant and with incorporation of a replacement planting, amenity value can be provided for the long term.

5.22 Tree T13 is an early mature Sycamore sited within the soft landscape area to the east of car parking area for Sidney Boyd Court, West End Lane, London, NW6 alongside trees T8, T9, T10 & T11. The tree has the following main characteristics being rated as a 'C1' category specimen (BS5837:2012):

- Off site tree growing against boundary wall.
- Low vigour with selectively reduced form.
- Ivy clad to 5m
- Major deadwood some overhanging site.
- Lowest branch over site at 3m to north

Trees T11 - T13 within and off site at rear of property as viewed in a south easterly direction

For the line of development where within the RPA , a precautionary area is recommended to be implemented whereby structural engineering methods minimise ground disturbance and excavations are undertaken under arboricultural supervision

The removal of deadwood and pruning of 1 x small low branch overhanging site is recommended to be undertaken prior to commencement of works in order to ensure clear once and also provide adherence of duty of care within development site and future playground environment

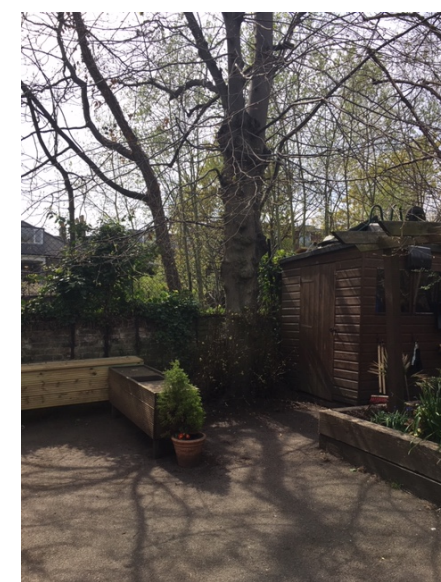
5.16 Tree T7 is a mature Lime sited on the rear southern boundary playground area. The tree has the following main characteristics being rated as a 'B1' category specimen (BS5837:2012):

- Generally structurally sound
- Lapsed crown reduced form last managed 3-4 years ago.
- Deadwood throughout and requiring management

5.17 The Root Protection Area (RPA) for this tree - 6.2m RPA radius / 122.34m<sup>2</sup> area will be impacted by the proposed development as follows:

- Encroachment of 2.2m of the north western RPA for this tree
- Development works including excavations and structural engineering solutions within the RPA for this tree
- General development works within the RPA of this tree

Tree T7 as viewed in a southerly direction

5.18 it is recommended that the following tree protection measures are carried out during development works:

- GROUND PROTECTION  
Retention of existing hard Standing within RPA area outside of development footprint until final landscape stages of development
- PRECAUTIONARY WORKS AREA  
For the line of development where within the RPA , a precautionary area is recommended to be implemented whereby structural engineering methods minimise ground disturbance and excavations are undertaken under arboricultural supervision
- TREE WORKS  
The cyclical management of the tree is recommended to be undertaken prior to commencement of works in order to continue management and also provide adherence of duty of care within development site and future playground environment
- TREE PROTECTION FENCING  
Basal shuttering is recommended to enclose the main stem of tree T7 for the entire development process
