Project No: P1323J1303

Demolition Survey (with MA only)

Survey Date: 4 Jul 2019

138-140 Highgate Road
Highgate
London
NW5 1PB

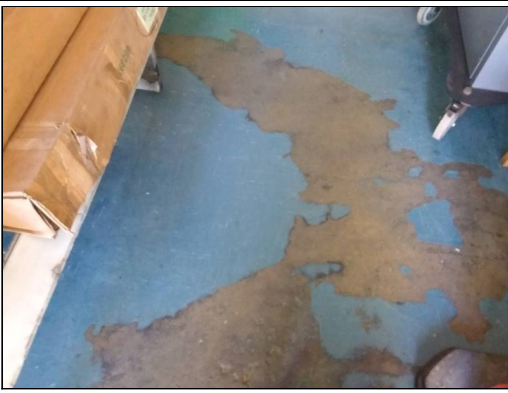
Survey Date:	Lead Surveyor	Survey Type	Floor	Analysis
	4 Jul 2019	Harry Houlihan	Demolition Survey	Ground Floor	Chrysotile (1)
	Building	Room	Item	Quantity	
	Commercial	Shop G01	Floor tiles & adhesive on floor	16m ²	
	Sample No (S,SP,P,As)	Product Type	Surface Treatment	Condition	Accessibility
	AB001060 (S)	Reinforced Composite (1)	Completely Sealed (0)	Low Damage (1)	Easily disturbed
	Material Risk Score				
3					
Recommended action	C - Repair or Remove				
Surveyor comments	Removal and disposal should be carried out in accordance with the Hazardous Waste Regulations and with current Asbestos Regulations 2012 by an asbestos removal contractor.

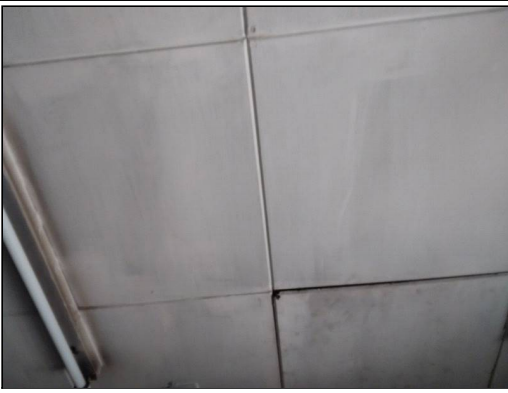
Survey Date:	Lead Surveyor	Survey Type	Floor	Analysis
	4 Jul 2019	Harry Houlihan	Demolition Survey	Ground Floor	Chrysotile + Amosite (2)
	Building	Room	Item	Quantity	
	Commercial	Shop G01	Ceiling tiles on ceiling	16m ²	
	Sample No (S,SP,P,As)	Product Type	Surface Treatment	Condition	Accessibility
	AB001061 (S)	Asbestos Insulating Board (2)	Surface Sealed (1)	Low Damage (1)	Occasionally likely to be disturbed
	Material Risk Score				
6					
Recommended action	C - Repair or Remove				
Surveyor comments	Removal and disposal should be carried out in accordance with the Hazardous Waste Regulations and with current Asbestos Regulations 2012 by an asbestos removal contractor.

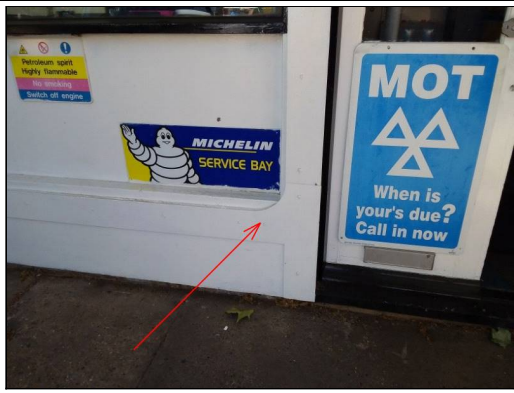
Survey Date:	Lead Surveyor	Survey Type	Floor	Analysis
	4 Jul 2019	Harry Houlihan	Demolition Survey	External	Chrysotile (1)
	Building	Room	Item	Quantity	
	Commercial	External E01	Cement board panelling around the front of shop.	15lm	
	Sample No (S,SP,P,As)	Product Type	Surface Treatment	Condition	Accessibility
	AB001062 (S)	Asbestos Cement (1)	Surface Sealed (1)	Low Damage (1)	Occasionally likely to be disturbed
	Material Risk Score				
4					
Recommended action	D - No Attention Required, Label				
Surveyor comments	Removal and disposal should be carried out in accordance with the Hazardous Waste Regulations and with current Asbestos Regulations 2012 by an asbestos removal contractor.

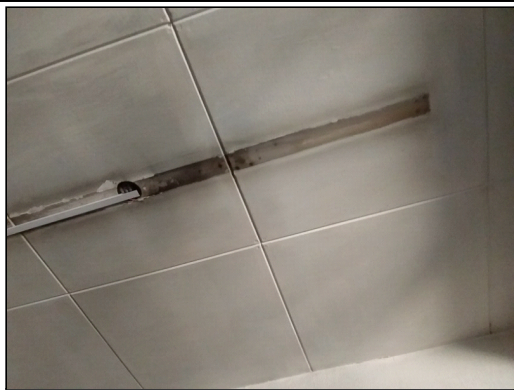
Survey Date:	Lead Surveyor	Survey Type	Floor	Analysis
	4 Jul 2019	Harry Houlihan	Demolition Survey	Ground Floor	Chrysotile + Amosite (2)
	Building	Room	Item	Quantity	
	Commercial	Store G02	Ceiling tiles on ceiling	5m ²	
	Sample No (S,SP,P,As)	Product Type	Surface Treatment	Condition	Accessibility
	As AB001061 (SP)	Asbestos Insulating Board (2)	Surface Sealed (1)	Low Damage (1)	Occasionally likely to be disturbed
	Material Risk Score				
6					
Recommended action	C - Repair or Remove				
Surveyor comments	Removal and disposal should be carried out in accordance with the Hazardous Waste Regulations and with current Asbestos Regulations 2012 by an asbestos removal contractor.

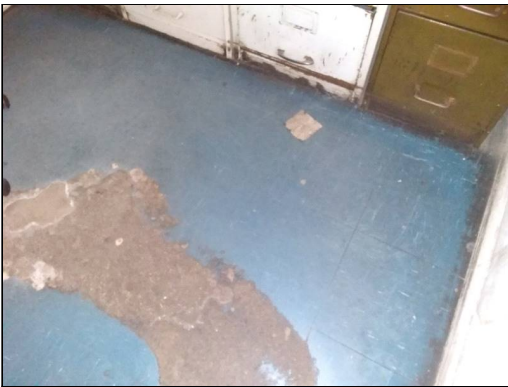
Survey Date:	Lead Surveyor	Survey Type	Floor	Analysis
	4 Jul 2019	Harry Houlihan	Demolition Survey	Ground Floor	Chrysotile (1)
	Building	Room	Item	Quantity	
	Commercial	Store G02	Floor tiles and adhesive on floor	5m ²	
	Sample No (S,SP,P,As)	Product Type	Surface Treatment	Condition	Accessibility
	As AB001060 (SP)	Reinforced Composite (1)	Completely Sealed (0)	Low Damage (1)	Easily disturbed
	Material Risk Score				
3					
Recommended action	C - Repair or Remove				
Surveyor comments	Removal and disposal should be carried out in accordance with the Hazardous Waste Regulations and with current Asbestos Regulations 2012 by an asbestos removal contractor.

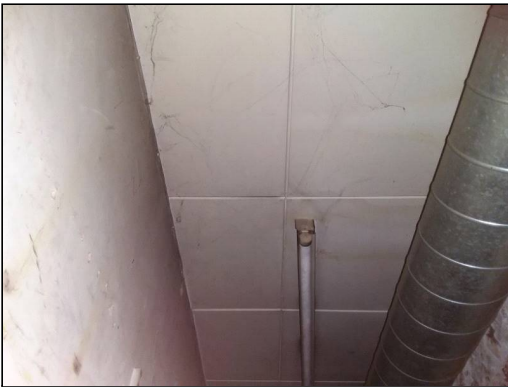
Survey Date:	Lead Surveyor	Survey Type	Floor	Analysis
	4 Jul 2019	Harry Houlihan	Demolition Survey	Ground Floor	Chrysotile + Amosite (2)
	Building	Room	Item	Quantity	
	Commercial	Cupboard G03	Ceiling tiles on ceiling	3m ²	
	Sample No (S,SP,P,As)	Product Type	Surface Treatment	Condition	Accessibility
	As AB001061 (SP)	Asbestos Insulating Board (2)	Surface Sealed (1)	Low Damage (1)	Occasionally likely to be disturbed
	Material Risk Score				
6					
Recommended action	C - Repair or Remove				
Surveyor comments	Removal and disposal should be carried out in accordance with the Hazardous Waste Regulations and with current Asbestos Regulations 2012 by an asbestos removal contractor.

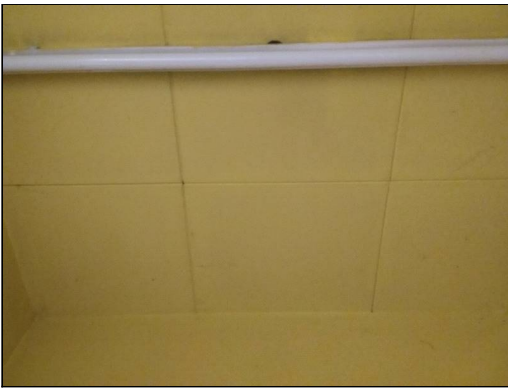
Survey Date:	Lead Surveyor	Survey Type	Floor	Analysis
	4 Jul 2019	Harry Houlihan	Demolition Survey	Ground Floor	Chrysotile + Amosite (2)
	Building	Room	Item	Quantity	
	Commercial	W/C G04	Ceiling tiles on ceiling	4m ²	
	Sample No (S,SP,P,As)	Product Type	Surface Treatment	Condition	Accessibility
	As AB001061 (SP)	Asbestos Insulating Board (2)	Surface Sealed (1)	Low Damage (1)	Occasionally likely to be disturbed
	Material Risk Score				
6					
Recommended action	C - Repair or Remove				
Surveyor comments	Removal and disposal should be carried out in accordance with the Hazardous Waste Regulations and with current Asbestos Regulations 2012 by an asbestos removal contractor.

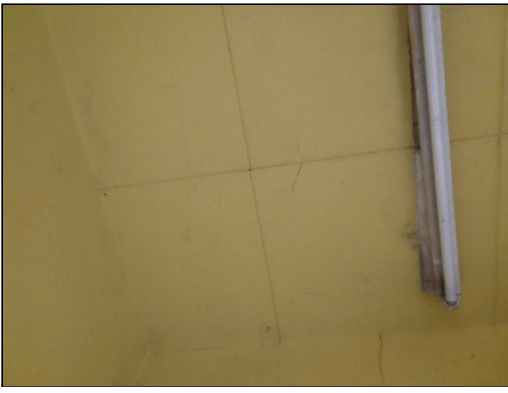
Survey Date:	Lead Surveyor	Survey Type	Floor	Analysis
	4 Jul 2019	Harry Houlihan	Demolition Survey	Ground Floor	Chrysotile + Amosite (2)
	Building	Room	Item	Quantity	
	Commercial	W/C G05	Ceiling tiles on ceiling	4m ²	
	Sample No (S,SP,P,As)	Product Type	Surface Treatment	Condition	Accessibility
	As AB001061 (SP)	Asbestos Insulating Board (2)	Surface Sealed (1)	Low Damage (1)	Occasionally likely to be disturbed
	Material Risk Score				
6					
Recommended action	C - Repair or Remove				
Surveyor comments	Removal and disposal should be carried out in accordance with the Hazardous Waste Regulations and with current Asbestos Regulations 2012 by an asbestos removal contractor.

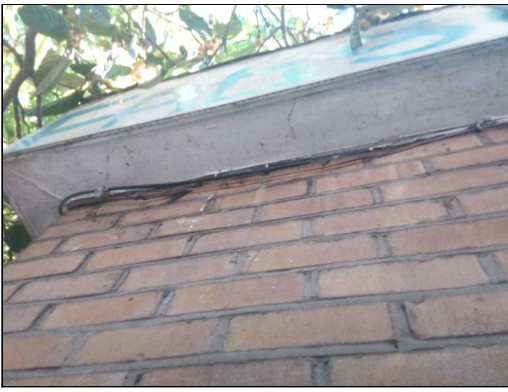
Commercial	External	External E01, Soffits around building	S AB001063	Asbestos Insulating Board	Medium Damage	Surface Sealed	Amosite	19lm	Occasionally likely to be disturbed	7	C - Repair or Remove	Removal and disposal should be carried out in accordance with the Hazardous Waste Regulations and with current Asbestos Regulations 2012 by an asbestos removal contractor.
Commercial	Ground Floor	Kitchenette G06, Floor tiles and adhesive on floor	SP As AB001060	Reinforced Composite	Low Damage	Completely Sealed	Chrysotile	5m ²	Easily disturbed	3	C - Repair or Remove	Removal and disposal should be carried out in accordance with the Hazardous Waste Regulations and with current Asbestos Regulations 2012 by an asbestos removal contractor.

Survey Date:	Lead Surveyor	Survey Type	Floor	Analysis
	4 Jul 2019	Harry Houlihan	Demolition Survey	External	Amosite (2)
	Building	Room	Item	Quantity	
	Commercial	External E01	Soffits around building	19lm	
	Sample No (S,SP,P,As)	Product Type	Surface Treatment	Condition	Accessibility
	AB001063 (S)	Asbestos Insulating Board (2)	Surface Sealed (1)	Medium Damage (2)	Occasionally likely to be disturbed
Material Risk Score					
7					
Recommended action	C - Repair or Remove				
Surveyor comments	Removal and disposal should be carried out in accordance with the Hazardous Waste Regulations and with current Asbestos Regulations 2012 by an asbestos removal contractor.

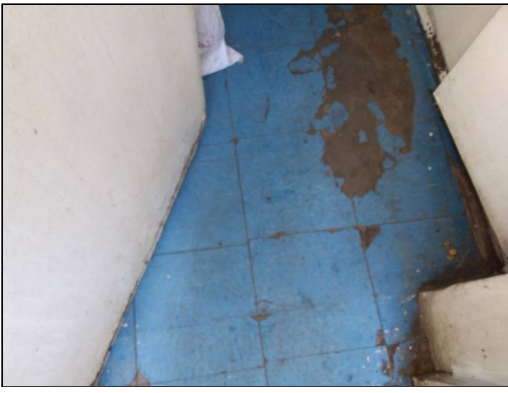
Survey Date:	Lead Surveyor	Survey Type	Floor	Analysis
	4 Jul 2019	Harry Houlihan	Demolition Survey	Ground Floor	Chrysotile (1)
	Building	Room	Item	Quantity	
	Commercial	Kitchenette G06	Floor tiles and adhesive on floor	5m ²	
	Sample No (S,SP,P,As)	Product Type	Surface Treatment	Condition	Accessibility
	As AB001060 (SP)	Reinforced Composite (1)	Completely Sealed (0)	Low Damage (1)	Easily disturbed
Material Risk Score					
3					
Recommended action	C - Repair or Remove				
Surveyor comments	Removal and disposal should be carried out in accordance with the Hazardous Waste Regulations and with current Asbestos Regulations 2012 by an asbestos removal contractor.

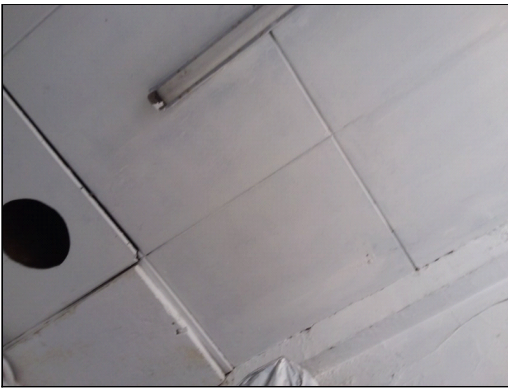
Survey Date:	Lead Surveyor	Survey Type	Floor	Analysis
	4 Jul 2019	Harry Houlihan	Demolition Survey	Ground Floor	Chrysotile + Amosite (2)
	Building	Room	Item	Quantity	
	Commercial	Kitchenette G06	Ceiling tiles on ceiling	5m ²	
	Sample No (S,SP,P,As)	Product Type	Surface Treatment	Condition	Accessibility
	As AB001061 (SP)	Asbestos Insulating Board (2)	Surface Sealed (1)	Low Damage (1)	Occasionally likely to be disturbed
	Material Risk Score				
6					
Recommended action		C - Repair or Remove			
Surveyor comments		Removal and disposal should be carried out in accordance with the Hazardous Waste Regulations and with current Asbestos Regulations 2012 by an asbestos removal contractor.

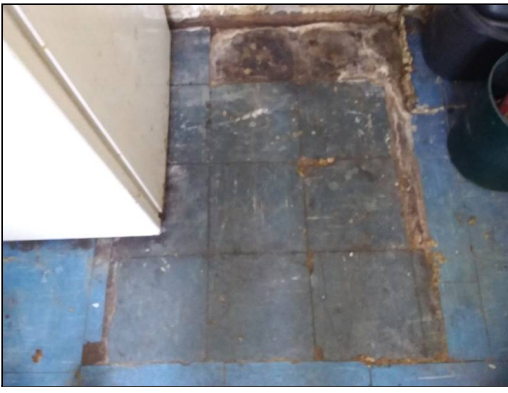
Survey Date:	Lead Surveyor	Survey Type	Floor	Analysis
	4 Jul 2019	Harry Houlihan	Demolition Survey	Ground Floor	Chrysotile (1)
	Building	Room	Item	Quantity	
	Commercial	Kitchenette G06	Floor tiles and adhesive on floor	0.5m ²	
	Sample No (S,SP,P,As)	Product Type	Surface Treatment	Condition	Accessibility
	AB001064 (S)	Reinforced Composite (1)	Completely Sealed (0)	Low Damage (1)	Easily disturbed
	Material Risk Score				
3					
Recommended action		D - No Attention Required, Label			
Surveyor comments		Removal and disposal should be carried out in accordance with the Hazardous Waste Regulations and with current Asbestos Regulations 2012 by an asbestos removal contractor.

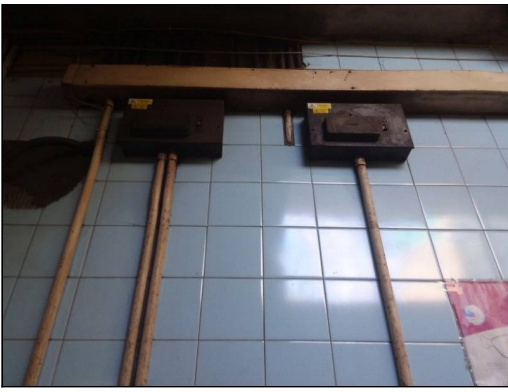
Survey Date:	Lead Surveyor	Survey Type	Floor	Analysis
	4 Jul 2019	Harry Houlihan	Demolition Survey	Ground Floor	Chrysotile (1)
	Building	Room	Item	Quantity	
	Commercial	Garage G07	Flash guards in fuses	Numerous	
	Sample No (S,SP,P,As)	Product Type	Surface Treatment	Condition	Accessibility
	Visual (P)	Asbestos Textiles/Paper (2)	Unsealed (2)	Low Damage (1)	Occasionally likely to be disturbed
	Material Risk Score				
6					
Recommended action	D - No Attention Required, Label				
Surveyor comments	The resin/plastic also known as "Bakelite" in aged consumer units, switch and junction boxes can contain asbestos fibres including in the fuse holders therefore the unit has been presumed. We were unable to sample it due to live electrics. If removed intact and whole then the complete unit needs to be treated as asbestos contaminated waste in accordance with the Hazardous Waste Regulations and with current Asbestos Regulations 2012.

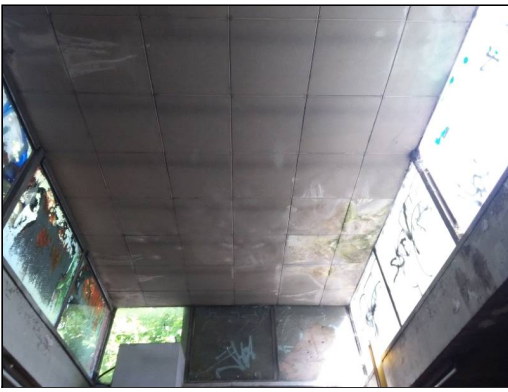
Survey Date:	Lead Surveyor	Survey Type	Floor	Analysis
	4 Jul 2019	Harry Houlihan	Demolition Survey	Ground Floor	Chrysotile + Amosite (2)
	Building	Room	Item	Quantity	
	Commercial	Garage G07	Ceiling tiles on ceiling of sky light	15m ²	
	Sample No (S,SP,P,As)	Product Type	Surface Treatment	Condition	Accessibility
	As AB001061 (SP)	Asbestos Insulating Board (2)	Surface Sealed (1)	Low Damage (1)	Occasionally likely to be disturbed
	Material Risk Score				
6					
Recommended action	C - Repair or Remove				
Surveyor comments	Removal and disposal should be carried out in accordance with the Hazardous Waste Regulations and with current Asbestos Regulations 2012 by an asbestos removal contractor.

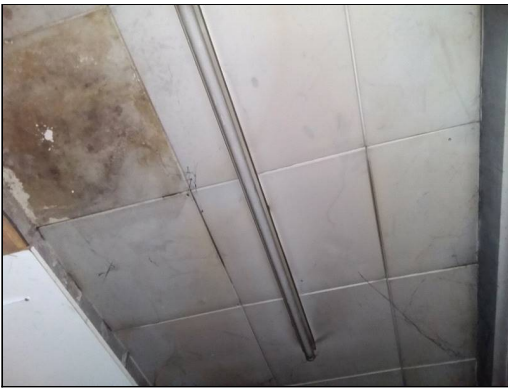
Survey Date:	Lead Surveyor	Survey Type	Floor	Analysis
	4 Jul 2019	Harry Houlihan	Demolition Survey	Ground Floor	Chrysotile + Amosite (2)
	Building	Room	Item	Quantity	
	Commercial	Store G08	Ceiling tiles on ceiling	5m ²	
	Sample No (S,SP,P,As)	Product Type	Surface Treatment	Condition	Accessibility
	As AB001061 (SP)	Asbestos Insulating Board (2)	Surface Sealed (1)	Low Damage (1)	Occasionally likely to be disturbed
	Material Risk Score				
6					
Recommended action	C - Repair or Remove				
Surveyor comments	Removal and disposal should be carried out in accordance with the Hazardous Waste Regulations and with current Asbestos Regulations 2012 by an asbestos removal contractor.

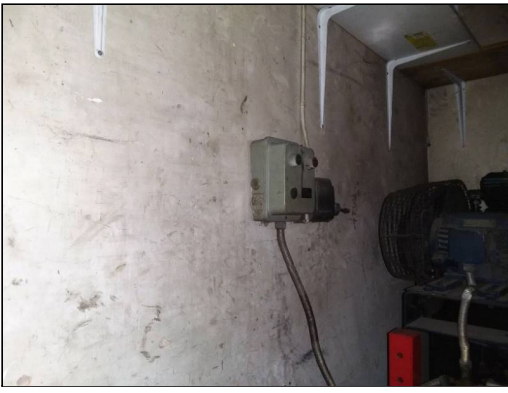
Survey Date:	Lead Surveyor	Survey Type	Floor	Analysis
	4 Jul 2019	Harry Houlihan	Demolition Survey	Ground Floor	Chrysotile (1)
	Building	Room	Item	Quantity	
	Commercial	Store G08	Flash guards in fuses	Numerous	
	Sample No (S,SP,P,As)	Product Type	Surface Treatment	Condition	Accessibility
	Visual (P)	Asbestos Textiles/Paper (2)	Unsealed (2)	Low Damage (1)	Occasionally likely to be disturbed
	Material Risk Score				
6					
Recommended action	D - No Attention Required, Label				
Surveyor comments	The resin/plastic also known as "Bakelite" in aged consumer units, switch and junction boxes can contain asbestos fibres including in the fuse holders therefore the unit has been presumed. We were unable to sample it due to live electrics. If removed intact and whole then the complete unit needs to be treated as asbestos contaminated waste in accordance with the Hazardous Waste Regulations and with current Asbestos Regulations 2012.

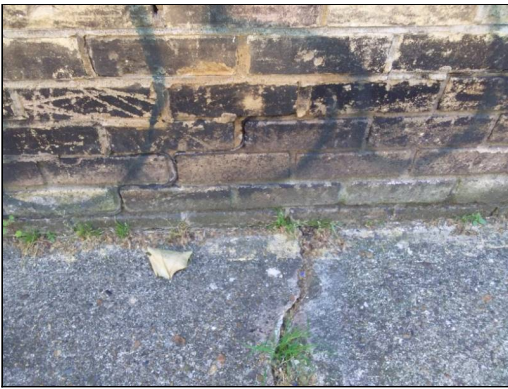
Survey Date:	Lead Surveyor	Survey Type	Floor	Analysis
	4 Jul 2019	Harry Houlihan	Demolition Survey	External	Chrysotile (1)
	Building	Room	Item	Quantity	
	Commercial	External E01	D.P.C lower walls	50lm	
	Sample No (S,SP,P,As)	Product Type	Surface Treatment	Condition	Accessibility
	AB001065 (S)	Well Bound Material (1)	Completely Sealed (0)	Low Damage (1)	Usually inaccessible or unlikely to be disturbed
	Material Risk Score				
3					
Recommended action	D - No Attention Required, Label				
Surveyor comments	Removal and disposal should be carried out in accordance with the Hazardous Waste Regulations and with current Asbestos Regulations 2012 by an asbestos removal contractor.
