TECHNICAL REPORT ON A SUSPECTED SUBSIDENCE CLAIM

Crawford Reference: SU1808160

Falkland Road Flat Management Limited
28 Falkland Road
London
NW5 2PX

SUBSIDENCE CLAIM

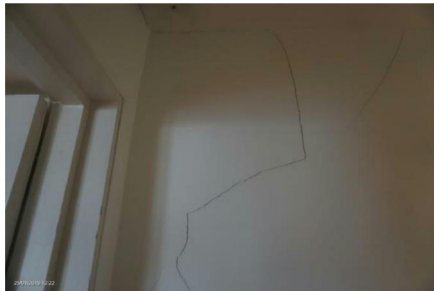
Rear Hall - Diagonal crack to left wall

Vertical crack to left wall - 1mm
Ceiling junction separation to the front - 1mm
Crack in ceiling - 0.5mm

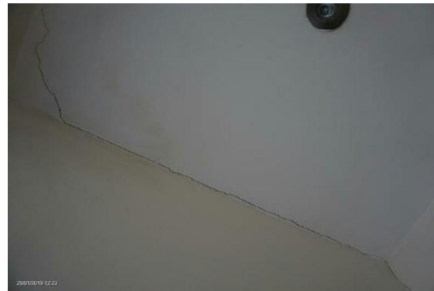
Rear Hall - Ceiling junction separation to the front

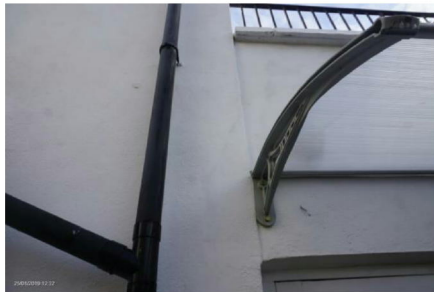
Right Elevation - Vertical crack

Hairline crack and outline of crack to left of extension

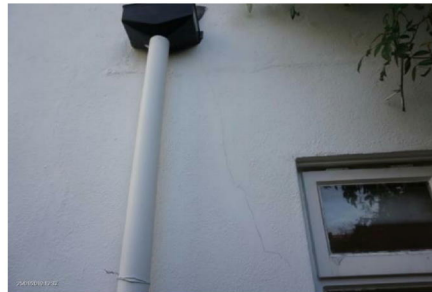
Right Elevation of Extension - Vertical crack

Vertical crack to left of window - 0.5mm

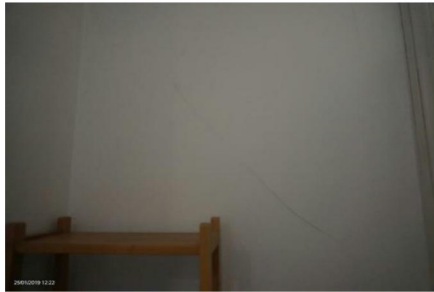
Hairline diagonal crack to front wall

Bathroom - Diagonal crack to front wall

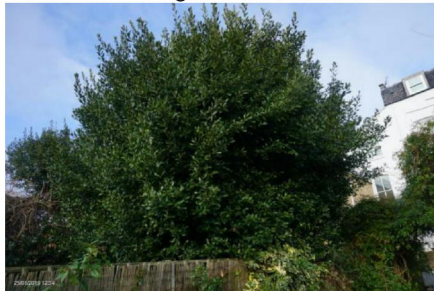
View of T1 Bay

The Bay (*Laurus*) is an evergreen that can reach heights of between 10 – 14mtrs. It's a slow growing tree (150mm p.a.) with weak root activity.

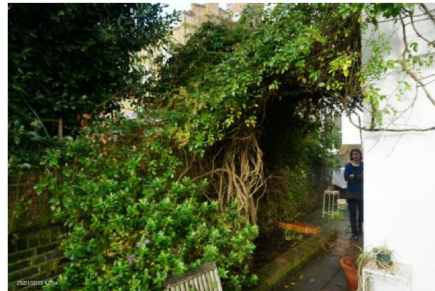
View of T2 Climber

Climbers: Can be significant in subsidence cases as they are frequently planted close to the property, trained up house walls. As their roots do not need to spread to provide support they are frequently compact, and can have an intense but localised desiccation effect. Most tolerate pruning well, but respond by sprouting vigorously and need regular maintenance. *Pyracantha* or firethorn is common and has roots which cannot be distinguished anatomically from apple, pear and other members of the *Pomoideae* group of the rose family. *Wistyeria* roots are similar to those of other members of the pea family, including laburnum and false acacia.

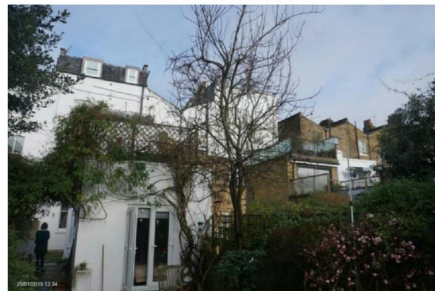
View of T4 Plum

Plums are members of the genus *Prunus*, which includes cherries, common and Portugal laurels and blackthorn. They are common in gardens and orchards and, although moderate water demanders, have wide spreading root systems that frequently send up sucker shoots a considerable distance from the original parent tree.
