6 Denmark Street Mews, Facade and Paint Removal Report

Overview of External Works

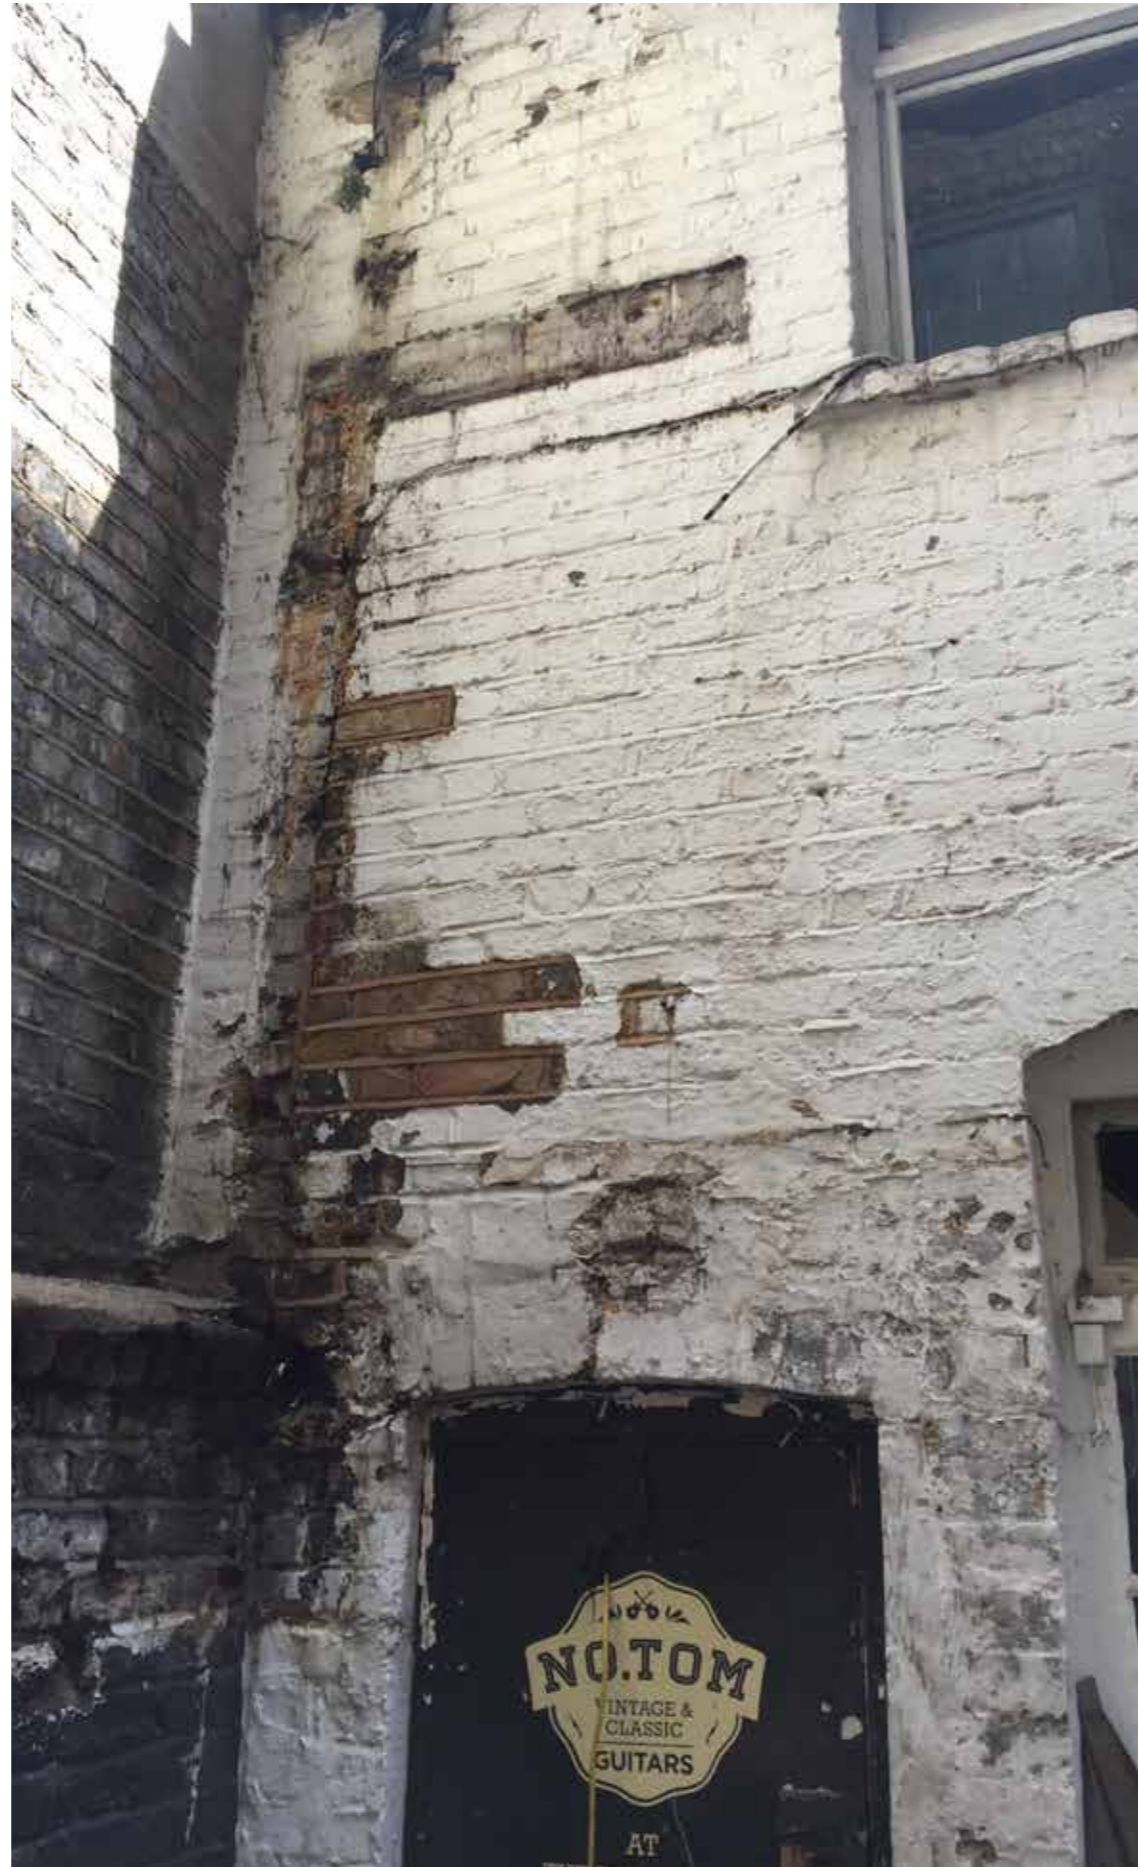
Exposed brickwork can also be seen where existing services have been removed. The brick here is in a worse conditions with some spalling to the face of the existing bricks, historical repairs with a mixture of stock and red bricks. Due to the overall poor condition of the bricks we are proposing that the facade is repainted.

Exposed brickwork where existing services have been removed

- Remove all layers of existing paint and debris from the brickwork.
- Lime Mortar repairs and replacement of bricks where required.
- Test sample to be carried out for inspection and to determine paint colour.
- Repaint facade.

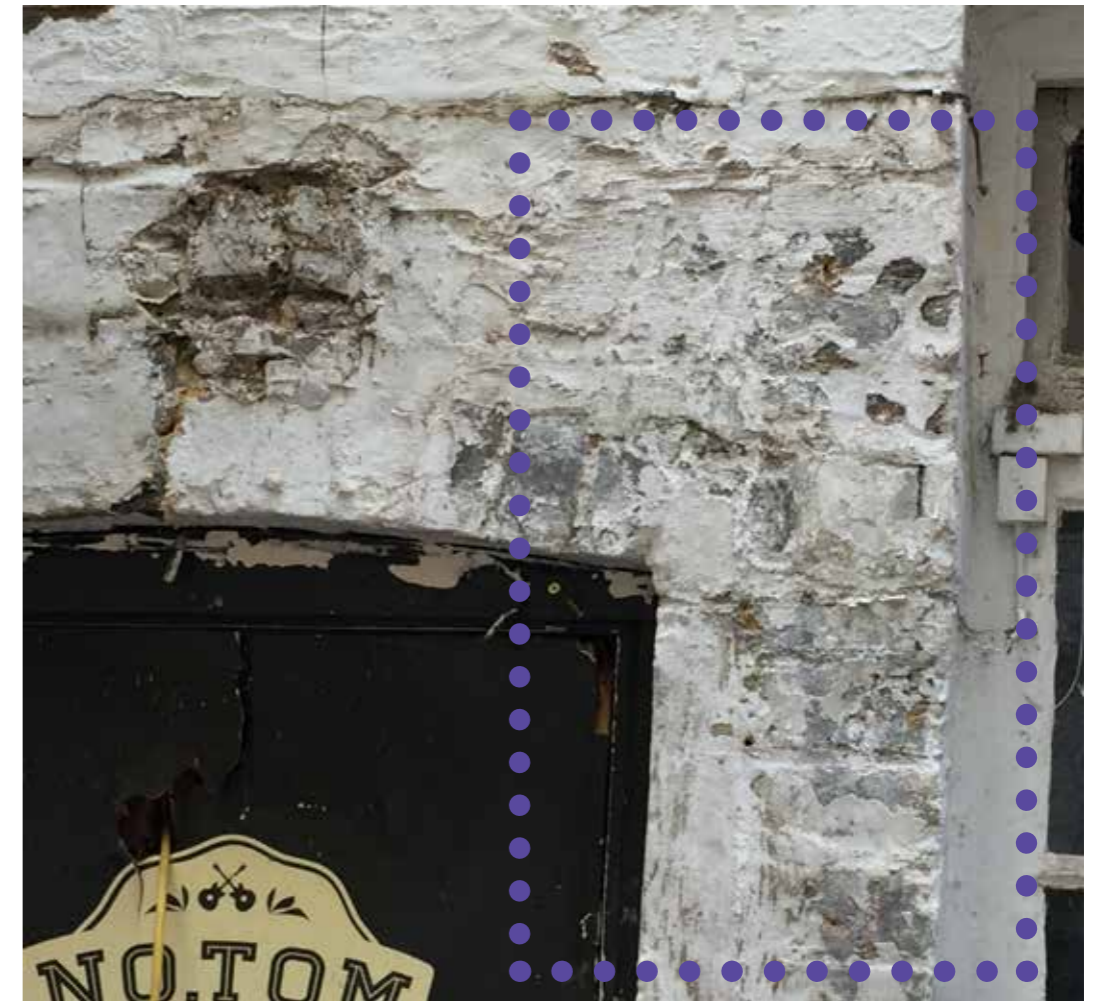
Removal of the paint in an area to the right of the entrance door has been carried out using a chemical peel as the paint is believed to be oil based with a number of layers. A method statement for the removal by the contractor accompanies this report. The brickwork in this area appears to be in fairly good condition and is a yellow stock brick. Further removal of paint in this area is required.

Area where test removal of paint has taken place
