99 South End Road  
LONDON NW3 2RJ

PRE-PLANNING ENQUIRY

SIDE EXTENSION ROOF  
EXISTING SITUATION

ER-001

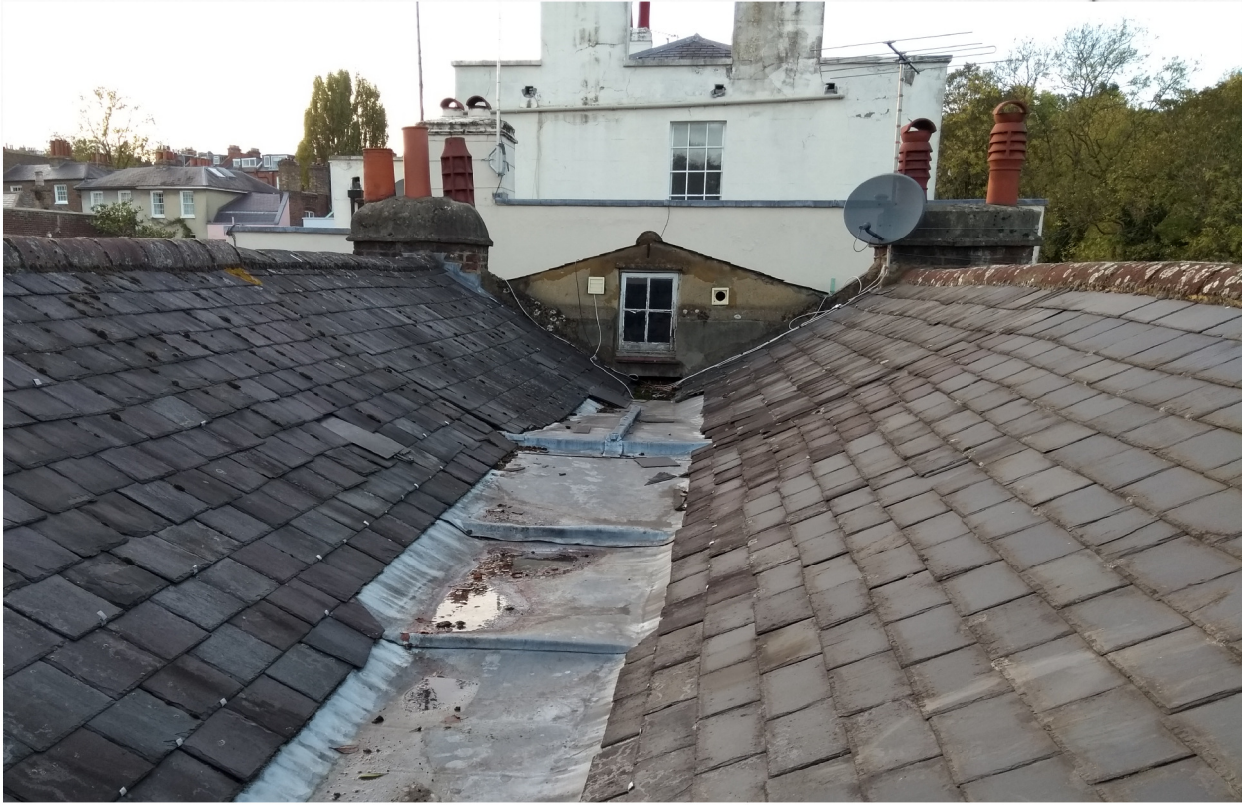
PHOTO 1

SIDE EXTENSION ROOF

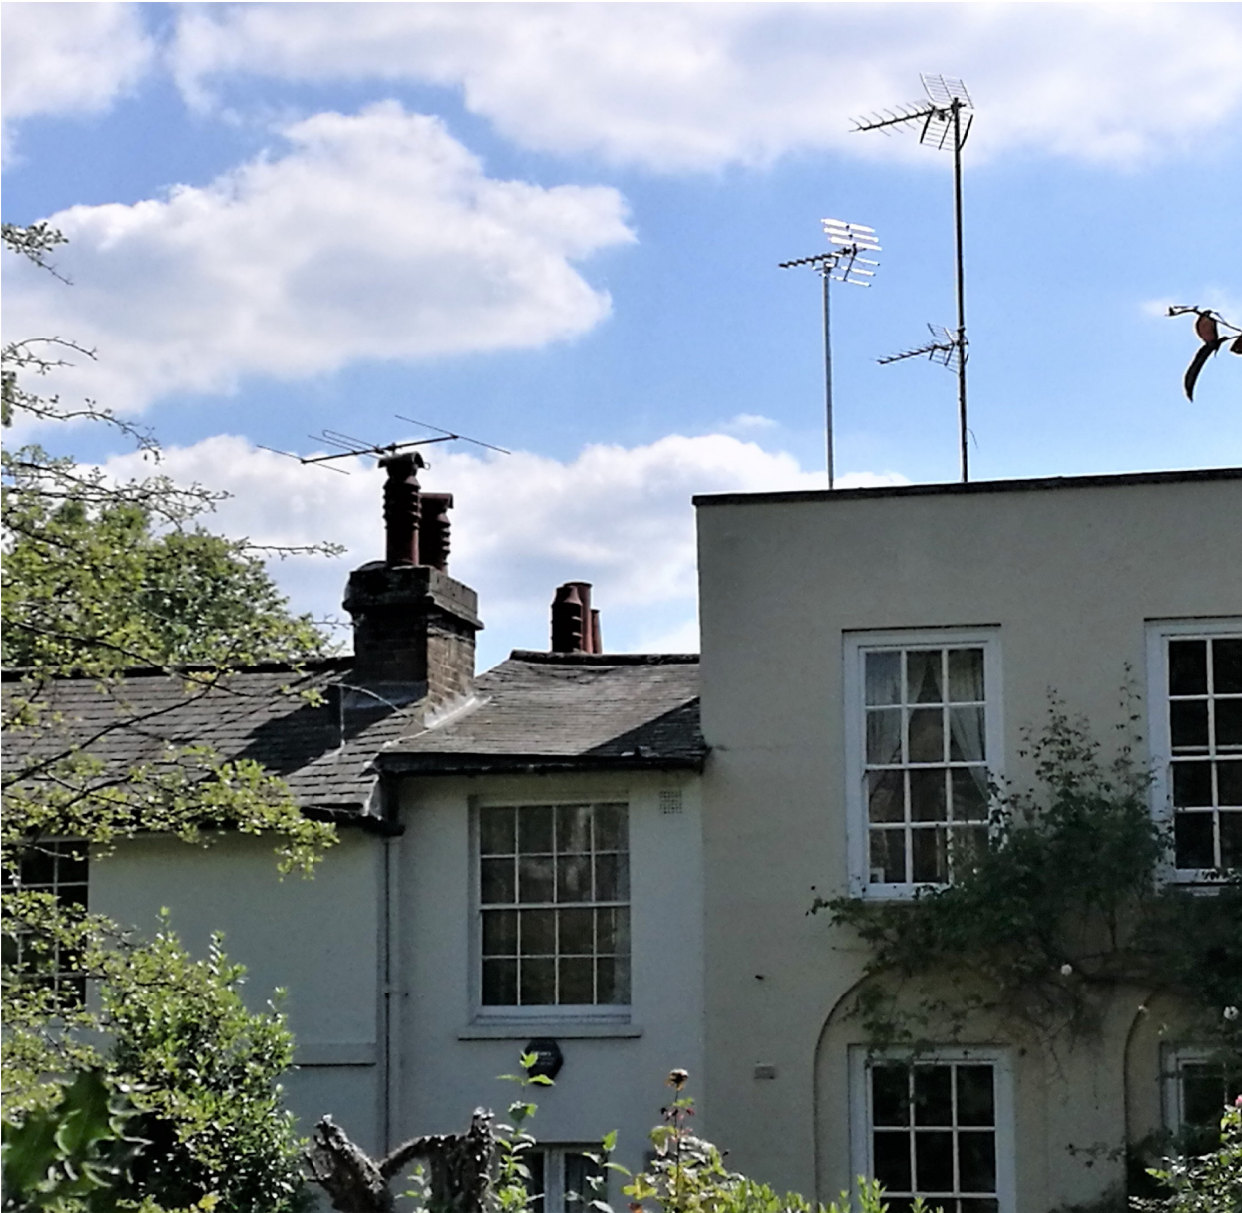
PHOTO 2

SIDE EXTENSION ROOF  
VIEWED FROM THE FRONT

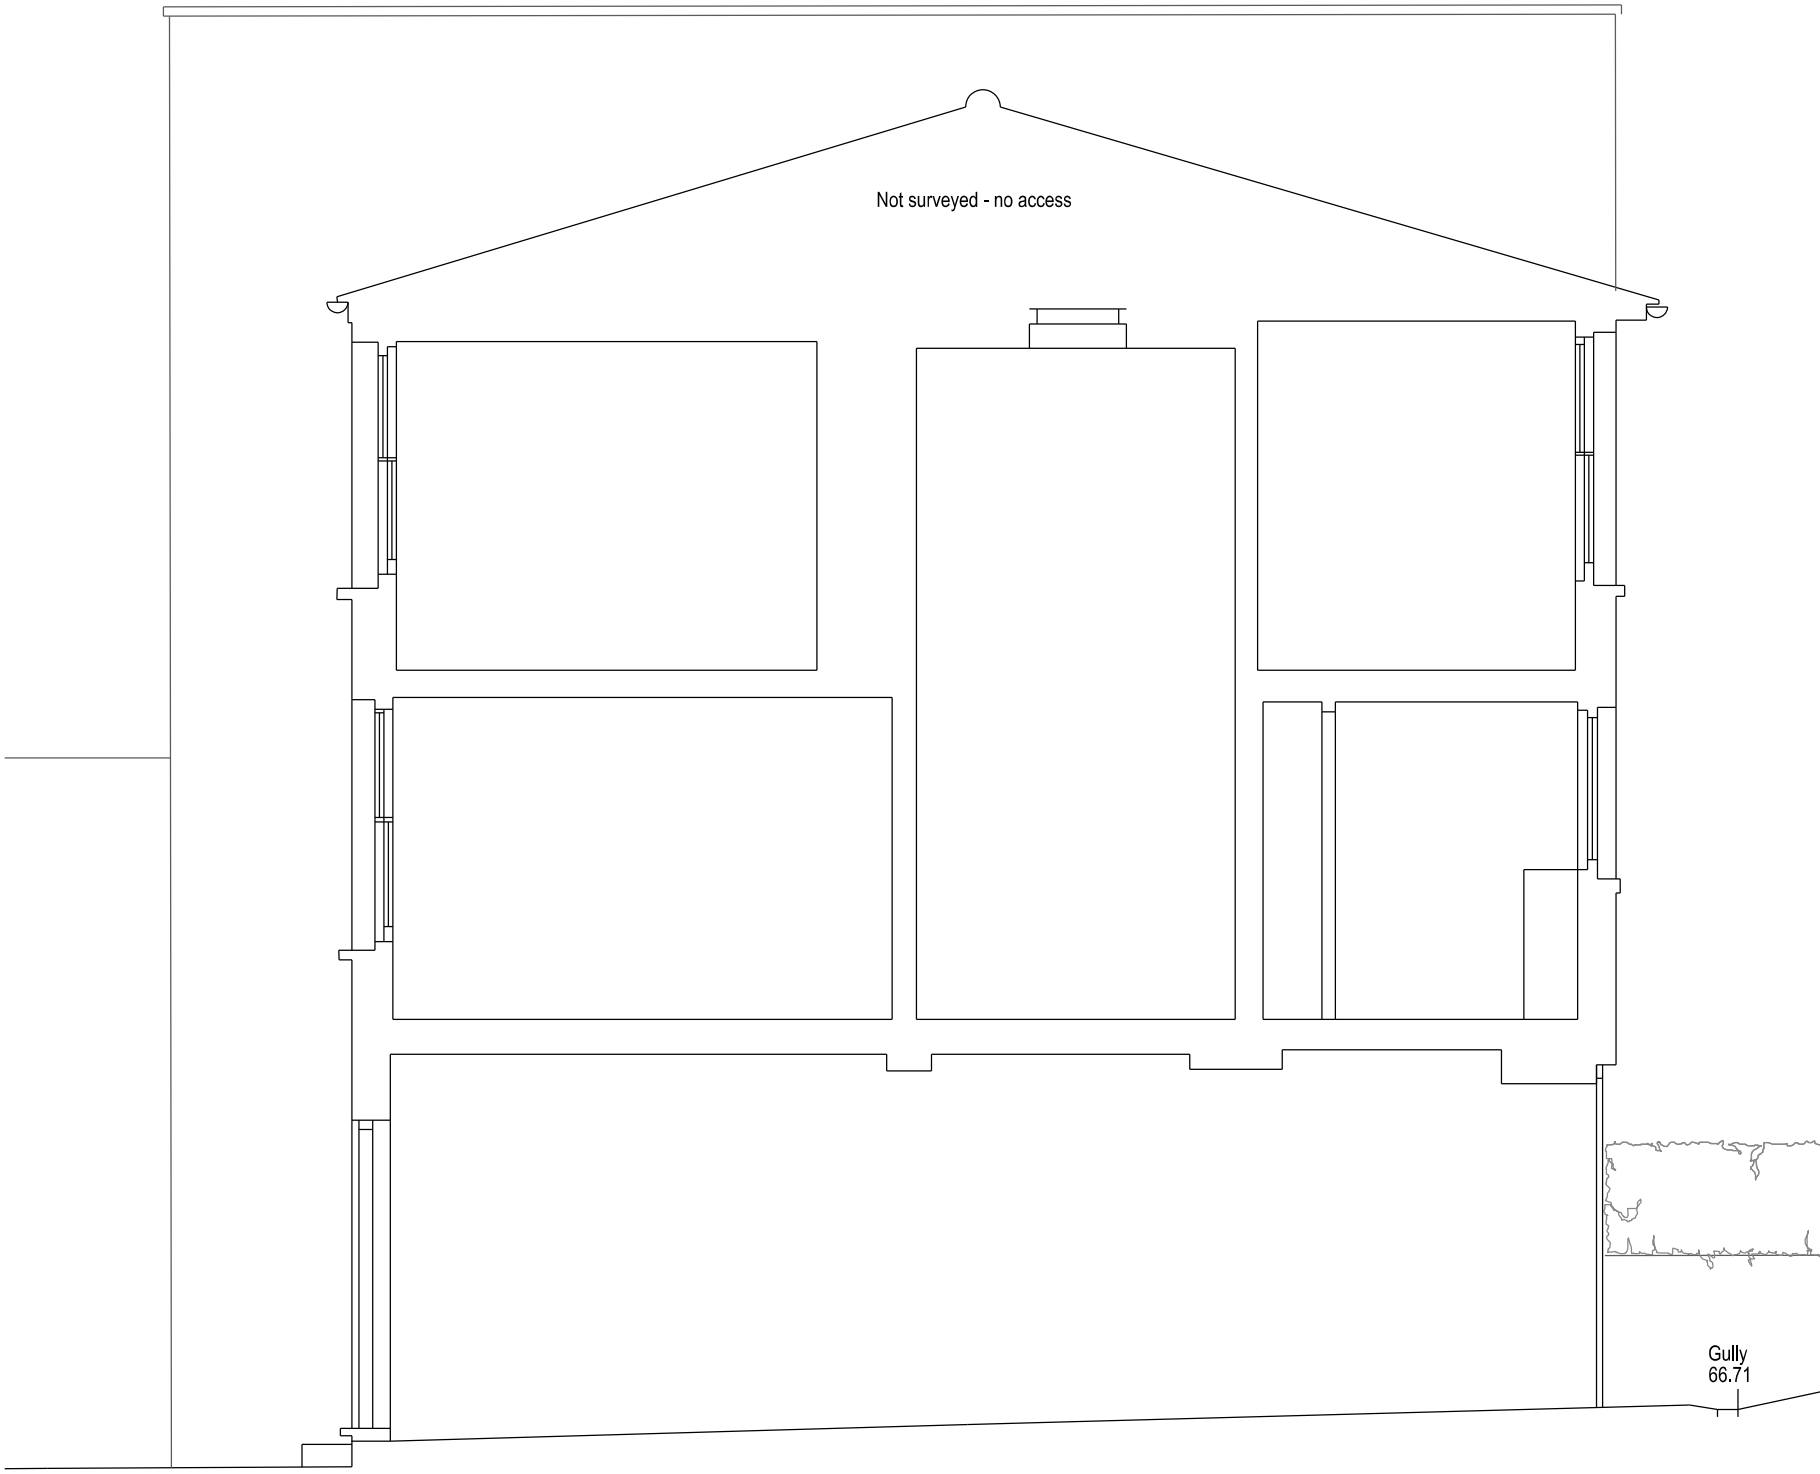
EXISTING SECTION

EXISTING ROOF TO SIDE EXTENSION:  
16 DEGREE PITCH SLATE ROOF ON TIMBER RAFTERS - NO INSULATION - POOR CONDITION, TIMBERS UNDERSIZED AND ROOF SAGGING, SLATE ROOF INADEQUATE PITCH (20 DEGREE MIN RECOMMENDED) - "JERRY BUILT"  
FLANK WALL CONSTRUCTED OFF ORIGINAL PARAPET WALL, RENDERED FINISH - POOR CONDITION, WATER INGRESS DUE TO INADEQUATE VERGE DETAIL TO SLATE ROOF  
SINGLE GLAZED TIMBER CASEMENT WINDOW - ROTTEN, REQUIRES REPLACEMENT  
RAINWATER OUTLET - ORIGINALLY FROM BEFORE SIDE EXTENSION - RAINWATER NOW DISCHARGES TO OPEN LEADED HOPPER INTERNALLY, THENCE TO REAR ELEVATION VIA OPEN CHANNEL DRAIN - DIFFICULT TO MAINTAIN WITH NO POSSIBLE OVERFLOW OTHER THAN INSIDE BUILDING  
EXPOSED FLANK TO EXTENSION ROOF WITH AD HOC LEAD AND RENDER FINISH - EXTREMELY POORLY CONCEIVED WITH DIFFERENT ROOF PITCHES CLASHING AND LEAVING VIRTUALLY IMPOSSIBLE WEATHERING DETAILS IN VERY DIFFICULT TO ACCESS LOCATIONS
