28th November 2017

Veteran Oak tree in Rear Garden of 7 Wedderburn Road

My November inspection of the tree

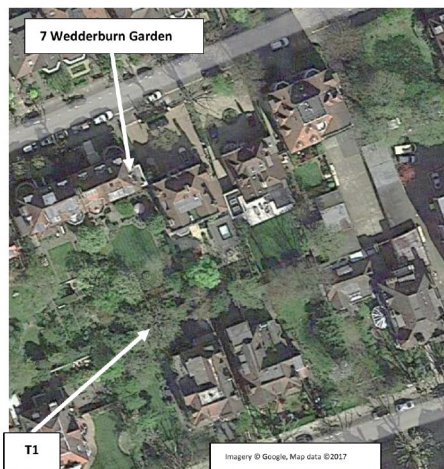
Fig. 1: Oak T1 (TPO C1185 2017) at rear boundary of 7 Wedderburn Road

The position of the tree relative to the house and neighbouring properties can be seen in Figs 1 and 2. It is situated close to the rear boundary of the garden. The ground beyond the property to the south, behind the tree, is retained by a wall marking the boundary between 7 Wedderburn Road and 3 Lyndhurst Gardens. To the rear the ground is lower than the apparent base of the tree by an estimated 1.5 m.

In the past the area of ground beneath the tree's crown within No. 7 has been altered. A rectangular raised bed has been constructed, extending approx. 4m into the garden and 11m across, retained by a low 0.3-0.5 m dry stone wall. The raising of the ground above the original base level of the tree could be in parts be as much as 0.6 m. Alterations to this area will have affected the northern aspect of the root zone of the oak. This landscape feature and associated flagstone path and seating form a 'garden room' with a wooden pergola separating the raised area about the tree from the more formal lawn and planting nearer the house.

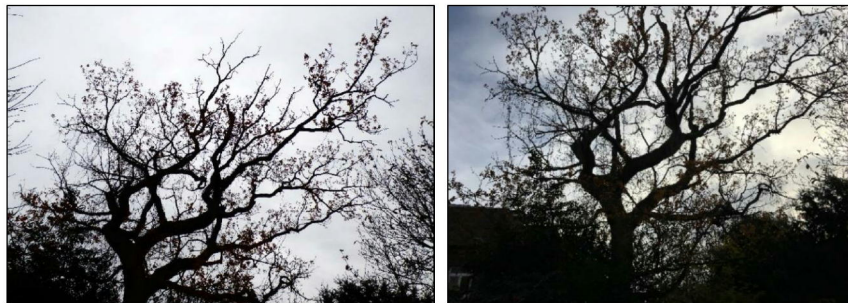
Fig 3a (LHS) and 3b (RHS) T1 viewed from north (November 2017)

Fig 3a shows areas of upper crown die back and past severe (not to current British Standard) pruning that has resulted in large diameter stubs.

Fig 3b shows zones of lower crown recovery and increasing vitality and suggests a future pruning outline.

The character of crown die back suggests that this is stress-induced rather than a reflection of naturally occurring ‘crown retrenchment’ that is an inherent part of the tree ageing process⁶. The signs of stress include areas of upper crown die back and local zones of declining vigour (see 3a, right of centre of upper crown).

There is new young growth in the crown that suggests the tree is in a recovery phase with a potentially viable future mid-crown (Fig. 3a). The tree is remediable through measures that address each of these issues. Remedial pruning is proposed to concentrate vitality in the mid, lower and inner crown. Fig 3b (RHS) suggests the context for a pruning strategy for the future branch architecture.

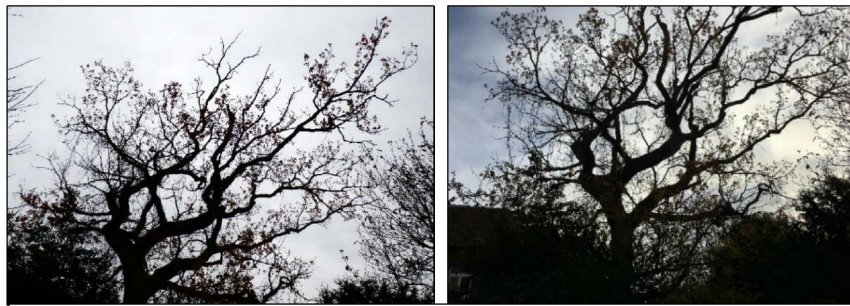
Fig 3a (LHS) and 3b (RHS) T1 viewed from north (November 2017)

Fig 3a shows areas of upper crown die back and past severe (not to current British Standard) pruning that has resulted in large diameter stubs.

Fig 3b shows zones of lower crown recovery and increasing vitality and suggests a future pruning outline.

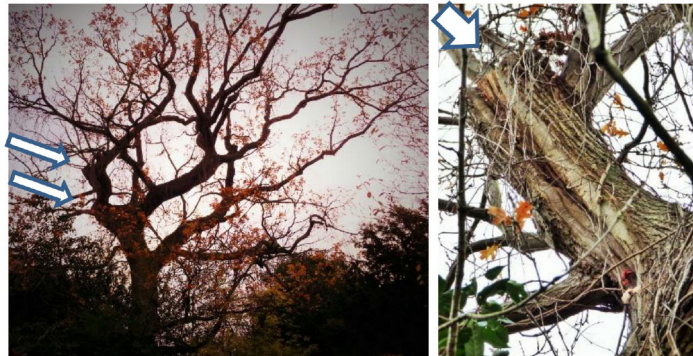
Fig. 4a (LHS) and Fig. 4b (RHS) (November 2017)

Illustrate scale of large diameter pruning wounds probably undertaken in 2010. Note Fig. 4b shows large live stub with substantial callus growth, a locally vigorous response.

The recent extensive pruning resulted in large-diameter wounds whose compartmentalisation has placed energy demands on the tree (Fig. 4a and 4b). Certain truncated branches have died (Fig. 5b) while others show recovery, including live stubs with reasonably vigorous callus growth (Fig. 4b).

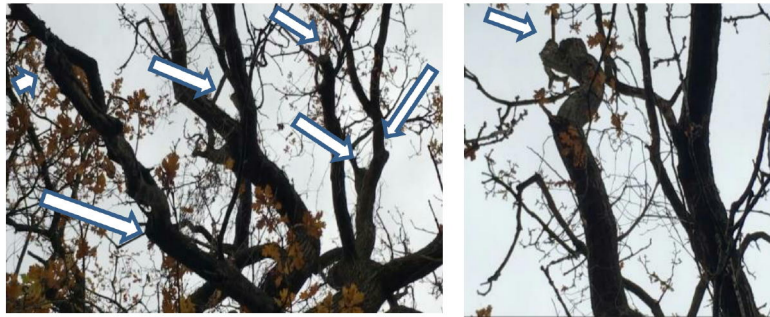
Fig. 5a (LHS) and Fig. 5b (RHS) (November 2017)

I have not seen any records of the tree before and after this reduction took place. However, my recent 2017 inspection noted the presence of large diameter pruning wounds about the crown indicating that branches had been substantially reduced resulting in some pruning cuts with dead ‘stubs’ (see Fig. 5b) and occasional other live stubs that now support new live growth (see Figs. 4a and 4b).

Fig. 5a shows numerous relatively large-diameter pruning cuts from thinning operations.
Fig. 5b illustrates large diameter stub (not to British Standard)

- Retaining maximum canopy volume for healthy recovery
- Using retrenchment ('slow pruning') techniques to concentrate vigour
- Adopting conventional BS 3998 pruning to reduce crown to compact form where appropriate, ensuring smallest possible diameter cuts
- Stabilizing dead wood to be stabilized and retained as feasible in the overall pruning programme
