# **Historic Building Condition Survey**

**Firemen's Cottages, West End Lane Fire Station  
West End Lane, West Hampstead, London**

Reference: 18442A

**August 2019**

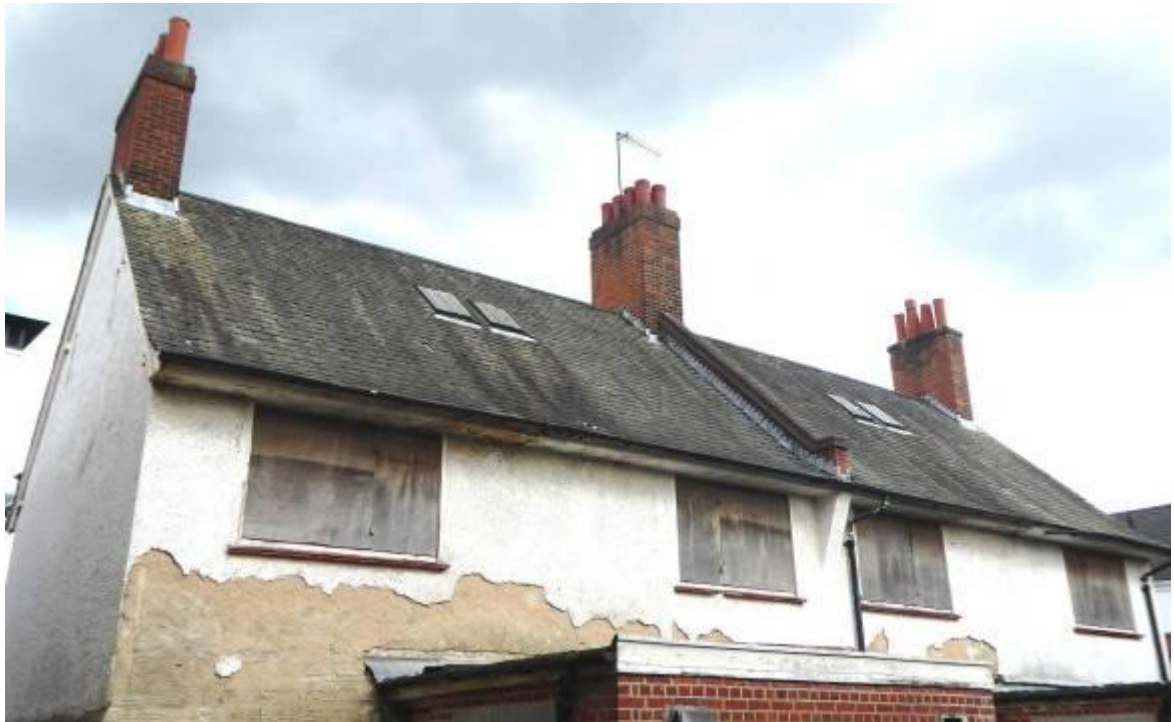
Fig 3.1: Main roof (rear)

- 3.1.2 The main roof coverings are in grey / green Westmoreland rustic pattern slates that are graduated from large slates in the bottom courses to small at the top of each slope. The ridge is capped with grey clayware ridge tiles that are mortared into position. At the bottom of the roof slopes, on both sides, there is a slight kick in the bottom of the slating where this projects over the wide eaves and this is being formed by a tilting fillet on the bottom of the rafters.

- 6.1.5 Over the cottages the existing roof coverings to the main roof due to their poor state of repair is to be stripped and then recovered with the existing slates on battens to replicate the existing. Replacement slates where necessary will fully match the existing in size, texture and colour from the appropriate quarries.

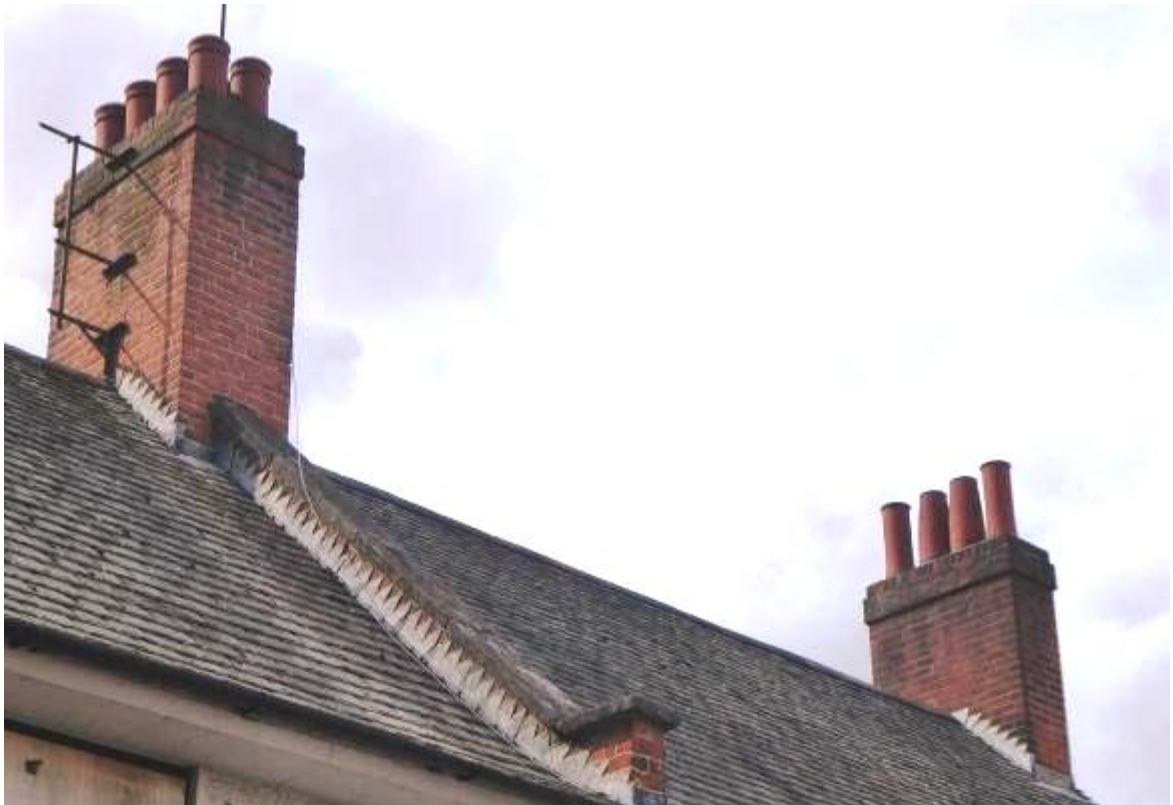
Fig 3.2: Chimneys

- 3.3.2 There are all rectangular on plan with three slightly projecting courses towards the head with one brick on edge course above those. This is all built in an orangey / red brick and appears to have been re-pointed in more recent times using a buff / grey cement type mortar.

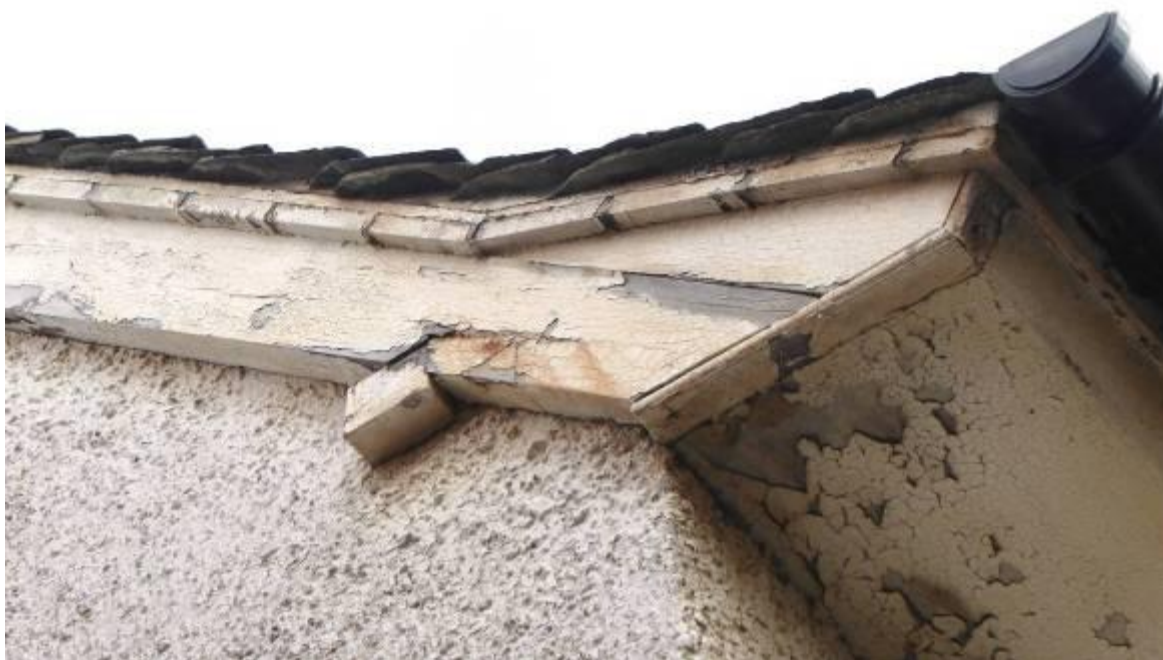
Fig 3.3.1: Main roof eaves and gable junction

- 3.4.1 On both the front and back of the terrace the eaves are a wide form and that appear to be completely rendered around the end of the rafter feet to both the underside (soffit) and to the front (fascia). This has a slight bevel junction between the two with the possibly a painted over timber fascia board on the front.
- 3.4.2 In the centre of the front and rear walls under the ends of the central roof wall there is a plain rendered angled bracket. This projects out from the face of the wall and merges with the underside of the eaves.

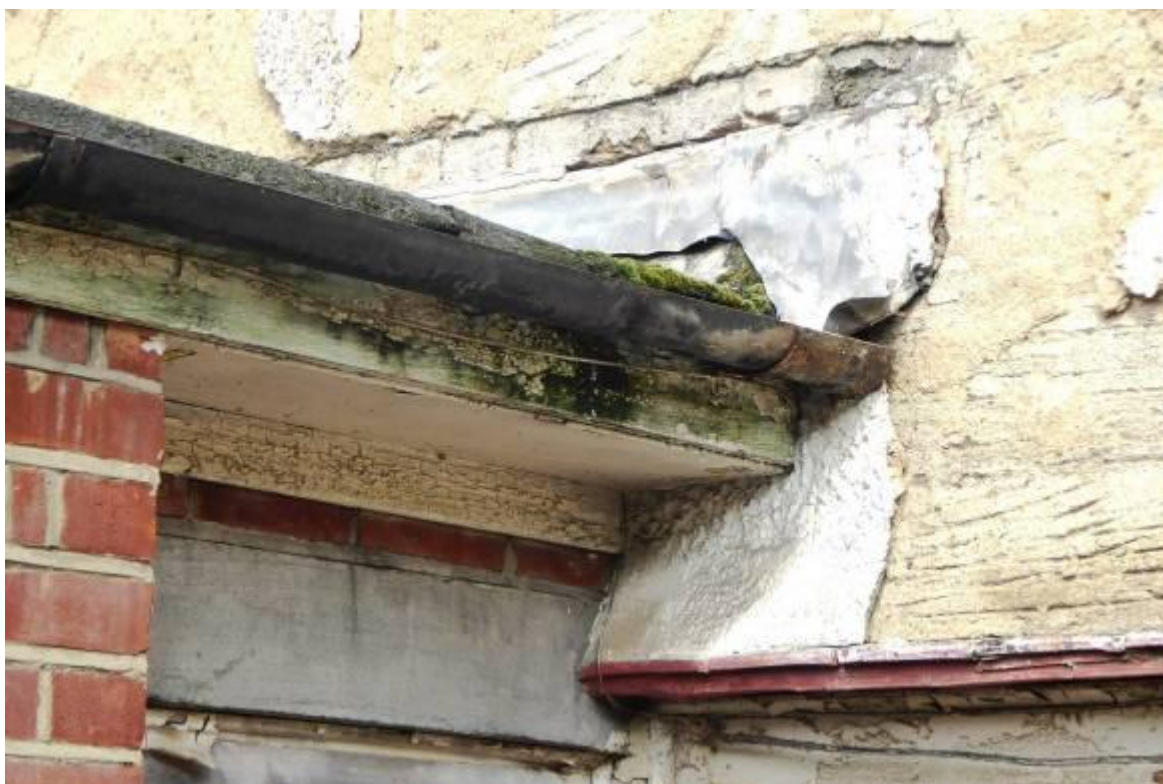
Fig 3.4.6: Flat roof eaves

- 3.4.6 To the perimeter of the flat roofs there is a fascia board fixed directly to the head of the wall all the way around including the closed end on the west side. On either side of each extension is half round section cast-iron guttering that drains to cast-iron downpipes at the west end of each side and which run down and discharge over gully grids at the base.

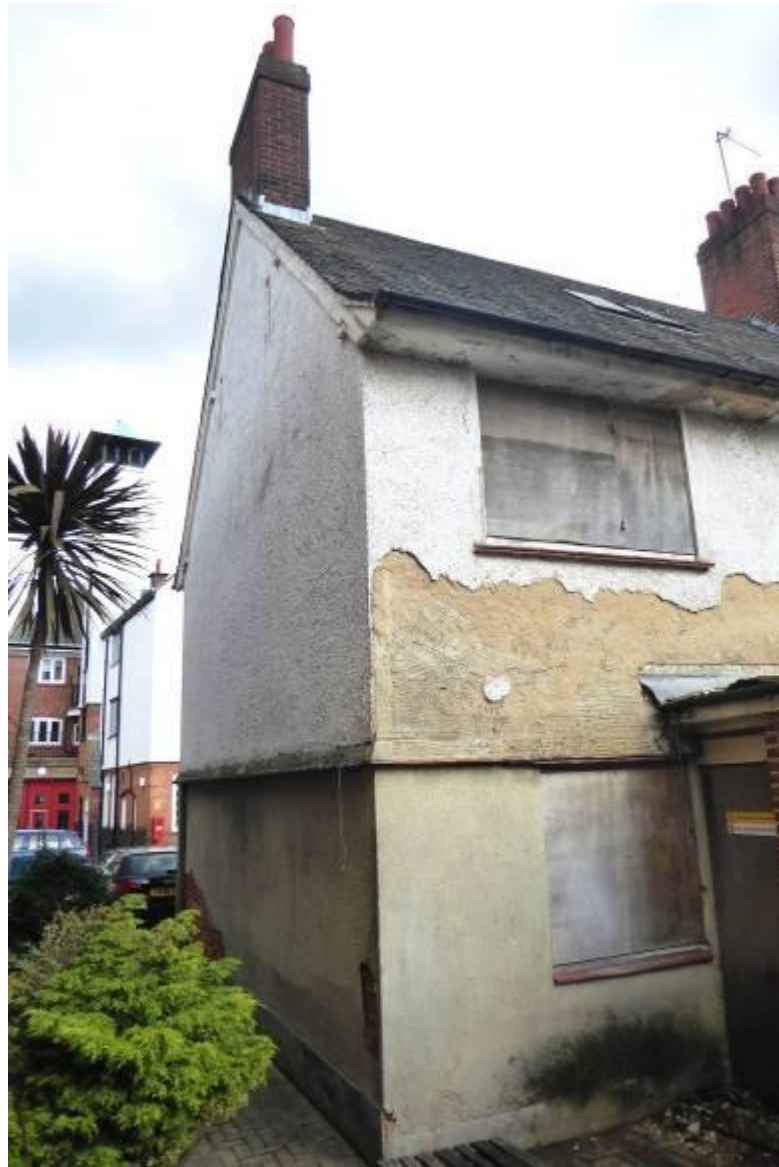
Fig 3.5.1: External wall of cottages

- 3.5.1 The external walls to the main house are all apparently of solid construction and are approximately one and a half bricks thick. These have facings in two distinct sections with the division being a line at ground floor window head height where there is a horizontal tile creasing band all the way around the building that appears to have been painted historically.

- 3.5.3 The walls below the tile creasing are now finished in a hard cement spatter dash type render that has used a coloured mortar over a plain cement type base coat. This finish has failed all around the building and is coming off.

- 3.5.5 Because of the application of the hard cement render to the lower part of the building there is much evidence of brick spalling and loss of the face of the brickwork from ground level up to approximately 1.2 m above ground level. This is likely to be due to a combination of condensation, general moisture entrapment and frost action resulting from this modern applied surface coating.

- 6.1.3 The external render to the lower section of the cottages has and is resulting in deterioration of the brickwork that it covers. This present material is to be removed and because of the severely deteriorated condition of the brickwork it is to be replaced with fully vapour permeable lime render with a smooth finish to contrast to the heavy textured finish above.

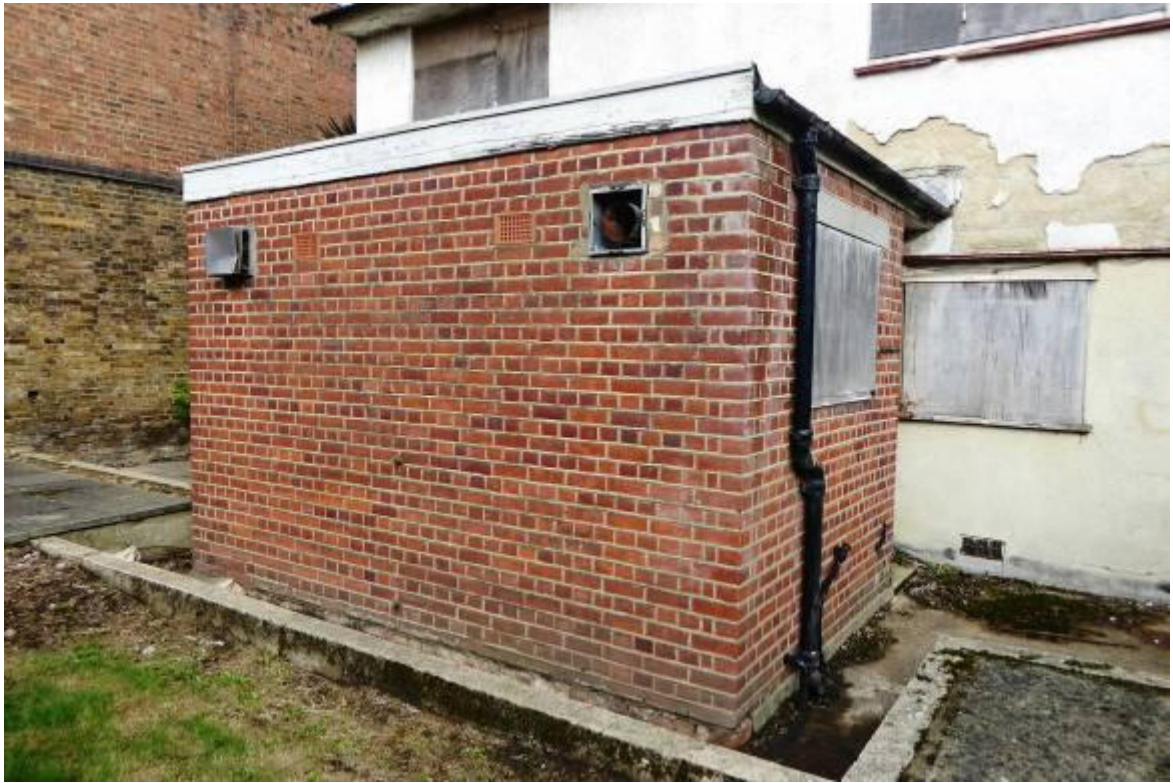
Fig 3.5.13: Rear extension walls

- 3.5.14 There are rendered faced or precast concrete lintels built-in over the head of the window and door openings in the rear extensions.
- 3.5.15 Running around the base of the extension walls from ground level to approximately internal floor level is a rendered band in a hard cement type mortar. There is a bitumen felt type DPC built-in one course of bricks above the paving.

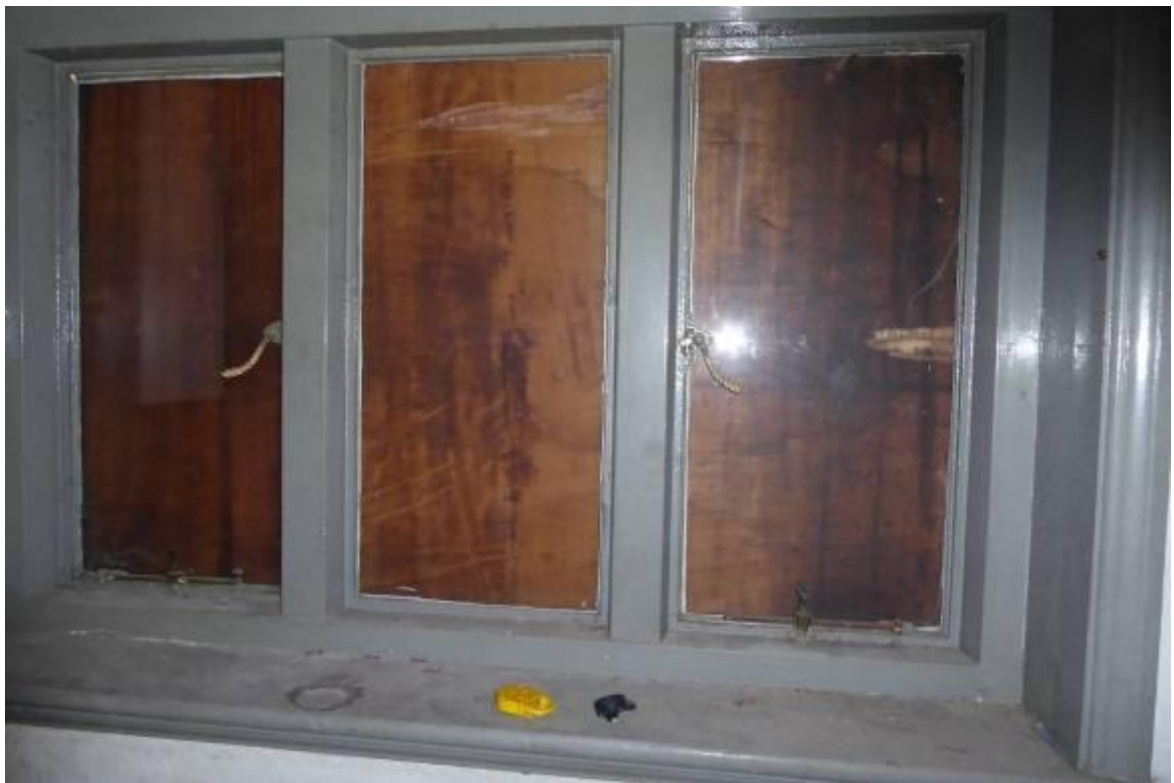
Fig 3.6.2: Internal view of typical sitting room window

- 3.6.3 In general terms the ground floor sitting room windows are a heavy timber framed three light frame with opening metal casement on either side and a fixed light in the centre. In the kitchens there is a similar timber framed two light window with one side being an opening timber casement. These are all single glazed in sheet glass with ironmongery possibly dating to the 1930s or 1950s.
- 3.6.4 Similarly at first floor level the front bedroom window is a three light casement with a heavy timber surround that is positioned against the dividing wall to the adjacent cottage. Externally these have with a cover panel across the end of the dividing

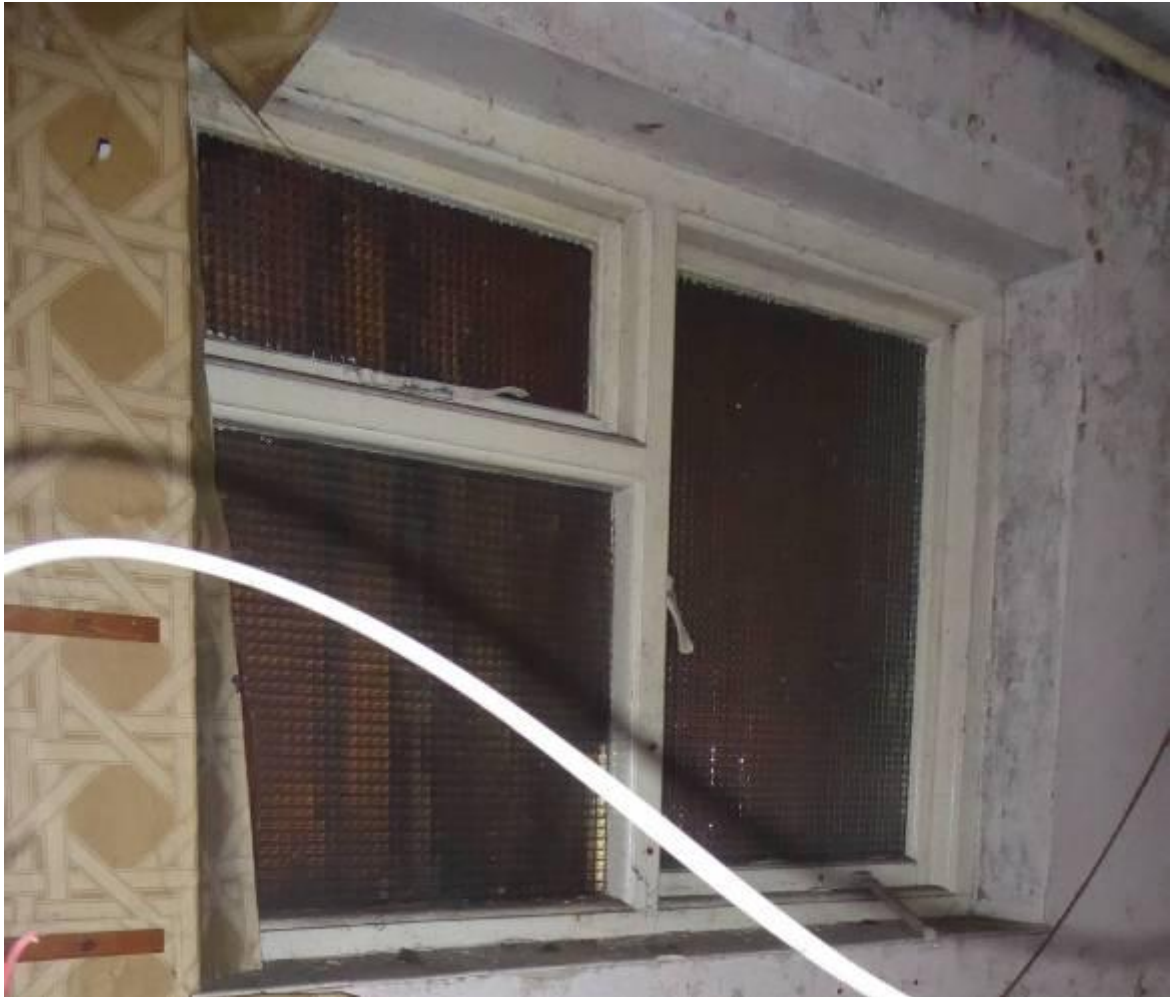
Fig 3.6.6: Typical bathroom window

- 3.6.6 The bathroom windows are a single glazed standard joinery item of 1960 – 70s style with an opening casement on one side of a central mullion with a top opening casement over a fixed light on the other. The ironmongery is all of that period and glazed in obscured pattern sheet glass

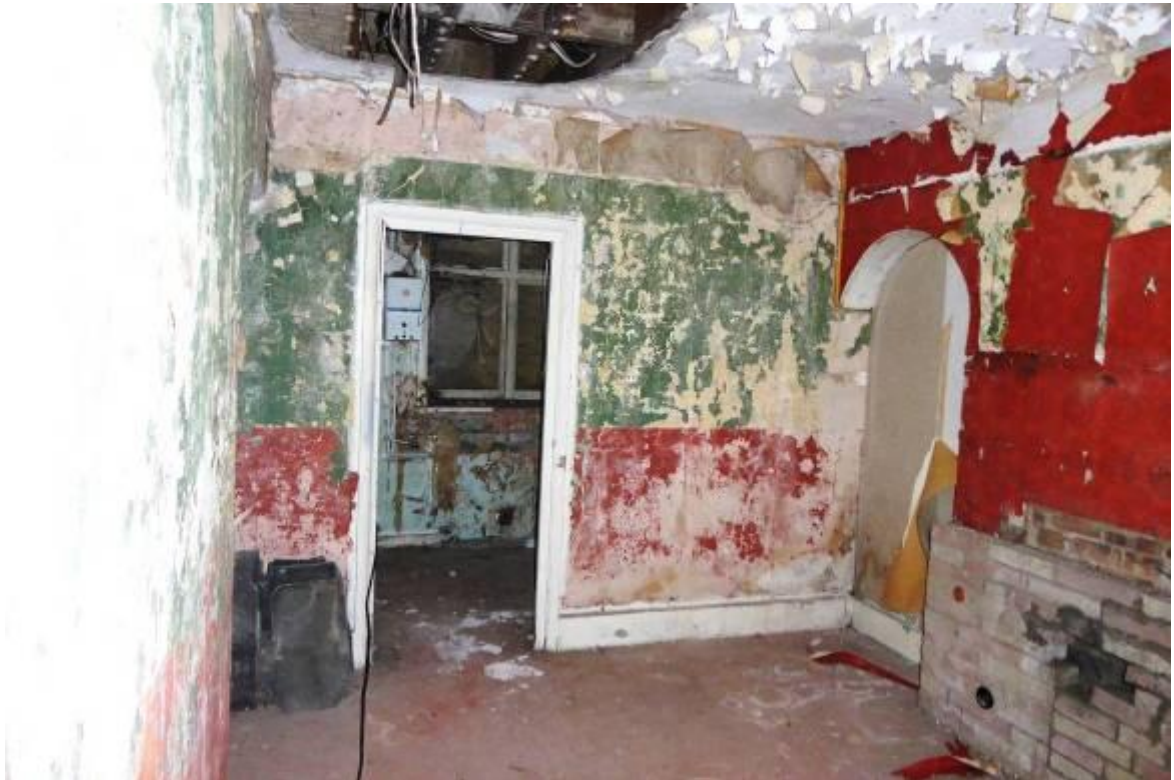
Fig 4.2: Sitting room

- 4.2.1 The floor is a solid concrete structure with a plain screeded surface and not a granolithic finish as the lobby.
- 4.2.2 The walls are generally as that described within the entrance lobby being of brickwork to the exterior and cast in-situ concrete for the internal structures. These have all been finished with what appears to be a two coat lime plaster and then painted.

- 4.2.9 The ceiling in its present form has the remains of polystyrene ceiling tiles applied over lining paper on top of plasterboard that has been fixed to the underside of the first floor joists. Along the abutting wall to the staircase (south) there is the remains of the lathing of the original ceiling and there is staining to the exposed floor joists to show where this form of ceiling was originally over the whole room.

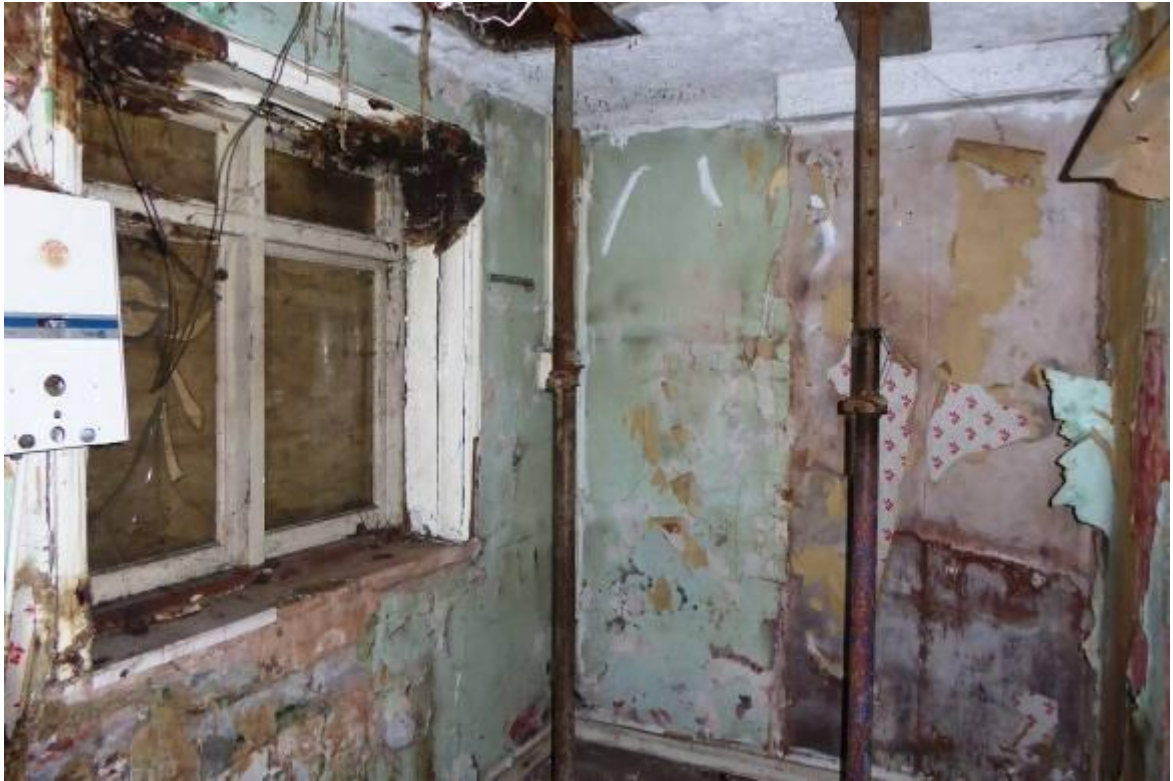
Fig 4.3: Kitchen

- 4.3.7 The ceiling, where it survives, is of lath and plaster and onto which a stippled finish of an Artex type has been applied over the top of lining paper.

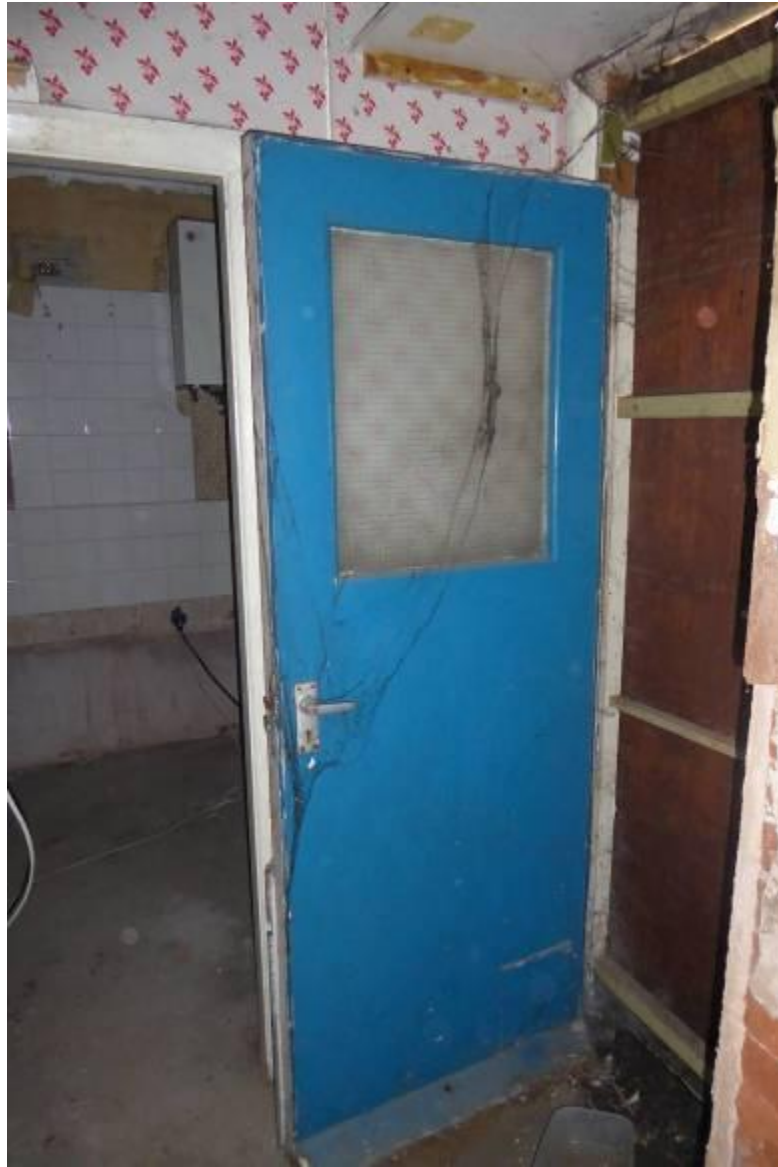
Fig 4.4: Bathroom / rear entrance lobby with external door

- 4.4.1 The floor is of solid construction with a screed type finish with no applied covering.
- 4.4.2 The walls are of solid construction with a painted plaster finish and standard joinery profile skirting boards to the base.

- 4.4.3 The door to the bathroom is a standard joinery 35 mm thick hardboard flush door that is fitted with an aluminium lever lock set.
- 4.4.4 The ceiling is of plasterboard.

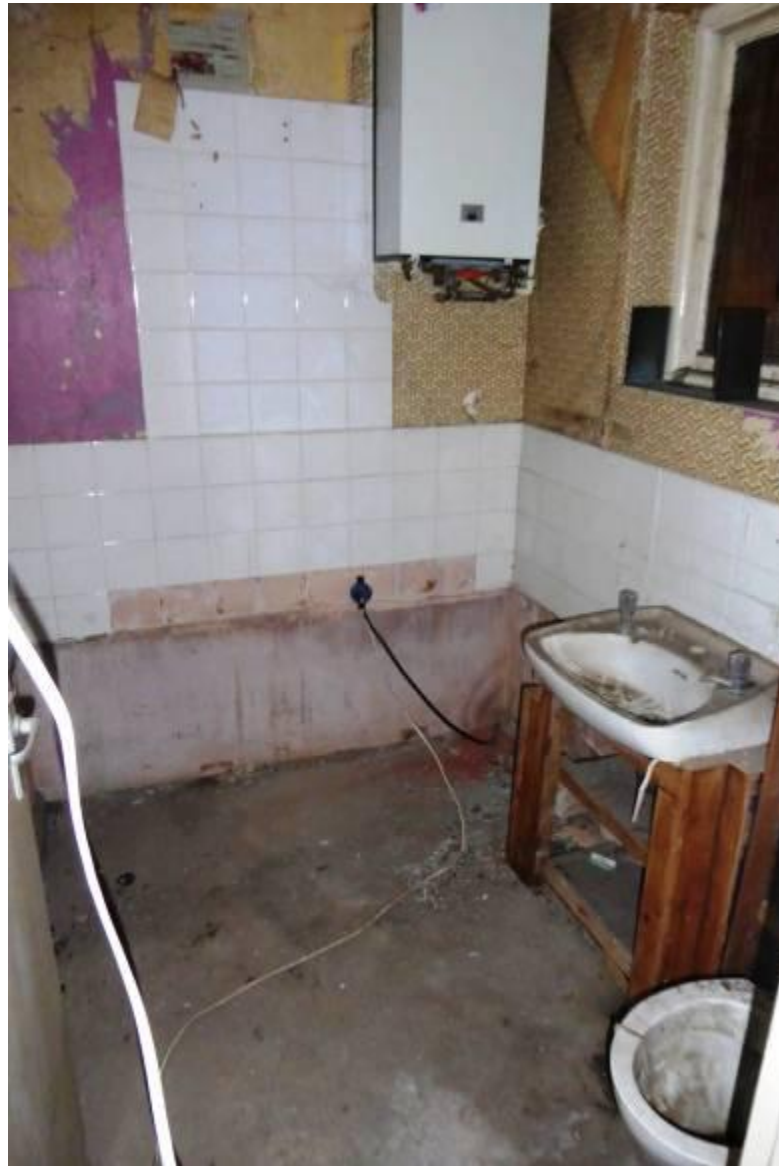
Fig 4.5: Bathroom

- 4.5.5 The ceiling is a flat soffit of plasterboard as could be suggested by hairline cracking on the board joints.
- 4.5.6 Sanitary fittings are all modern units made by Royal Doulton and from their overall style would suggest a date to the late 1960's or early 1970's.

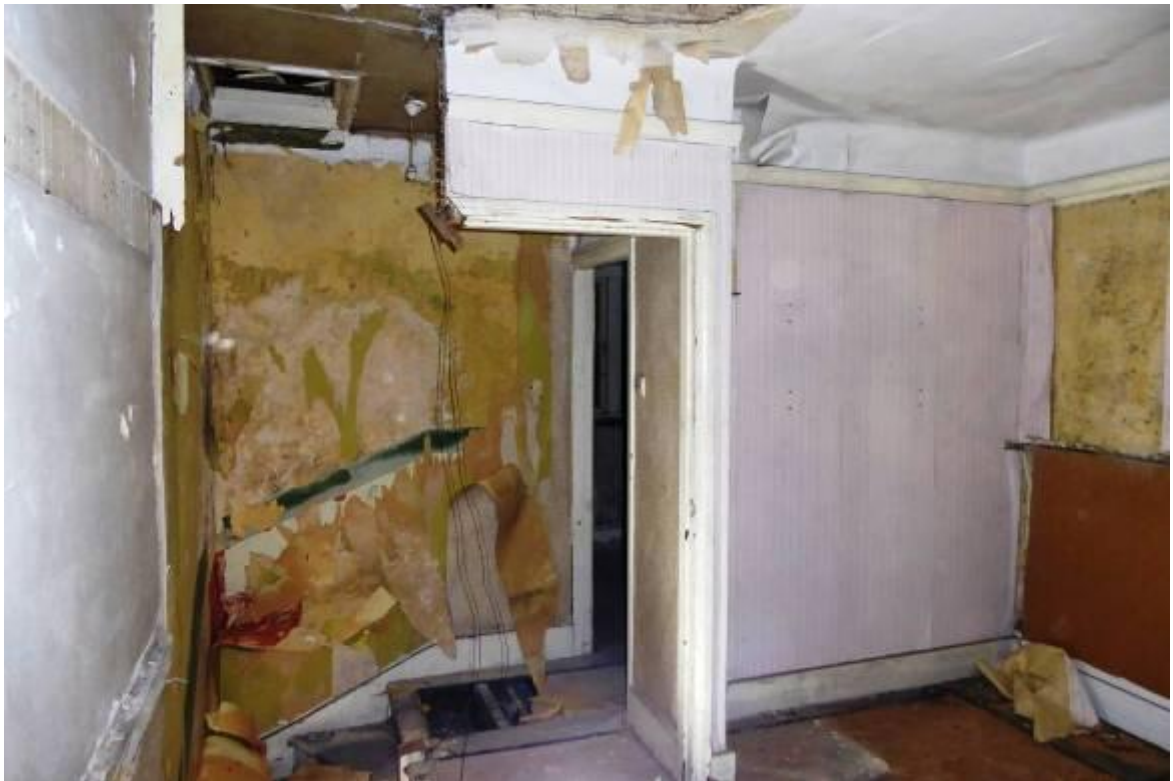
Fig 4.7: Landing from front bedroom through removed wall

- 4.7.2 The remains of a short timber balustrade could be seen where there is the sawn off base of a square newel post together with sockets in the edge of the landing to take the balusters. This previously guarded the open side of the landing and extended to the sidewall to the front bedroom wall and door, which was also missing

- 4.7.5 The doors into both the front and rear bedrooms have simple painted timber door linings with architraves similar to those noted on the ground floor. Running across the door heads is a small section of painted timber picture rail.
- 4.7.6 The ceiling is of modern plasterboard where the original lath and plaster ceiling has been replaced.

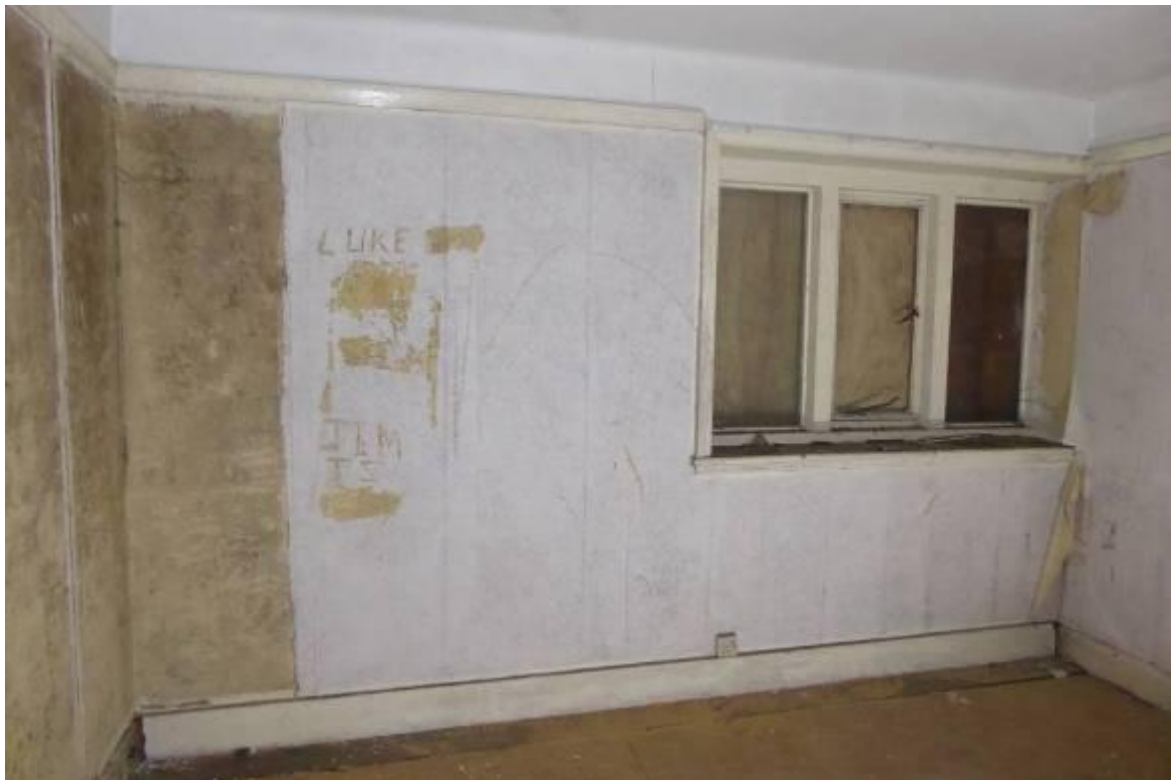
Fig 4.8: Front bedroom

- 4.8.1 The floor is largely Stirling board or similar, but there is softwood boarding as that for the landing still remaining in some locations.

- 4.8.3 Skirting boards to the base of the walls all the way around are similar to that noted within the sitting room.
- 4.8.4 Around the head of the walls approximately 300 mm down from the ceiling is a simple splayed profile painted timber picture rail.

- 4.8.5 In the northwest corner is a chimneybreast in the base of which are the remains of a fire opening that has had a timber board fitted over it. It has a polished slate hearth in front and the fire surround is missing.

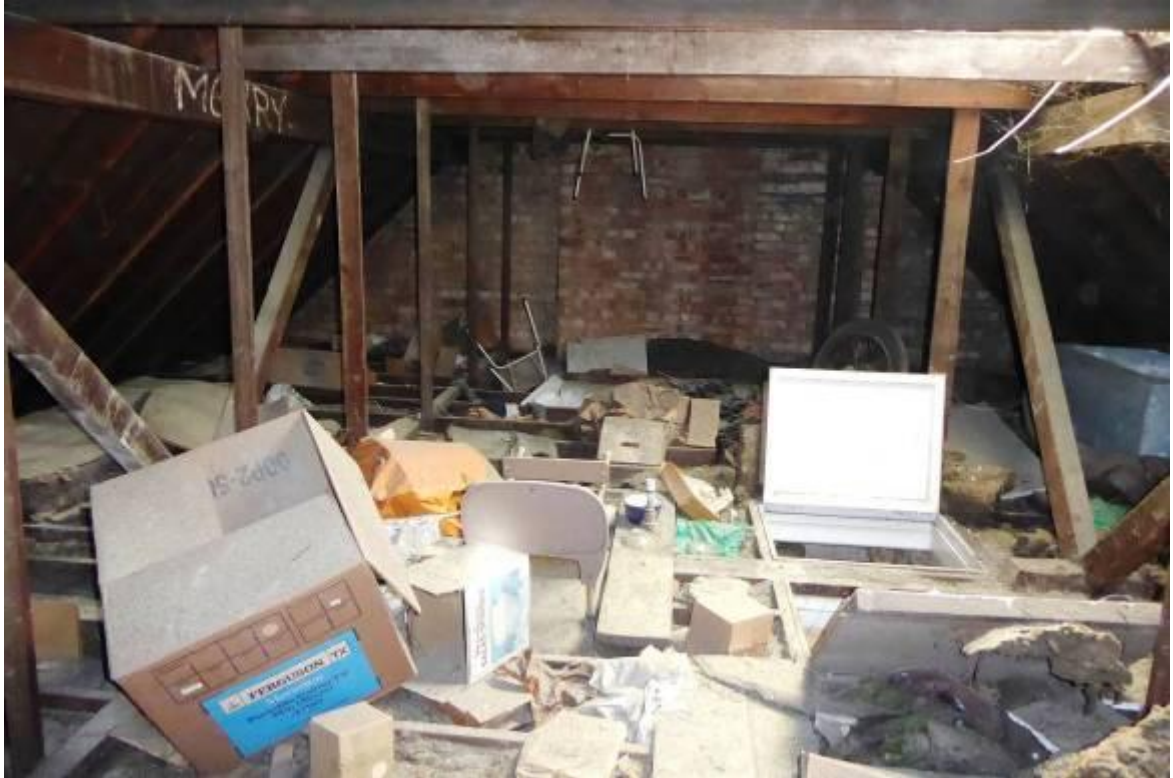
Fig 4.10: Roof space from north gable

- 4.10.4 The roof is a purlin type structure that has large section timbers spanning through in centre of the slopes over both cottages from the central party wall to the north gable wall. The purlins are strutted by diagonal braces onto the head of wall between these two cottages. The rafters span from the wall heads, over the purlins to a ridge board at the top. At high level over the purlin collars connect to the roof structure and these are on every other rafter for the length of the roof.

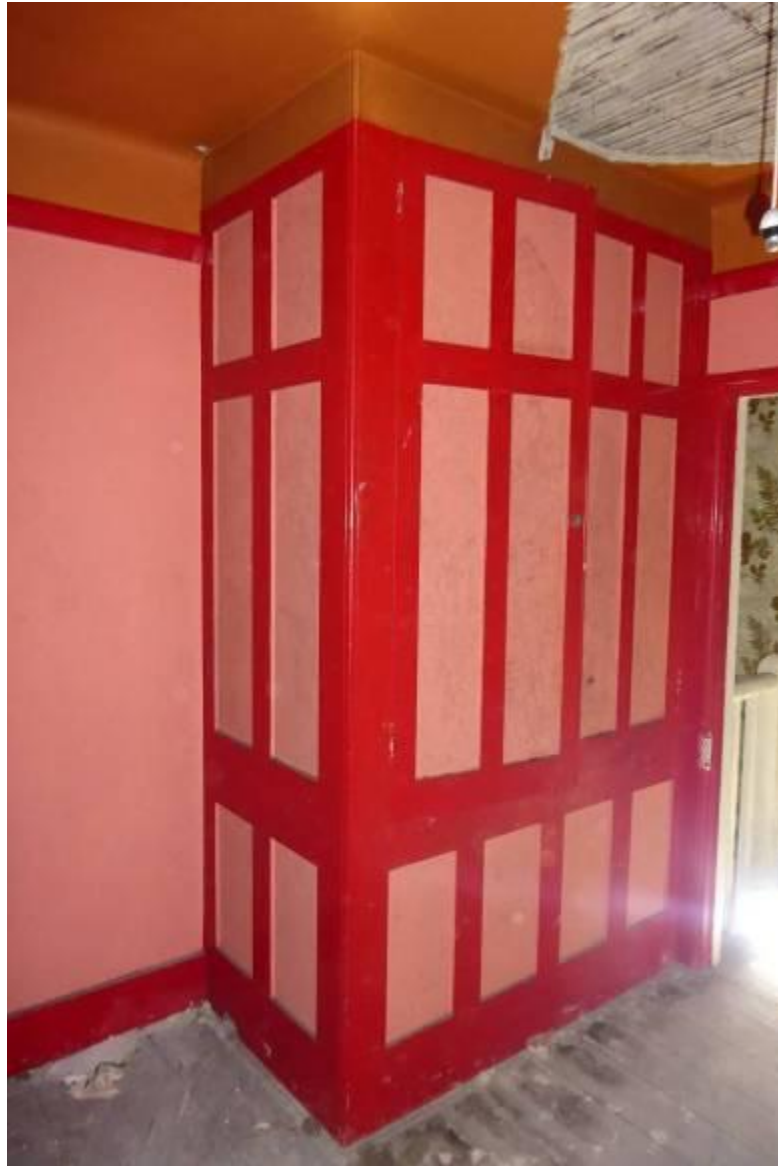
Fig 5.2.10: Cottage 2 front bedroom over stairs cupboard

- 5.2.10 The built in cupboard over the staircase to the front bedroom appeared to be in almost original condition, being fully panelled all the way around.

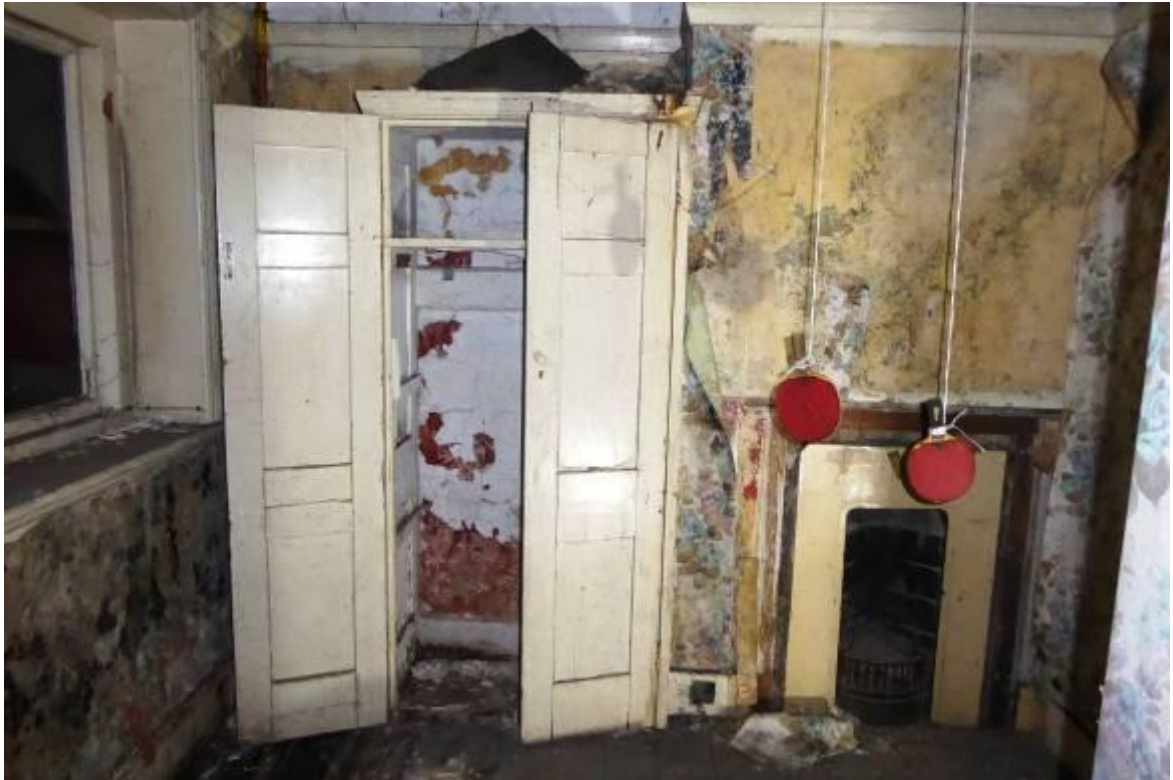
Fig 5.2.14: Rea bedroom cupboard

- 5.2.14 In the rear bedroom in the left side of the chimneybreast is a fitted wardrobe with a pair of three panel doors to the front and similar panels on the outer side. Its overall style and form could suggest a dating to the 1930's.
