Schedule of Condition and Proposed Works

House No. 3
West Hampstead Cottages
West Hampstead Fire Station
325 West End Lane
London NW6 1RR

Dron & Wright

July 2019

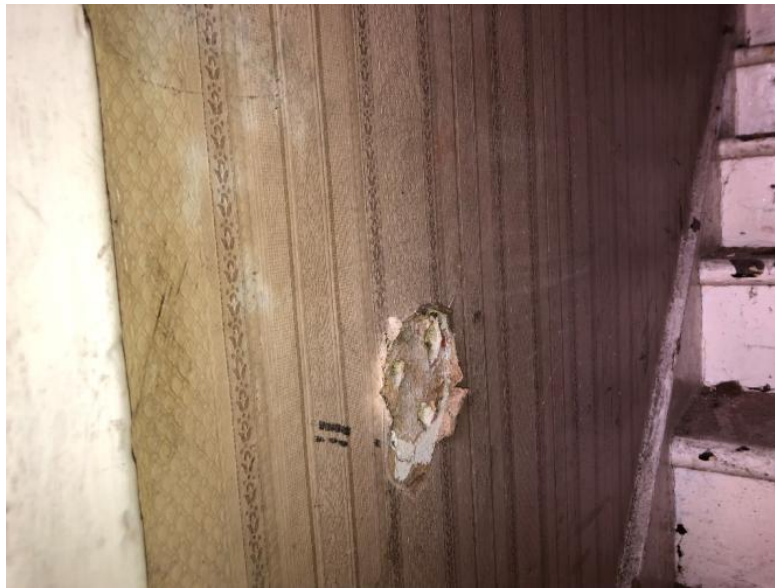
A wall mounted timber handrail appears to have been removed from the south wall. The position of the former fixing brackets remains visible as per the image below:

Position of former fixing brackets

- Retain timber staircase as existing.
- Redecorate exposed stair stringers with brush applied satinwood paint.
- Install new edge-fixed carpet floor coverings to staircase.
- Replace existing wall mounted timber handrail with new stained timber 'mopstick' handrail.

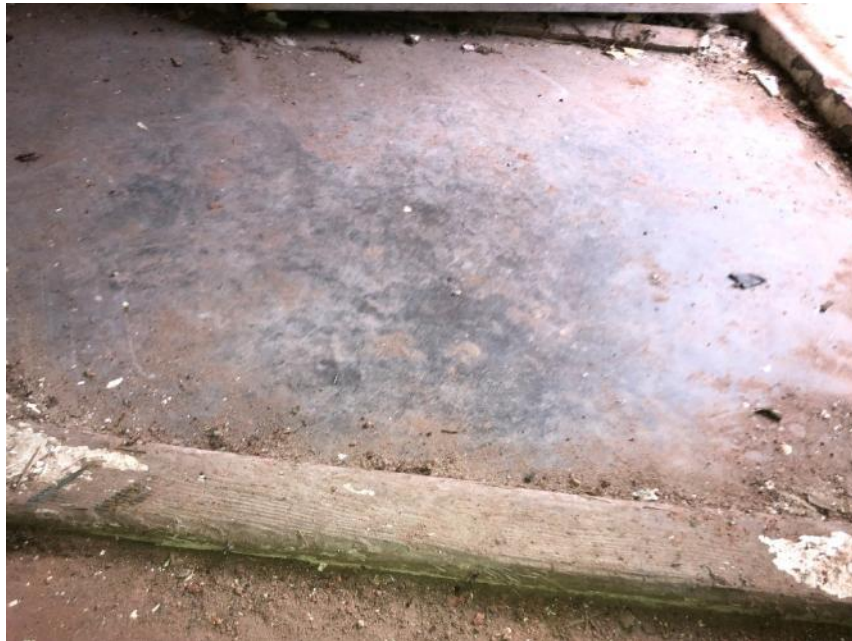
View of hall floor surface

The concrete surface appears in fair condition throughout with no visible defects.

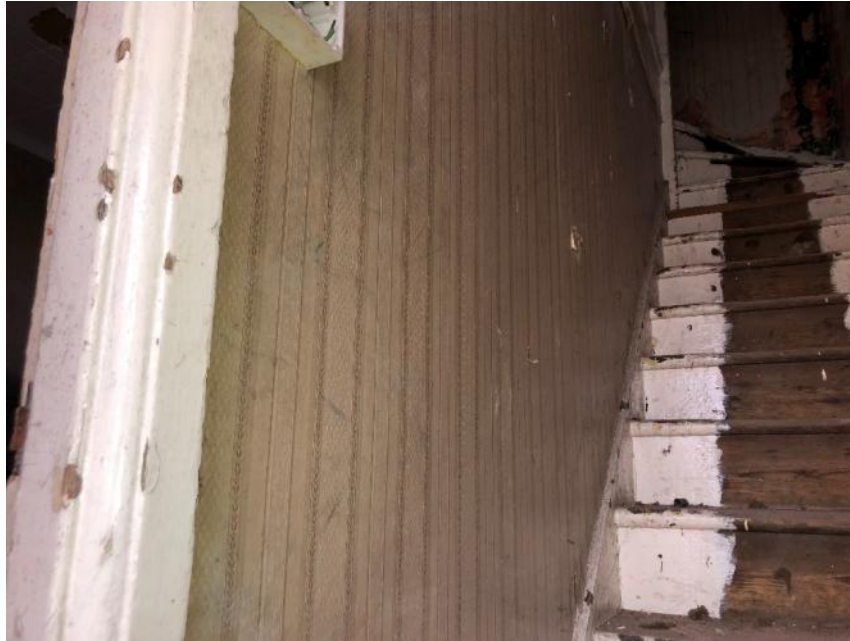
General view of stairwell walls

All wallpaper finishes are stained and discoloured throughout however the wall surfaces appear generally sound as per the image below:

- Strip off and dispose of all existing wallpaper coverings.
- All loose, friable or damaged plaster surfaces are to be removed to a stable substrate. (The full extent of all damaged plasterwork is to be assessed following removal of all decorative wall coverings).
- Where removed, all plaster surfaces to be reinstated using non-hydraulic lime-based plaster applied to the level of the existing finishes.
- All stable and un-damaged plaster surfaces will be retained.
- All new and existing plaster surfaces to be covered with lining paper and decorated with emulsion paint.

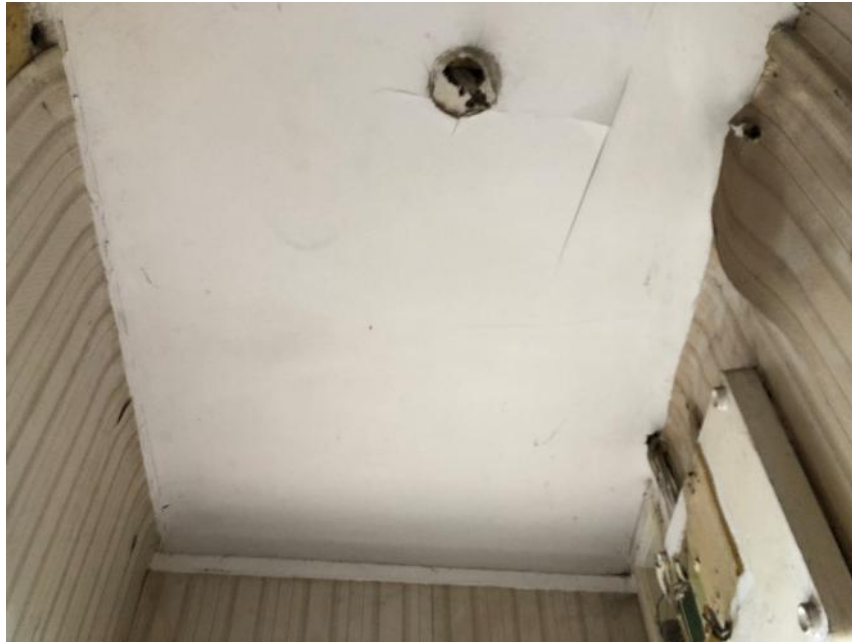
View of hall ceiling

The decorative finishes are and discoloured throughout and the ceiling paper de-bonding in areas. The plastered surfaces appear to be in fair condition with no visible defects.

- Strip off painted ceiling paper and dispose.
- Any underlying loose or friable surfaces to be removed to a stable substrate and reinstated using non-hydraulic lime based plaster.
- Redecorate all new plaster surfaces with emulsion paint.

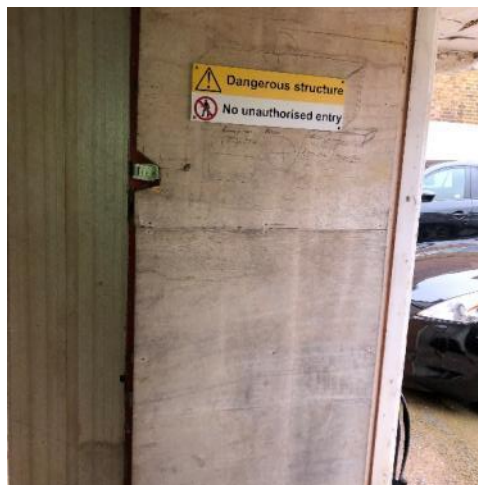
View of exterior face of door

The decorated surfaces are discoloured, damaged and in poor condition throughout. The timber surfaces appear to be in generally sound condition, although there are areas of surface damage and redundant fixing holes where door furniture has been removed.

- Remove timber boarding and assess condition of interior and exterior surfaces.
- Where defective timber surfaces are identified, carry out timber repairs as necessary to match the detail and dimensions of the existing.
- To glazed panels, install new obscured glazing with applied lead strips to external surface, as detailed in Appendix A.
- Prepare and redecorate all previously decorated surfaces; exterior surfaces to be decorated with brush applied exterior gloss paint and interior surfaces with brush applied satinwood paint.
- Install new interior and exterior ironmongery; ironmongery details to be confirmed.

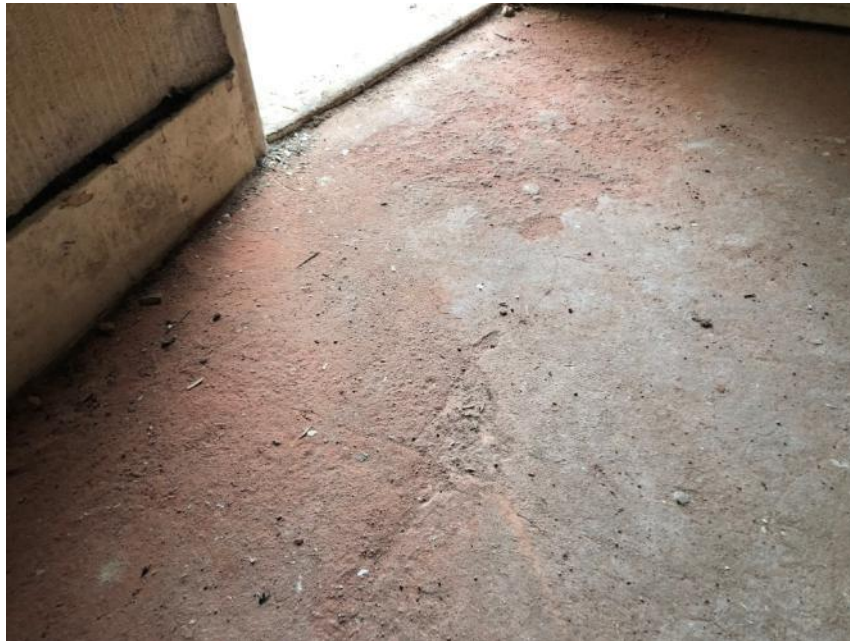
There are localised areas of cracking to the screeded concrete surfaces alongside localised areas of surface abrasion as per the image below:

Surface abrasion adjacent to entrance door

- Clear all surface dirt and debris.
- Once cleared, remove any loose and friable materials and repair as necessary to match existing,
- Install new edge-fixed carpet floor coverings throughout.

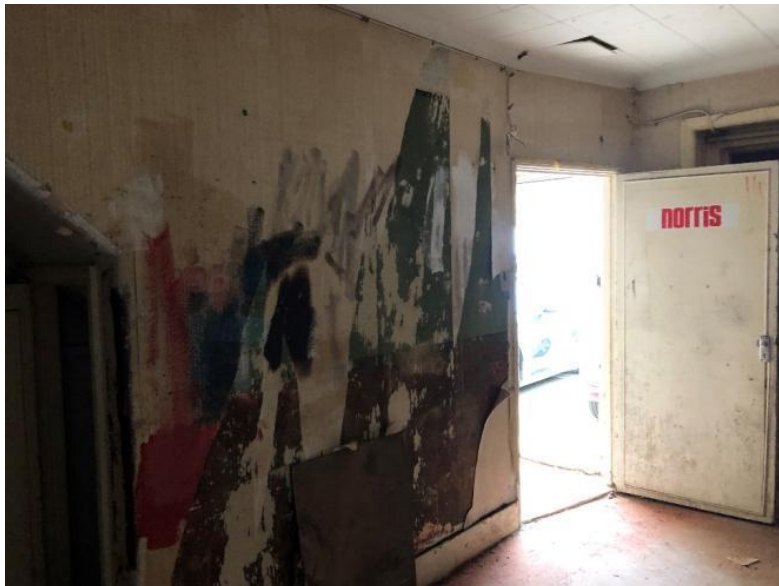
The wallpaper finishes are discoloured and stained throughout and appear to have been vandalised with graffiti in some areas as per the image below:

View of graffiti on wall surface

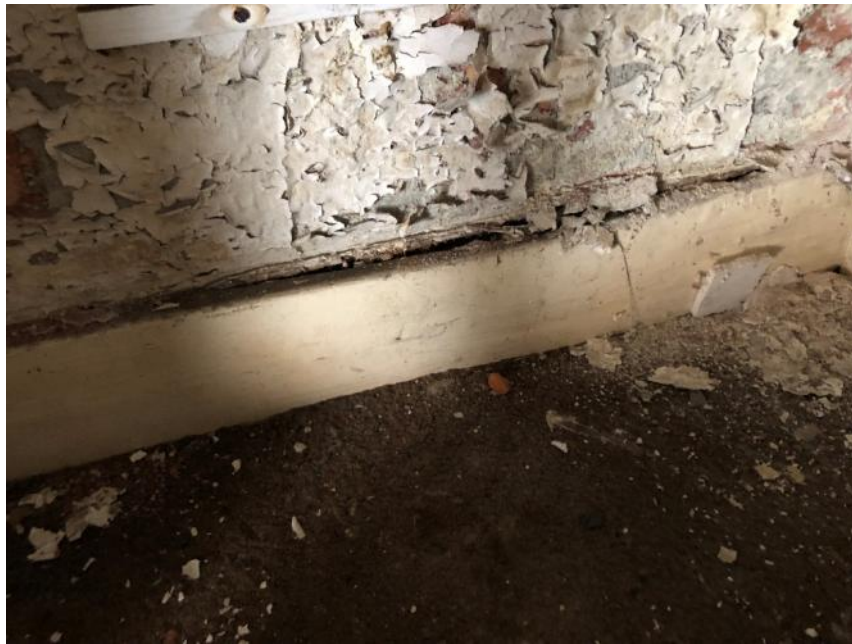
The majority of plaster surfaces appear sound and free from visible defects, however some plaster surfaces have suffered damage due to water ingress, as per the images below.

Damp affected wall surfaces to south-west corner

- All loose, friable and damp affected plaster surfaces are to be removed to a stable substrate. (The full extent of damaged plasterwork is to be assessed following removal of all decorative wall coverings).

- Where removed, plaster surfaces to be reinstated using non-hydraulic lime-based plaster applied to the level of the existing finishes.
 - All stable and un-damaged plasterwork will be retained.

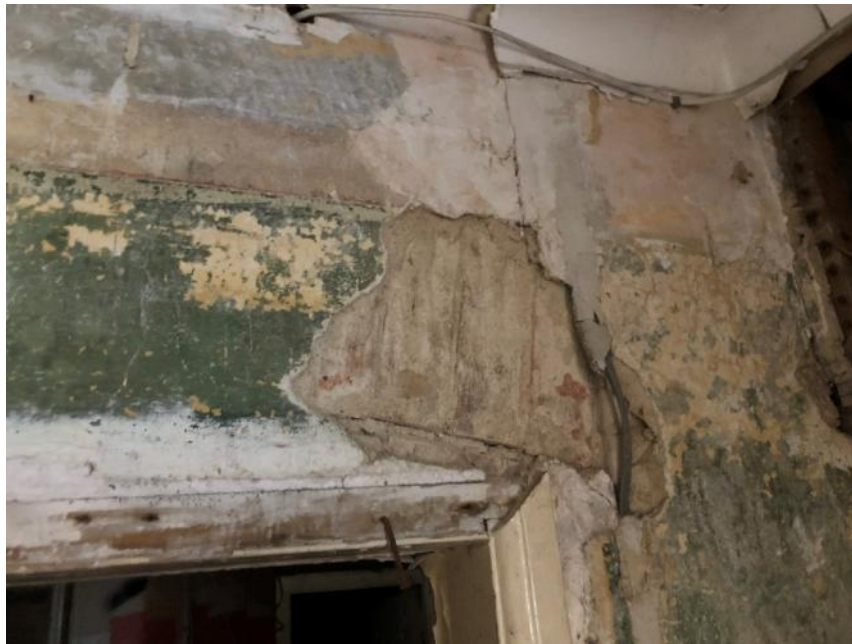
A section of damaged and damp affected plasterwork is also located at high level to the west of the room. The plaster finishes in this area are no longer stable and have debonded exposing the underlying masonry, as per the image below:

Damaged and damp affected plaster surfaces at high level

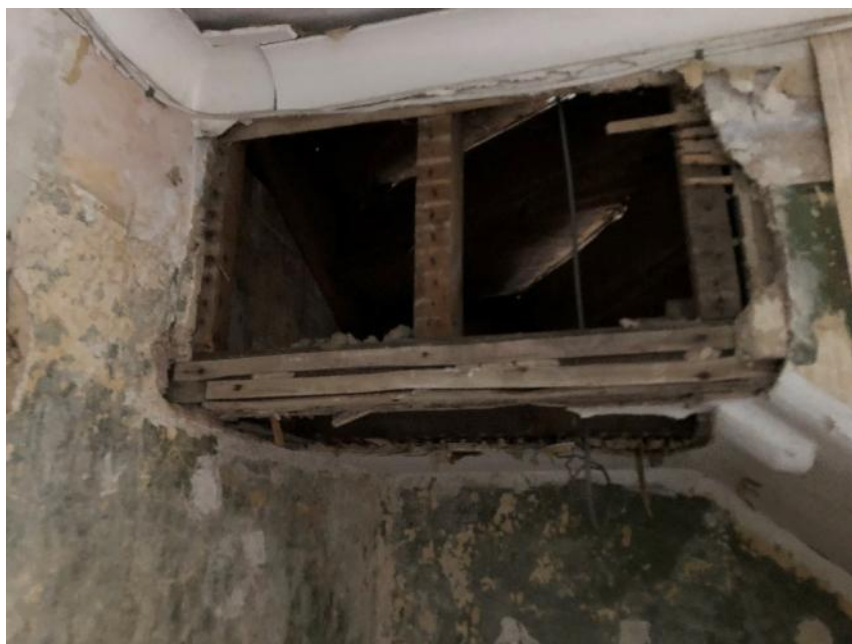
To the north-west corner of the room, lath and plaster wall surfaces covering approximately 1 square metre have been stripped away exposing the underside of the adjacent staircase as per the image below:

Damaged and damp affected plaster surfaces at high level

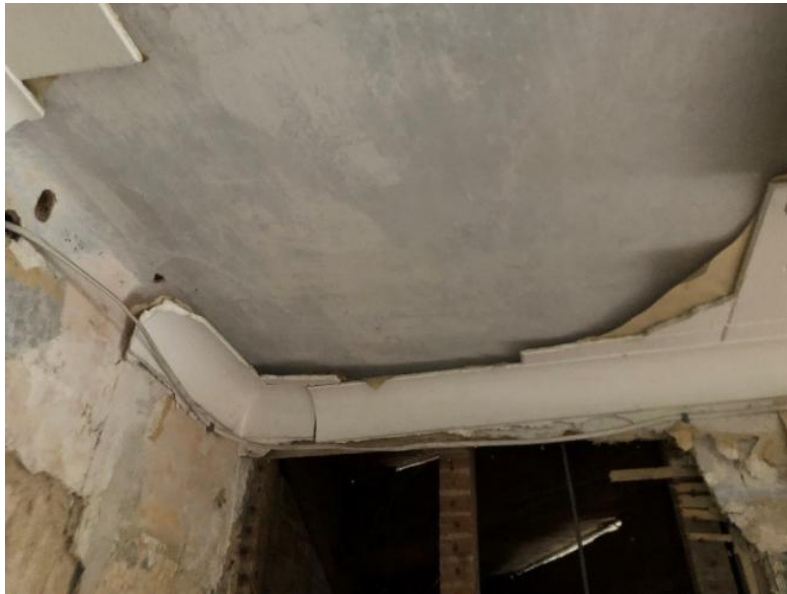
Sections of the polystyrene tile finishes and modern plaster covings have de-bonded and fallen away in areas, exposing the underlying plaster surfaces as per the image below:

De-bonded polystyrene tiles and covings

- Remove all modern plaster coving and polystyrene tile finishes and dispose.
- All loose or friable plaster surfaces are to be removed to a stable substrate. (The full extent of damaged plasterwork is to be assessed following removal of all decorative wall coverings),
- Where removed, all damp affected plaster surfaces to be reinstated using non-hydraulic lime-based plaster applied to the level of the existing finishes,
- Missing timber laths to be reinstated as part of this process
- All stable and un-damaged plasterwork will be retained,
- All new and existing plaster plasterwork to be decorated with emulsion paint.

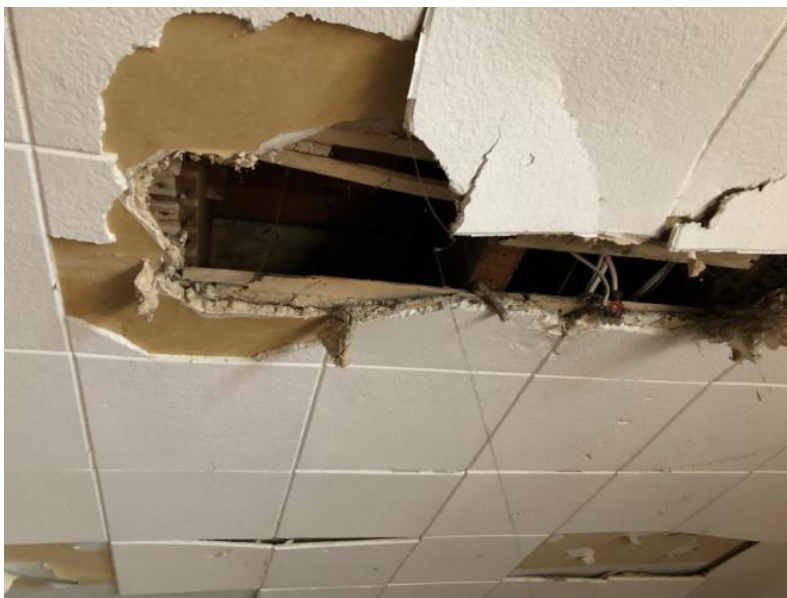
To the centre of the room is a damaged area of approximately 1 square metres in size. Here, the polystyrene tile finishes, plasterwork and underlying timber laths have been removed, exposing the underlying timber floor structure, as per the image below:

Damaged polystyrene tiles and plasterwork

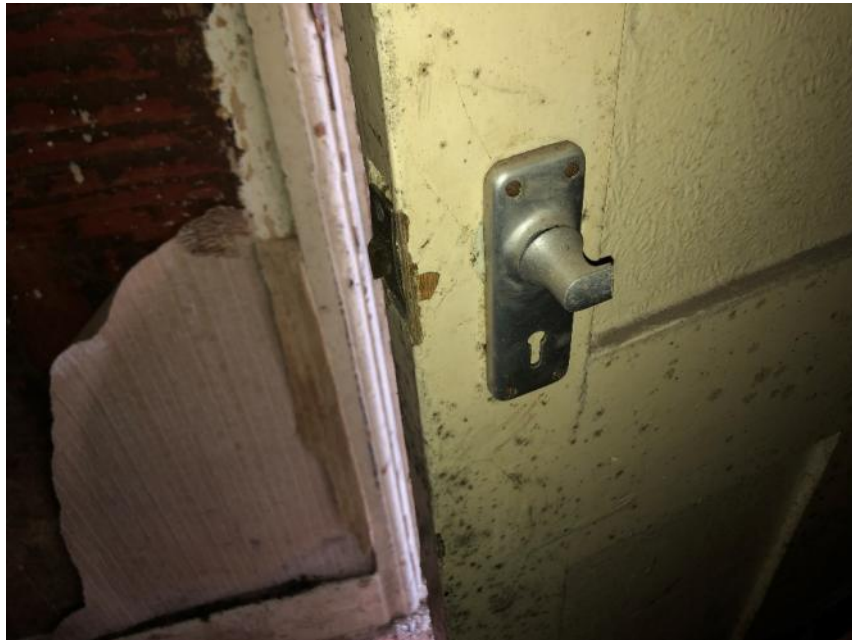
All timber surfaces appear sound and in fair condition although the decorations are stained and discoloured throughout. The stainless steel door furniture is damaged as per the image below:

Damaged door furniture

- Remove remaining damaged door furniture and dispose.
- Remove overpanelling and dispose, making good underlying timber surfaces as necessary.
- Thoroughly prepare all timber surfaces and redecorate with brush applied satinwood paint.
- Install new door furniture – details to be confirmed.

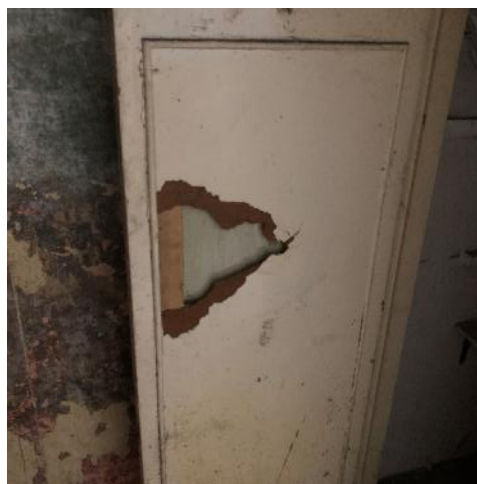
All timber surfaces appear sound and in fair condition although the decorations are stained and discoloured throughout.. The draw bolt is damaged and partially missing as per the image above. The overboarding to the inner face of the door is damaged revealing the underlying panelled timber surface, as per the image below:

Damage to overboarded surface

- Remove damaged door furniture and dispose.
- Remove overpanelling from inner and outer face of door and dispose, making good underlying timber surfaces as necessary.
- Thoroughly prepare all timber surfaces and redecorate with brush applied satinwood paint.
- Install new metal door furniture – details to be confirmed.

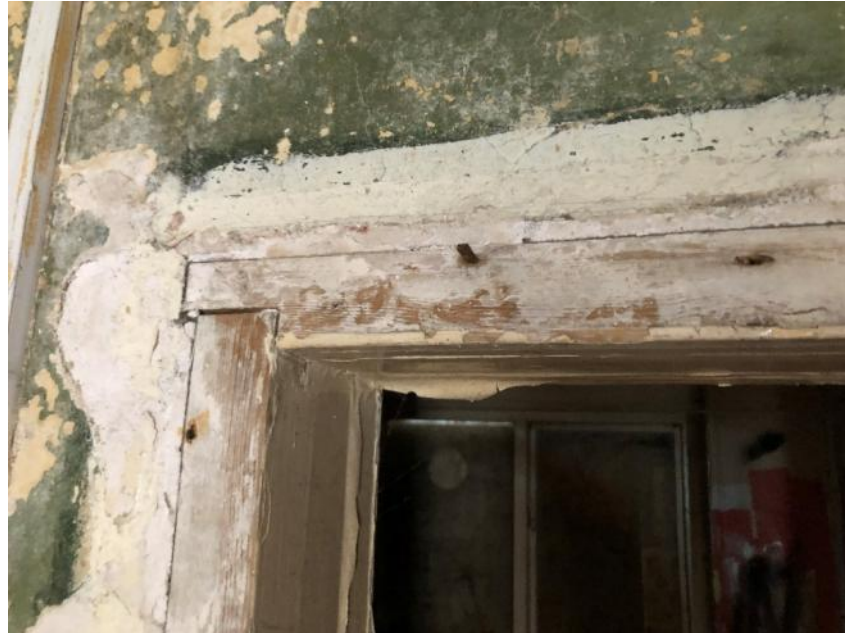
The kitchen entrance door doorway incorporates timber door lining; however the door architrave is missing save for one remaining section to the northern aspect of the door as per the image below:

Missing door architrave detail

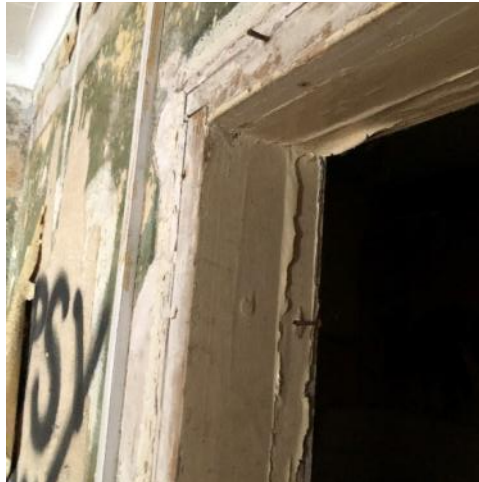
The door linings and architraves to the kitchen are partially missing. The remaining timber surfaces have suffered damaged due to water ingress and as such are in poor condition, as per the image below:

Damaged lining and architrave to Kitchen entrance

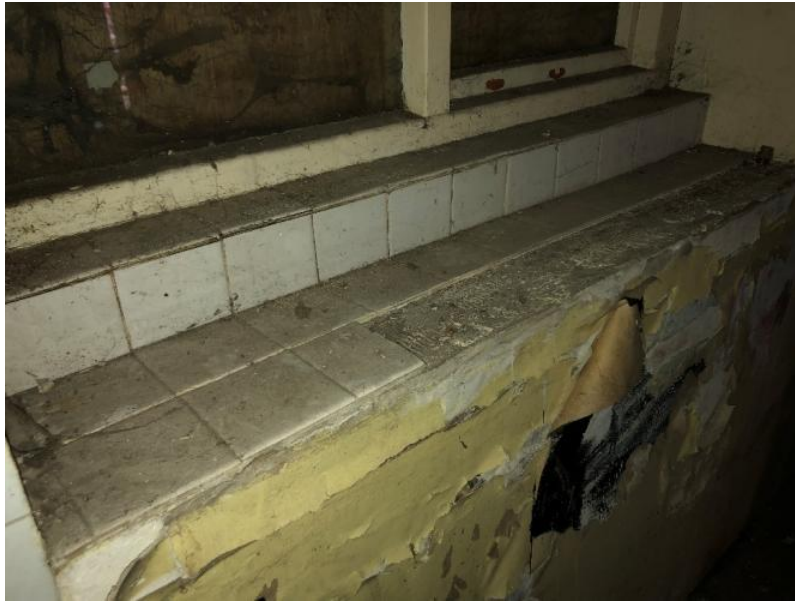
The wall surfaces appear generally sound although the plaster finishes and decorations have suffered damage in some areas where redundant wall mounted fittings have been removed as illustrated below:

Damage caused by the removal of former wall mounted fittings

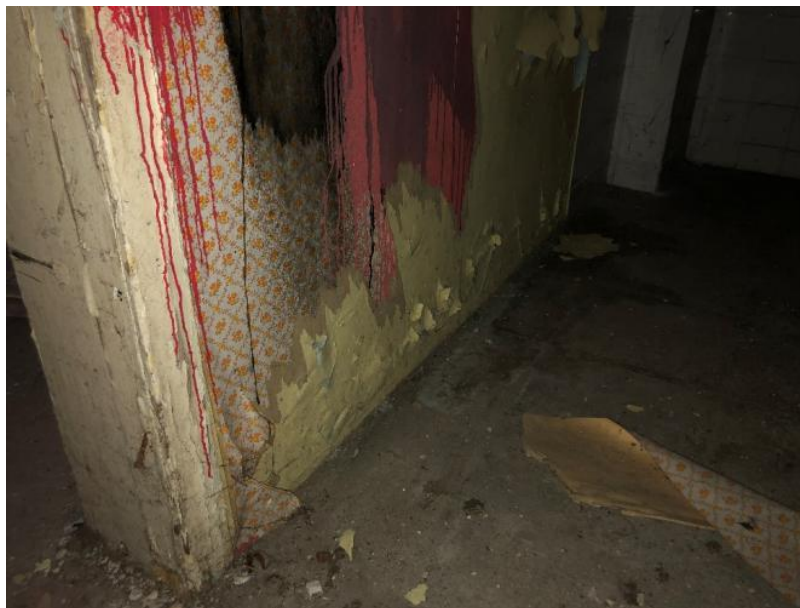
Low level wall surfaces to the north and east of the room appear to have suffered damage and deterioration due to water ingress as per the image below:

Damp affected wall surfaces

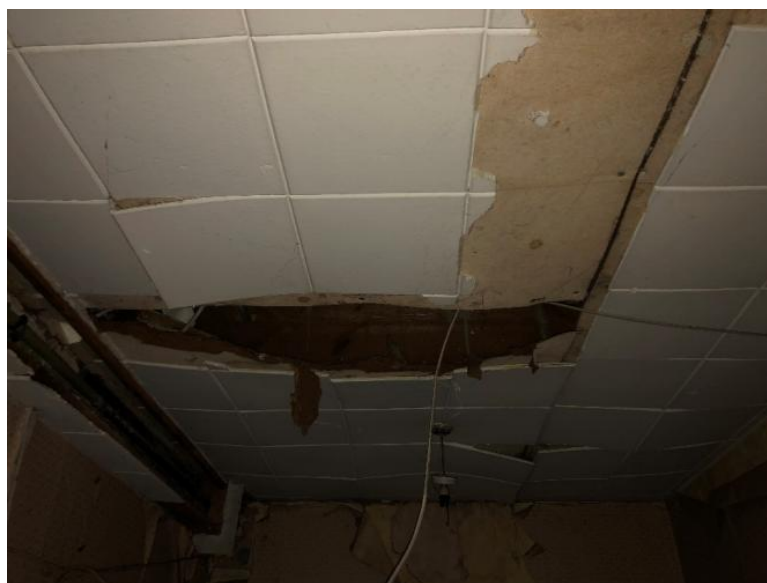
The polystyrene ceiling tiles have de-bonded and fallen away throughout the room. The underlying plasterboard finishes are distorted throughout and where exposed appear to have been affected by water ingress. To the centre of the room, a section of plasterboard appears to have fallen away, exposing the underlying timber floor structure, as per the image below:

General view of Kitchen ceiling

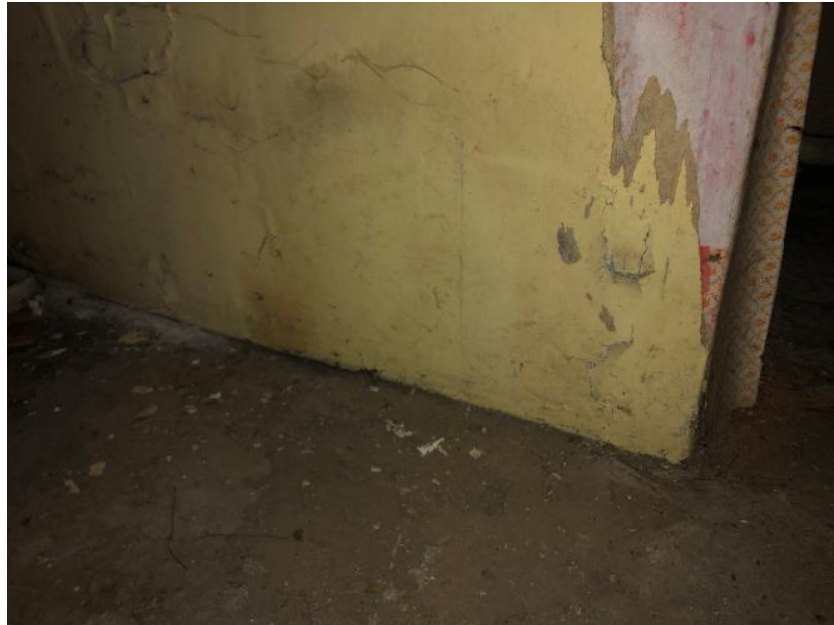
No skirting boards installed, as per the image below:

No skirting boards installed

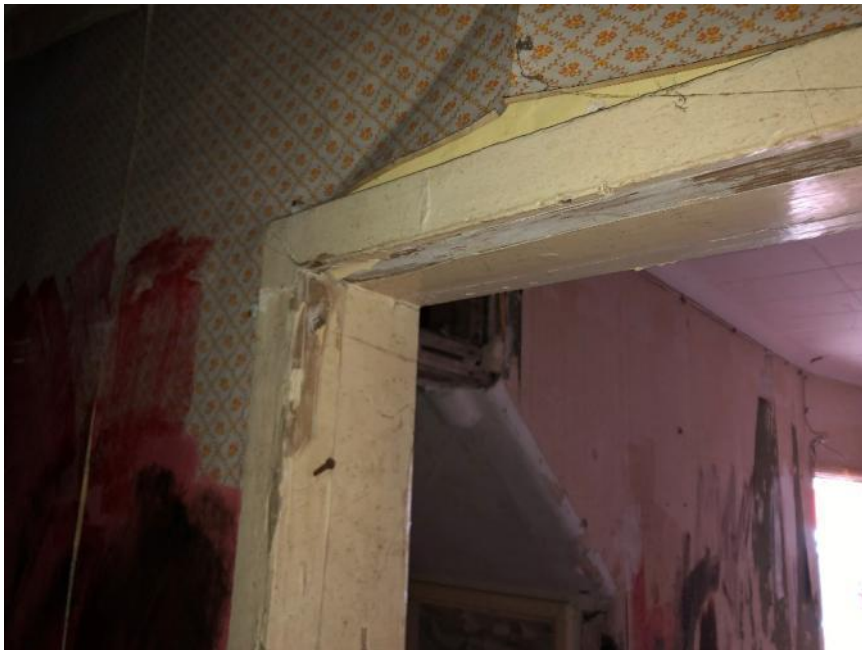
The kitchen entrance door linings and architraves have been affected by damp ingress and as such are in poor condition throughout. All timbers are softened and distorted in a manner indicative of fungal decay. This corresponds with the water damage noted to adjacent wall surfaces as per the image below:

Decayed timber door lining and architrave

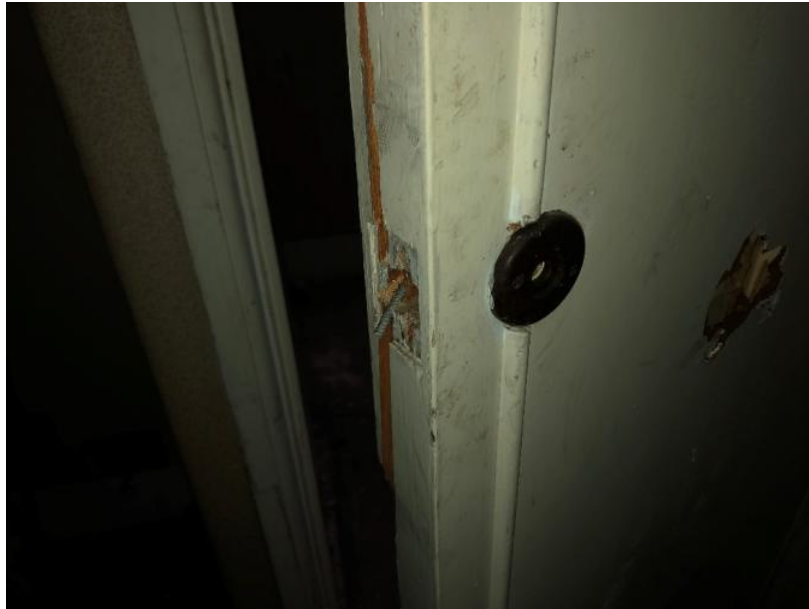
The plastic door furniture and cylinder latches fitted to each door are damaged/partially removed, as per the images below:

Damaged/missing plastic door furniture to Bedroom 1

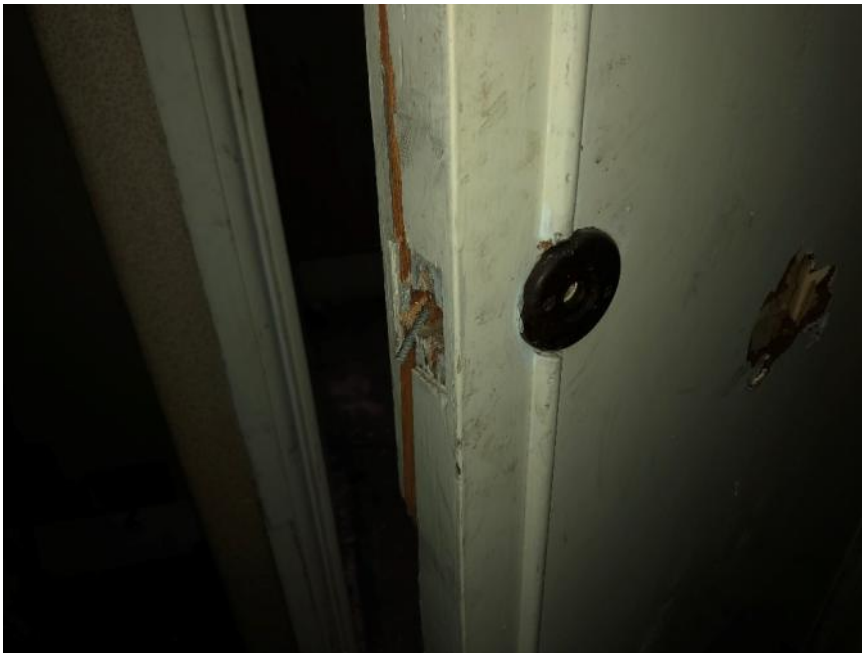
The Bedroom 1 entrance door appears to have been forced open and as a result has suffered damage to the leading edge, as per the image below:

Split/damaged timber to leading edge of Bedroom 1 entrance door

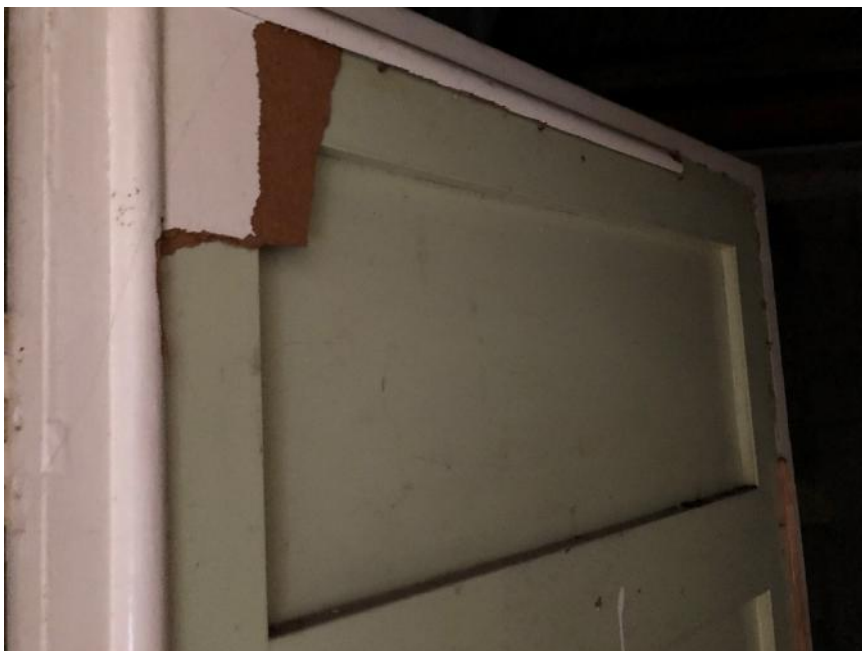
The plywood boarding to the external face of the Bedroom 2 entrance door has for the most part been removed, exposing the timber panelled surfaces beneath, as per the image below:

Damaged plywood overboarding to Bedroom 2 Entrance door

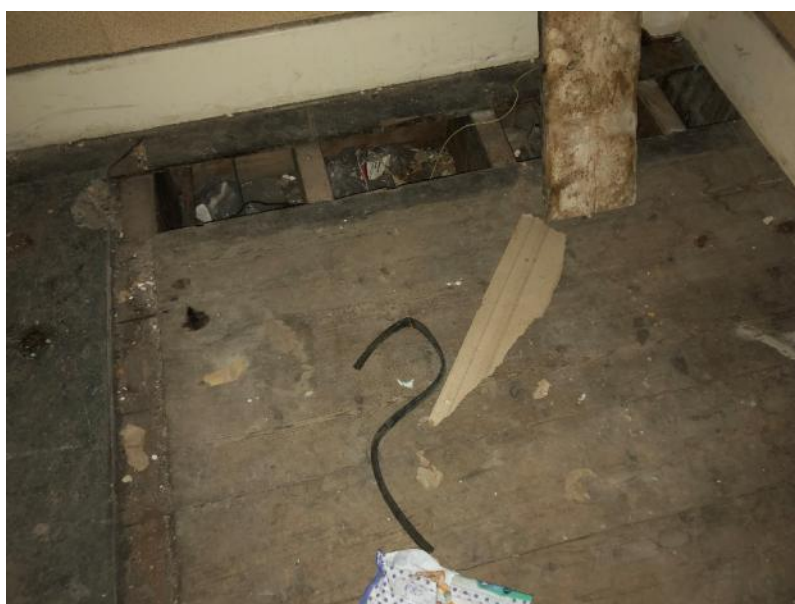
The exposed timber floor surfaces appear to be in fair condition with no visible defects, although 1 no. floor board to the western aspect of the room has been removed, as per the image below:

1 no. timber floorboard removed

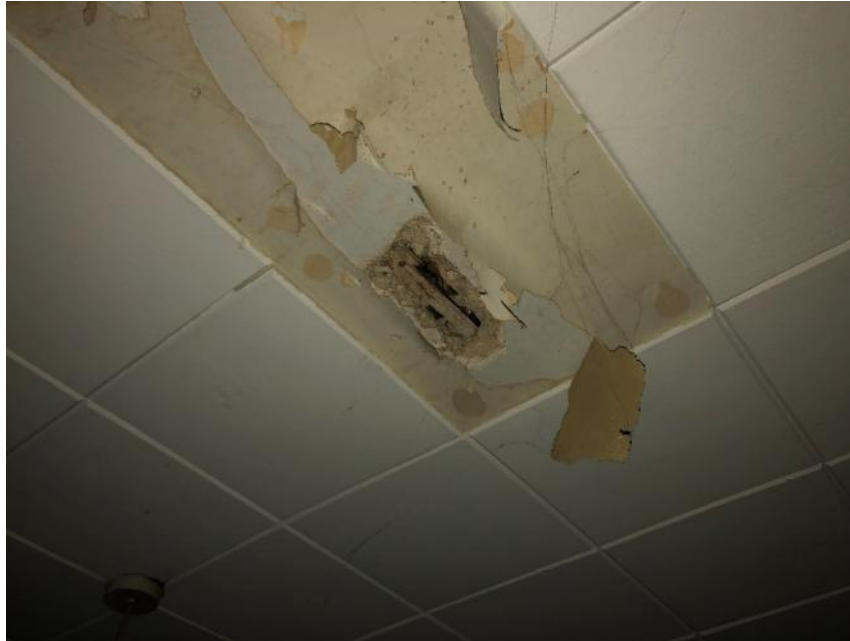
The decorative finishes are generally discoloured throughout. The polystyrene tiles have de-bonded in places, exposing the underlying plaster surfaces. There is 1 no. area of damaged plasterwork to the north-east corner of the room of approximately 0.3 square metres as per the image below:

Damaged plasterwork

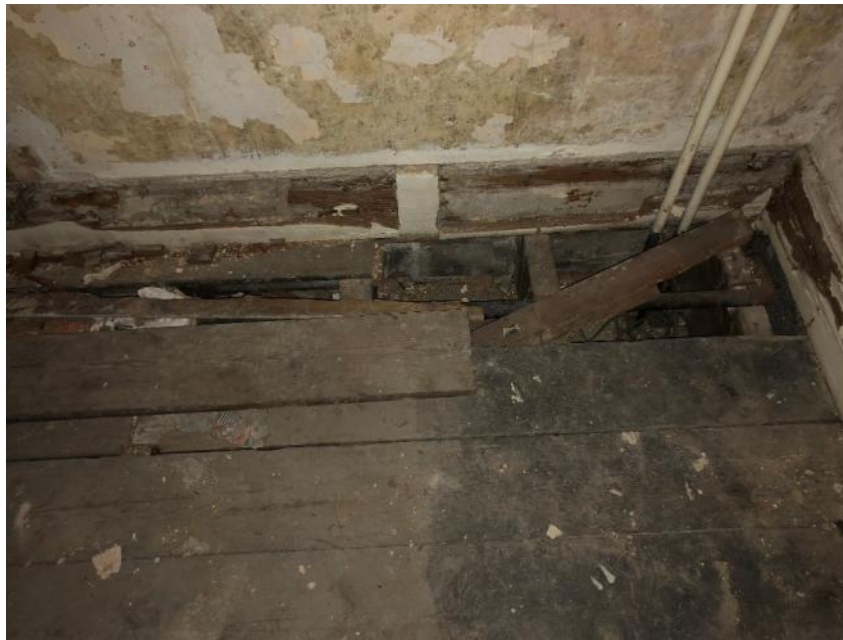
The majority of exposed timber floor surfaces appear to be in fair condition with no visible defects. However, a series of damaged floorboards to the north-west corner of the room have been removed, exposing the underlying floor structure, as per the image below:

1 no. lifted timber floor board

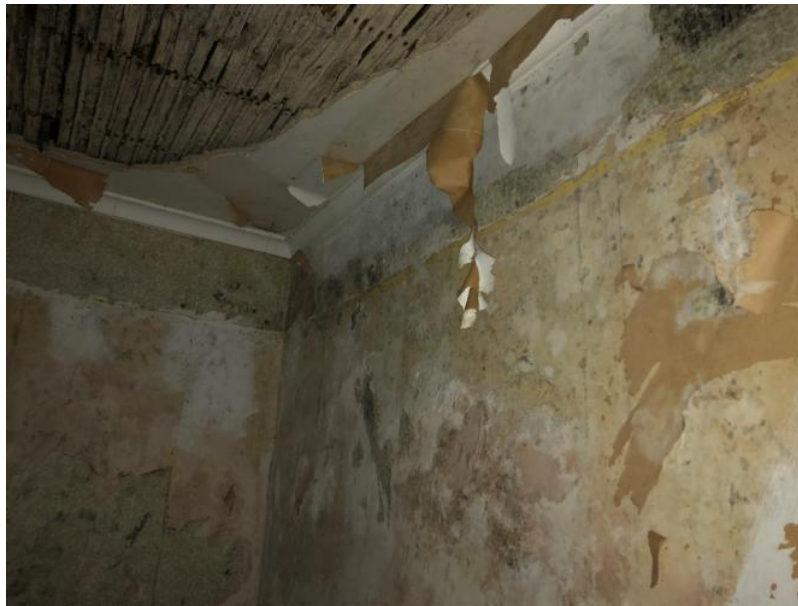
Damp affected and damaged plaster surfaces

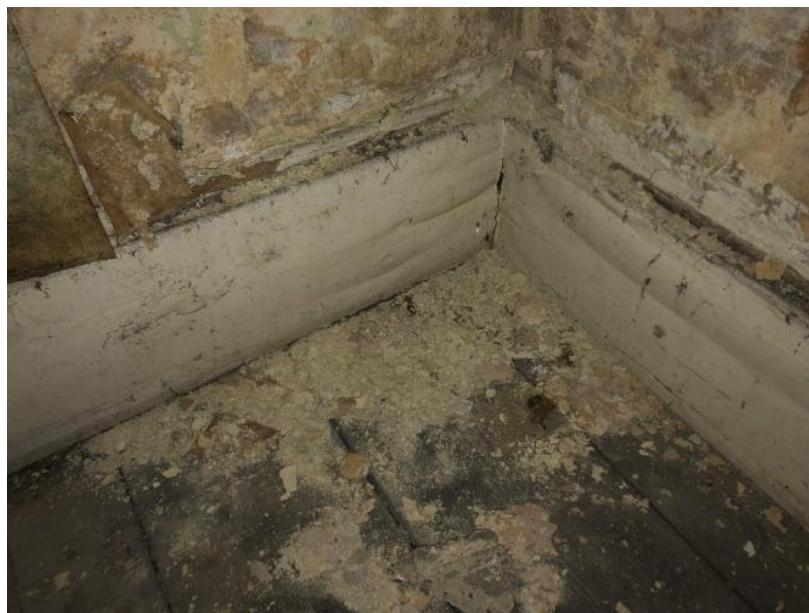
Damp affected plaster surfaces

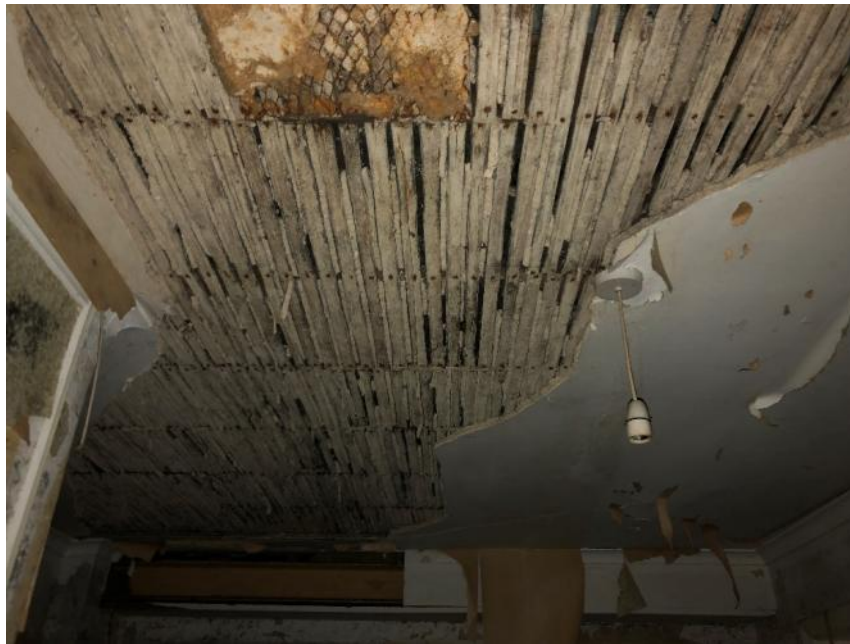
Collapsed area of bedroom ceiling

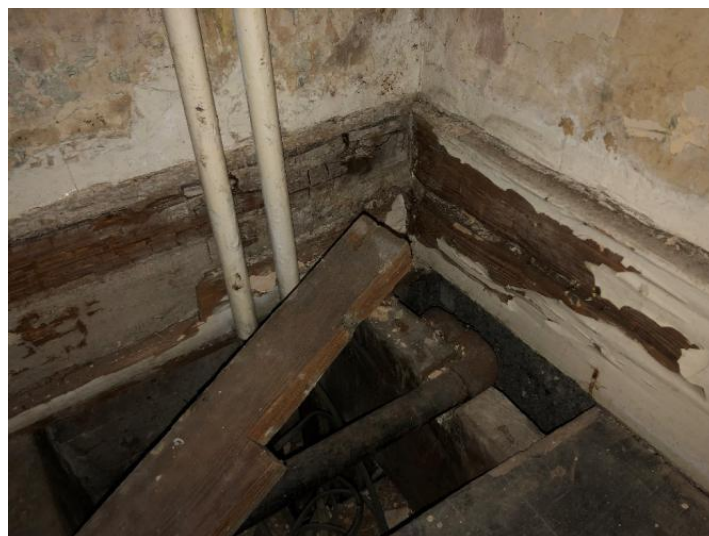
View of decayed skirting boards

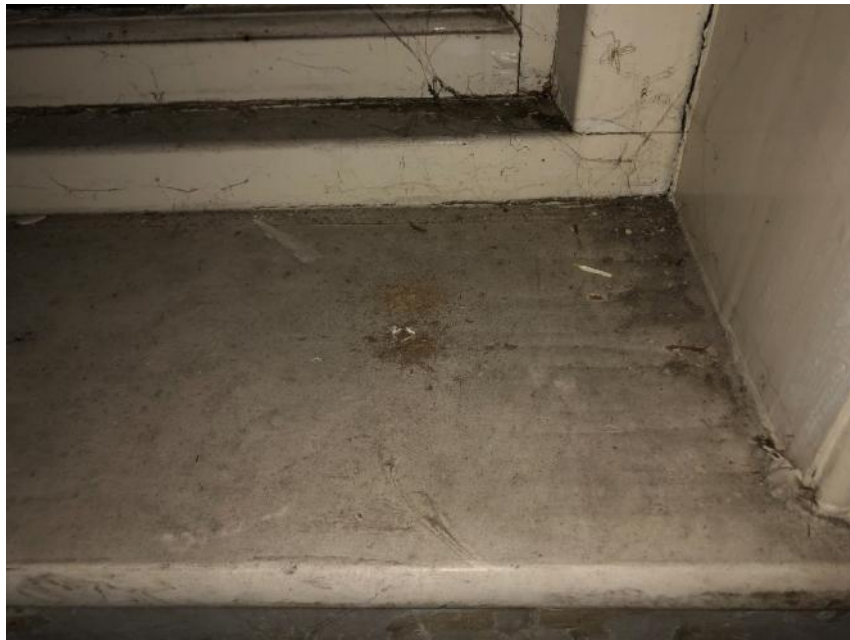
View of damaged timber window board
