Appendix AF-1

Photographs of unauthorised works to the Building, 101 Brecknock
Road. Photographs taken in February and August 2019

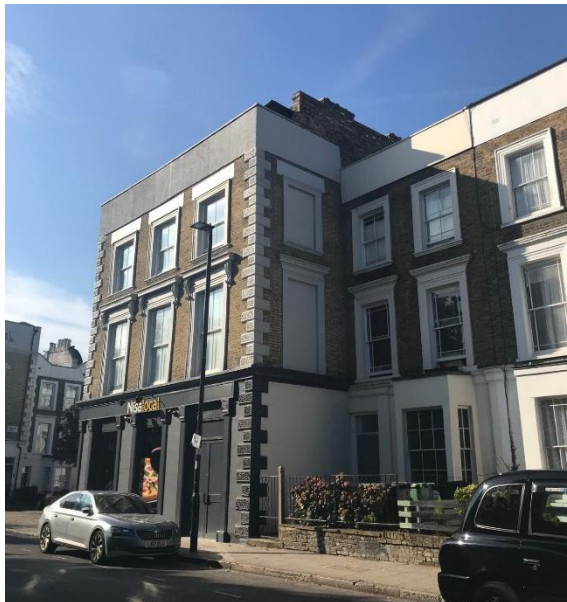
Image 4. The Building. Photograph showing the prominence of the building adjacent contemporary terrace houses.

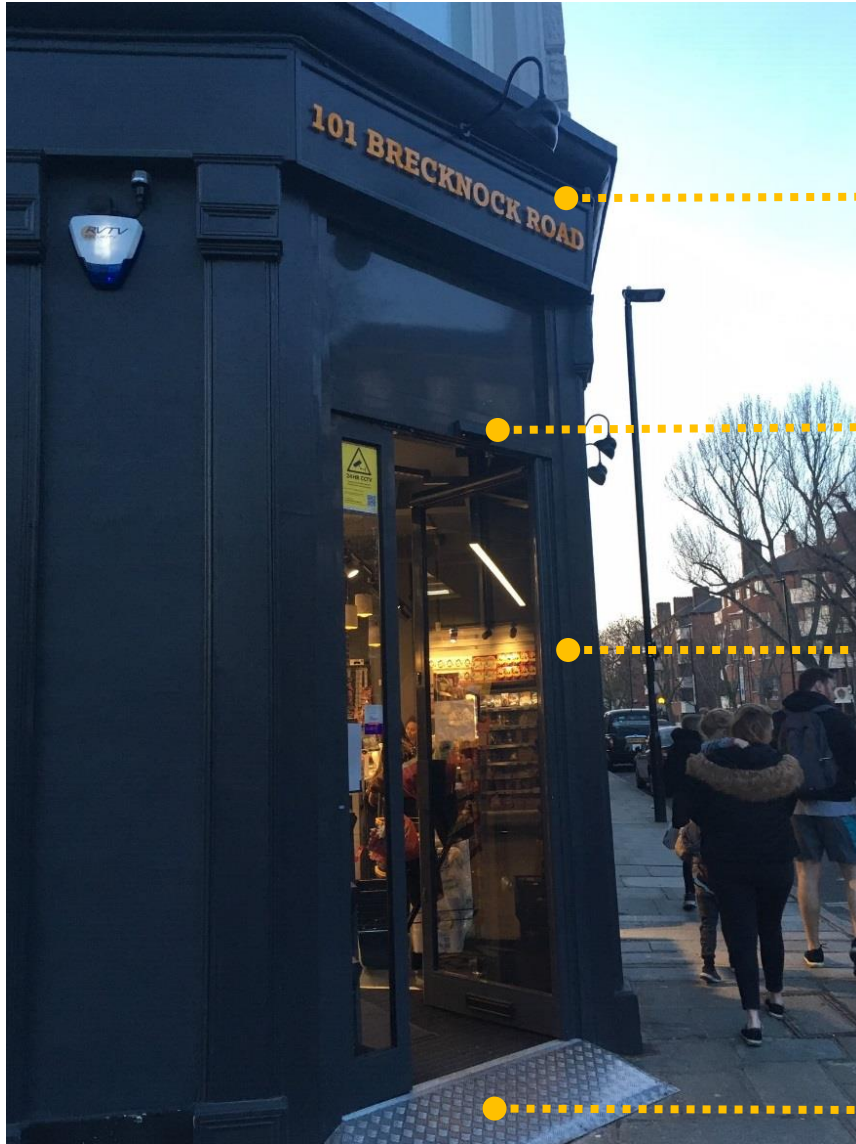
Image 5. Splayed Corner Elevation

Lettering Modern typeface; shiny material.

Door sensor Sensor above the door.

Door Uncharacteristic modern door; recess has been removed. The internal lobby and associated internal doors have been removed.

Step Traditional stone step has been removed.

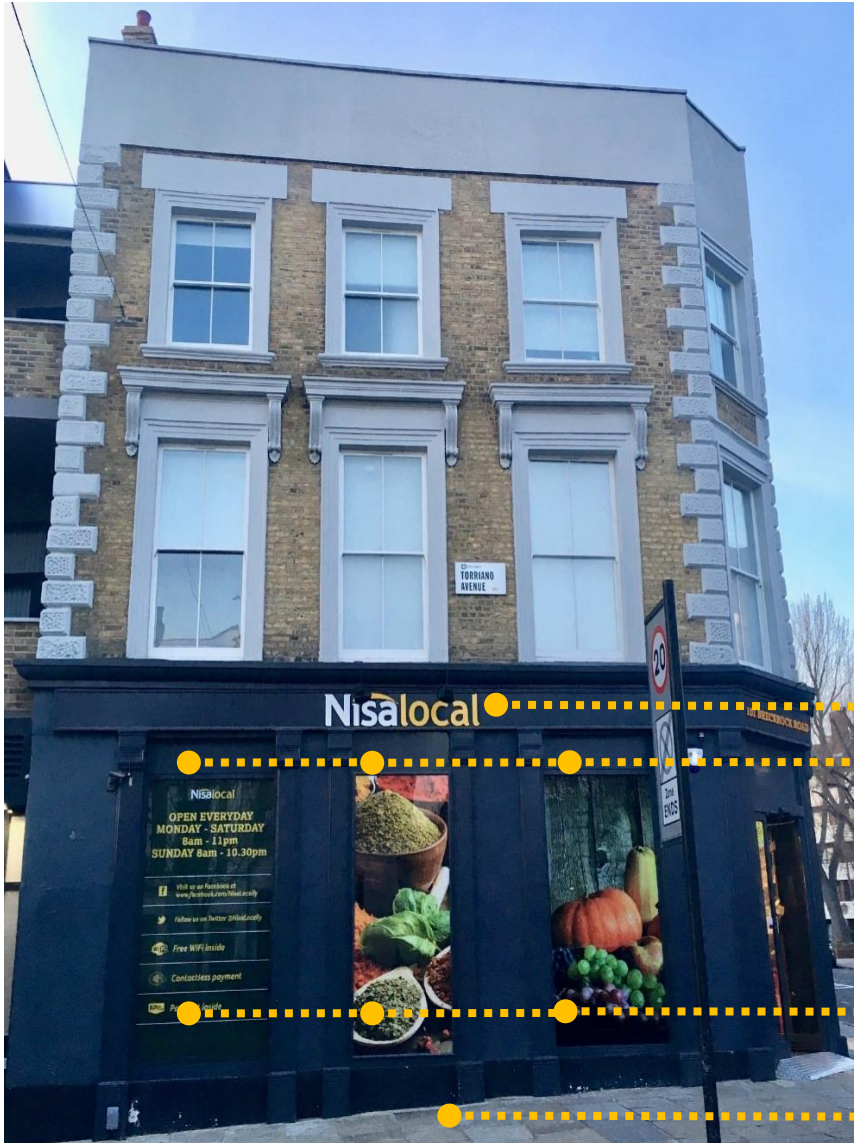
Image 6. Torriano Avenue Elevation

Lettering Modern typeface, shiny material.

Panels have been inserted above openings.

Vinyl graphics applied to the window glass.

Traditional **step** removed.

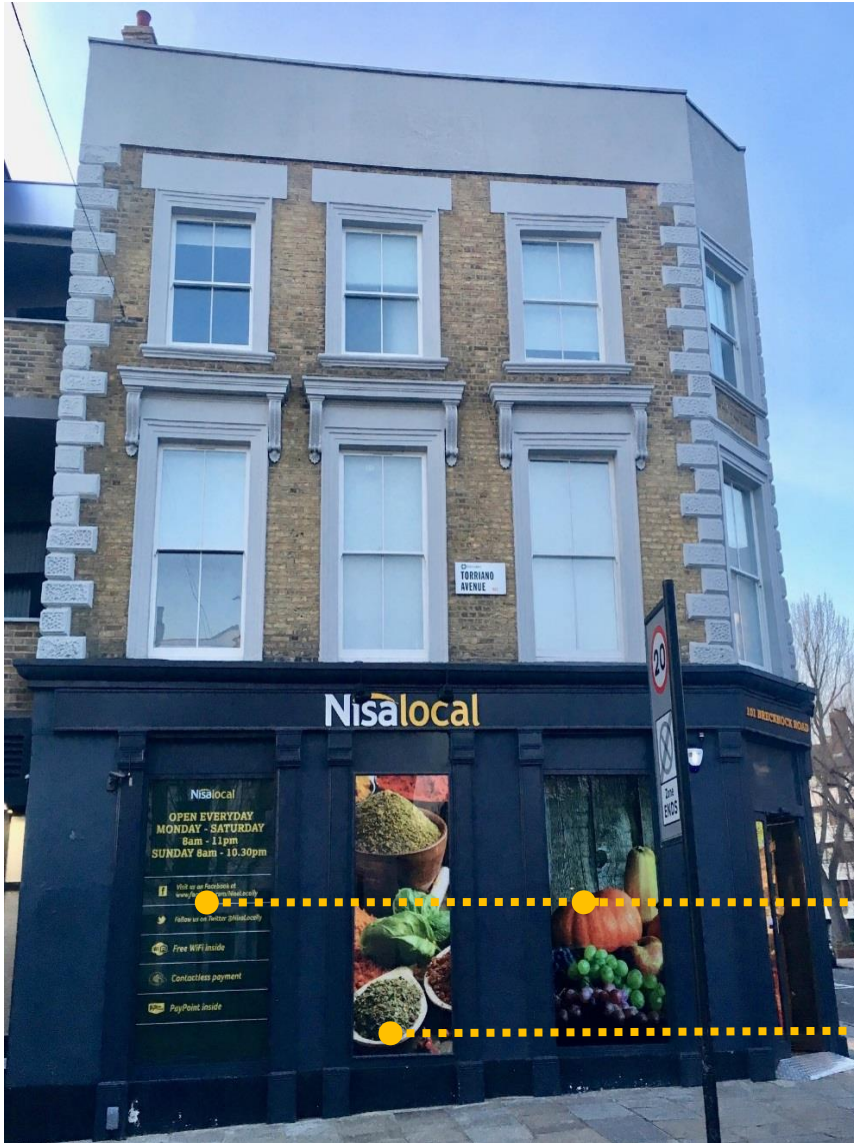
Image 7. Torriano Avenue Elevation

Window openings have been enlarged; **stall risers** and **ledges** removed.

Loss of **door, fanlight**; door opening, **step** and **recess**.

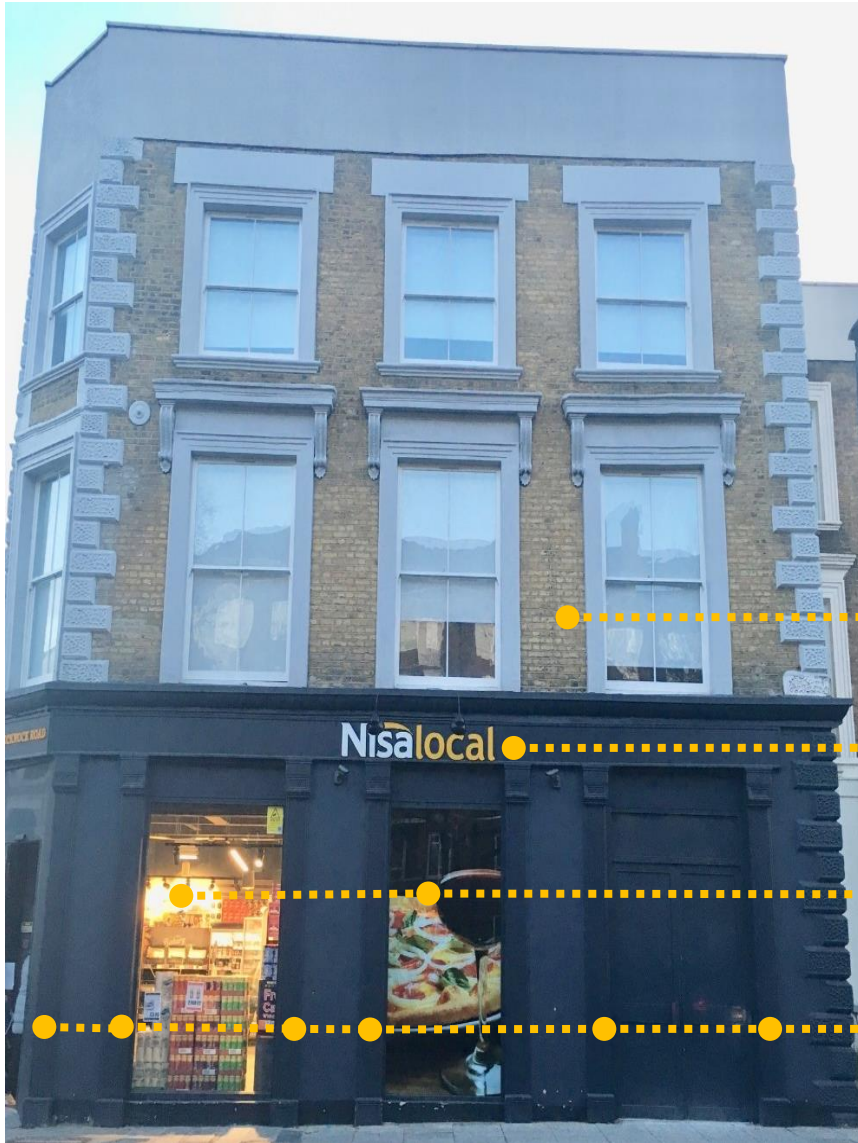
Image 8. Brecknock Road Elevation

Traditional **Hanging sign** has been removed.

Lettering Modern typeface, shiny material.

Window openings lowered; **stall risers** and **ledges** removed.

Re-arrangement of **pilasters**, plus an additional pilaster.

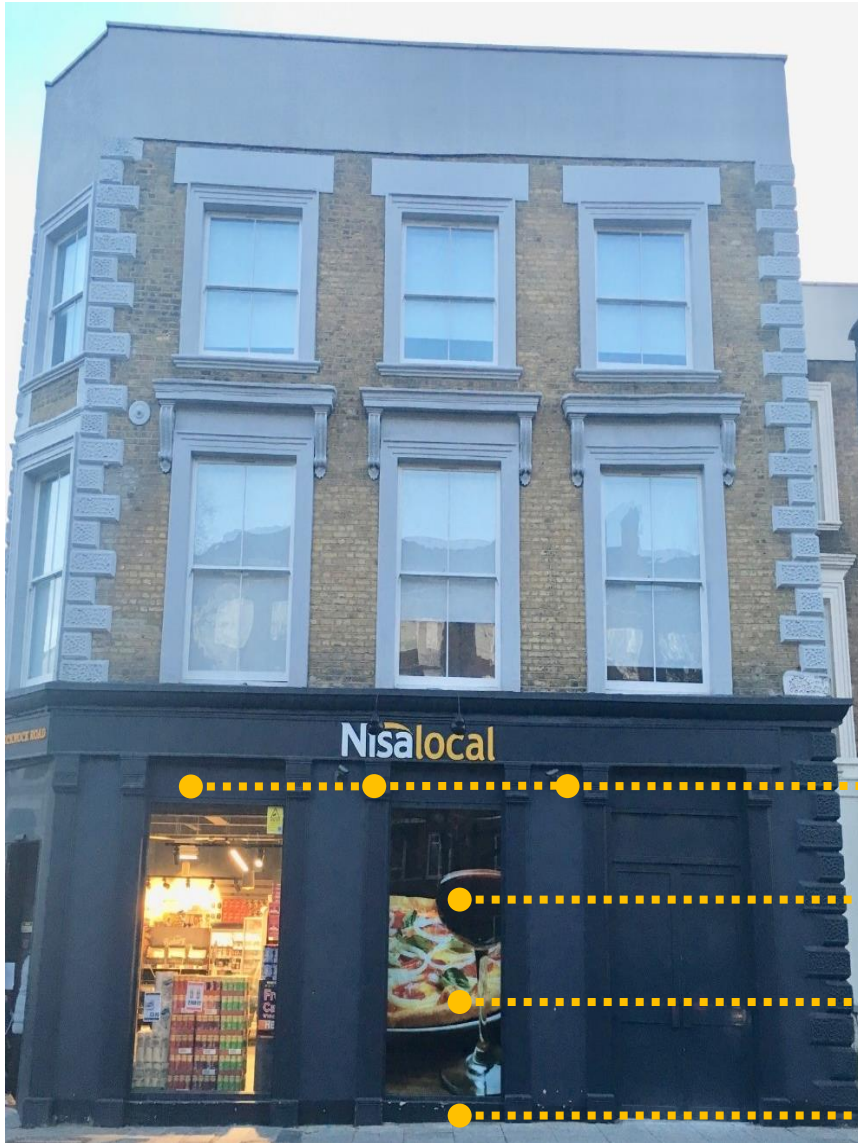
Image 9. Brecknock Road Elevation

Panels have been inserted above openings.

Vinyl graphics applied to the window glass.

Door, fanlight and **recess** removed.

Traditional **step** removed.

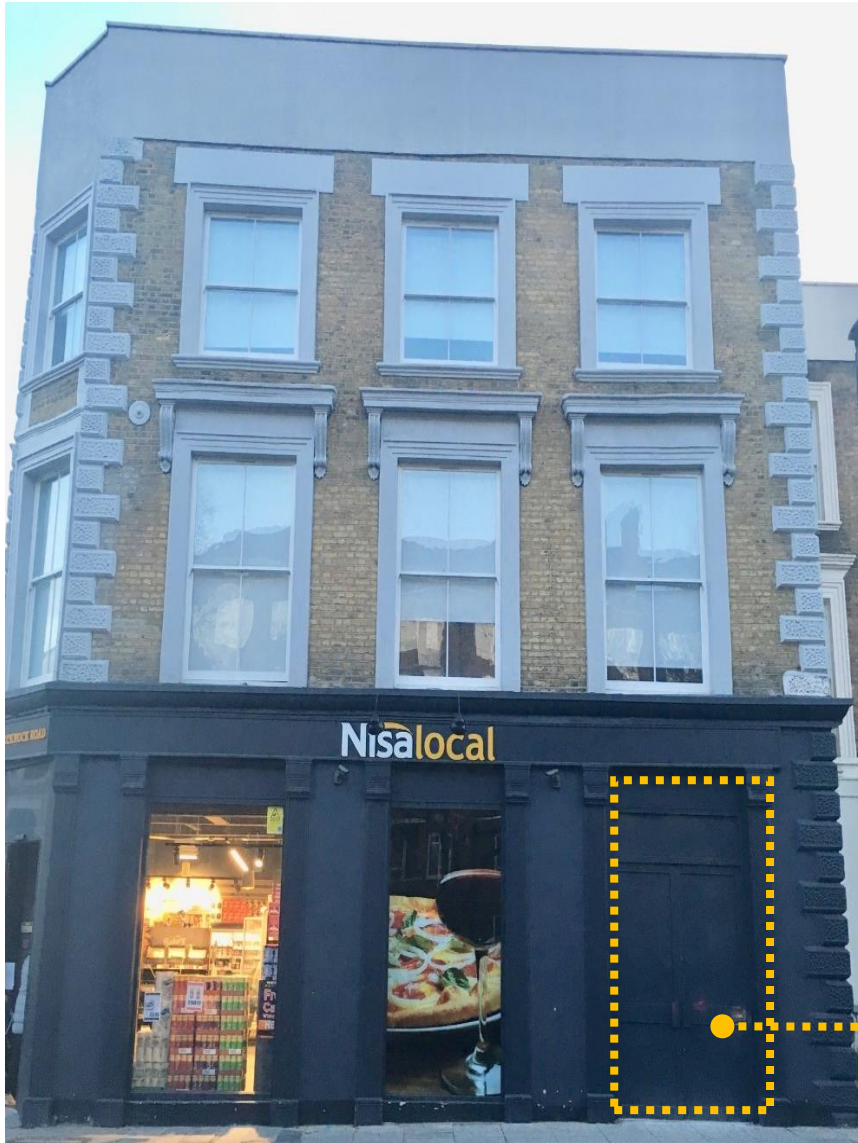
Image 10. Brecknock Road Elevation

Double doors - These doors are unsympathetic, and out of keeping with the traditional character.
