143 Abbey Road, London, NW6 4SL

Structural Inspection Report

Job Number: 27944

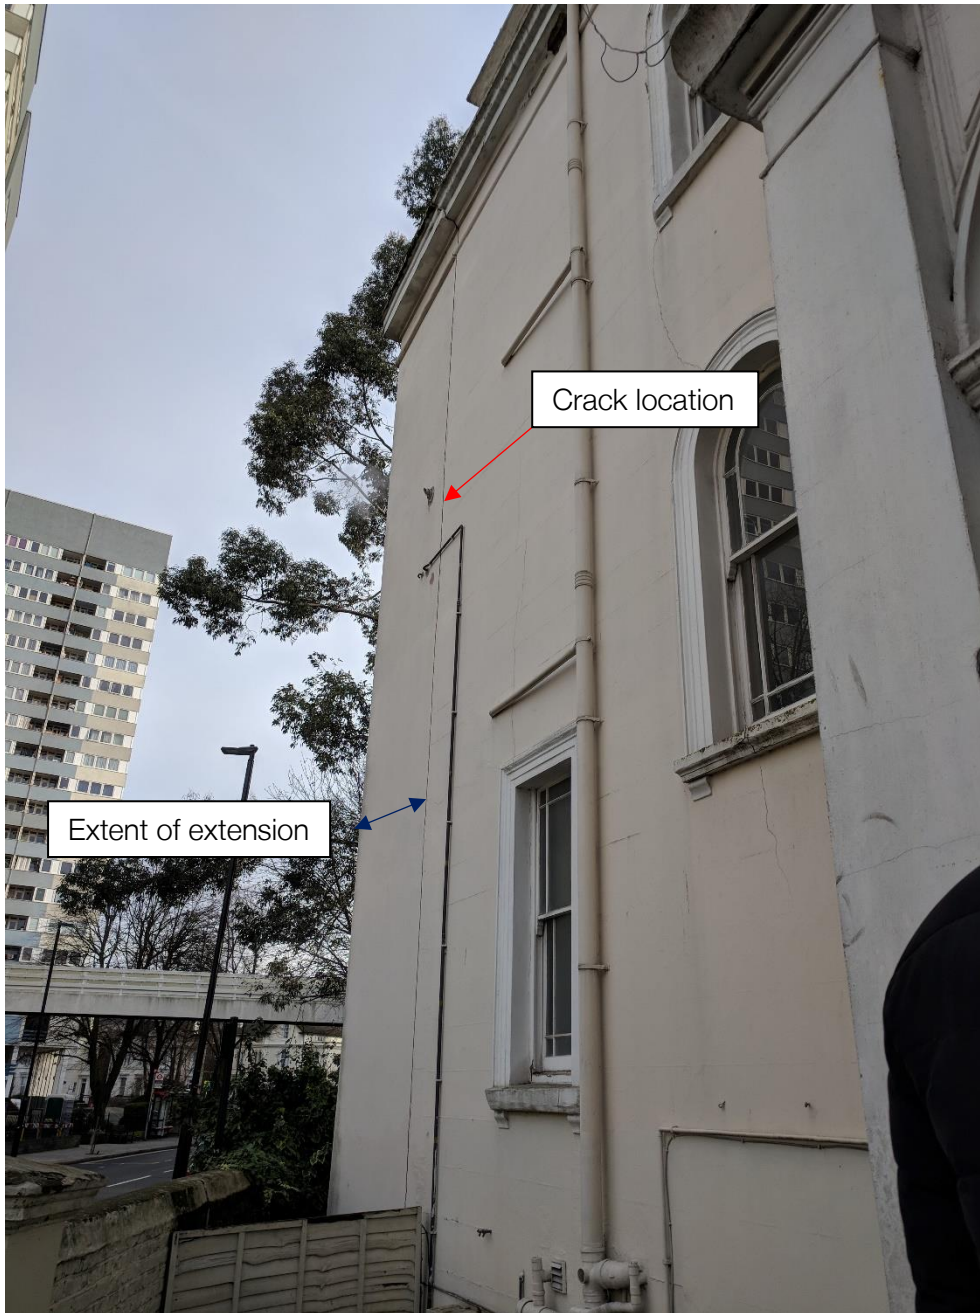
- The junction between the original house and the rear extension on the wall facing the main road. Cracking can be seen both externally and internally. Externally, the crack runs up the entire height of the building from lower ground floor to roof (see Photographs 1&2). Internally, at lower ground floor, the crack is present in the corner of the kitchen and tracks away from the junction of the cross wall at approximately mid-height. The crack then penetrates the coving and tracks along junction with the wall and ceiling (see Photograph 3). Internally, at ground floor, the crack is also present in the corner of the kitchen and tracks across the junction with the wall and ceiling. The crack can only be seen at high level, due to built in kitchen units (see Photograph 4).

Photograph 1 - Cracking between original house and extension

Local repairs can be carried out on the cracks, however, if the foundations are not deep enough to overcome the effects of the volume changes in the clay, then movement may continue to occur seasonally. It is noted that whilst the cracks are unsightly, the cracking is not currently considered structurally significant.

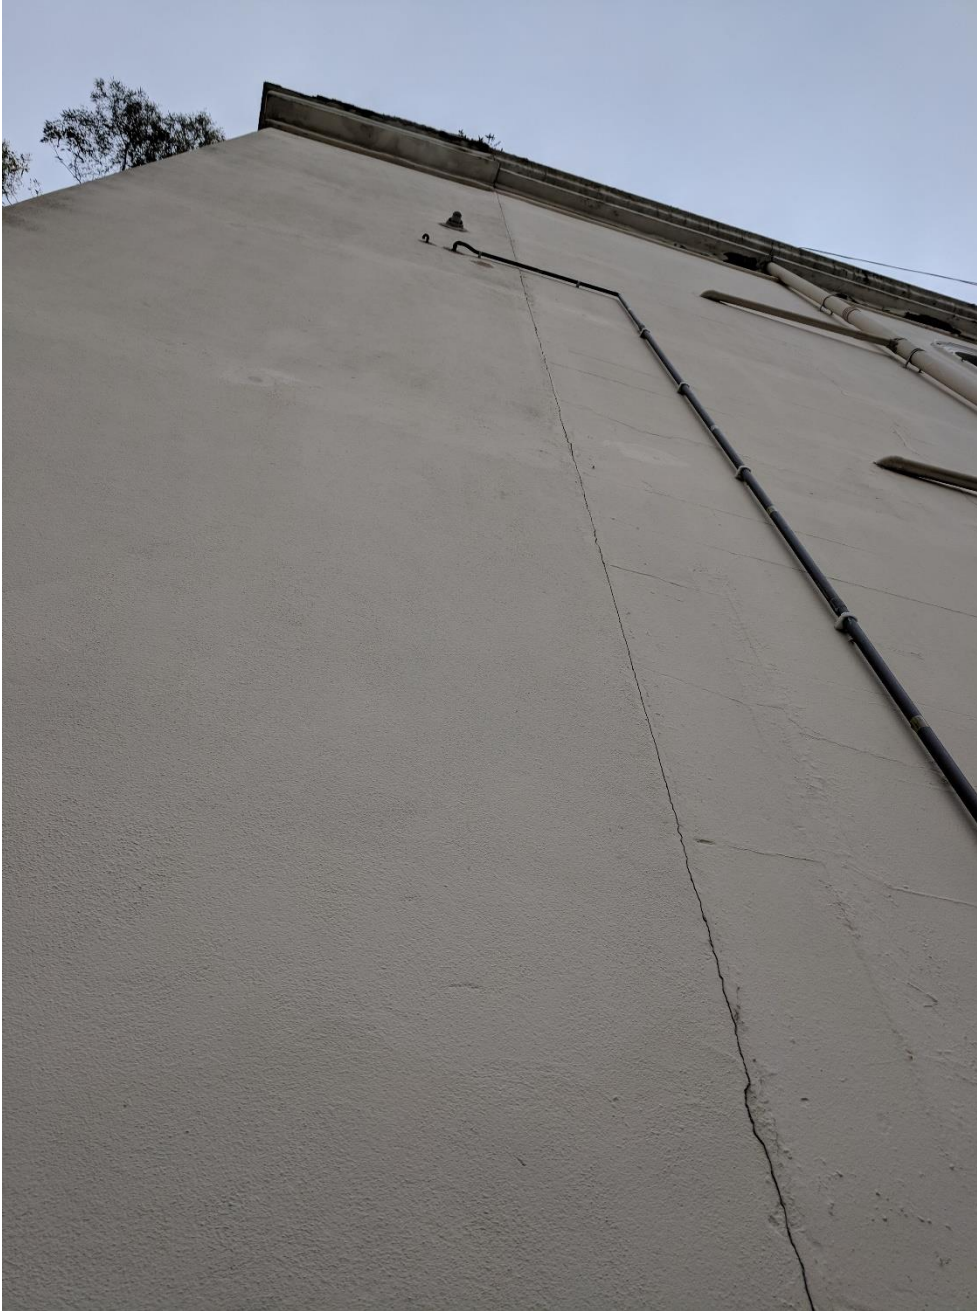
Photograph 2 - Cracking between original house and extension

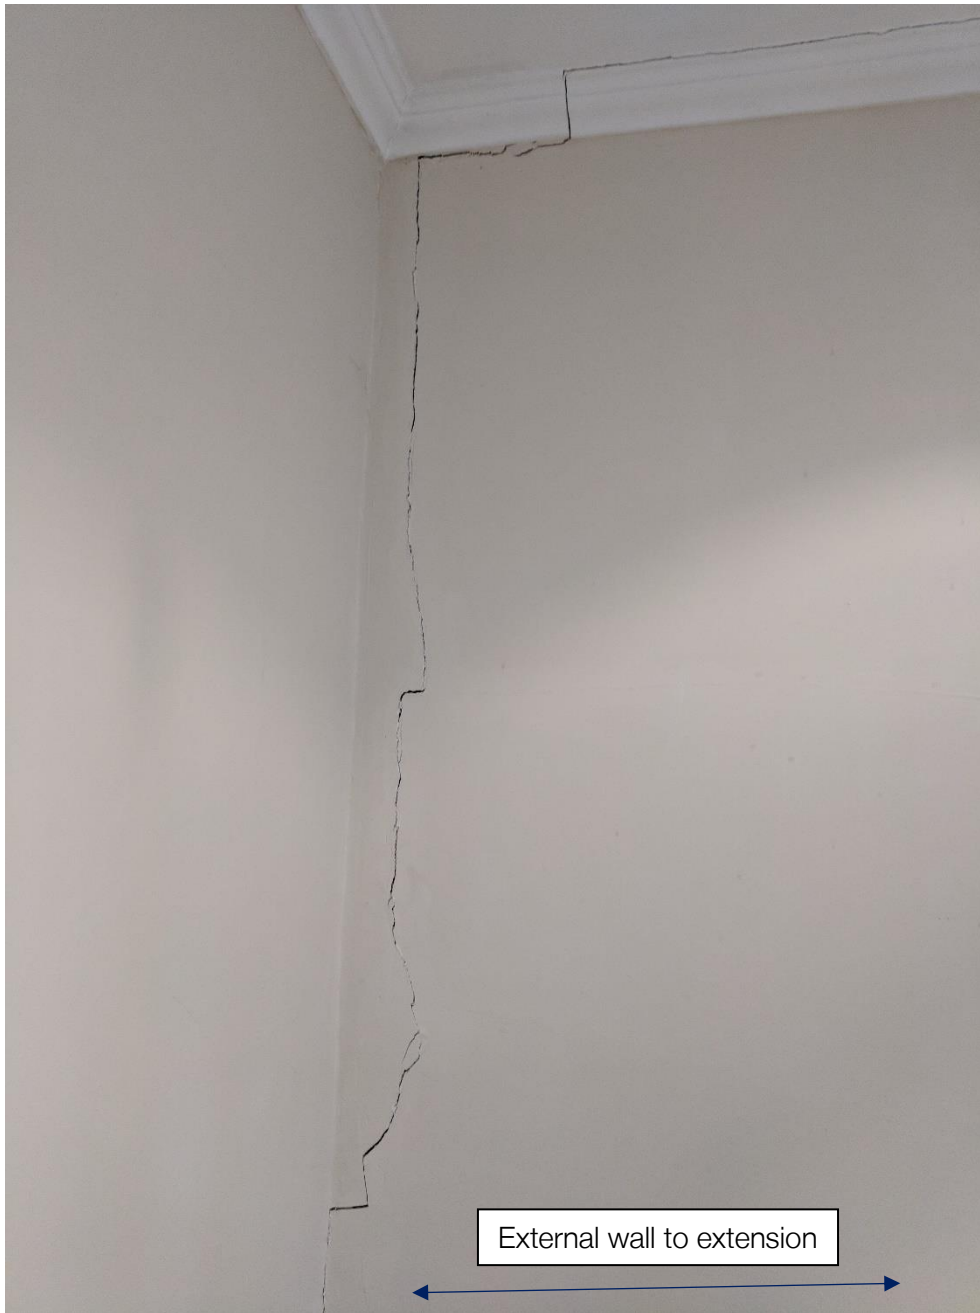
Photograph 3 - Internal crack at lower ground floor level

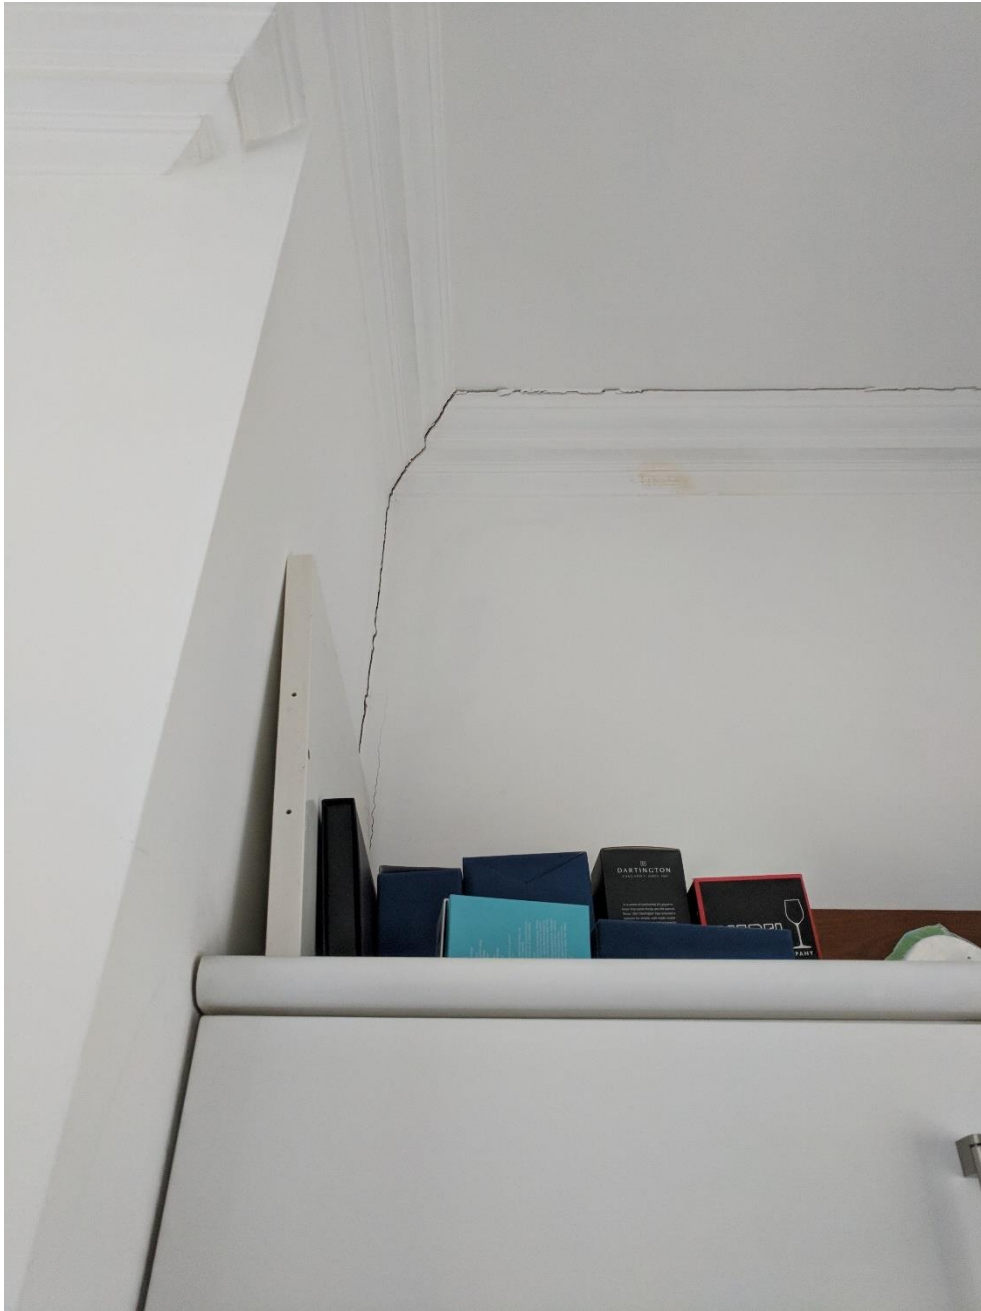
Photograph 4 - Internal crack at ground floor level

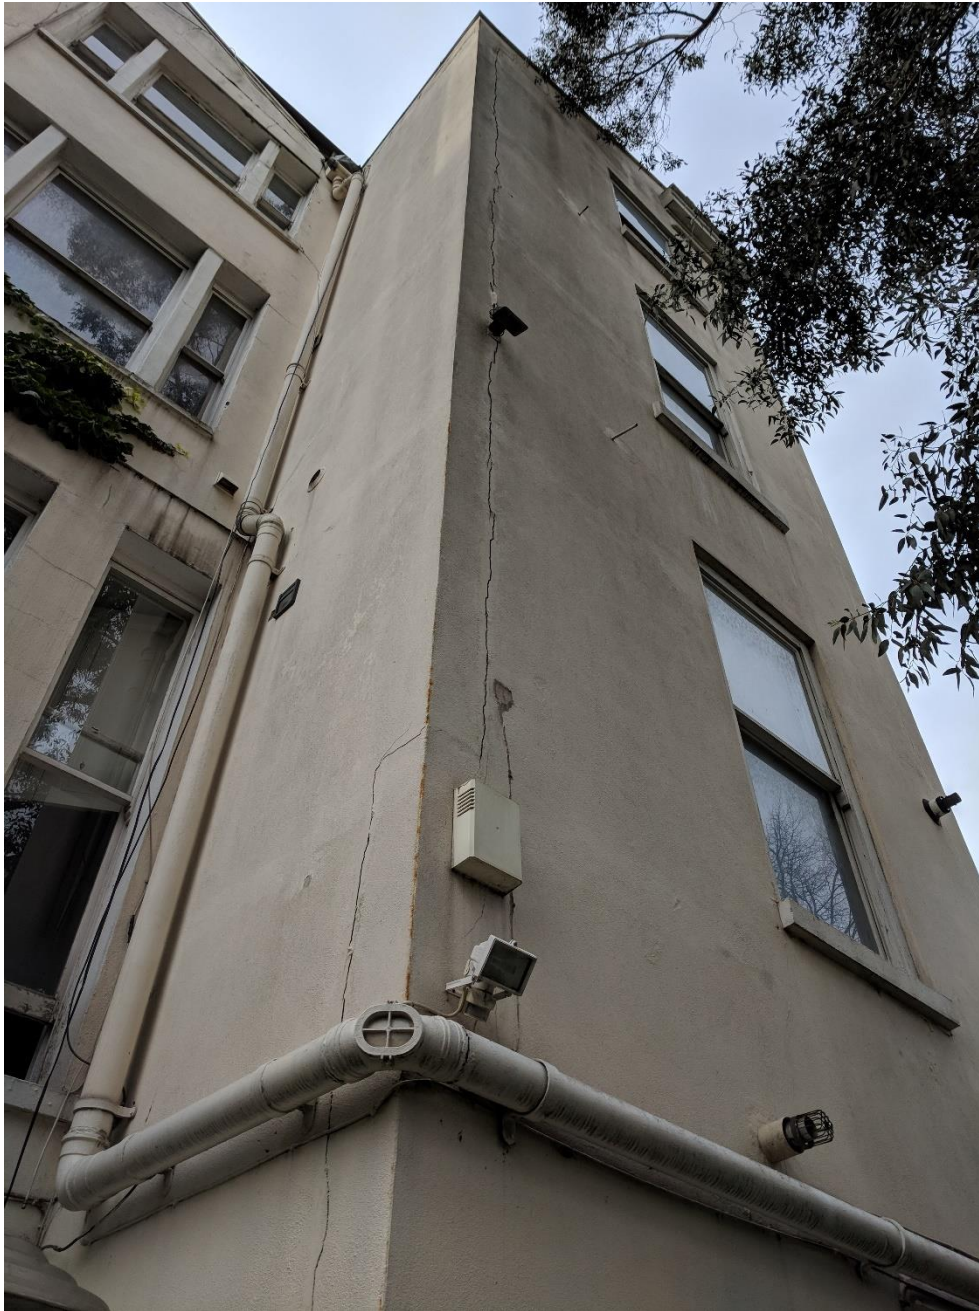
- To the side and rear wall of the extension. Cracking can be seen both externally and internally. Externally, the crack runs from lower ground to just above ground floor level on the side wall and then tracks around the corner and continues up the rear wall to roof level (See Photograph 5). An internal crack can be seen in the kitchen at ground floor level at the junction between the rear and side wall (see Photograph 6). The internal crack tracks along the junction with the ceiling and wall.

A large Eucalyptus tree exists on the boundary of the garden to 143 Abbey Road and the adjacent land. The Eucalyptus tree is approximately 5m from the rear wall to the extension and is approximately 12m tall. The tree canopy spreads towards the top of the tree and is touching the building at roof level (see Photograph 5 - on the right hand side).

The cracking observed is consistent with signs of subsidence and shows that the foundations to the rear extension have settled. As discussed above, this is likely to be caused by the presence of a near by Eucalyptus tree and the highly shrinkable nature of the underlying soils. In addition, the recent dry, hot summer of 2018 will have meant the tree was drawing more water from the soils, thus causing a higher volume change in the clay.

Photograph 5 - External crack to rear extension

An alternative, longer term solution would be to mass concrete underpin all the existing foundation to an appropriate depth (approximately 2.7m, subject to a more detailed review) within the trees zone of influence. However, this is likely to prove less feasible in terms of cost and disruption.

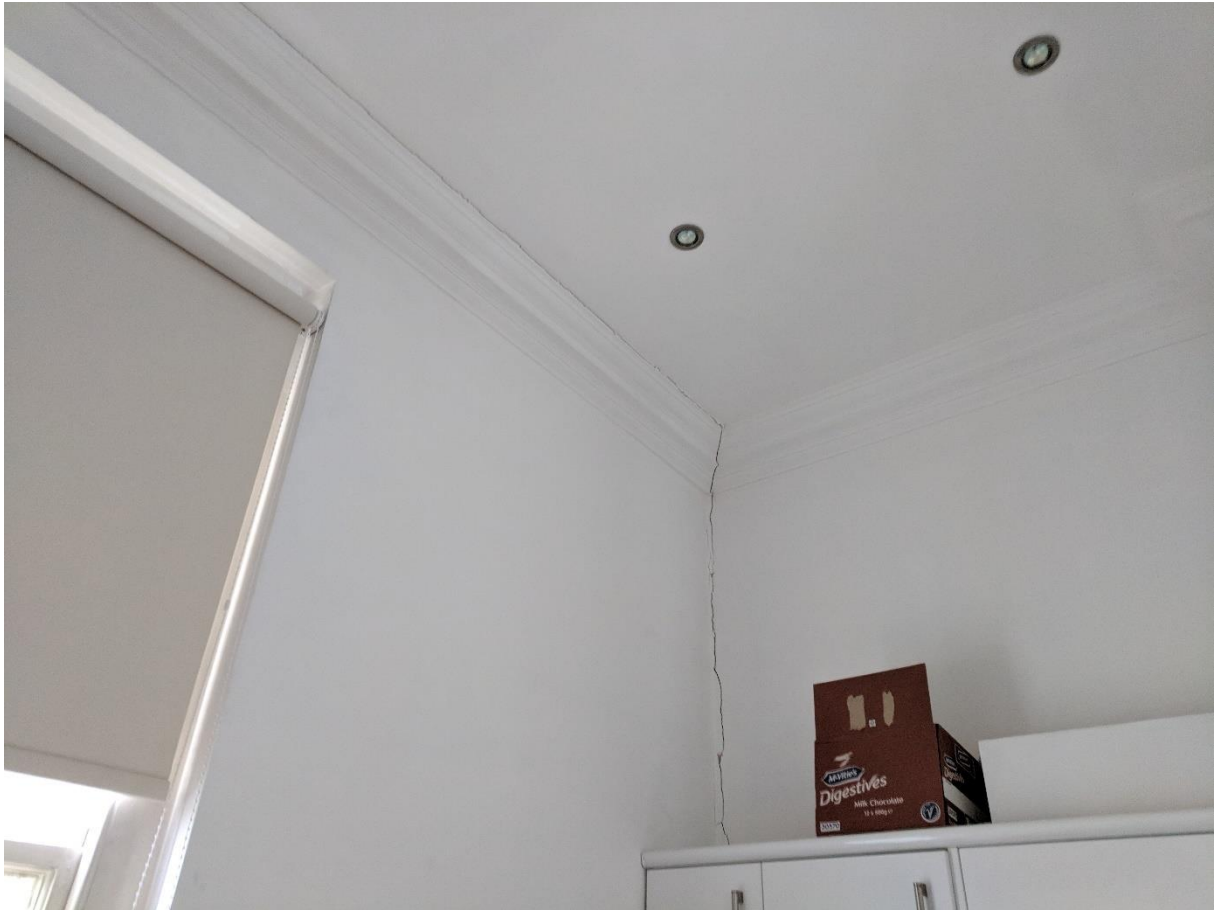
Photograph 6 - Internal crack at ground floor level on junction of rear and side wall
