THE DIOCESE OF LONDON

ST PETERS VICARAGE, 53 BELZISE SQUARE,
LONDON, NW3 4HY

FULL CONSTRUCTION MANAGEMENT PLAN

Asbestos Demolition Survey (with MA only)

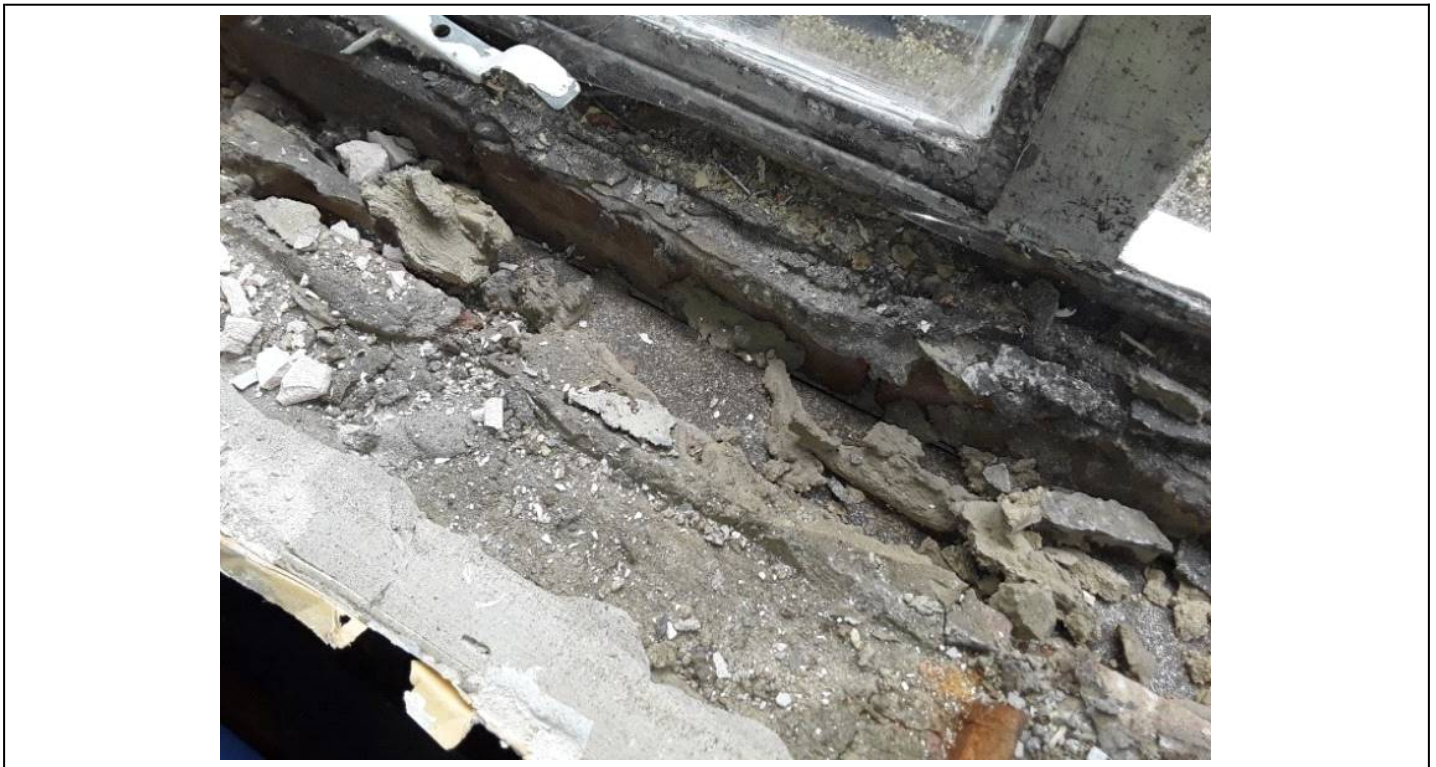
MATERIAL ASSESSMENT (MA)		ACCESSIBILITY	
Product Type:	1	Difficult	
Damage:	1		
Treatment:	0		
Asbestos Type:	1		
MA Score:	3

Total Assessment:	3	Very Low	
Sample notes:	N/A		
Comments:	No comments		
Recommendation:	Remove under Controlled Conditions	Timescale	12 Months

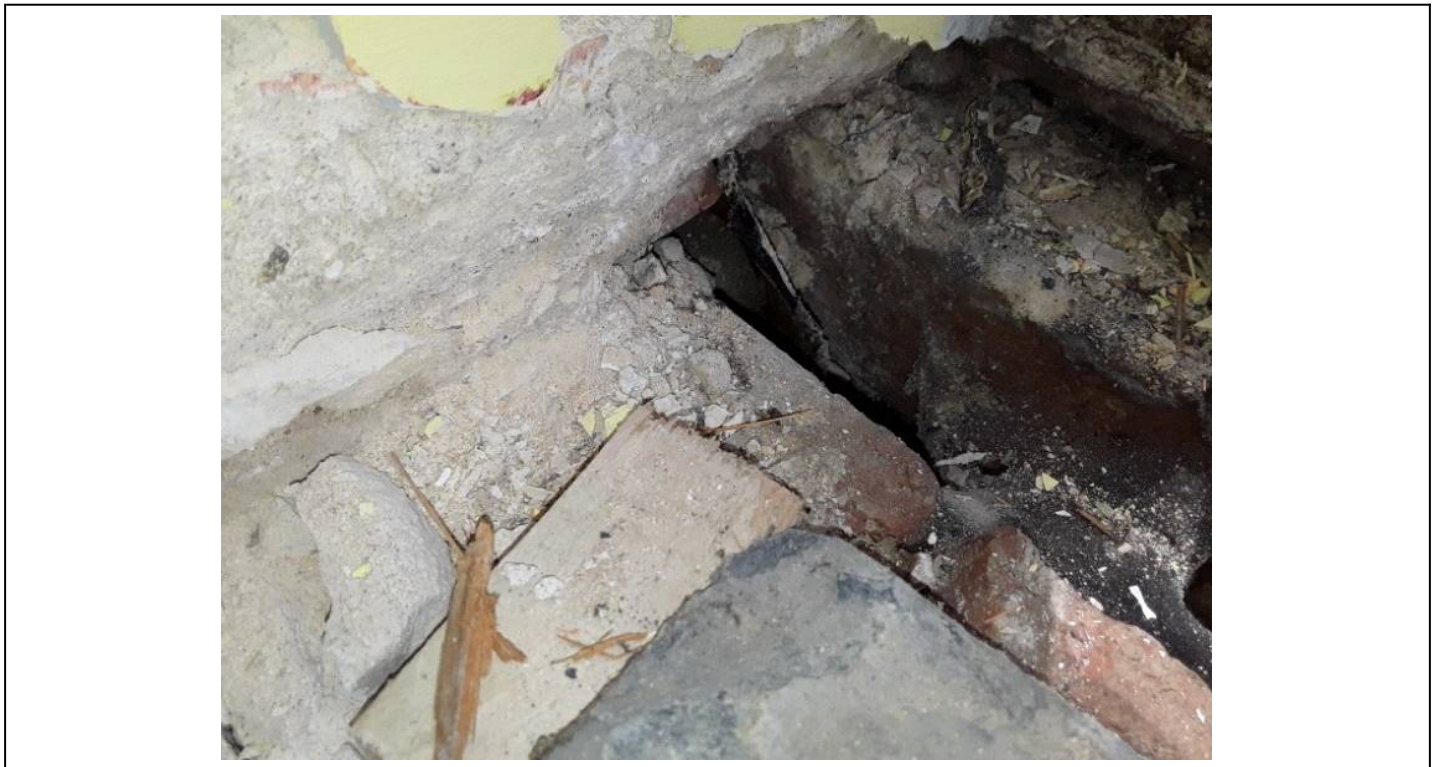
MATERIAL ASSESSMENT (MA)		ACCESSIBILITY	
Product Type:	1	Difficult	
Damage:	1		
Treatment:	0		
Asbestos Type:	1		
MA Score:	3

Total Assessment:	3	Very Low	
Sample notes:	N/A		
Comments:	No comments		
Recommendation:	Remove under Controlled Conditions	Timescale	12 Months

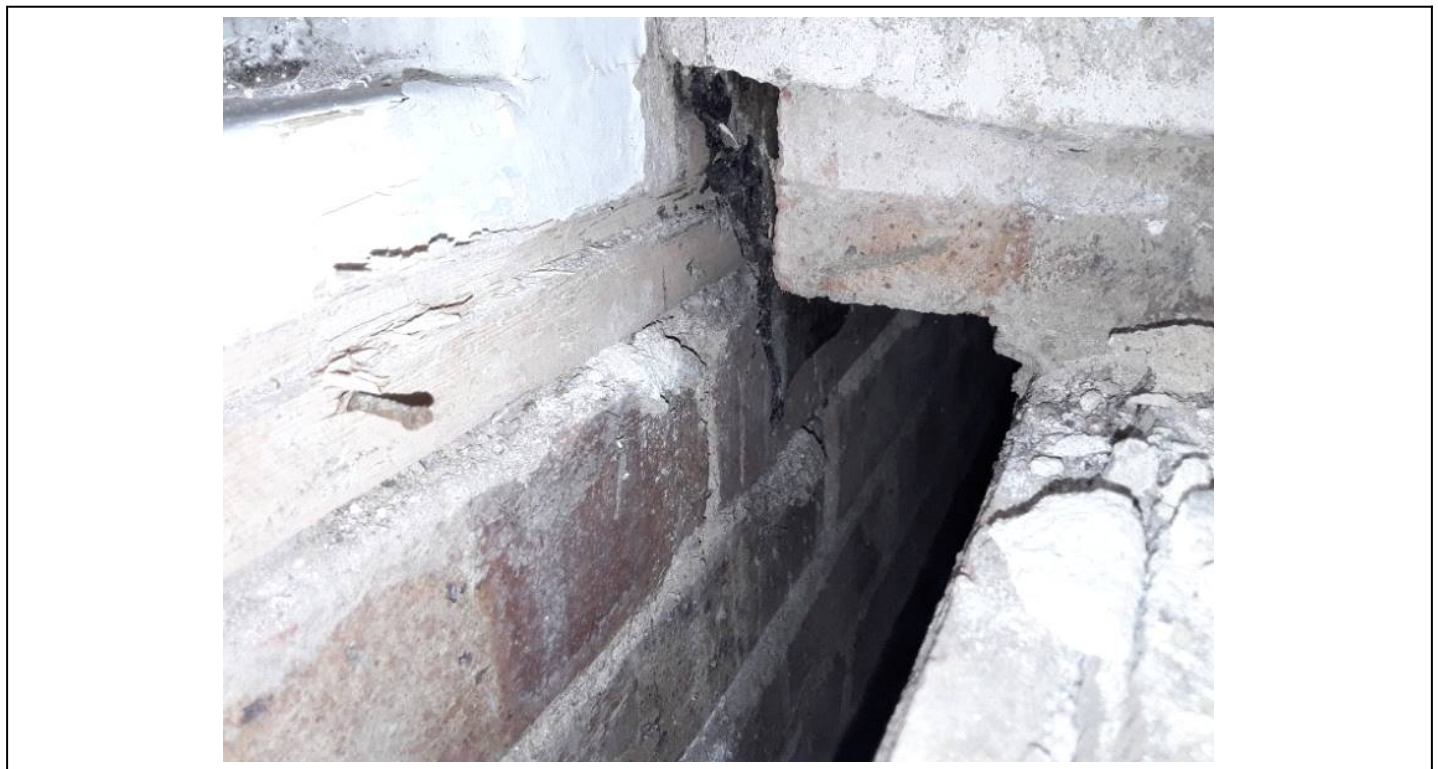
MATERIAL ASSESSMENT (MA)		ACCESSIBILITY	
Product Type:	1	Difficult	
Damage:	1		
Treatment:	0		
Asbestos Type:	1		
MA Score:	3

Total Assessment:	3	Very Low	
Sample notes:	N/A		
Comments:	No comments		
Recommendation:	Remove under Controlled Conditions	Timescale	12 Months

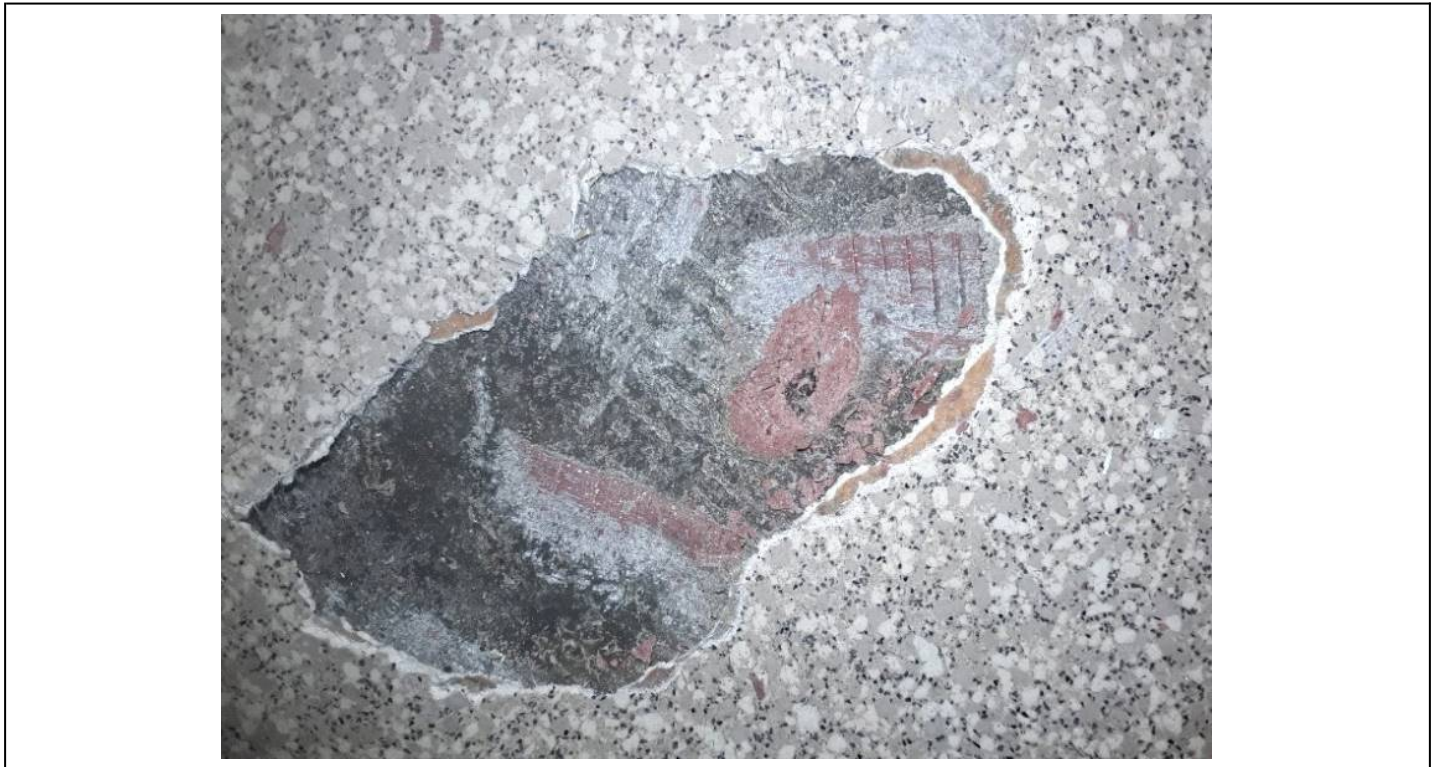
MATERIAL ASSESSMENT (MA)		ACCESSIBILITY	
Product Type:	1	Easy	
Damage:	1		
Treatment:	0		
Asbestos Type:	1		
MA Score:	3

Total Assessment:	3	Low	
Sample notes:	N/A		
Comments:	Below the vinyl.		
Recommendation:	Remove under Controlled Conditions	Timescale	12 Months

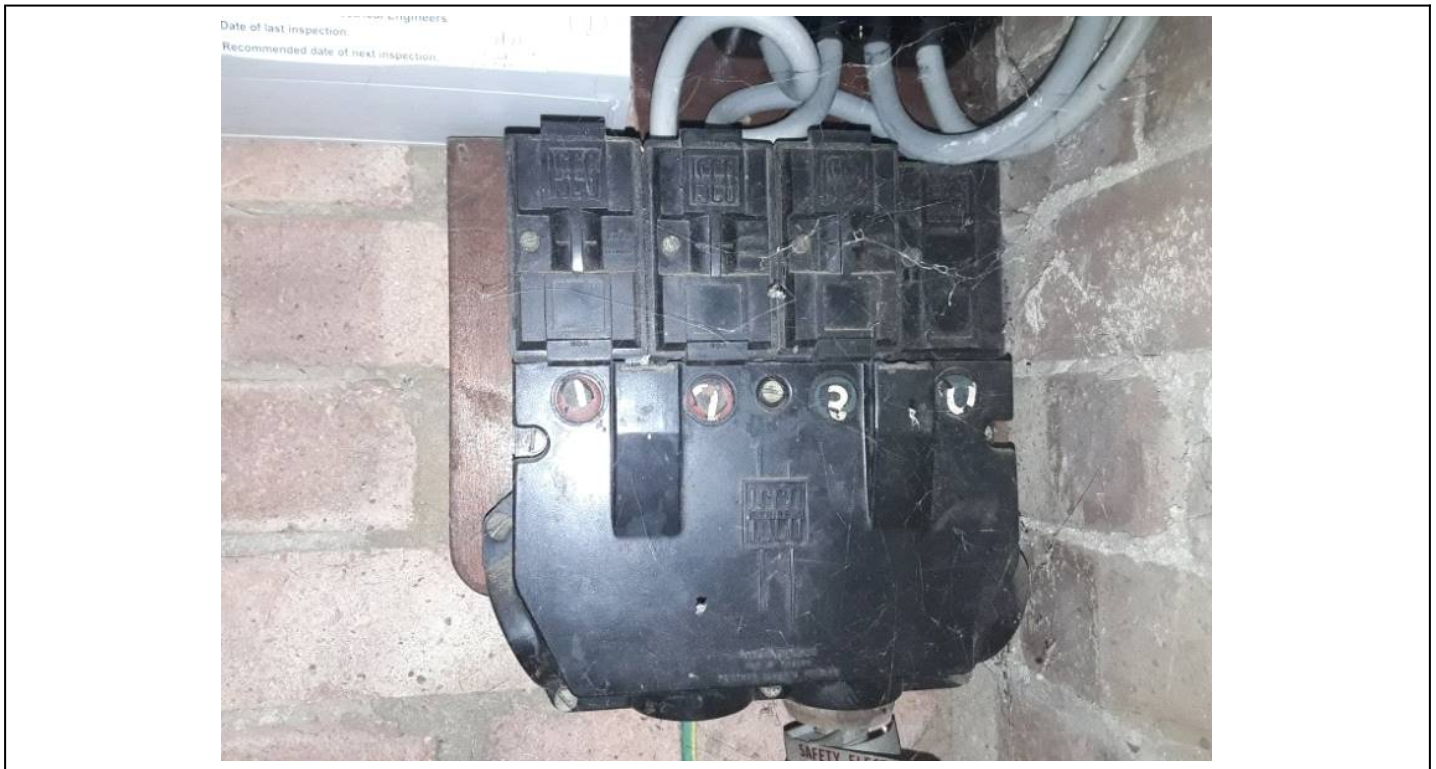
MATERIAL ASSESSMENT (MA)		ACCESSIBILITY
Product Type:	N/A	N/A
Damage:	N/A	
Treatment:	N/A	
Asbestos Type:	N/A	
MA Score:	N/A

Total Assessment:	N/A	N/A
Sample notes:	N/A	
Comments:		
Recommendation:	Inspect prior to Maintenance	Timescale N/A

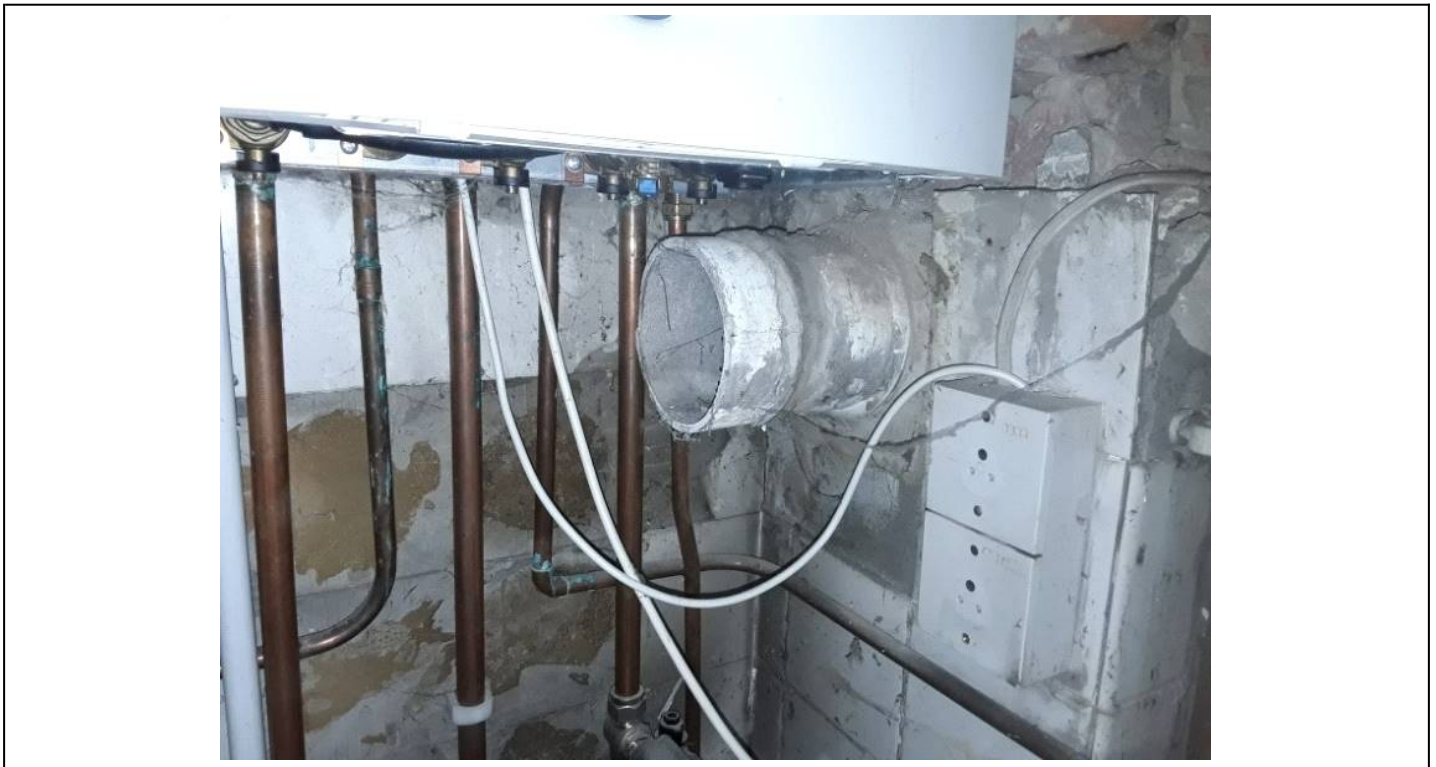
MATERIAL ASSESSMENT (MA)		ACCESSIBILITY	
Product Type:	1	Easy	
Damage:	1		
Treatment:	1		
Asbestos Type:	1		
MA Score:	4

Total Assessment:	4	Low	
Sample notes:	N/A		
Comments:	No comments		
Recommendation:	Remove under Controlled Conditions	Timescale	12 Months

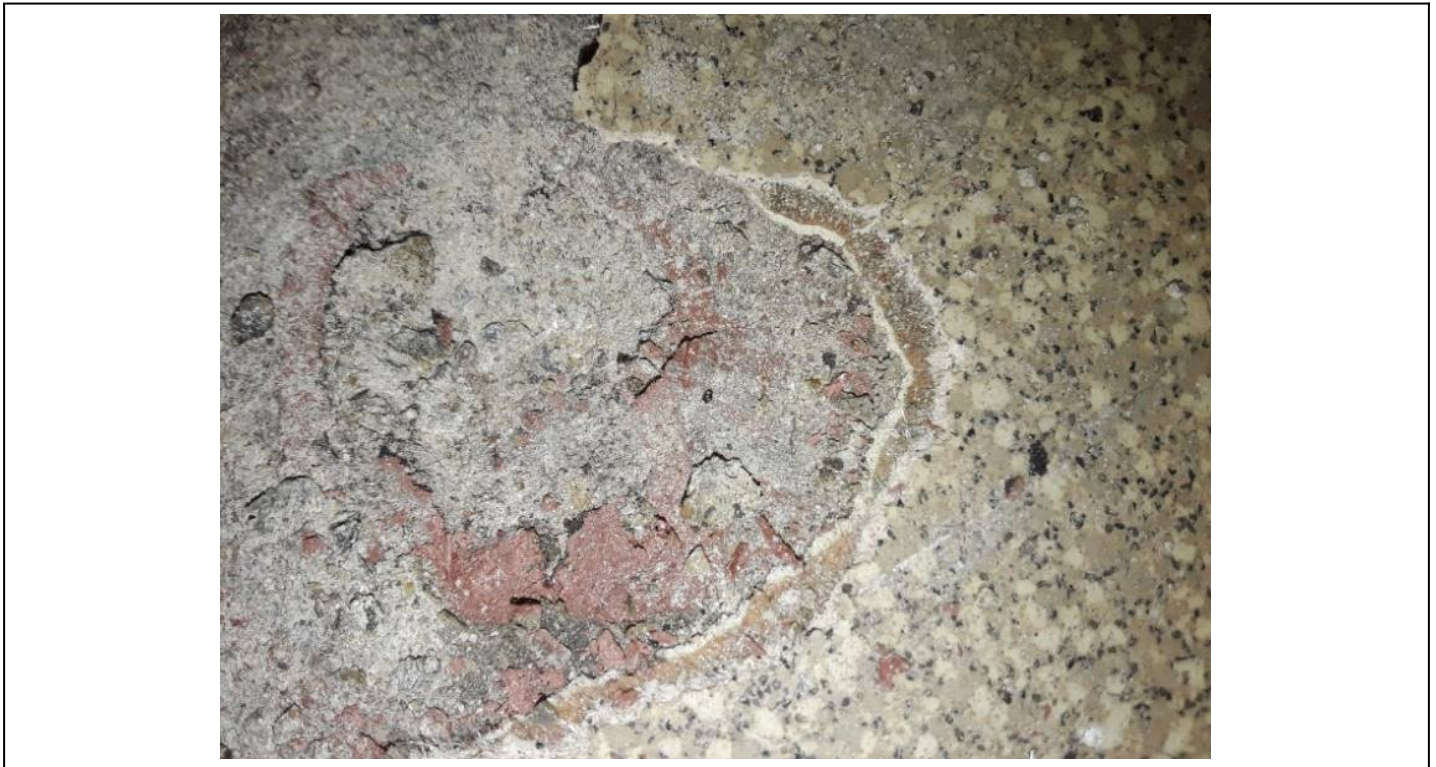
MATERIAL ASSESSMENT (MA)		ACCESSIBILITY	
Product Type:	1	Easy	
Damage:	1		
Treatment:	0		
Asbestos Type:	1		
MA Score:	3

Total Assessment:	3	Low	
Sample notes:	N/A		
Comments:	Asbestos found in both vinyl and bitumen		
Recommendation:	Remove under Controlled Conditions	Timescale	12 Months

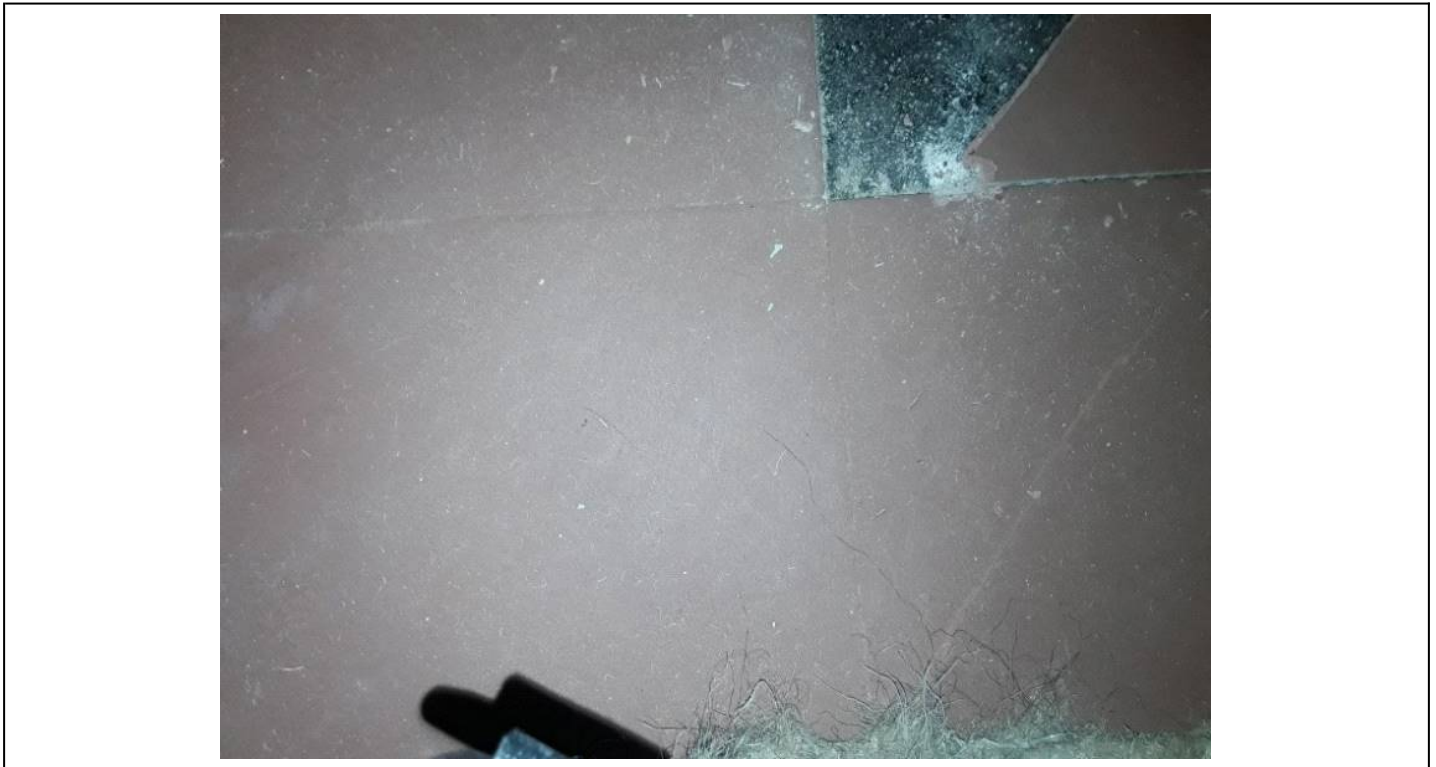
MATERIAL ASSESSMENT (MA)		ACCESSIBILITY	
Product Type:	1	Easy	
Damage:	1		
Treatment:	0		
Asbestos Type:	1		
MA Score:	3

Total Assessment:	3	Low	
Sample notes:	N/A		
Comments:	Asbestos found in both tiles and bitumen		
Recommendation:	Remove under Controlled Conditions	Timescale	12 Months

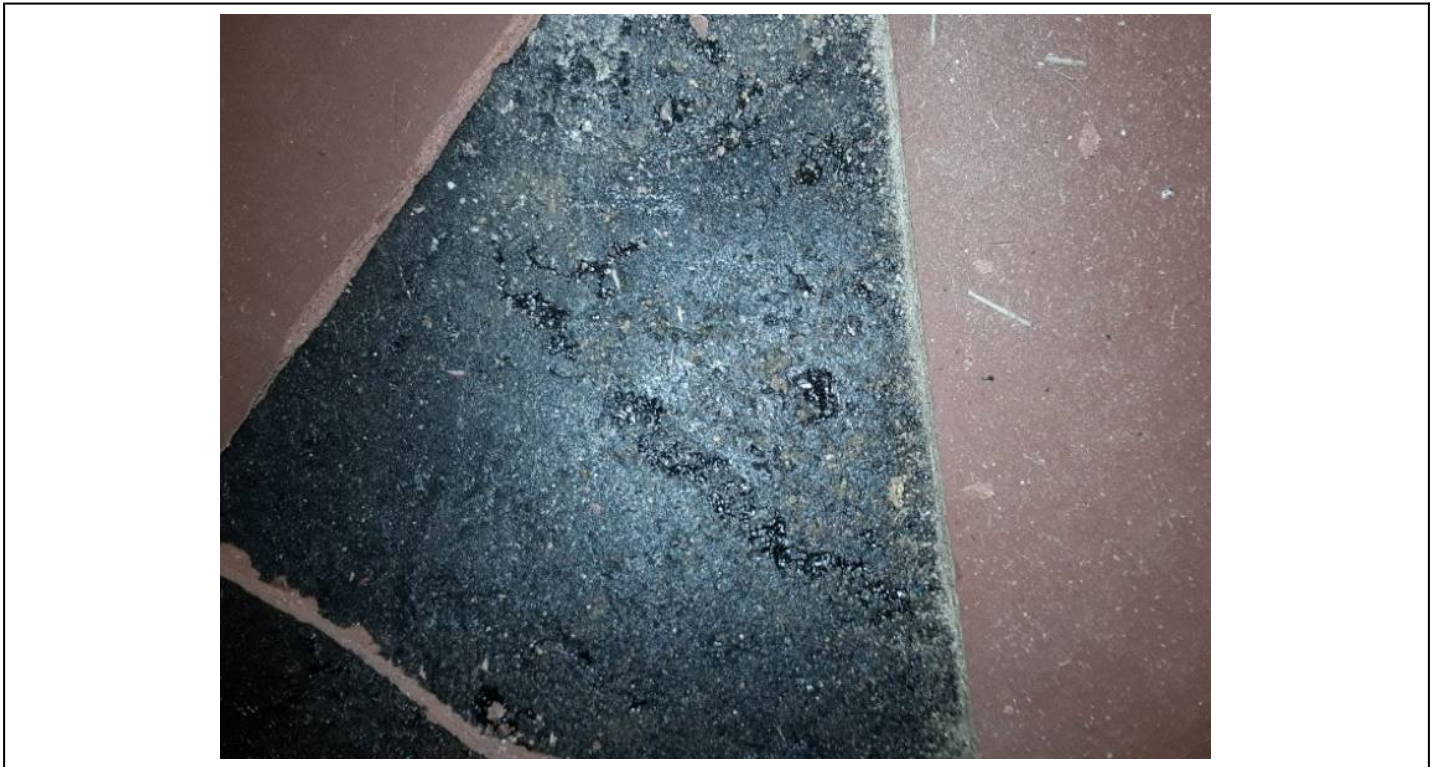
MATERIAL ASSESSMENT (MA)		ACCESSIBILITY	
Product Type:	1	Easy	
Damage:	1		
Treatment:	0		
Asbestos Type:	1		
MA Score:	3

Total Assessment:	3	Low	
Sample notes:	N/A		
Comments:	No commentsn		
Recommendation:	Remove under Controlled Conditions	Timescale	12 Months

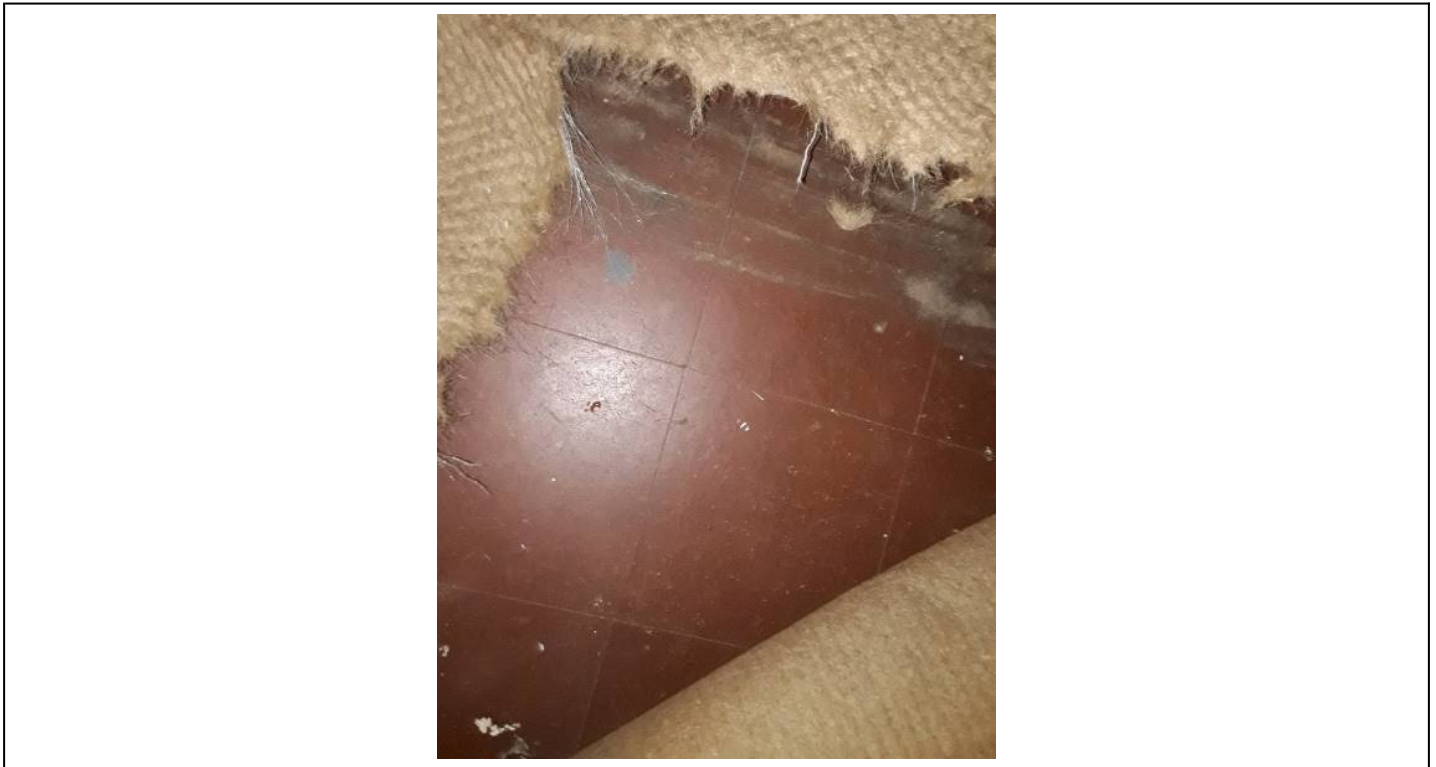
MATERIAL ASSESSMENT (MA)		ACCESSIBILITY	
Product Type:	1	Easy	
Damage:	1		
Treatment:	0		
Asbestos Type:	1		
MA Score:	3

Total Assessment:	3	Low	
Sample notes:	N/A		
Comments:	Asbestos found in both tiles and bitumen		
Recommendation:	Remove under Controlled Conditions	Timescale	12 Months

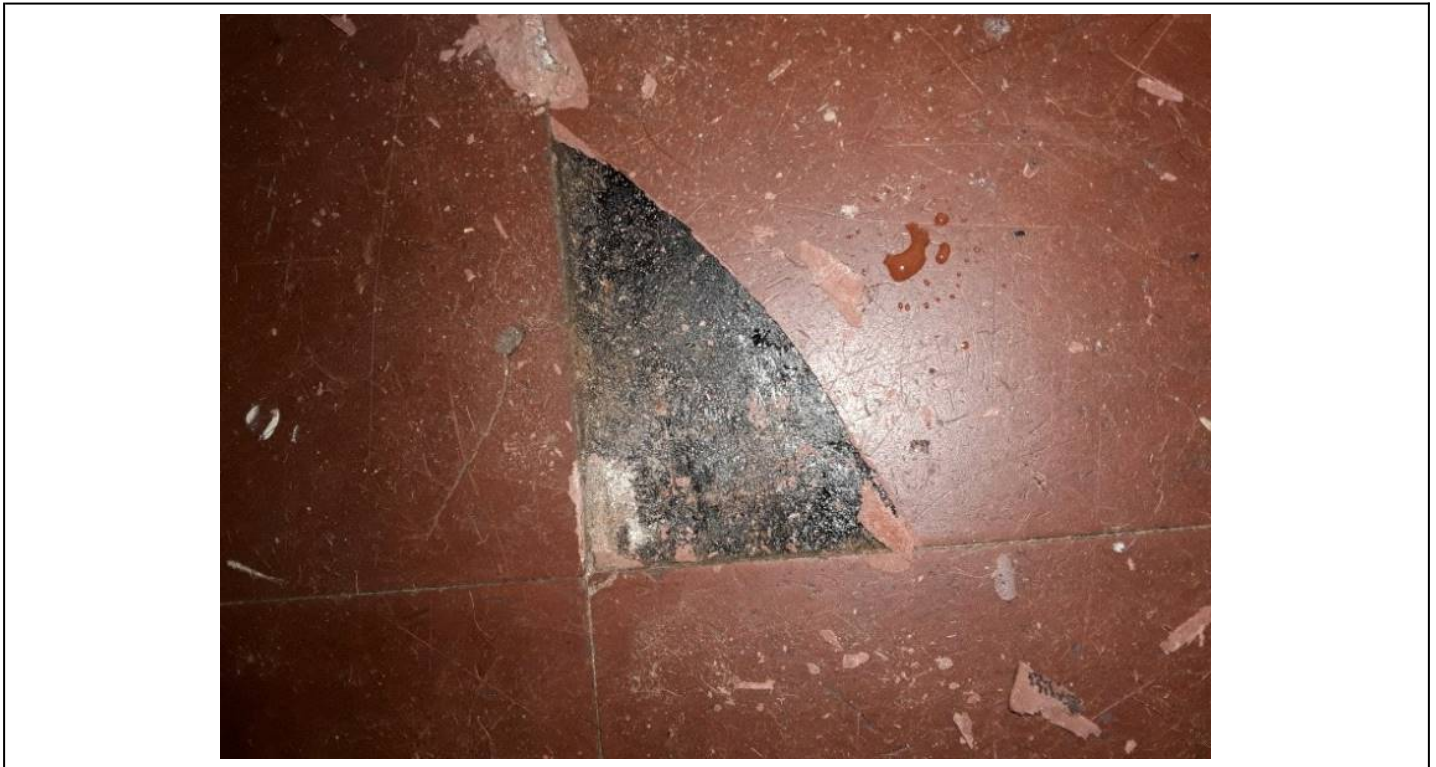
MATERIAL ASSESSMENT (MA)		ACCESSIBILITY	
Product Type:	1	Easy	
Damage:	1		
Treatment:	0		
Asbestos Type:	1		
MA Score:	3

Total Assessment:	3	Low	
Sample notes:	N/A		
Comments:	No commentsn		
Recommendation:	Remove under Controlled Conditions	Timescale	12 Months

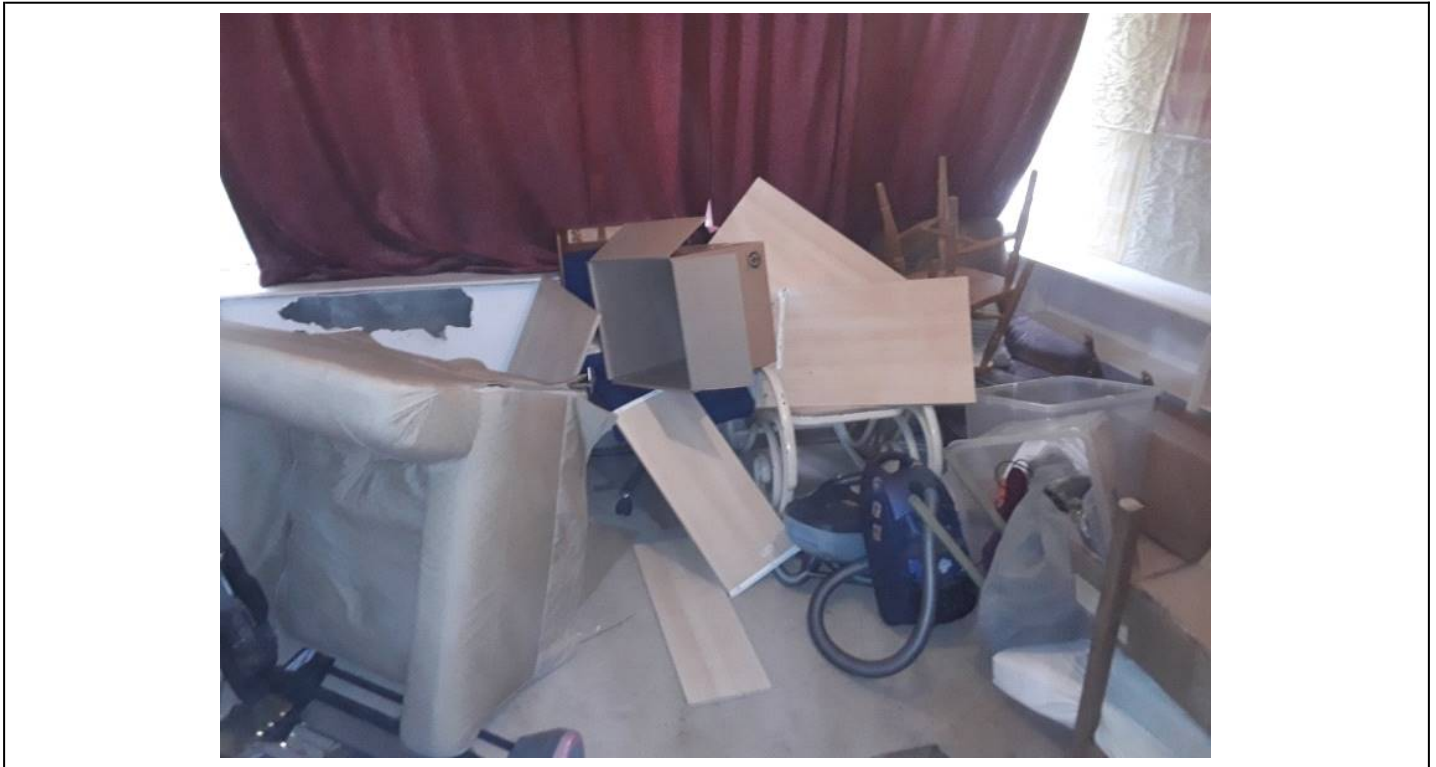
MATERIAL ASSESSMENT (MA)		ACCESSIBILITY	
Product Type:	N/A	N/A	
Damage:	N/A		
Treatment:	N/A		
Asbestos Type:	N/A		
MA Score:	N/A

Total Assessment:	N/A	N/A	
Sample notes:	N/A		
Comments:			
Recommendation:	Inspect prior to Maintenance	Timescale	N/A

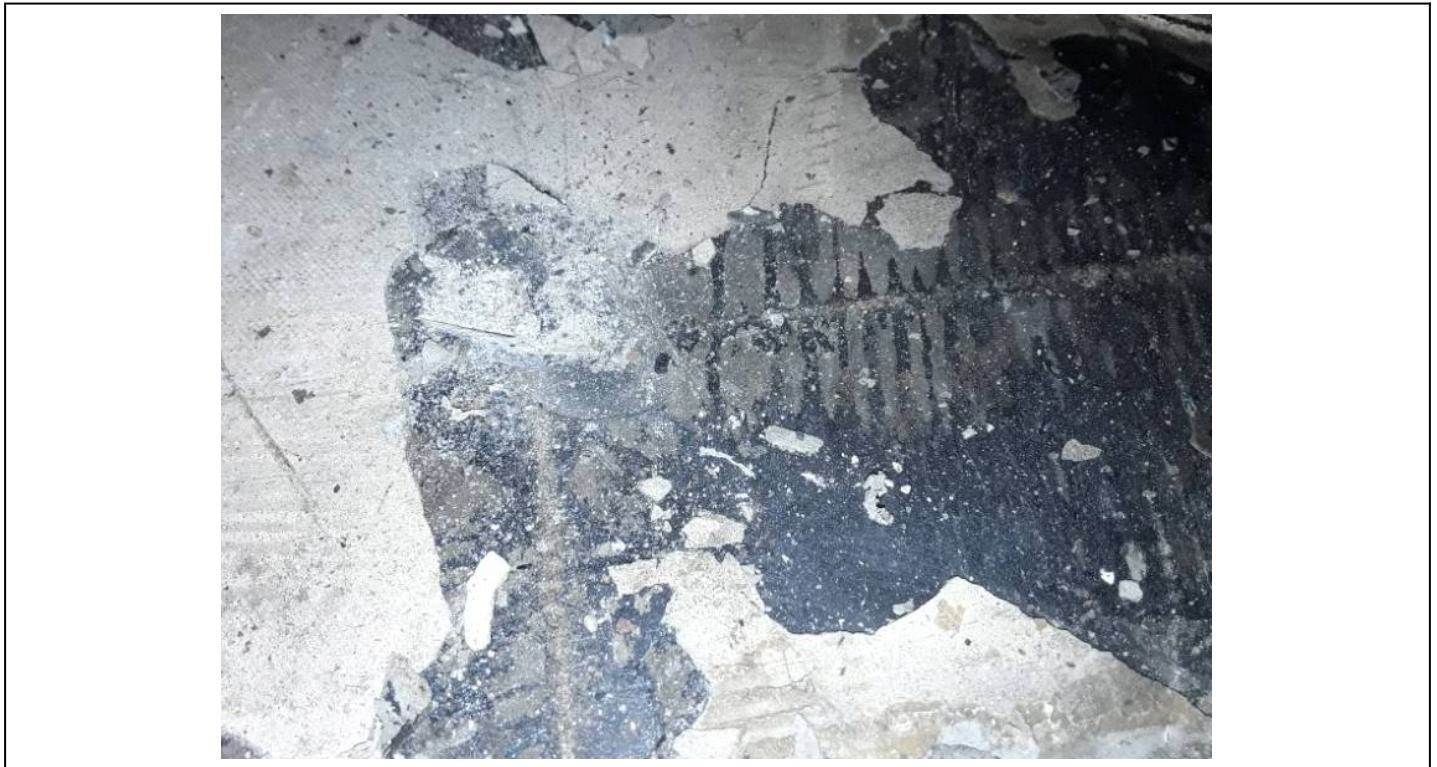
MATERIAL ASSESSMENT (MA)		ACCESSIBILITY	
Product Type:	1	Easy	
Damage:	1		
Treatment:	1		
Asbestos Type:	1		
MA Score:	4

Total Assessment:	4	Low	
Sample notes:	N/A		
Comments:	Below the vinyl.		
Recommendation:	Remove under Controlled Conditions	Timescale	12 Months

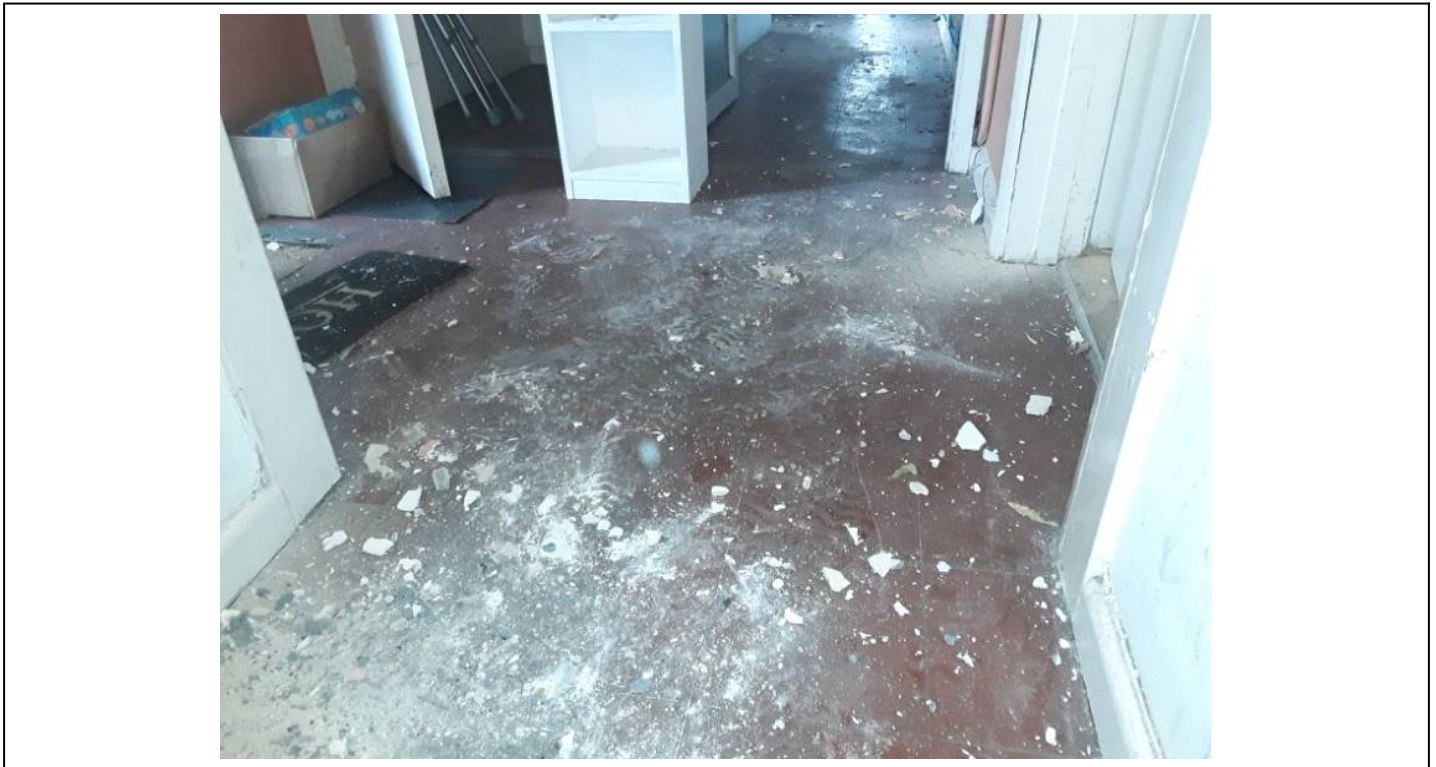
MATERIAL ASSESSMENT (MA)		ACCESSIBILITY	
Product Type:	1	Easy	
Damage:	1		
Treatment:	0		
Asbestos Type:	1		
MA Score:	3

Total Assessment:	3	Low	
Sample notes:	N/A		
Comments:	No comments.		
Recommendation:	Remove under Controlled Conditions	Timescale	12 Months

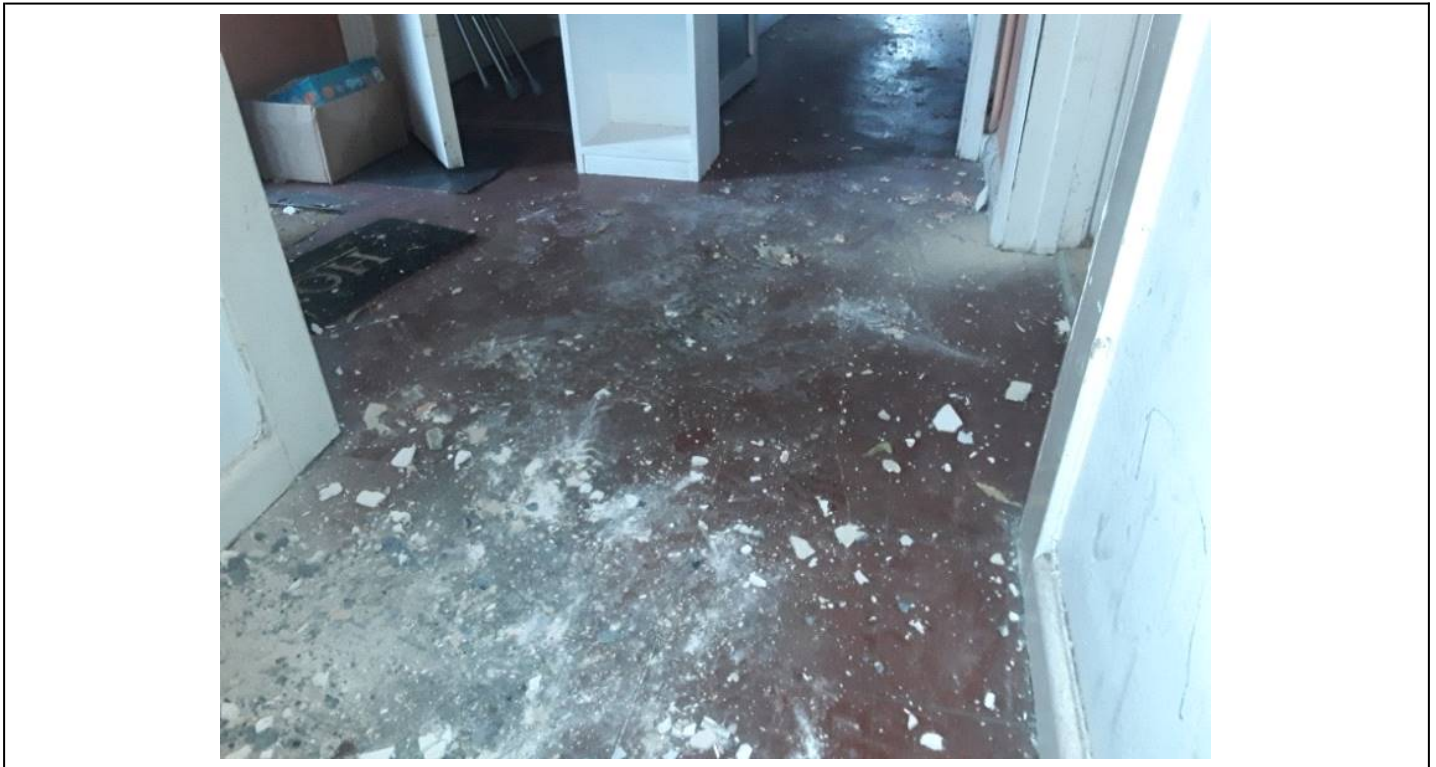
MATERIAL ASSESSMENT (MA)		ACCESSIBILITY	
Product Type:	1	Easy	
Damage:	1		
Treatment:	0		
Asbestos Type:	1		
MA Score:	3

Total Assessment:	3	Low	
Sample notes:	N/A		
Comments:	No comments		
Recommendation:	Remove under Controlled Conditions	Timescale	12 Months

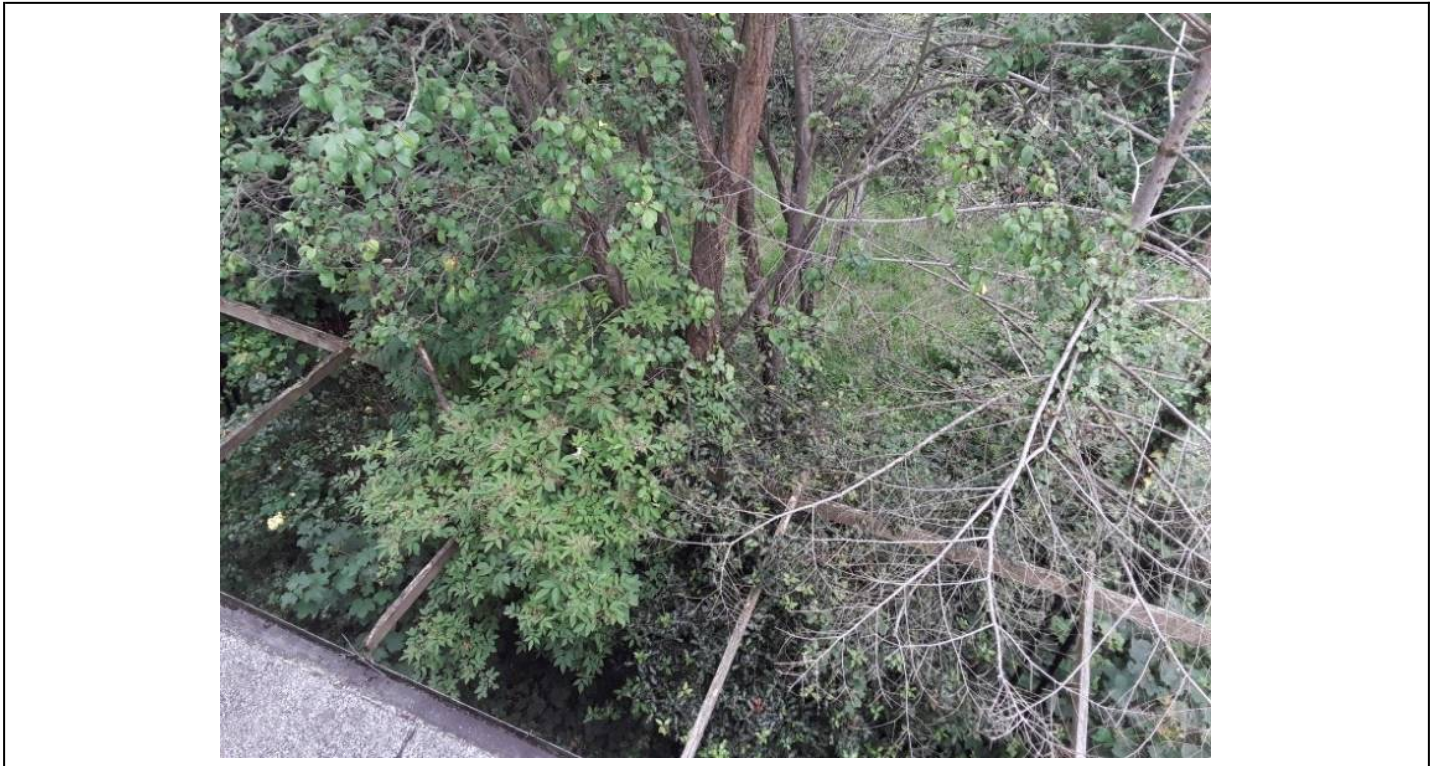
MATERIAL ASSESSMENT (MA)		ACCESSIBILITY	
Product Type:	N/A	N/A	
Damage:	N/A		
Treatment:	N/A		
Asbestos Type:	N/A		
MA Score:	N/A

Total Assessment:	N/A	N/A	
Sample notes:	N/A		
Comments:			
Recommendation:	Inspect prior to Maintenance	Timescale	N/A

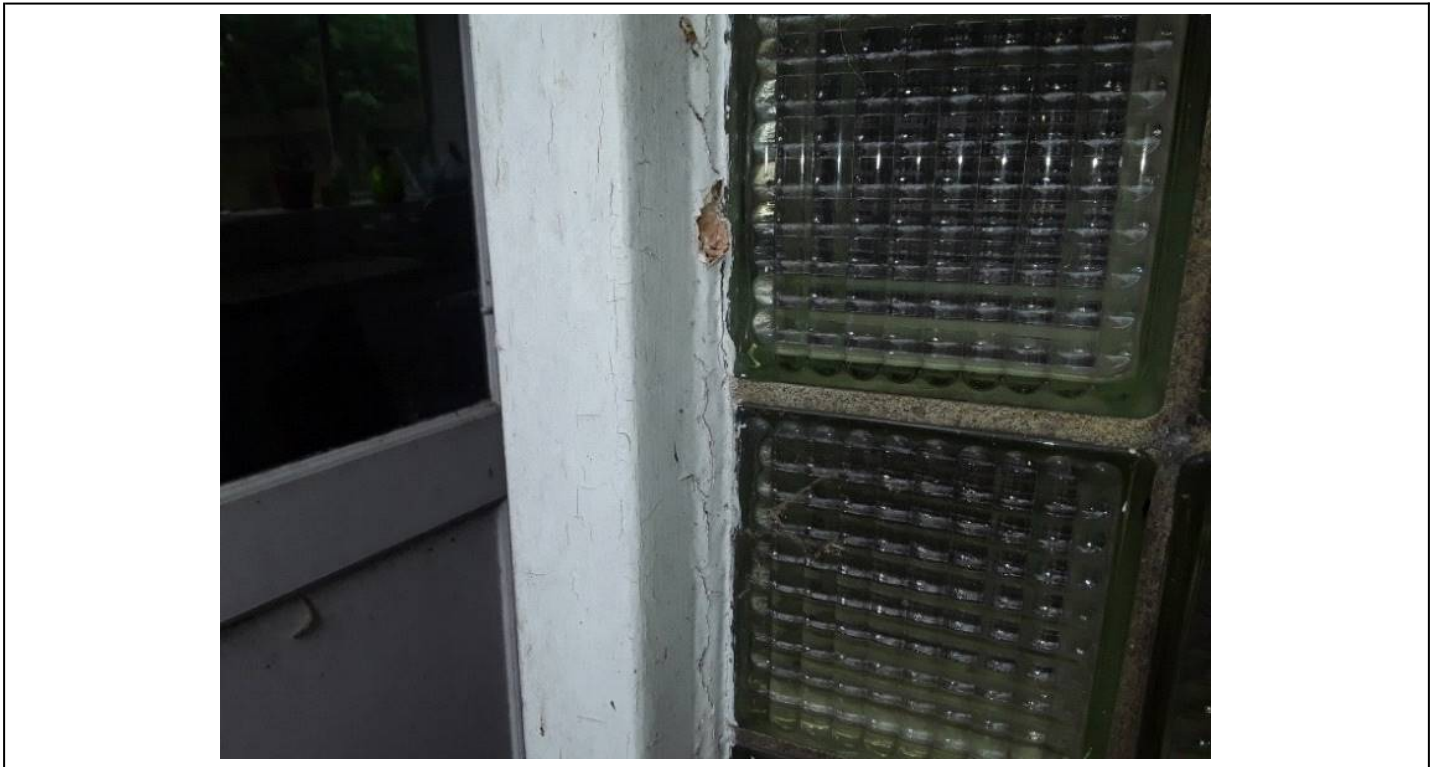
MATERIAL ASSESSMENT (MA)		ACCESSIBILITY	
Product Type:	1	Medium	
Damage:	1		
Treatment:	0		
Asbestos Type:	1		
MA Score:	3

Total Assessment:	3	Low	
Sample notes:	N/A		
Comments:	No comments		
Recommendation:	Remove under Controlled Conditions	Timescale	12 Months
