Arboricultural Appraisal Report

Subsidence Damage Investigation at:

85 St Augustines Road
London
NW1 9RR

CLIENT:	B Maule & Co Ltd
CLIENT REF:	[REDACTED]
MWA REF:	[REDACTED]
MWA CONSULTANT:	Andy Clark
REPORT DATE:	17/09/2019

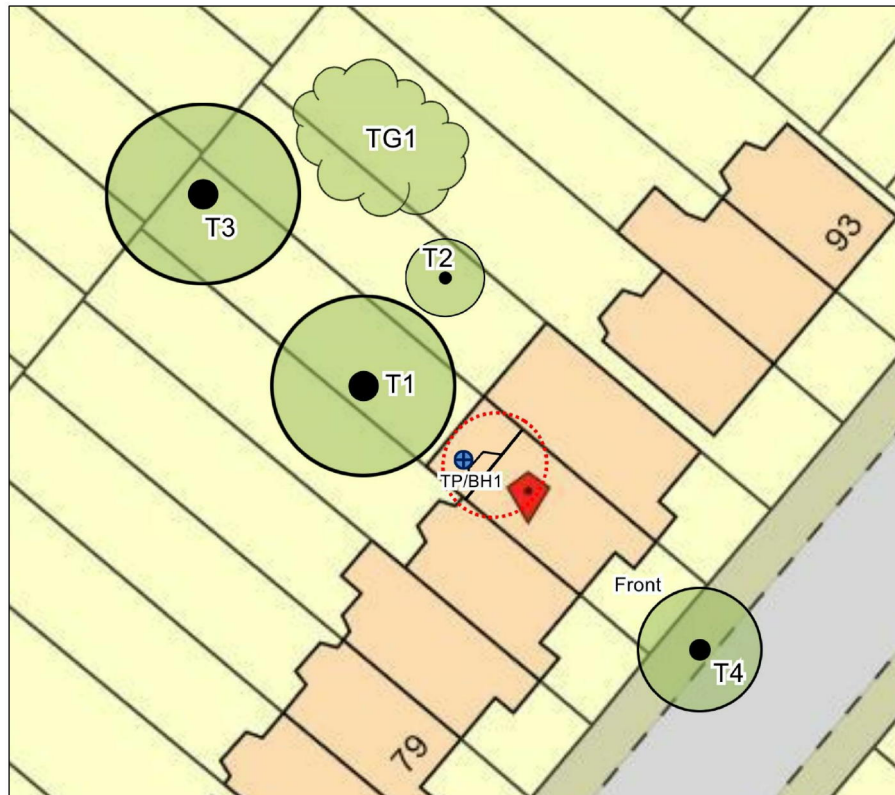
Site Plan

Approximate areas of damage

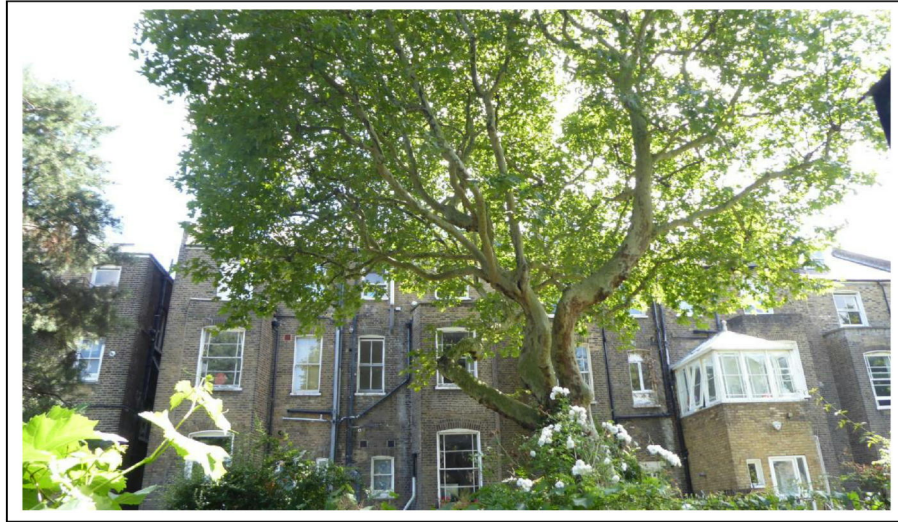
Roots were observed to a depth of 1.6m bgl in TP/BH1, and recovered samples have been positively identified (using anatomical analysis) as *Platanus* spp.; the origin of which will be T1 London Plane, confirming its influence on the soils below the foundations.

Based on the technical reports currently available, engineering opinion and our own site assessment we conclude the damage is consistent with shrinkage of the clay subsoil related to moisture abstraction by vegetation. Having considered the information currently available, it is our opinion that T1 London Plane is the principal cause of the current subsidence damage.

Tree No.	Species	Ht (m)	Dia (mm)	Crown Spread (m)	Dist. to building (m)	Age Classification	Ownership
T1	London Plane	16.5 *	650	14.5	7.3	Younger than Property	Policy Holder
Management history		Subject to past management/pruning – previously crown reduced.					
Recommendation		Remove (fell) to near ground level and treat stump to inhibit regrowth.

View of T1 London Plane

If an arboricultural solution is to be implemented to mitigate the influence of the implicated trees/vegetation we recommend that T1 London Plane is removed.

Consideration has been given to pruning alone as a means of mitigating the vegetative influence, however in this case, this is not considered to offer a viable long-term solution due to the proximity of the responsible vegetation. Recommended tree works may be subject to change upon receipt of additional information.

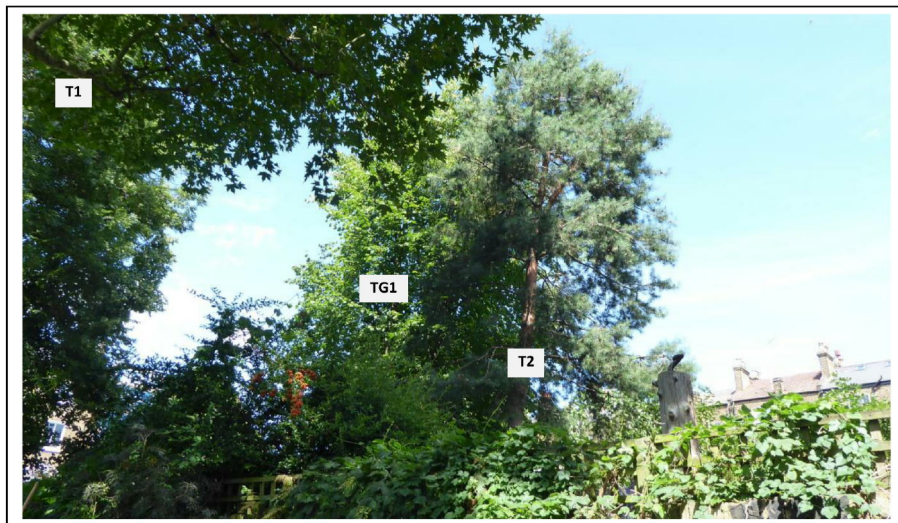
Tree No.	Species	Ht (m)	Dia (mm)	Crown Spread (m)	Dist. to building (m)	Age Classification	Ownership
T2	Pine	10.0	220 *	4.5 *	11.6	Younger than Property	Third Party: 87 St. Augustine's Road, NW1 9RR
Management history		No past management noted.					
Recommendation		Maintain broadly at no more than current dimensions by periodic pruning.					
T3	Ash	18.5 *	650	14.5	20.9	Younger than Property	Policy Holder
Management history		No past management noted. Significant decay to base of main stem with stem lean towards 3p gardens – tree appears to be resting on PH shed structure.					
Recommendation		Remove (fell) to near ground level and treat stump to inhibit regrowth. H&S Risk					
T4	False Acacia	11.0	420	7.5	3.6	Younger than Property	Local Authority
Management history		Subject to past management/pruning – previously crown reduced.					
Recommendation		None at present					
TG1	Lime	12.0	300 Ms *	7.5	13.5 *	Younger than Property	Third Party: 89 St. Augustine's Road, NW1 9RR

View of T2 Pine with TG1 Lime group visible beyond

Management history		No past management noted.					
Recommendation		Maintain broadly at no more than current dimensions by periodic pruning.

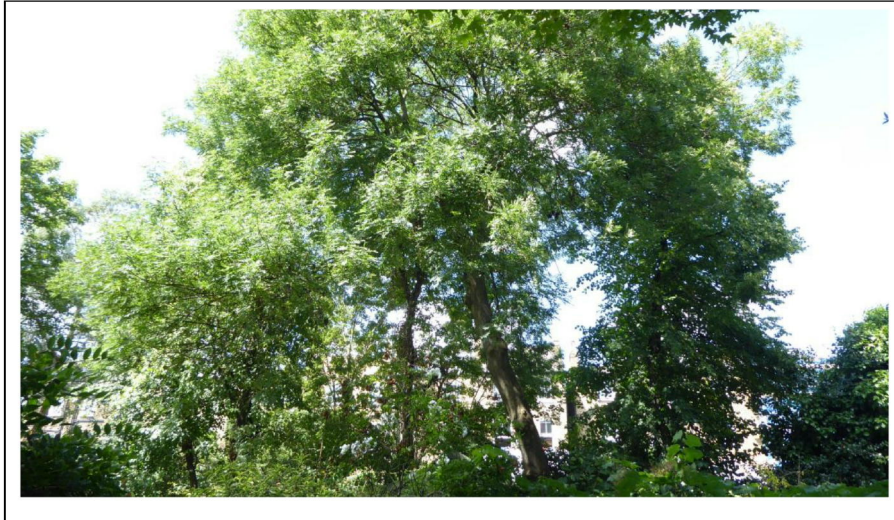
View of T3 Ash

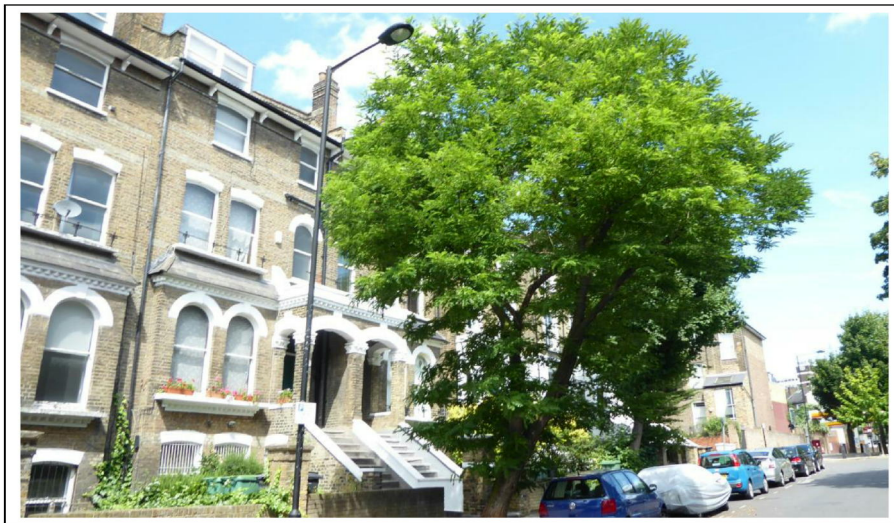
View of T4 False Acacia
