122C Finchley Road, London, NW3 5HT

Introduction

I have been instructed by John McMorrow of Trabur Building and Property Maintenance to inspect a mature Lime tree situated to the immediate rear of 122C Finchley Road, NW3 5HT.

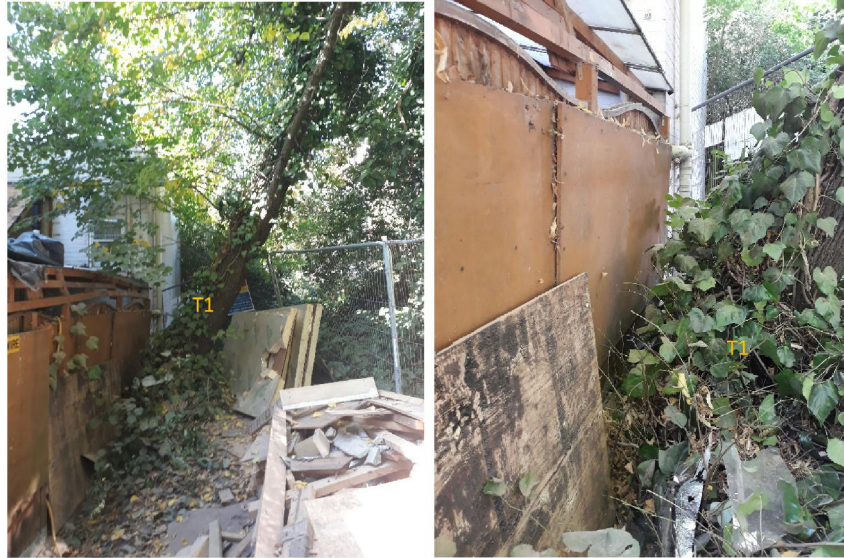
T1 is a mature Ivy clad Lime tree located at the foot of a vegetated bank and growing directly against a retaining wall at the rear of 122c Finchley Road. The tree has a prominent lean of approximately 25° in the north-easterly direction from its base against the wall.

The boundary wall is historic, having been reinforced in 2005 as part of a planning consent for works to the rear of 122C, it is my professional opinion that the wall is largely responsible for keeping the tree in its current position and that given the right weather conditions the tree may well fail with the target area being the college car park and corner of the building itself at 6 Netherhall Gardens.

Photos above show T1 Lime in proximity to 122C Finchley Road.

The tree is not structurally stable enough to be considered for inclusion within a tree preservation order and should be removed as a matter of some urgency.

Fell to ground level and treat stump to prevent regrowth.

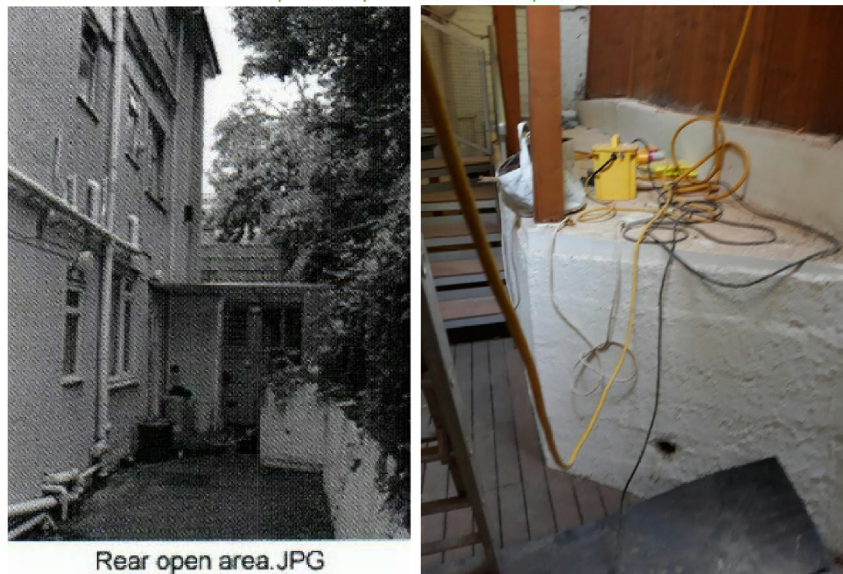
Furthermore, I believe the tree may well have been upright in 2005 but has since rotated in the ground with the rotation being resisted by the boundary retaining wall which is now cracking.

Photos above show an original photo from the 2004 application, clearly showing the boundary retaining wall. The second photo shows the reinforcement added in 2005 which I believe is responsible for holding T1 Lime in place.

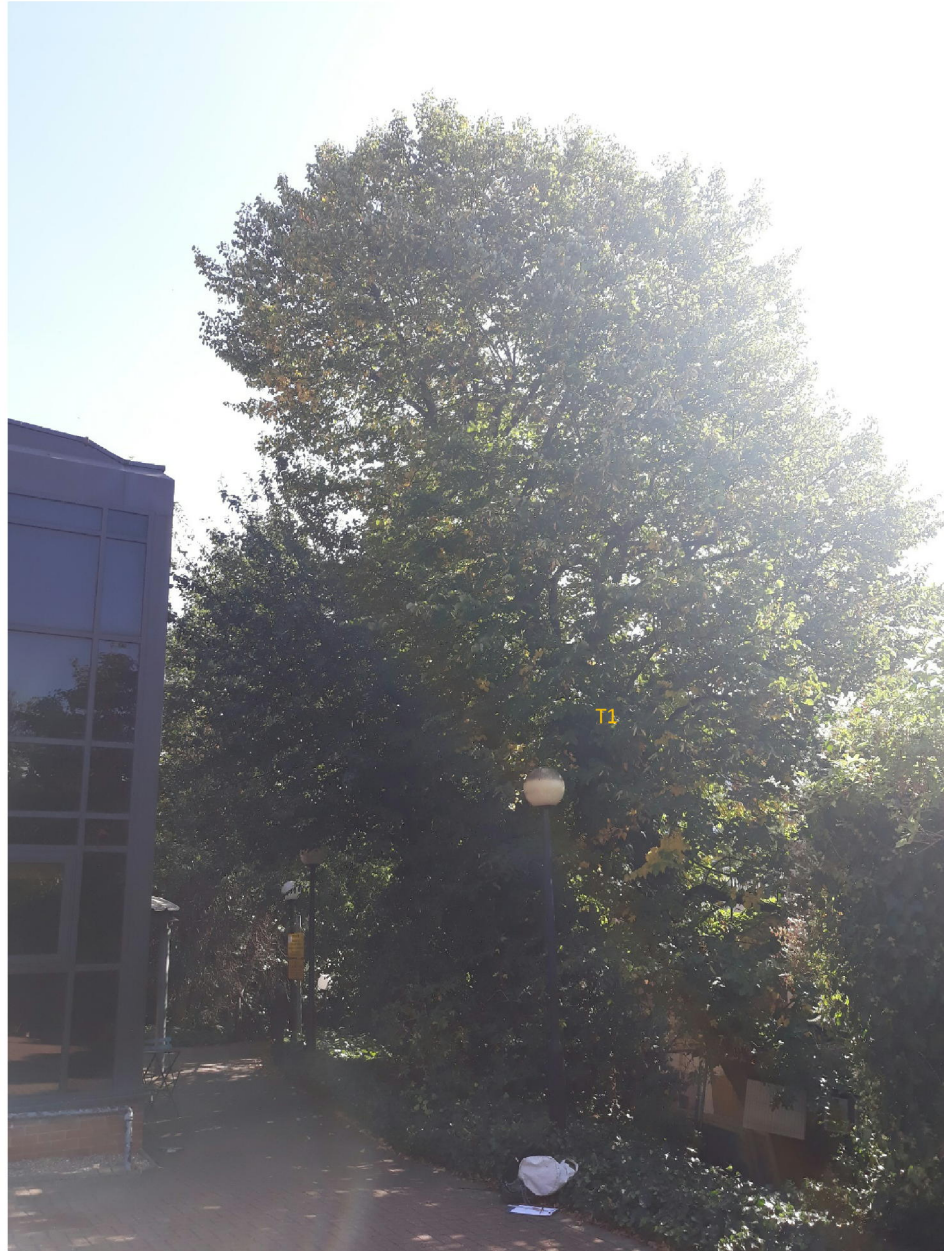
Photo above of T1 Lime taken from the car park of 6 Netherhall Gardens.
