22 Frogna! Way - Curtilage Wall and Outbuilding

Structural Inspection Report

Job Number: 23261

Date	Version	Notes/Amendments/Issue Purpose
June, 2018	2	For Information

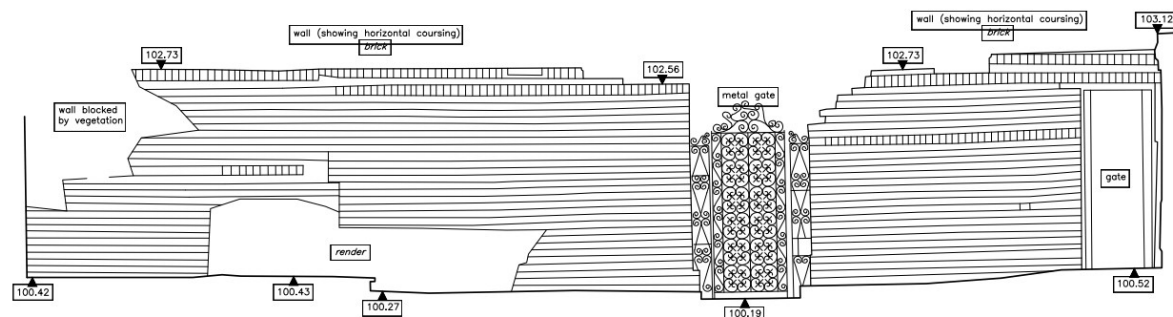
Elevation 5, Matrix Surveys

Elevation 5 depicts the initial straight-line boundary wall with two openings. The left-hand side section, behind the existing shed, has notable previous remedial works to the lower part of the wall. Photograph 2 shows the extent of the concrete render applied to the lower section of the wall. Above the concrete render the brickwork is in poor condition with the corbel portion no longer insitu.

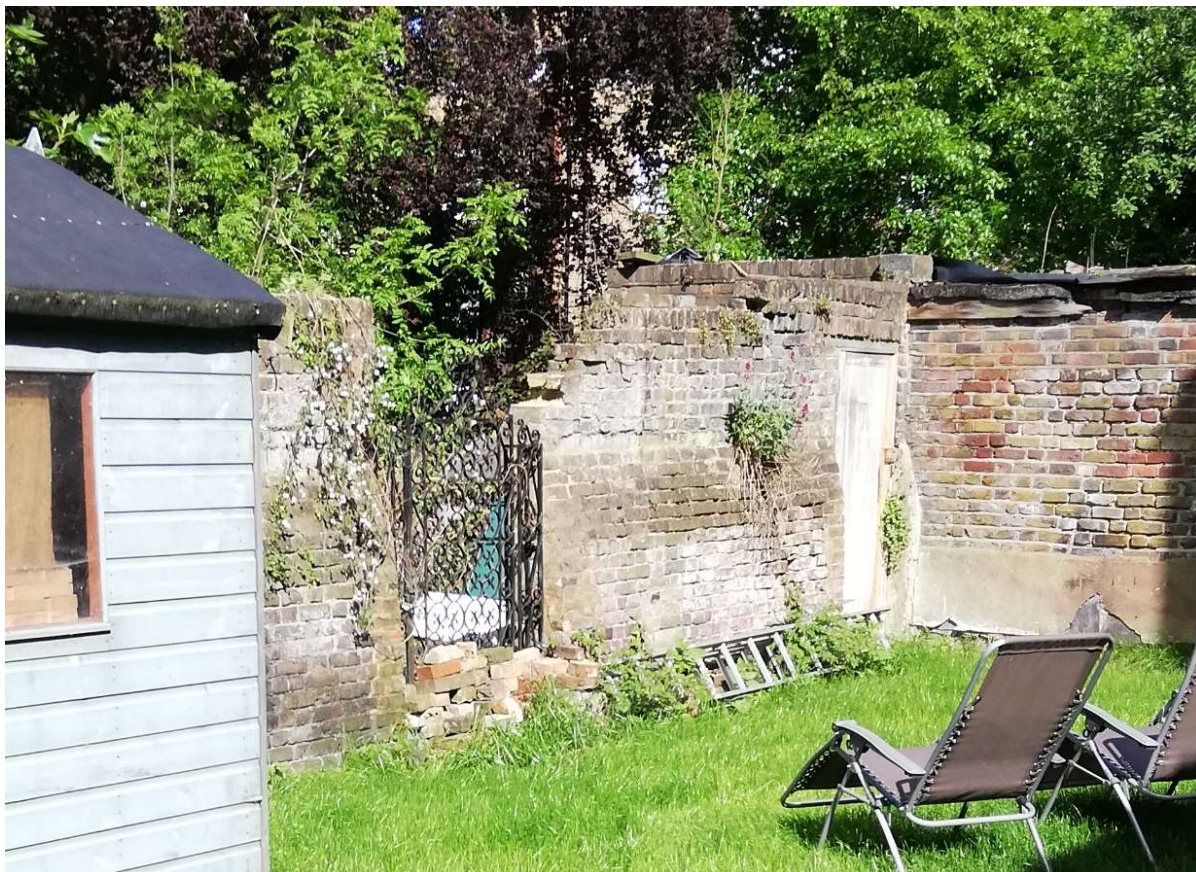
Photo 1, View from 20 Perrins Cottage

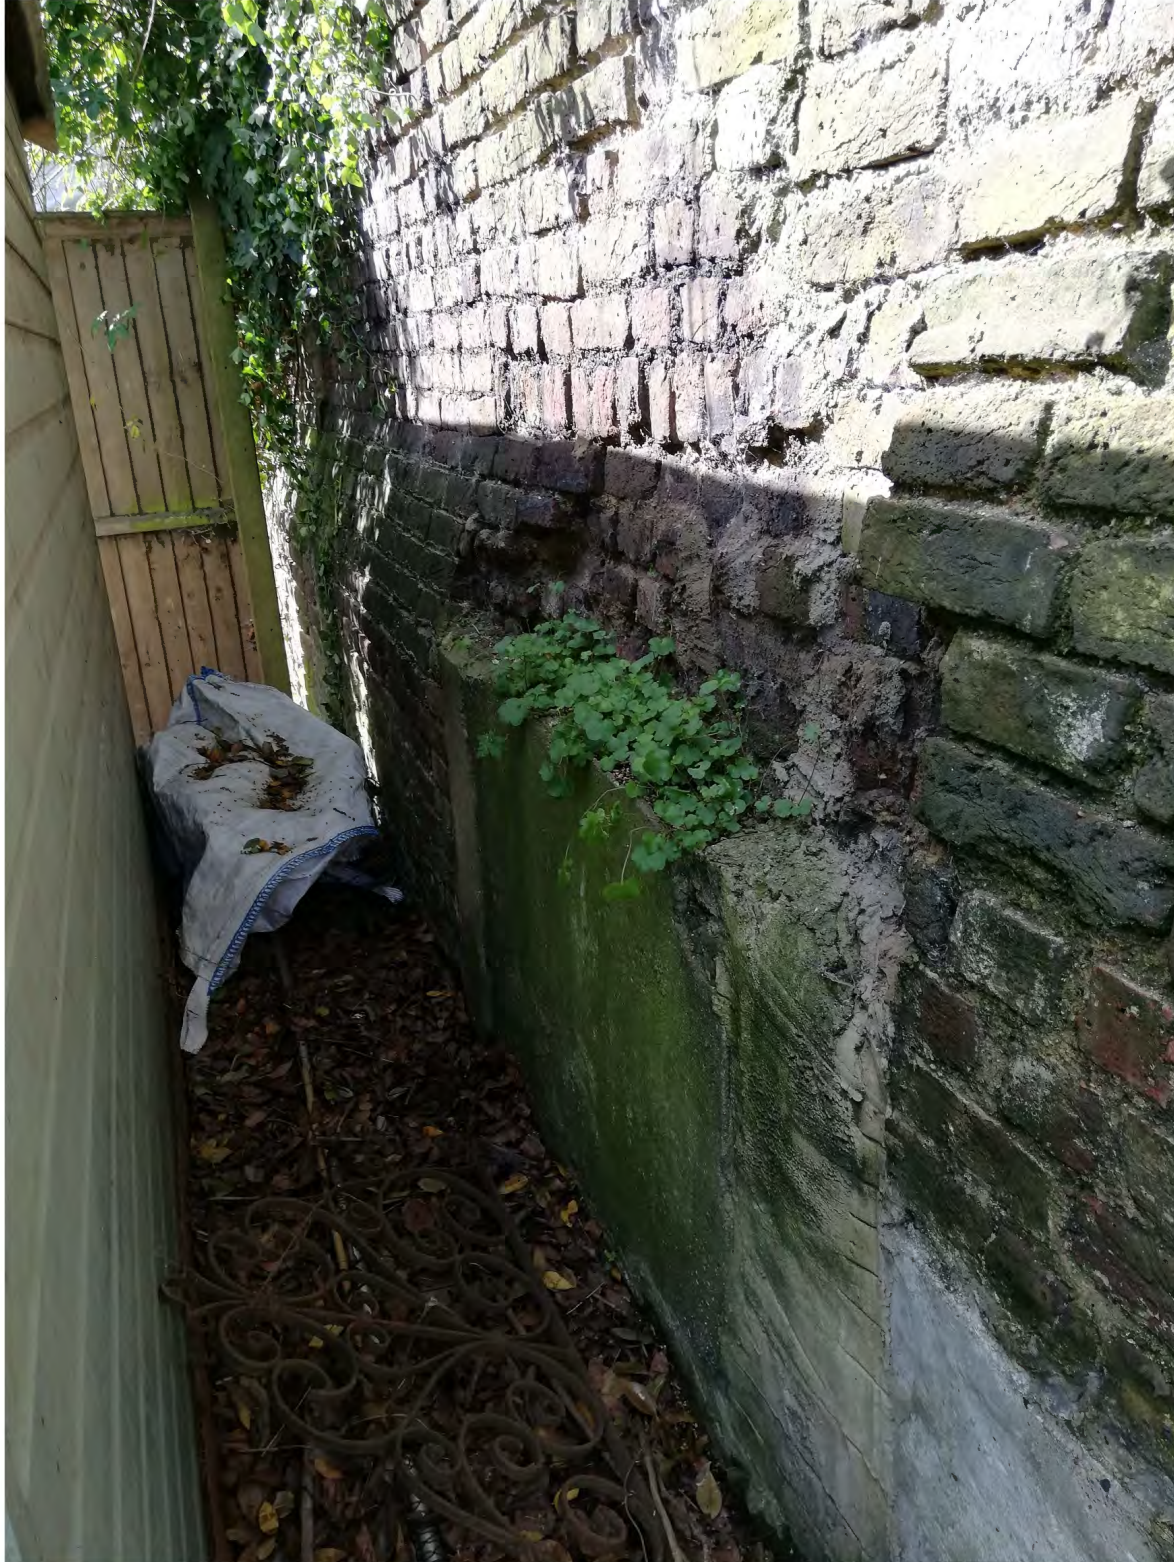
Photo 2, Southern section of wall behind existing shed

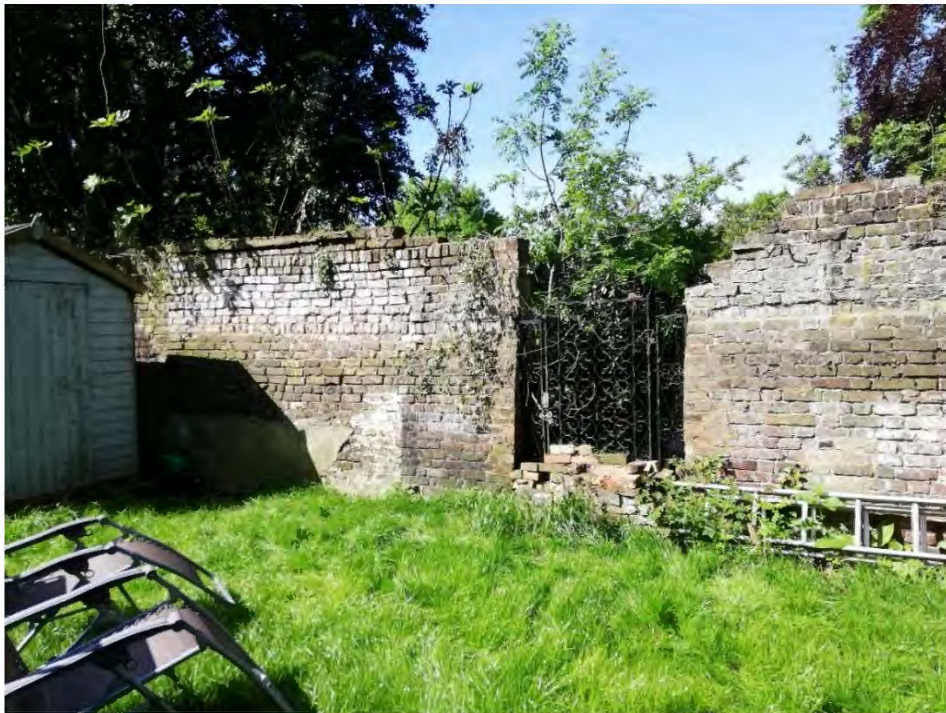
The right-hand section of the wall on this elevation has two openings (refer to Photograph 3 & 4). These openings provide access between the two properties. On review the openings do not look to be of a similar age as the wall construction as new brickwork and cement mortar is visible, refer to photograph 5.

The brickwork at high level surrounding the openings is in poor condition and a number of courses are missing locally from the upper section of the wall.

Photo 3, Opening 1, Full height

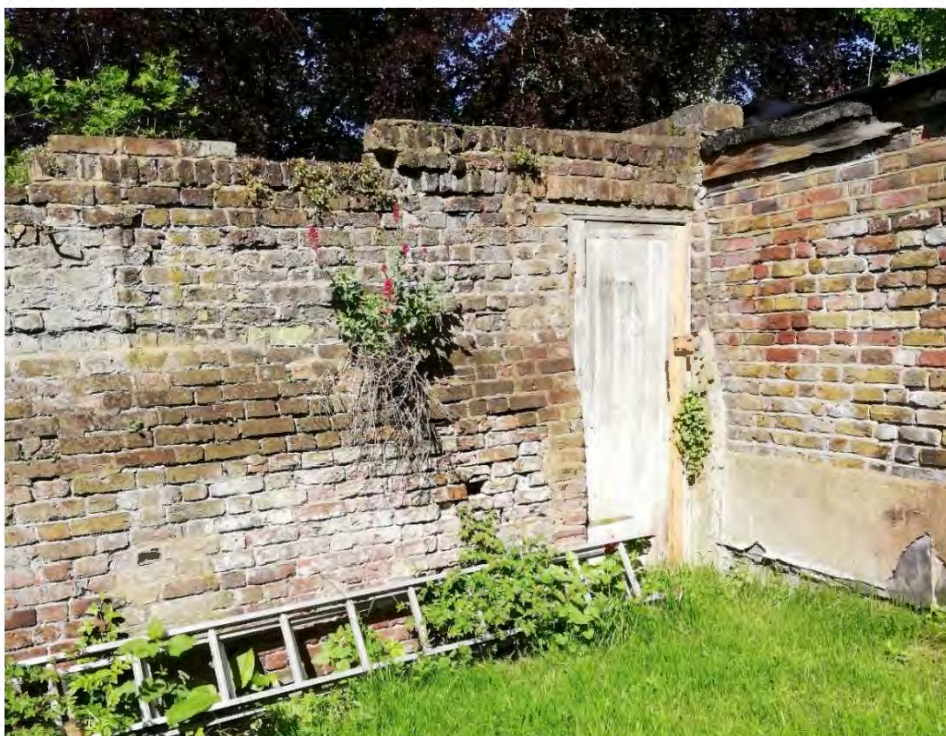
Photo 4, Opening 2

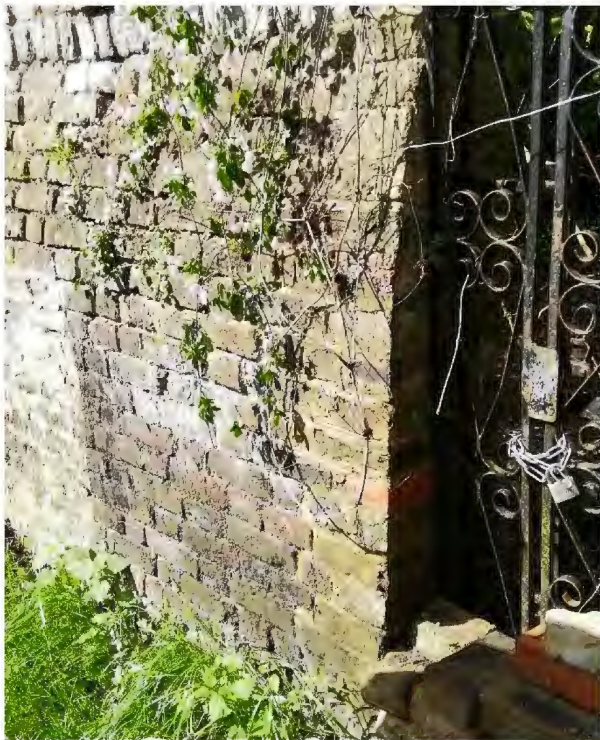
Photo 5, new/old brickwork at opening reveal

Photographs 5 & 6 show the composition of the wall itself. At its base it is a brick & a half thick reducing to one brick thick for the upper section. To achieve the change in thickness the wall corbels at approximately 1000mm above the current ground level. The Wall is approximately 2.3m high from 20 Perrins Walk side.

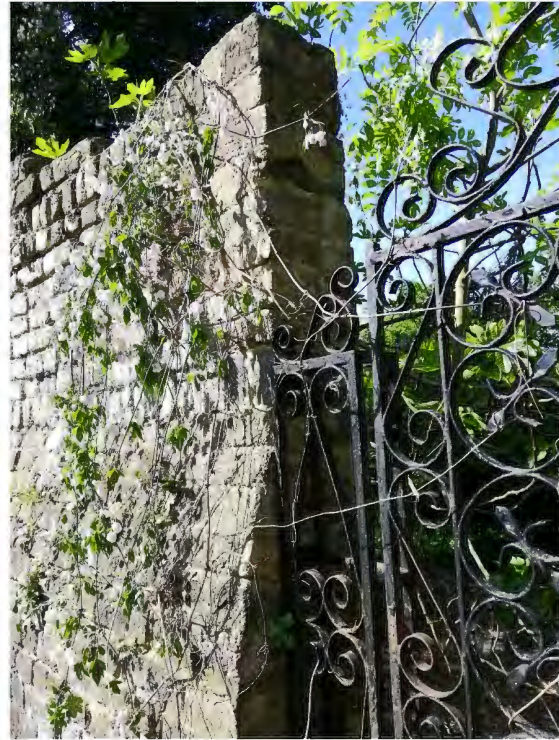
Photo 6, Corbel detail

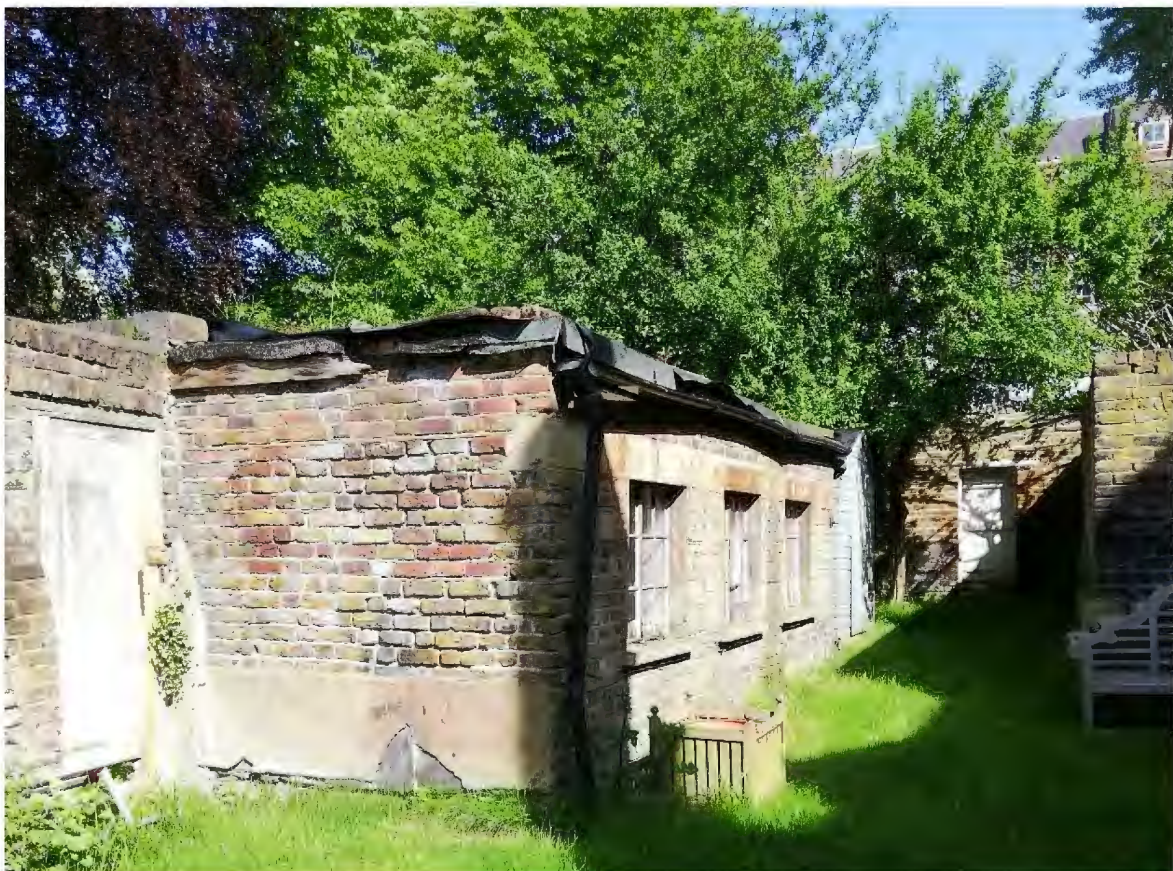
Photo 7, Outbuilding on 20 Perrins Cottage Side

The outbuilding is centrally located along the length of the wall and steps its footprint straddles the two properties. The construction of the outbuilding looks to be of London stock brick and no structural defects of concern in the masonry were seen during the site visit on the 11th May, although sections do require re-pointing. An anchor plate is evident on the top right-hand side corner of its east elevation.

The roof to the outbuilding was noted to be in disrepair.

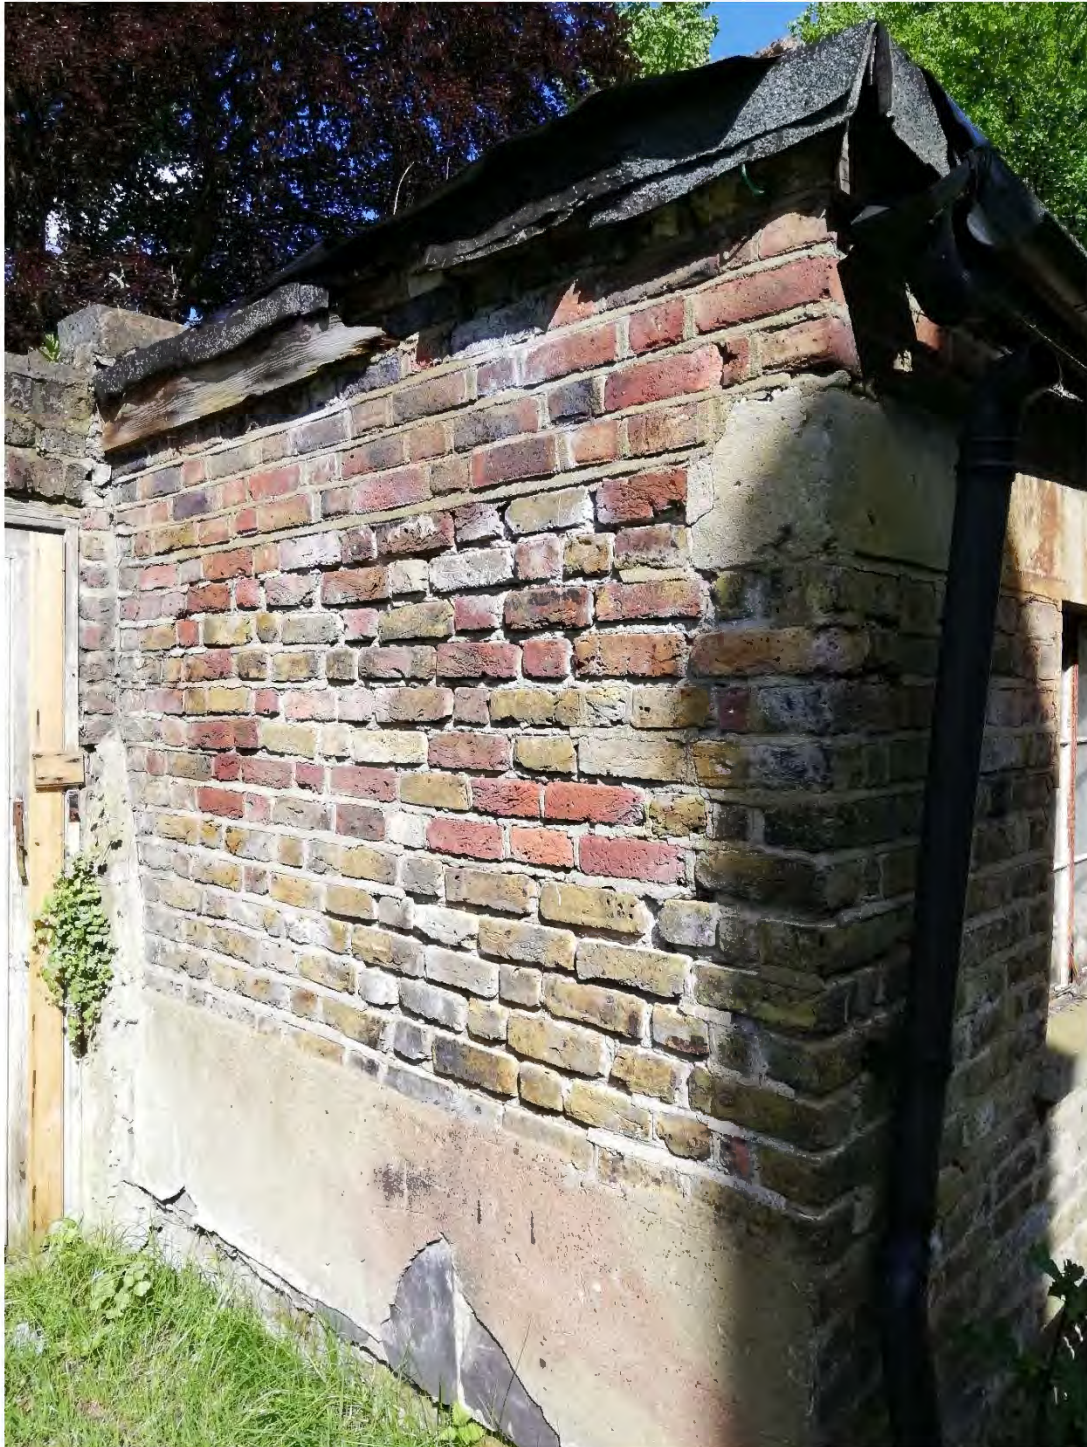
Photo 8, View of Outbuilding Masonry

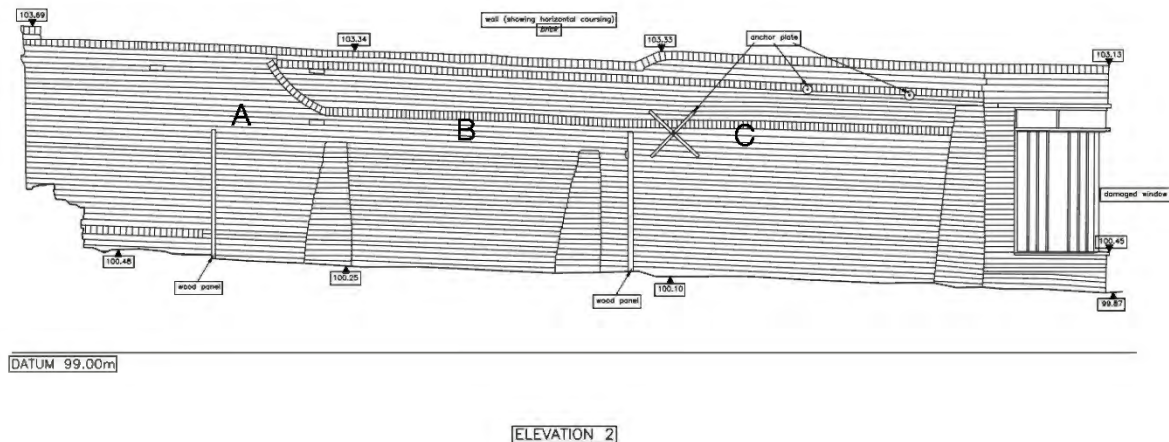
Elevation 2, Matrix Surveys

Elevation 2, below, shows the northern part of the curtilage wall. This elevation forms part of the outbuilding façade (from its right-hand extent to the crossed anchor plate).

Measurements taken on site of the lean to the wall were measured at 48mm, 131mm and 144mm and correspond to the locations A, B & C in Elevation 2, above.

Location A on Elevation 2 & D on Elevation 4 have a centre of gravity that still falls within the middle third of the wall base and no added stability measures are required. However, at locations B and C on Elevation 2, and location E on Elevation 4, the wall is potentially unstable in the long term.

Separately, we have also investigated the structural capacity of the retaining section of the wall, Elevation 2. This wall is not satisfactory to support the required applied wind loads and retaining forces from the neighbouring property when checked using current codes of practice.

Finally, we have investigated the structural design of the 2.3m high freestanding wall with piers at a maximum of 5.0m centres as a standalone item. Location C on Elevation 2, where the wall spans 5.0m between piers is not satisfactory. The maximum allowable spacing of piers for the wall to be compliant with current codes is 4.6m. This is achieved at Locations A and B on Elevation 2, although as noted earlier, this section of wall fails once the retaining forces are taken into account in any event.

We would therefore recommend that Elevation 2 & 4 are either strengthened or taken down and rebuilt to modern codes of practice.

Three new buttresses would be introduced to Elevation 2 at central locations between the existing buttresses, and the existing buttresses should also be rebuilt. These piers will have new footings and be properly tied into the existing wall to ensure they work together structurally.

The existing masonry would be carefully taken down and a new concrete retaining wall built to the base of Elevation 2. This retaining wall will be faced with existing bricks so that it matched the current visual appearance of the wall.

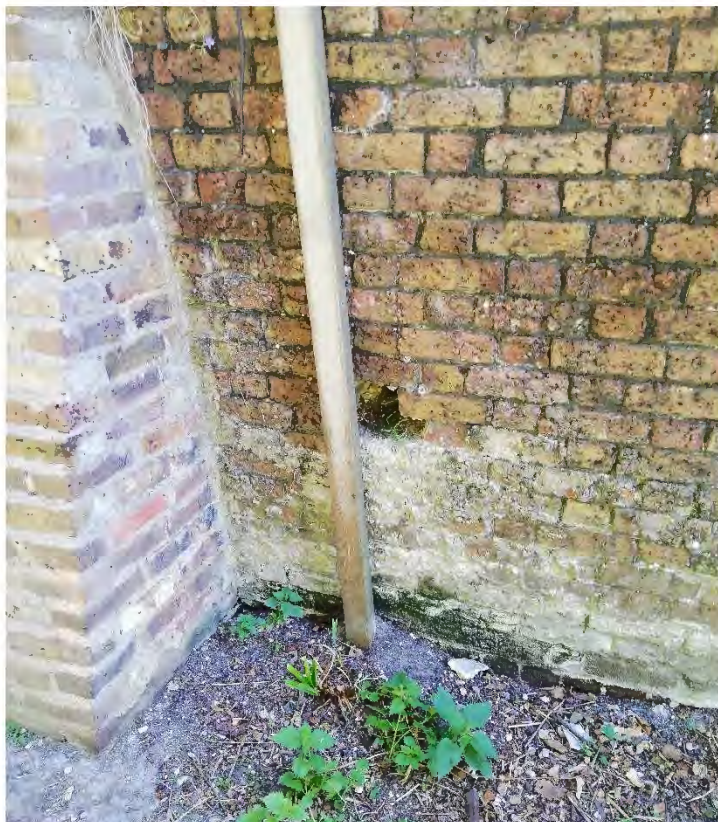
There are buttresses located on this elevation which are all of a raked masonry brickwork construction and taper towards their top. The right-hand side, taller pier looks to be constructed

in the same brick as the remainder of the wall. The two smaller piers, to the left-hand side and centre, are obviously of recent construction and are likely to be an attempt to strengthen the wall against the obvious bow at approximately 2.3m above ground level. The bonding of the new buttresses does not match that of the wall, and they do not look to be properly keyed into the existing wall.

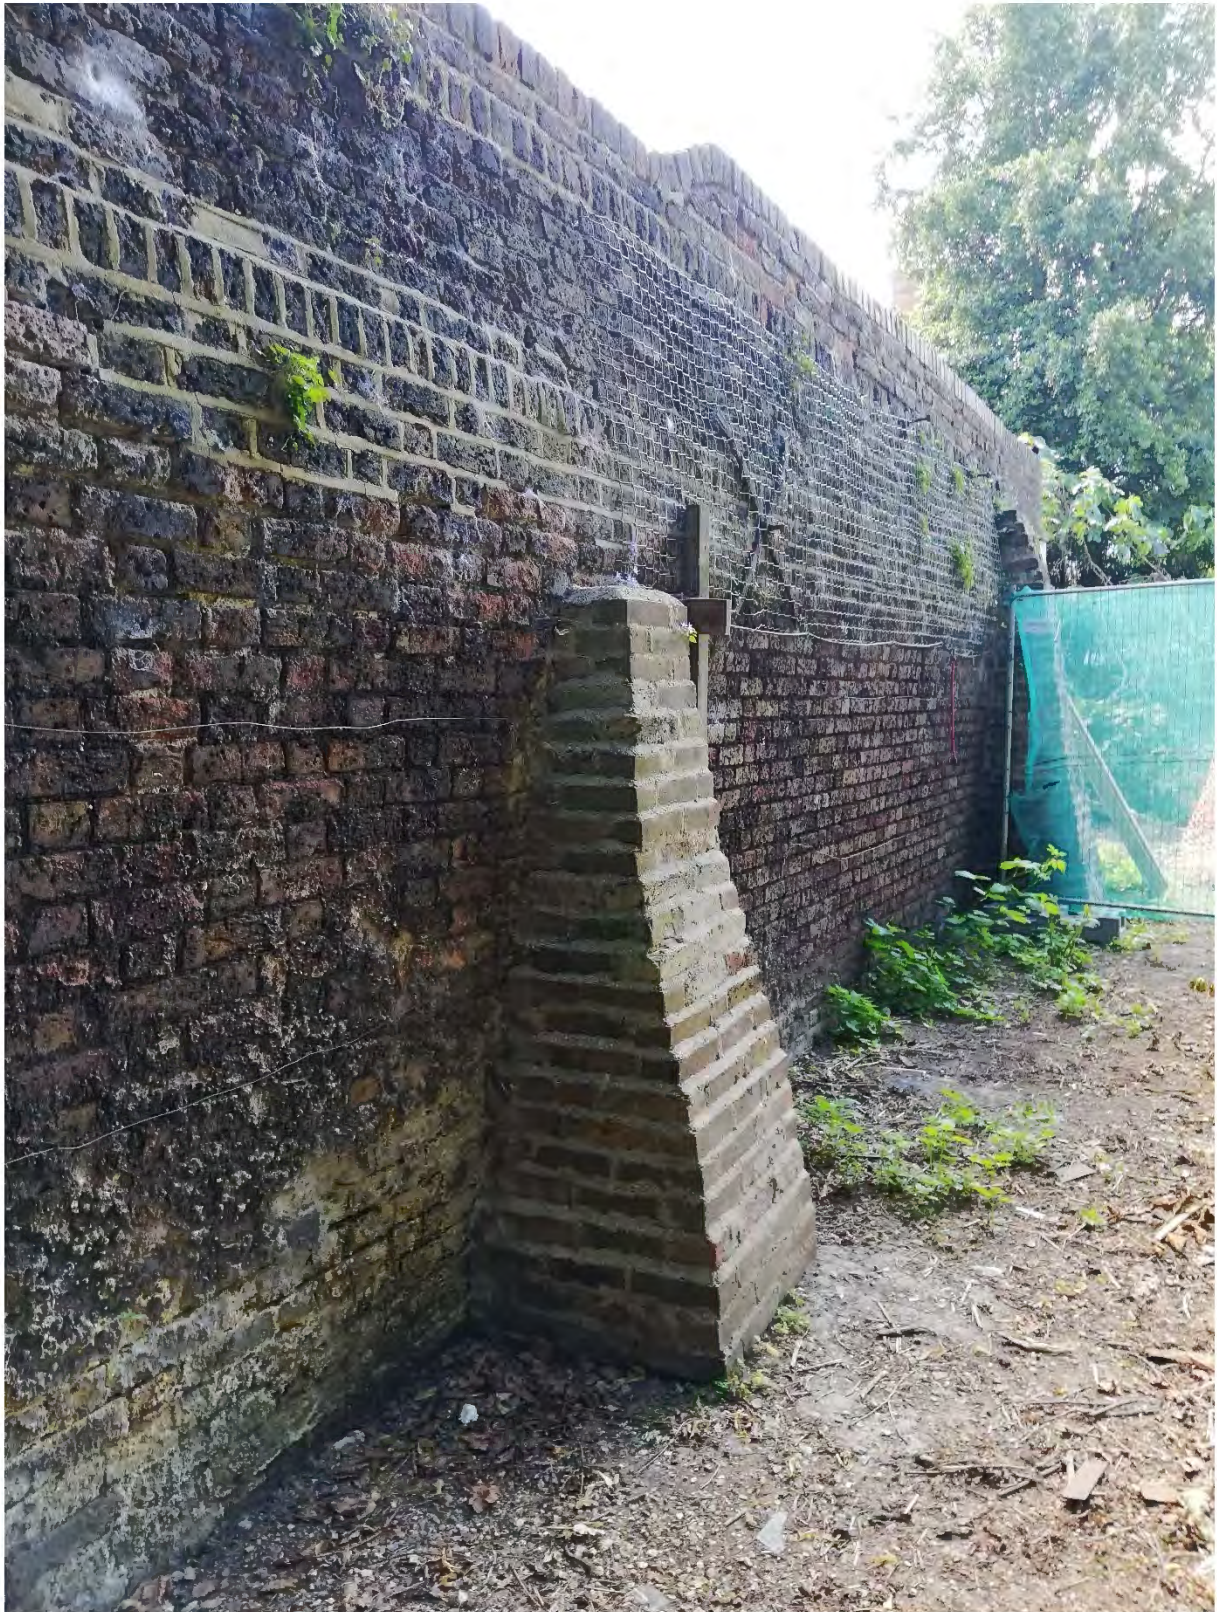
Photo 9, North section of wall and viewing toward the into Outbuilding entrance

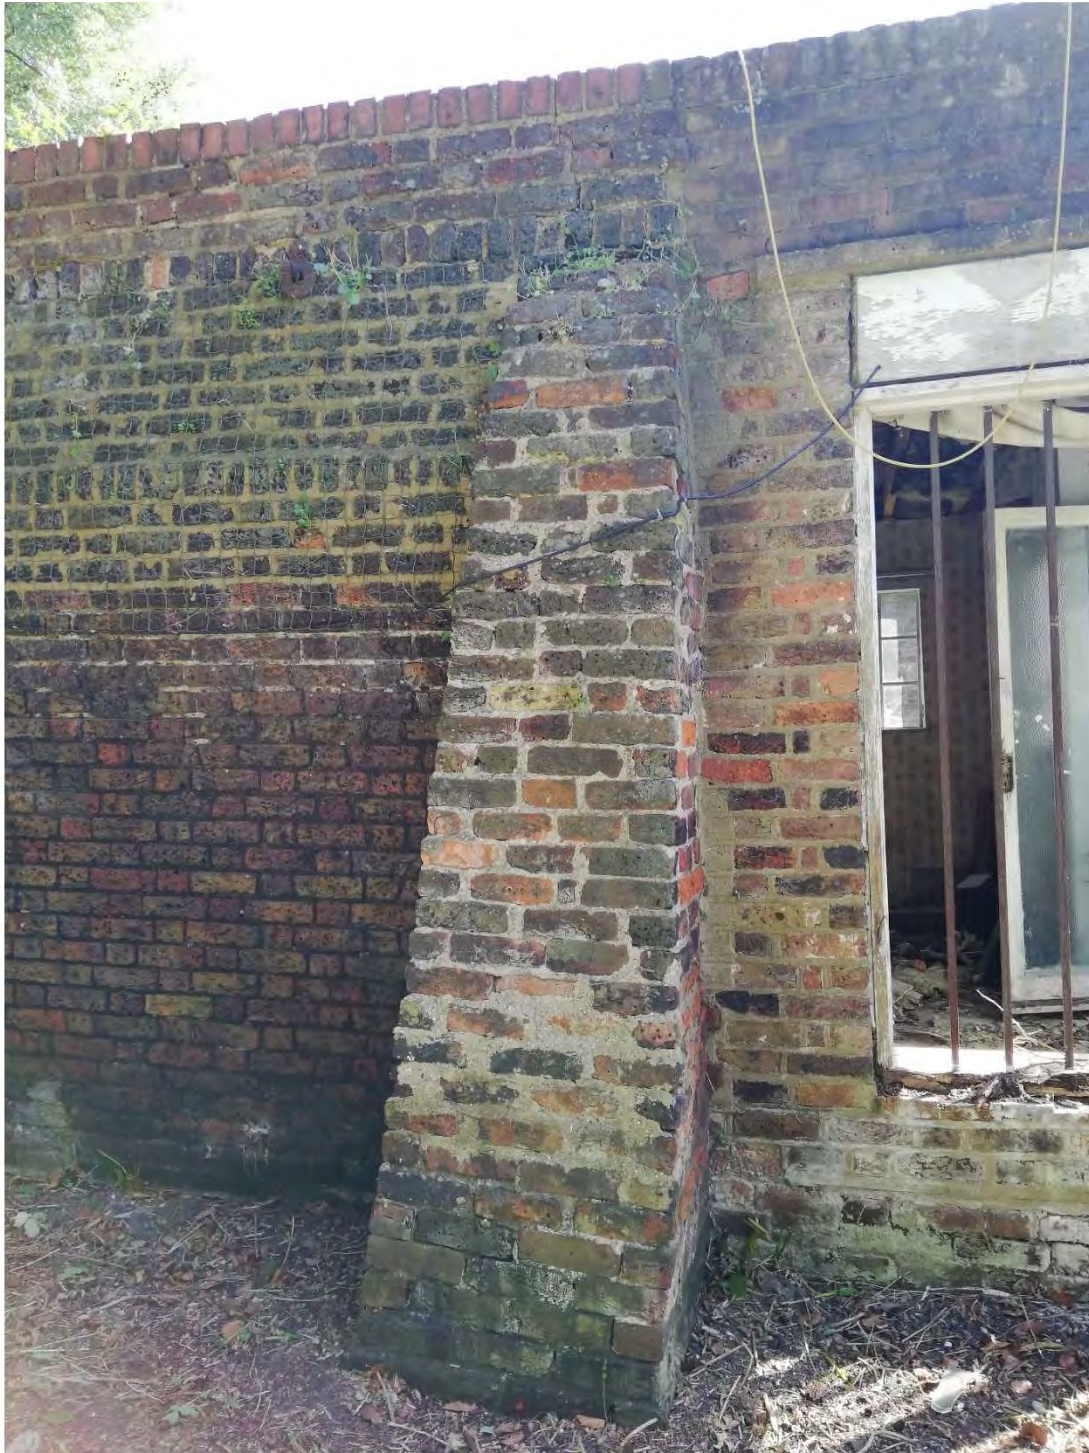
Photo 10, Right-hand side masonry pier to Outbuilding

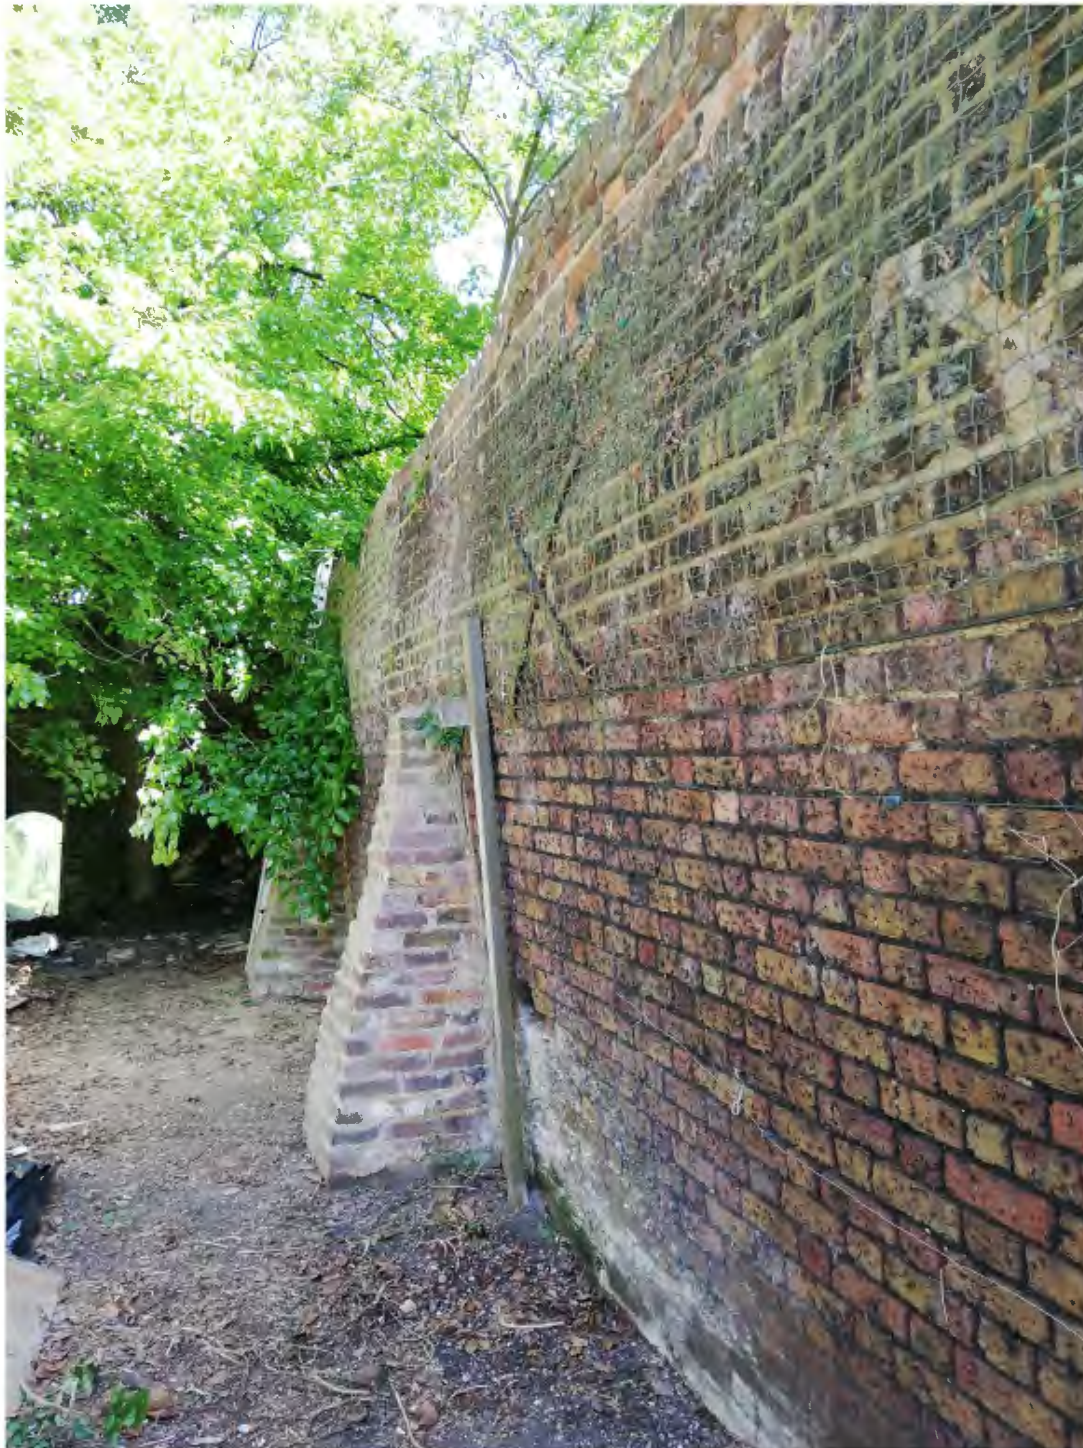
Photo 11, North Section of Wall showing newer piers and bow at the top of the elevation. Also evident is the anchor plate situated in front of the nearest pier.

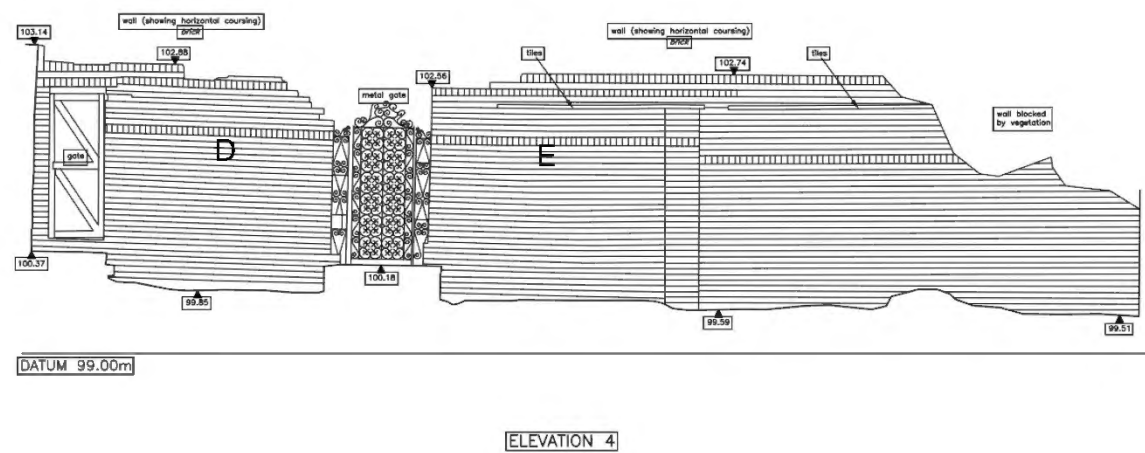
Elevation 4, Matrix Surveys

Once the vegetation had been removed from this section of the wall we were able to see the condition of the masonry. The new brickwork and cement mortar is more visible on this side of the wall and, similar to the northern section, there is a slight bow to the wall at approximately 2.3m above ground level.

Measurements taken on site of the lean to the wall were measured at 51mm and 110mm which correspond to the locations D & E on Elevation 4.

We also recommend introducing two new piers either side of Opening 1 to strength this wall panel and repair the upper courses of masonry.

Elevation 4 & the upper section of Elevation 2 would then be reinstated with concealed wind posts to provide the required structural capacity.

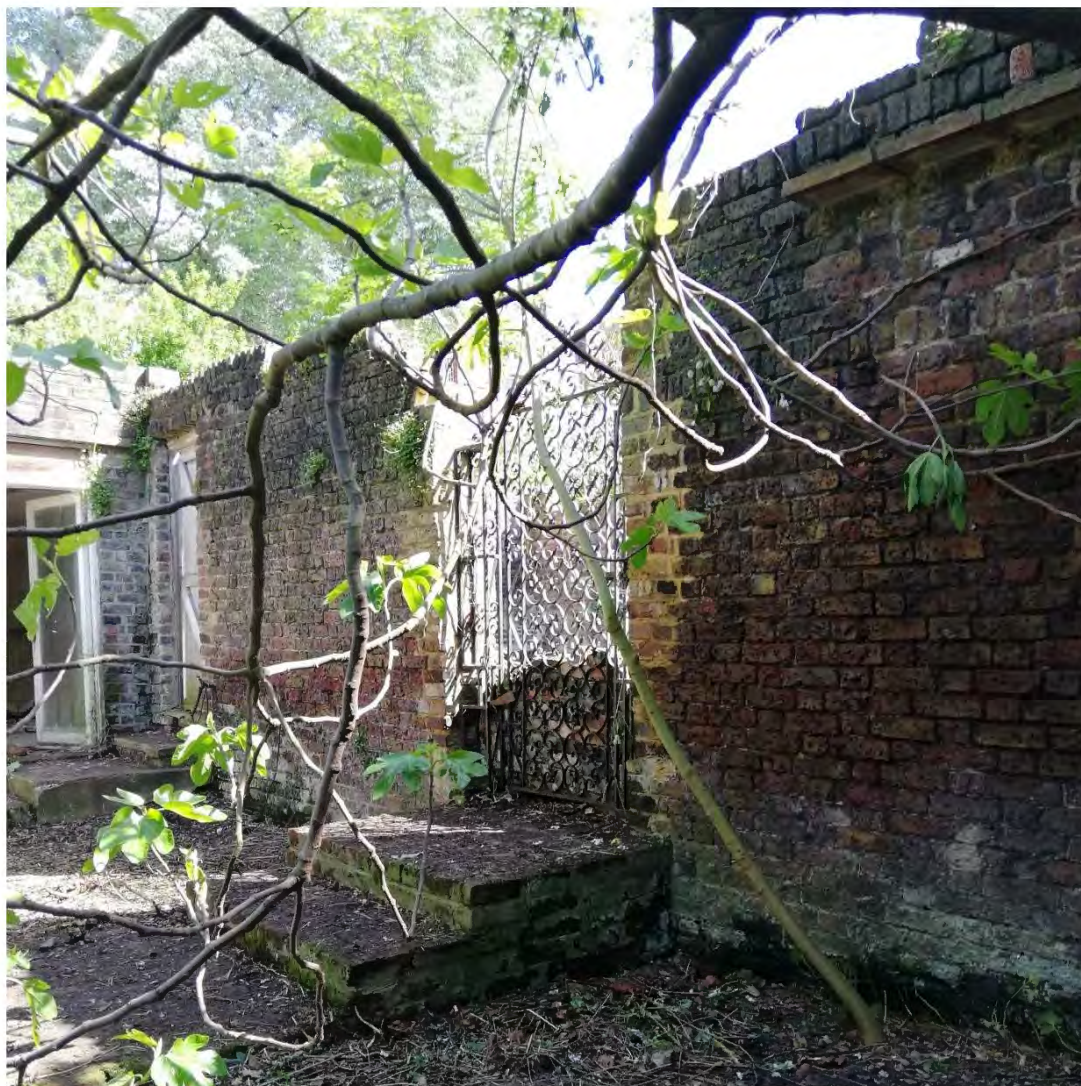
Photo 14, Opening 1 in foreground with Opening 2 & Outbuilding in background

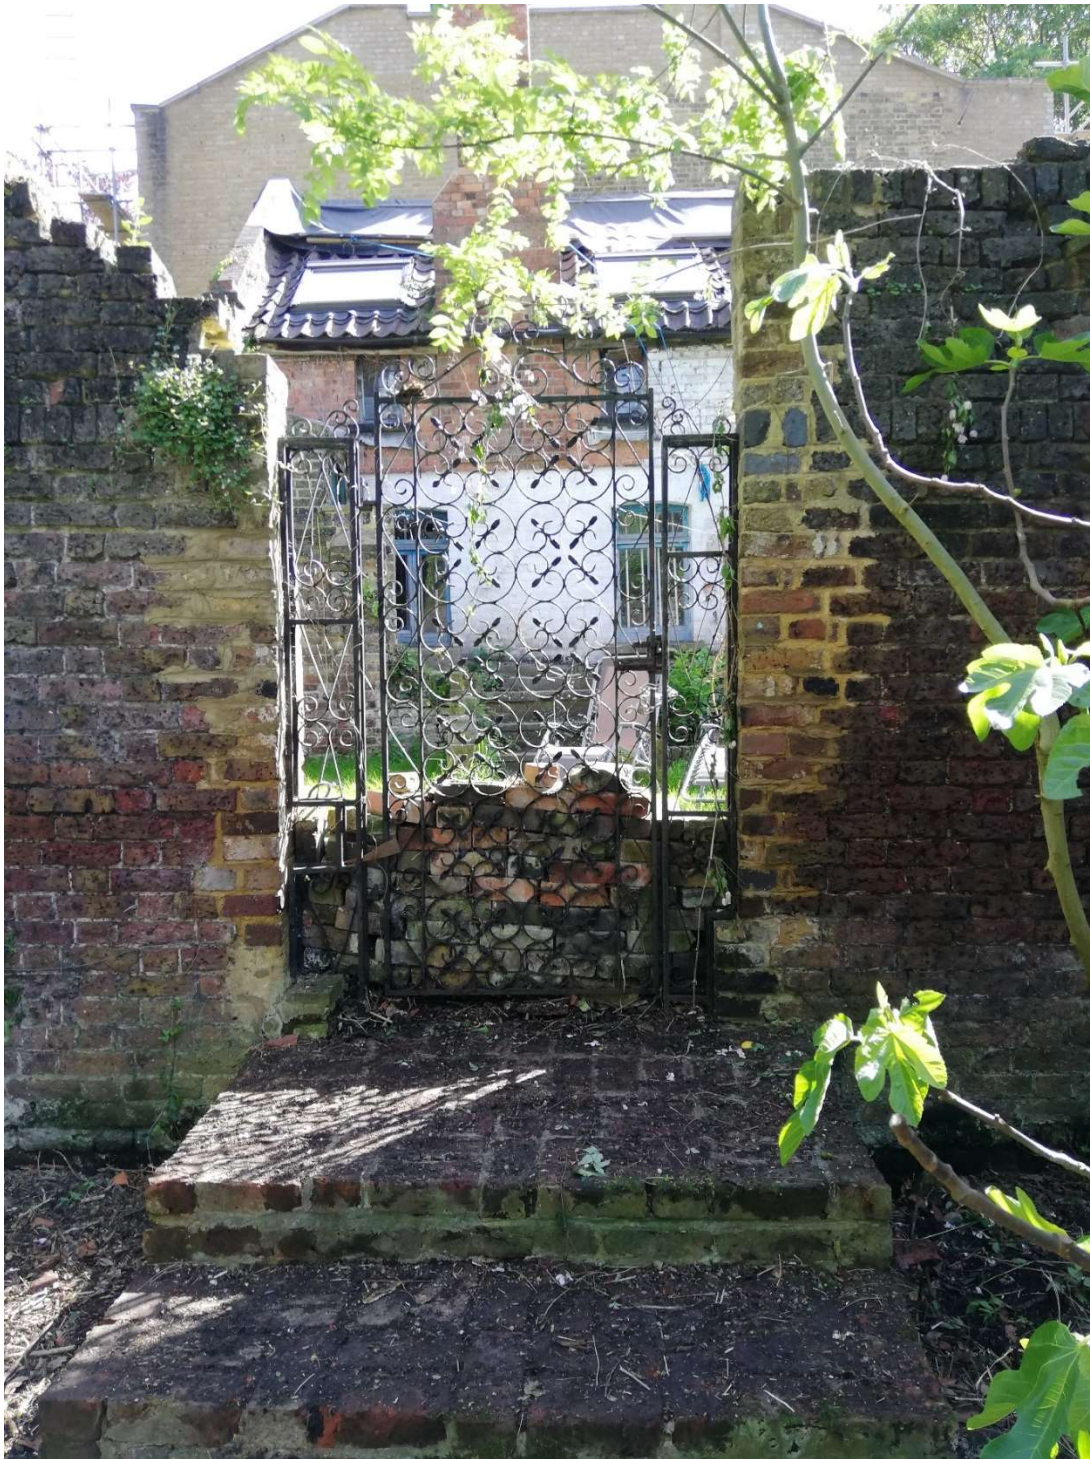
Photo 15, Opening 1 with new brickwork evident

As with observations from the 20 Perrins Walk side, the top masonry courses are noted to be in poor condition.

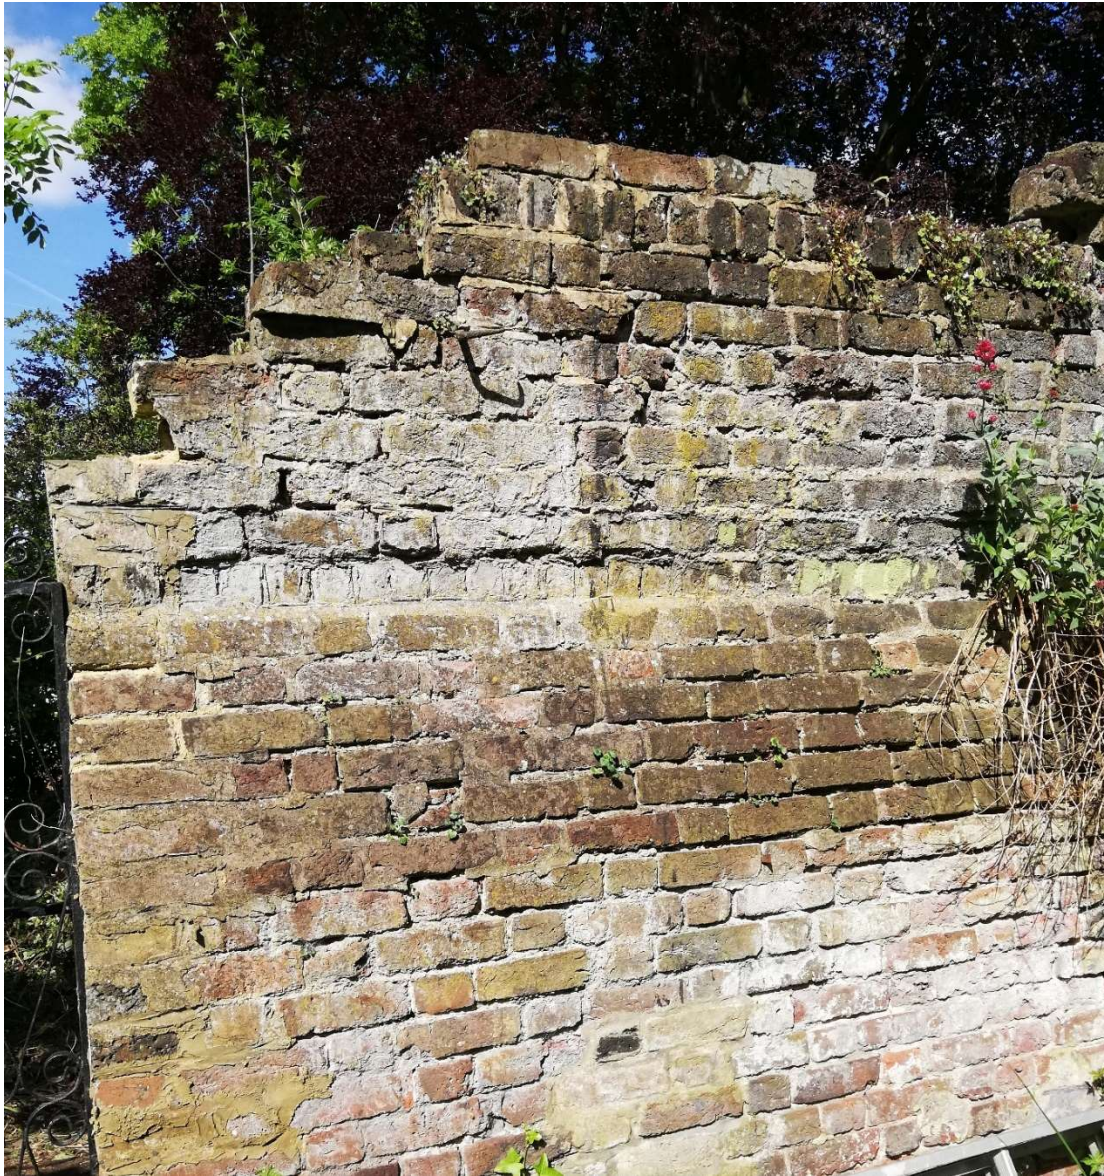
Generally the masonry on the 20 Perrins Cottage elevation looks to be in worst condition. This is probably due to increased exposure from its orientation. If the wall is strengthened rather than rebuilt, both elevations would require repointing.

Photo 16, Disrepair at the top of the wall adjacent to Opening 1

Where possible all masonry should be reused or new to match existing, and any re-pointing should be done with a suitable lime mortar by Limetec or similar in accordance with our specification.
