STRUCTURAL CALCULATIONS

**154 Royal College Street,
London,
NW1 0TA**

SURVEY REPORT

Project No. 190508

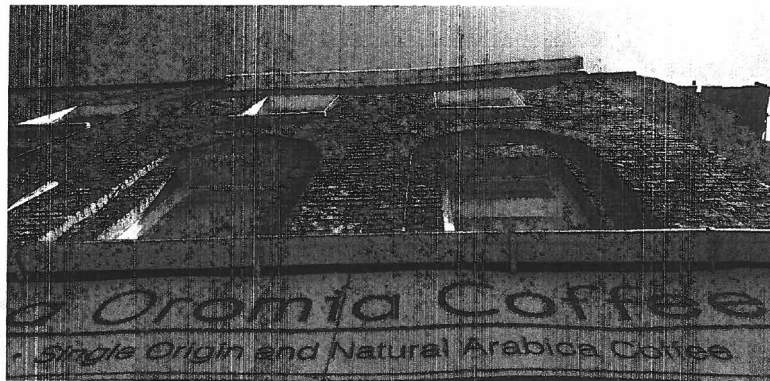
The property is situated along a level road with no significant gradients. When looking at the front of the building, it is very apparent that the window and decorative arches are non-symmetrical. The front façade looks distorted to an extent where obvious movement has occurred.

The coping to the roof looks to be sagging to a max around the centre of the span between the 2 upper floor windows. The brickwork also looks to be following the same pattern. The cladding above the ground floor shop unit is also deflecting, following a similar shape to that of the roof coping but with a higher deflection. The arches over the first-floor windows are slanted leaning toward the centre and similarly to the header courses over the upper floor windows.

Pic 1 – View of front elevation at street level

Our recommendation is to rebuild the front elevation, leaving a section of the side panels to maintain stability whilst the central portion is removed. The contractor should remove each brick and stack for reuse. The removed section should commence at shopfront beam level as this is the location where the sagging started. The new wall should be built creating an exact replica of the existing including all arches and indentation, stitched and bonded into the remaining side panels. A carefully created method statement should be drawn up proposing the sequence of works to ensure a safe and structurally adequate rebuild.

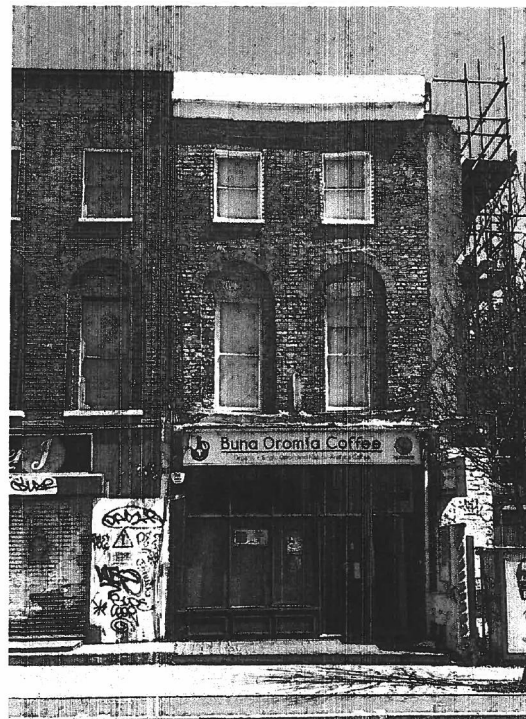
The front wall is not only sagging towards the centre but is also not vertical. The wall starts to lose verticality at first floor and continues to the roof level. Therefore, the degree of non-verticality is far greater at second floor level.

The most concerning part of the wall are the arched lintels over the first-floor windows. Arches rely on symmetry to avoid any over stressing at any points along the arch. This can be seen with some blown sections of mortar which will lead to failure and eventual collapse.

Pic 2 – View of front elevation

Upon the rebuild, we would also suggest installing brick reinforcement to provide additional resistance to the entire wall.

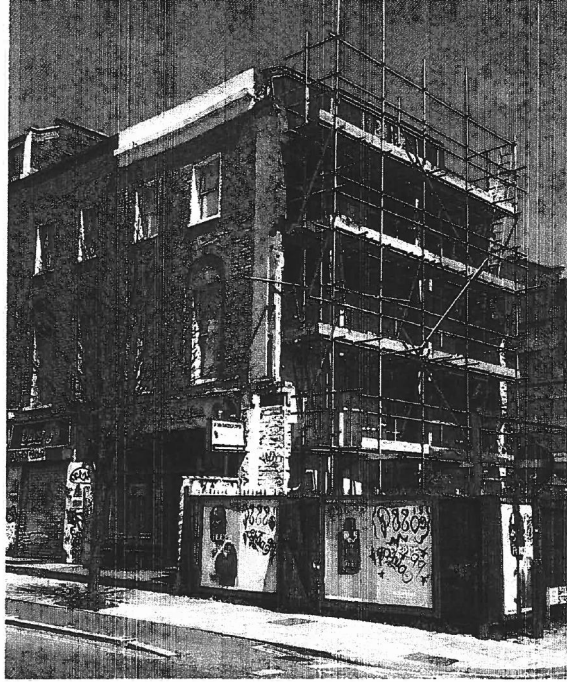
The adjoining building which would have been the end of terrace has been demolished. We do not believe to be significant at this stage.

Pic 3 – View of side elevation

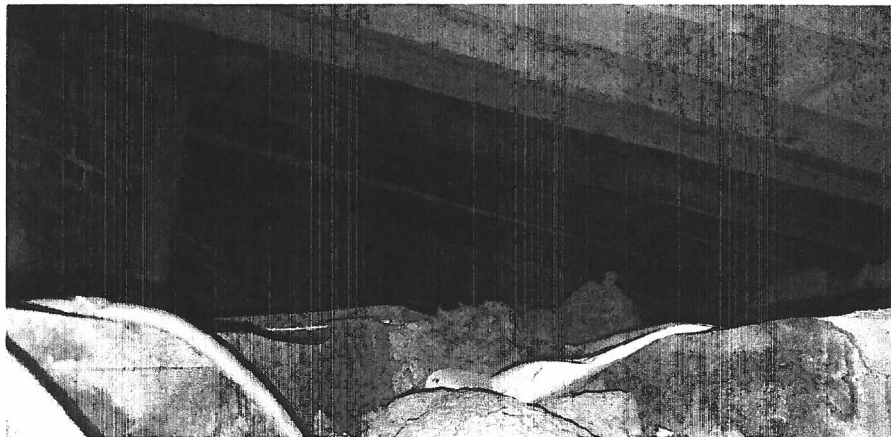
The roof consists of a butterfly style timber frame and sagging can be seen at the valley point, which is down the centre of the building.

Pic 4 – View inside the roof space

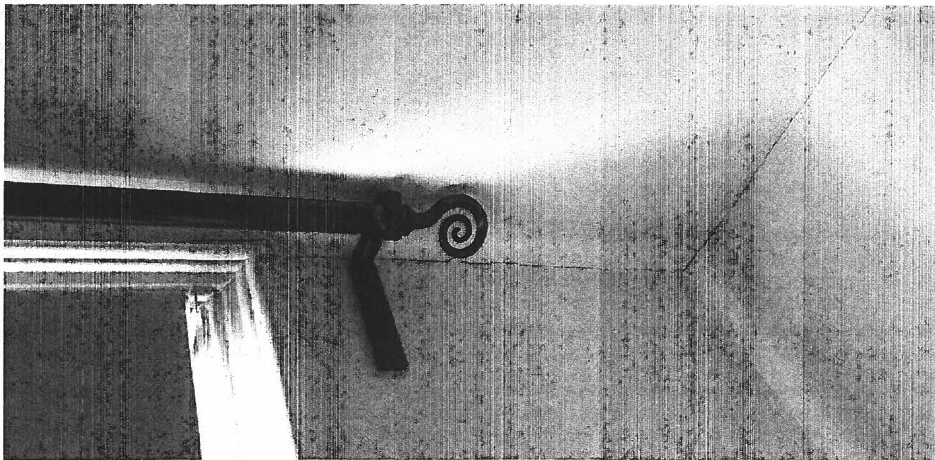
Internally, it is obvious to see the ceilings and floors are not horizontal and falls are felt all over with the deepest sag towards the middle of the building. Skirting boards can be seen coming away from the wall and significant plaster cracks along the interface between walls and ceiling.

Pic 6 – Internal crack at ceilings
