**Brill Owen  
Pakenham Street  
PAS128 M4P Utility Mapping Survey  
Site Report  
Project No. 1752**

Prepared by:  
James Ephgrave  
40SEVEN Limited

Commissioned by:  
Stephen Manship

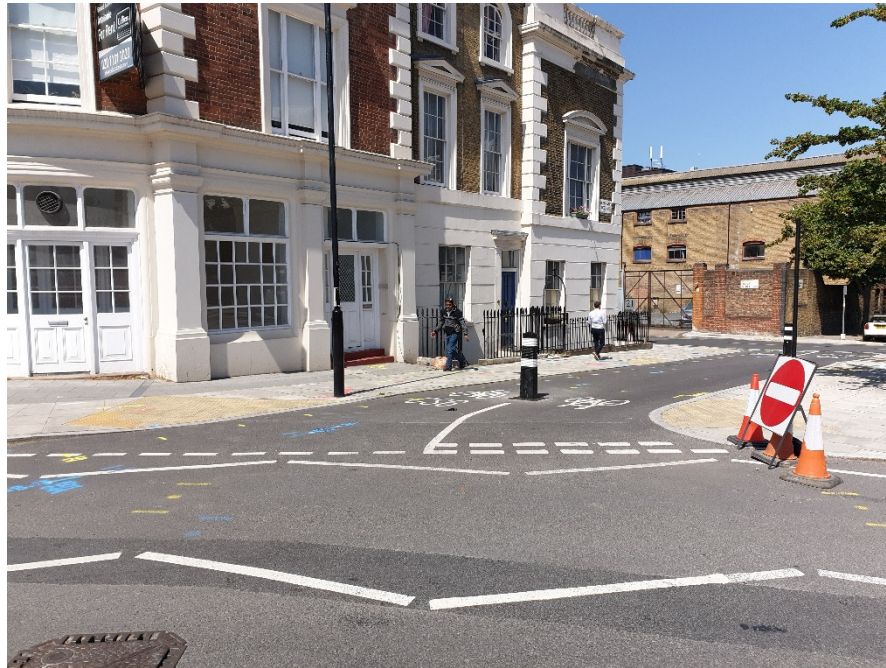
**Photo 1**

**Description: General View of survey extents.**

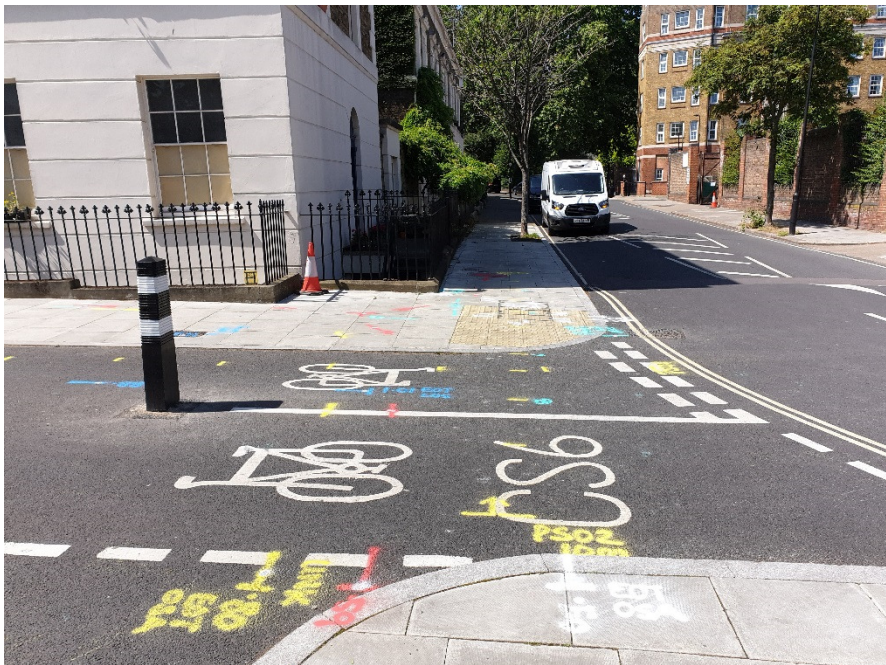
**Photo 2**

**Description: General View of survey extents.**

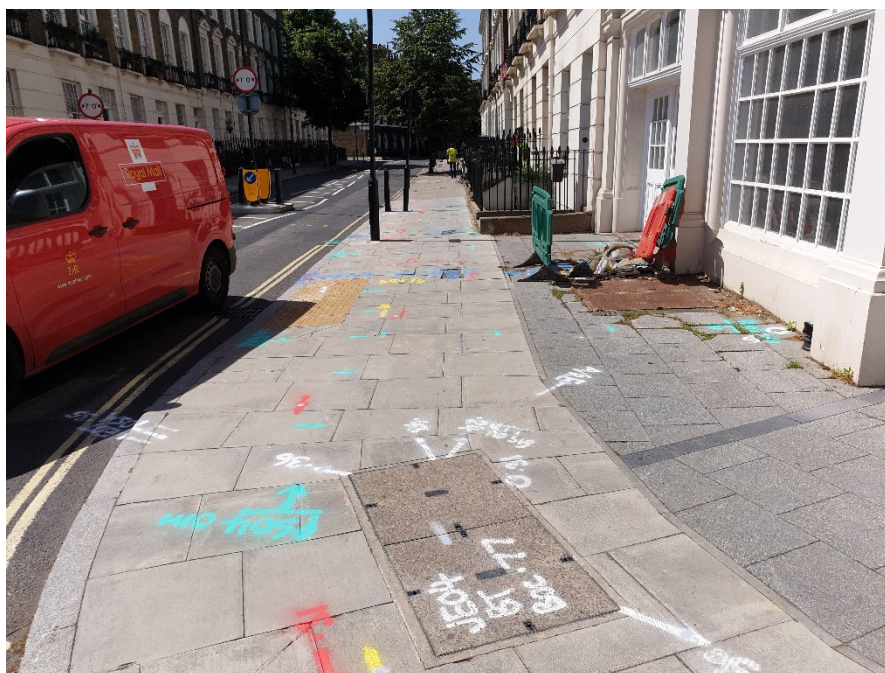
**Photo 3**

**Description: General View of survey extents.**

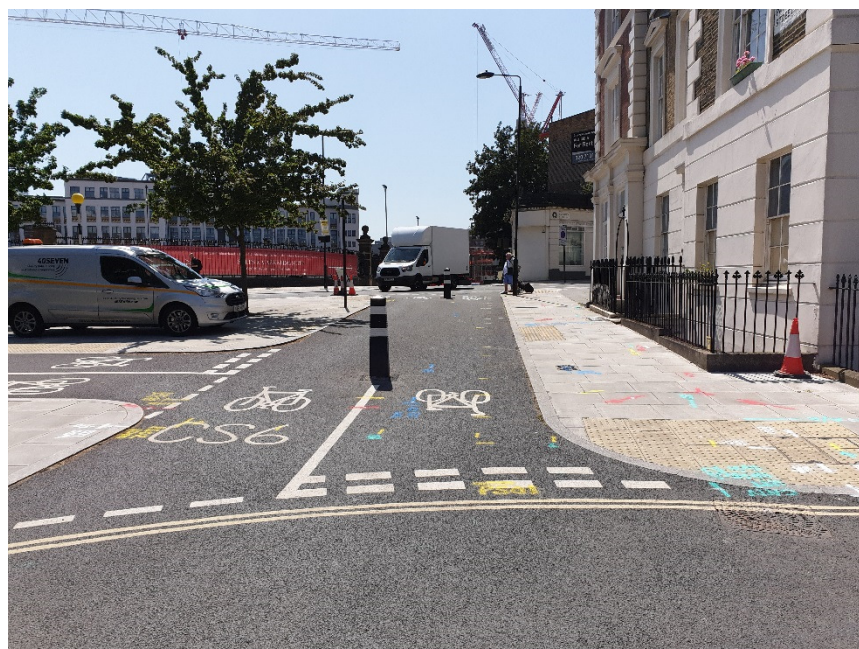
**Photo 4**

**Description: General View of survey extents.**

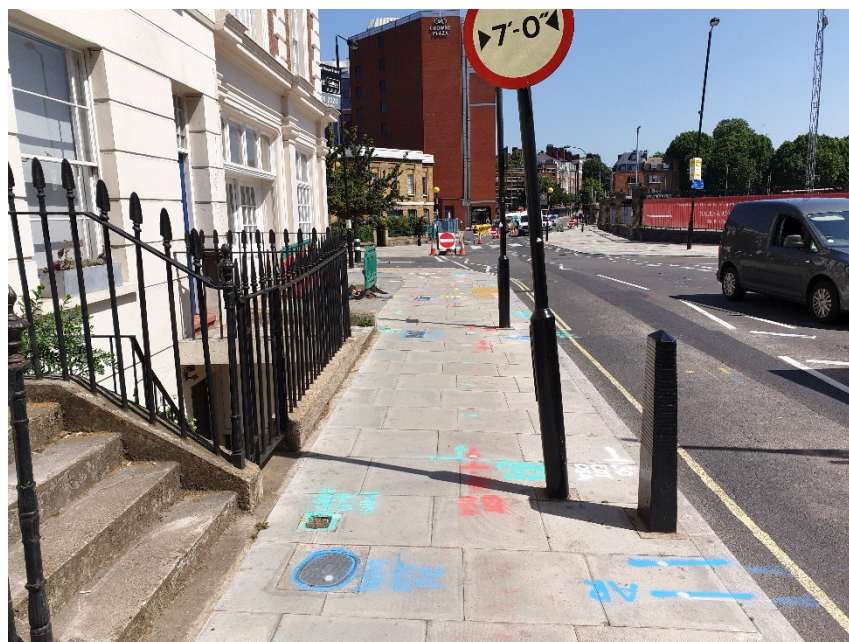
**Photo 5**

**Description: General View of survey extents.**

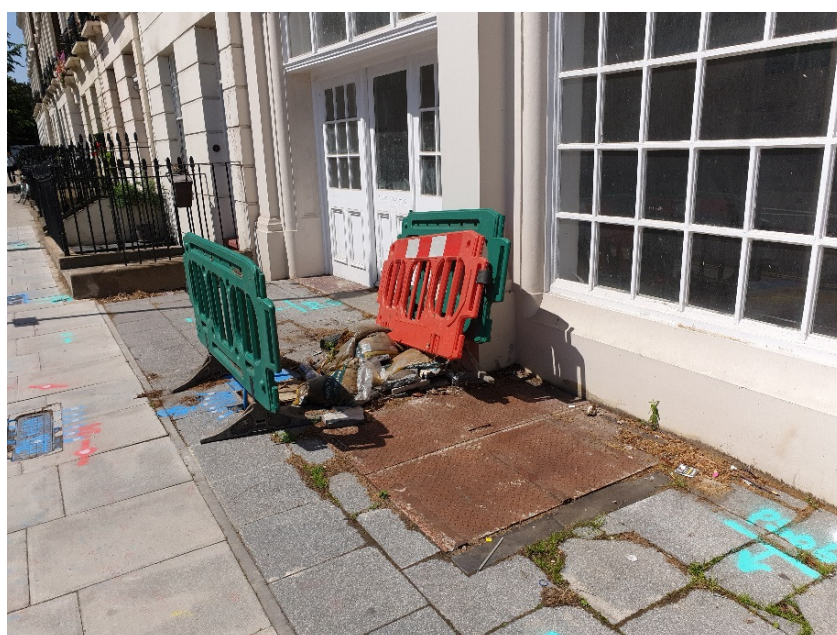
**Photo 6**

**Description: General View of survey extents.**

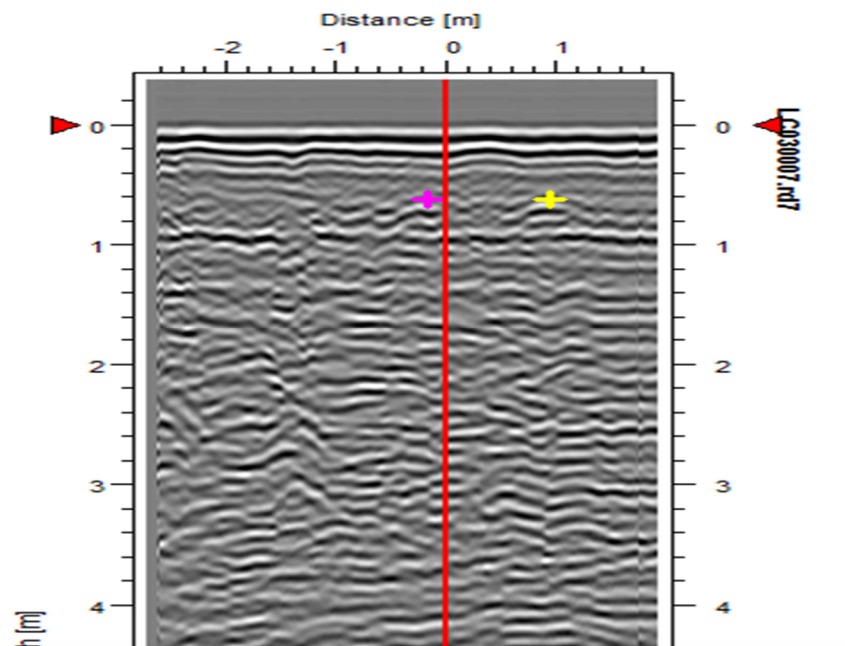
**GPR 1**

**Description: Examples of GPR Images.**

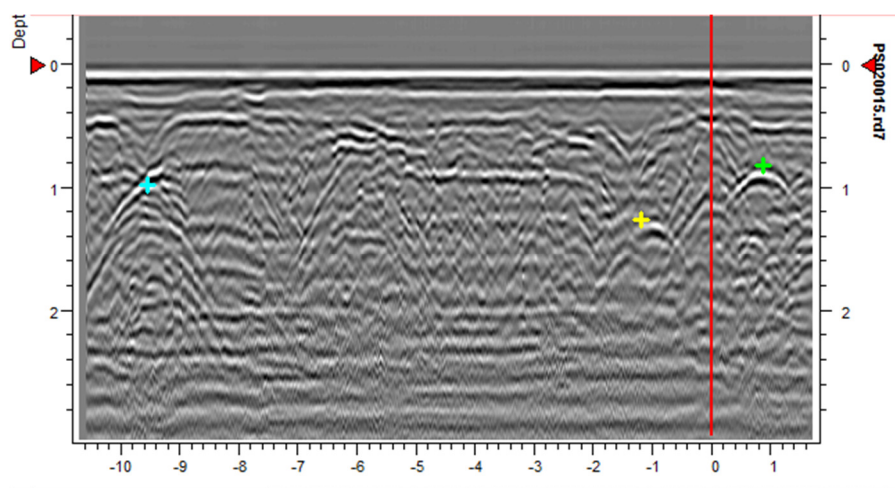
**GPR 2**

**Description: Examples of GPR Images.**
