## SITE INVESTIGATION FACTUAL REPORT

Report No: [REDACTED]  
Client: Sedgwick International UK - Maidstone  
Site: 15a & 15b Fitzjohns Avenue  
Client Ref: [REDACTED]  
Date of Visit: 07/08/2019

Home Emergency Response - Subsidence Investigation - Drainage Services – Crack & Level Monitoring – Property Video Surveys

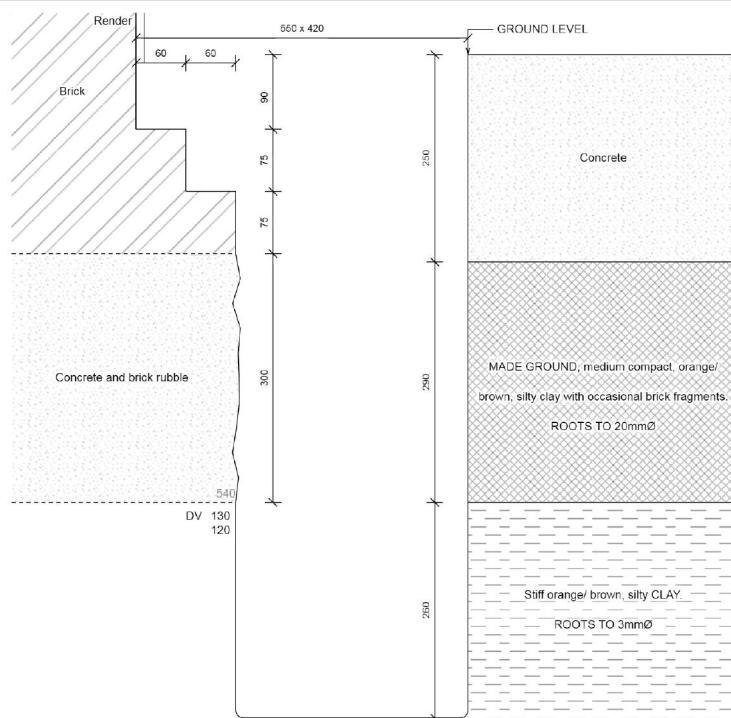
TRIAL PIT REF: TP1

For Strata below 800mm see Bore Hole log
