#### FURTHER INVESTIGATION REPORT:

Whitestone House Hampstead NW3 1EA

Ref: JFA/WSH/PCS/02 Date: 8th May 2019

Carry out Resistograh testing of two trees, T4 and T8 and carry out Picus Tomograph Decay detection on the main stem of T5.

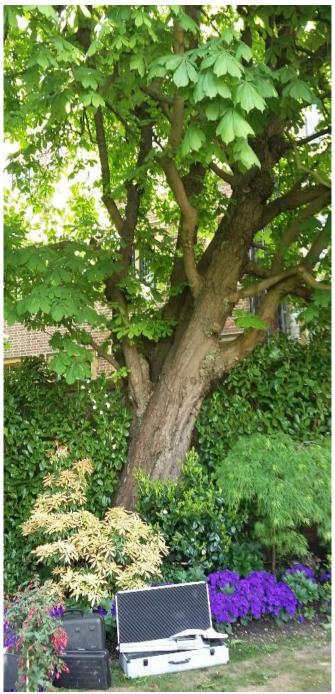
Photograph 1: T4

This mature tree is situated on the southern boundary of the property 0.5 metre from the fenceline. It leans south west and part of the stem is in contact with the top of the fence at 2m. There is a cavity from ground level to 1.8 metres height to the south. The cavity has callous wood around its periphery and is starting to occlude.

Crown reduce by 3-4m to reduce wind loading within 12 months

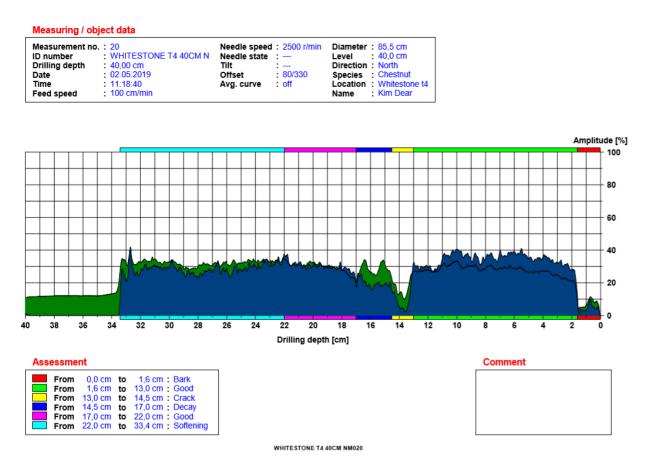
Figure 1: Resistograph trace of drilling of north side of stem 40cm above ground level

Comparison of the Resistograph traces from 2016 with those shown above showed no significant alteration in the structural integrity of the stem.

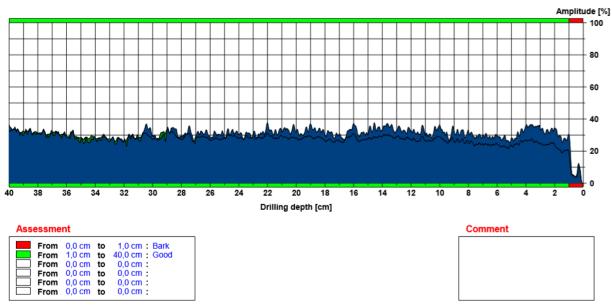
WHITESTONE T4 40CM EM021

Figure 2: Resistograph trace of drilling of east side of stem 40cm above ground level

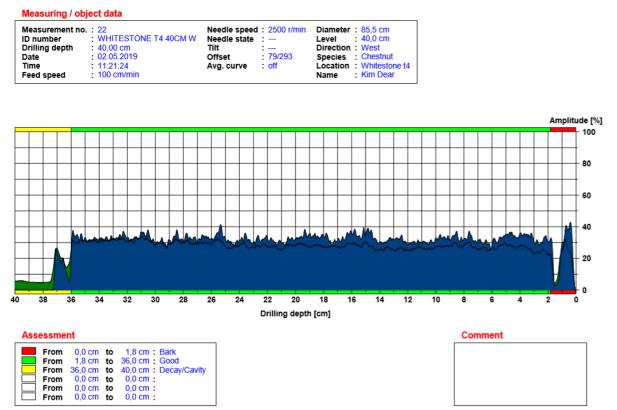
WHITESTONE T4 40CM WM022

Figure 3: Resistograph trace of drilling of west side of stem 40cm above ground level

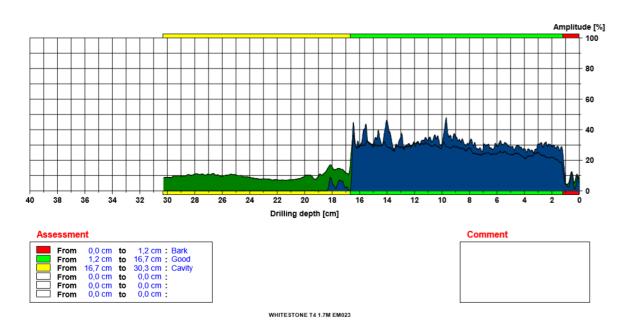
Figure 4: Resistograph trace of drilling of east side of stem 170cm above ground level

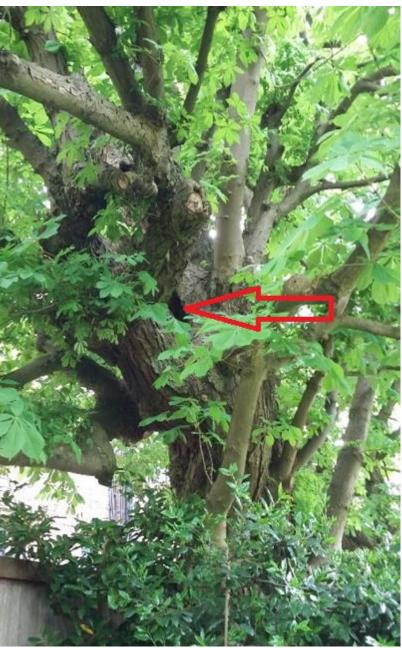
Photograph 2: T5 (note cavity indicated by arrow)

This mature tree is 10 metres East of T4, 0.5m from the southern boundary of the property. It has a cavity at 4 metres above ground level (as shown in Photograph 2) and further cavities throughout the crown. This tree was tested by Picus Sonic Tomography in 2016, and was shown to have a substantial cavity at 30cm above ground level.

A climbing inspection was also carried out, and a plumb line dropped from the cavity at 4 metres confirms the tree is hollow into the root ball below ground level.

The tree should be either felled or re-pollarded to 4m in height within 12 months.

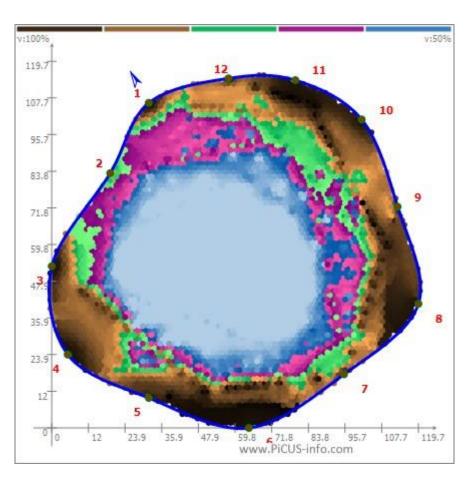
Figure 5: Tomograph of main stem of T5 taken at 40cm above ground

The combination of the extent of the decay cavity at the base of the main stem both radially and axially and the leverage effect of the pollard regrowth indicates a high likelihood of failure at the stem base.

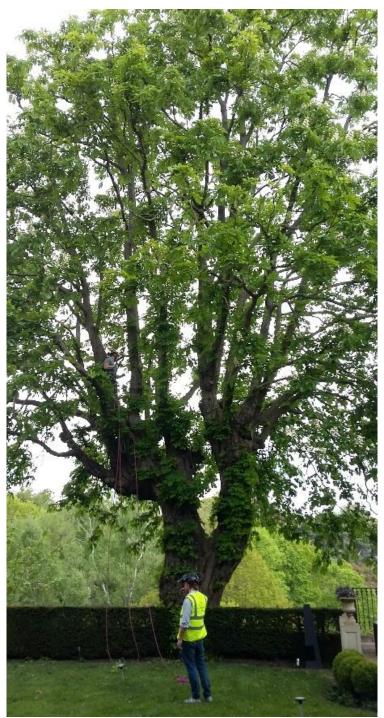
Photograph 3: T8

This tree is situated on the northern boundary of the property. It is on a near vertical bank, with a 3metre difference in ground level north to south. There is a retaining wall included into the stem to the east and west. The crown was pollarded approximately 15-20 years ago, and there is substantial regrowth from the pollard heads, some of which are decayed / exhibit cavities.

Crown reduce by 3-4m to reduce wind loading within 12 months with a larger (5-6m) reduction of the regrowth from decayed pollard heads.

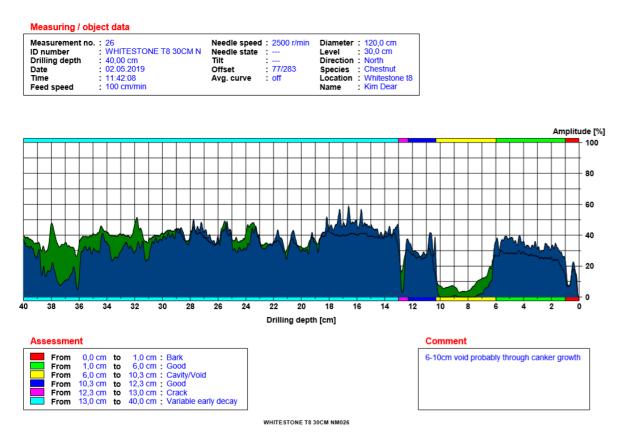
Three Resistograph tests were performed, one at the base of the tree, 3 metres below the garden of the property, and two at a level with the garden. These show some varied levels of decay on the north side of the tree. There are no fungal pathogens currently visible, so this decay could be attributable to the damage caused by the proximity of the retaining wall to the stem.

Figure 6: Resistograph trace of drilling of north side of stem 30cm above its base

The Resistograph traces identify they presence of some decay within the main stem but that this decay is not currently of a significant level.

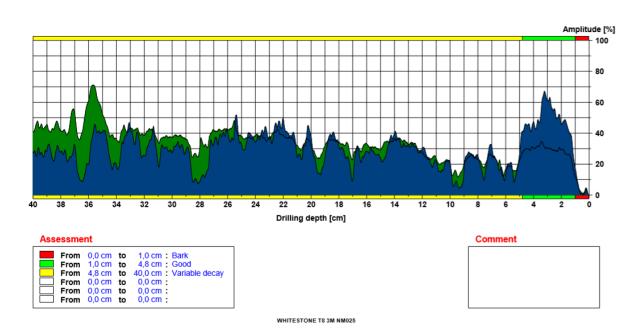
Figure 7: Resistograph trace of drilling of north side of stem 3m above its base (garden level)

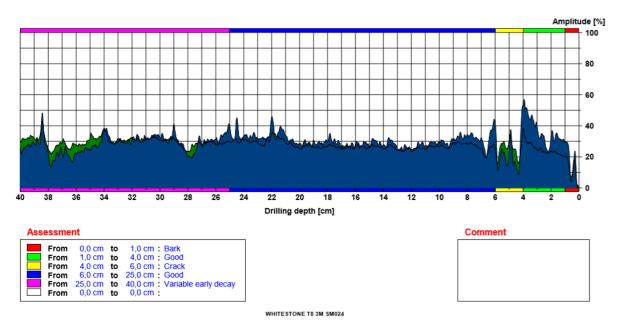
Figure 8: Resistograph trace of drilling of south side of stem 3m above its base (garden level)
