Project Name: St John's Downshire Hill

Visual Inspection Report

Date: August 2018

Project Number: A5653

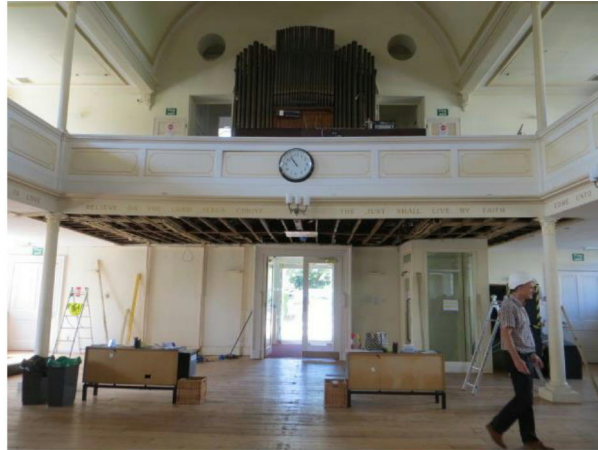
- 3.4.1 The transverse edge beam spans approximately 8.5m, and has a noticeable deflection at the midpoint. This was measured at approximately 45-50mm, which is a large deflection, even over such a span. The architect and client noted that the deflection has always been there to the best of their knowledge, and existed at the time of the 2004 refurbishment.

Photograph 1
General view of balcony, showing central deflection

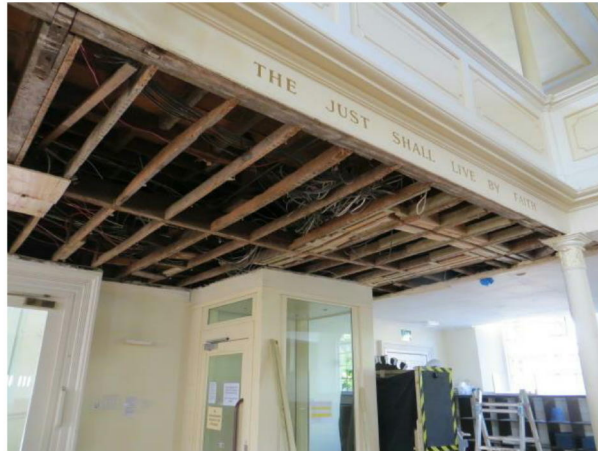
Photograph 2
General view of timber structure

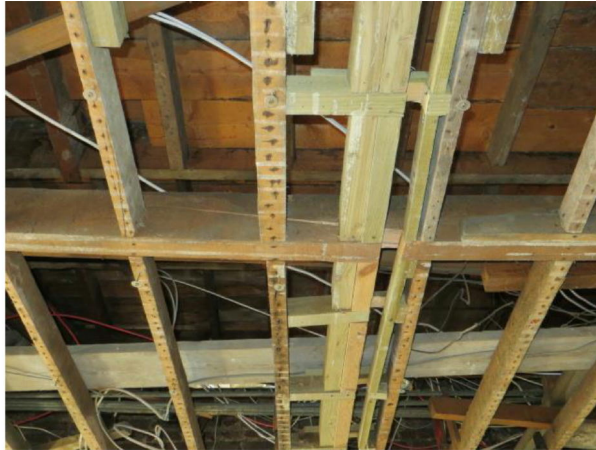
Photograph 3

- 3.2.1 In general there are some long spanning timber elements, and the notching out has significantly reduced the capacity of some of these members. Of particular note are the two timbers which support the ceiling joists, which span between the trusses. From each of the locations where these have been notched large splits have formed and the beams have failed. It is likely that the resulting deflection will have been one of the main factors of the cracking within the ceiling. These members require replacing.

Notching to eastern ceiling support member causing failure

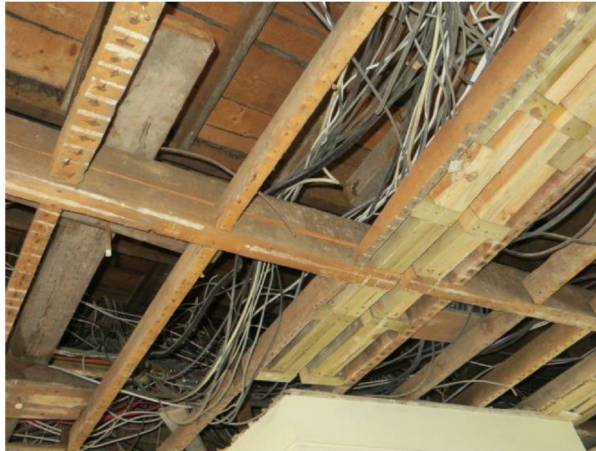
Photograph 4

Notching to western ceiling support member causing failure

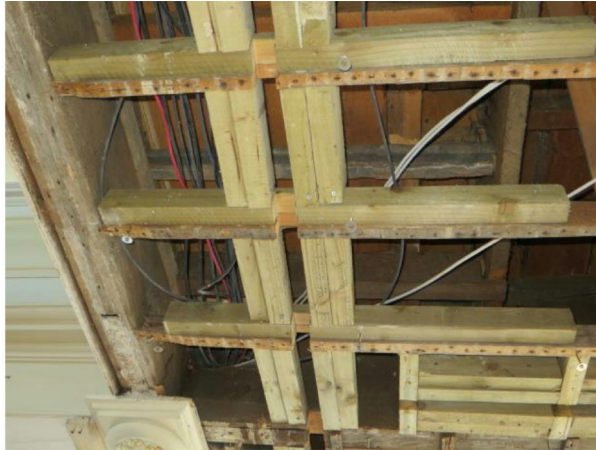
- 3.2.2 A number of the ceiling joists have been notched and strengthened with timbers connected to the side. However, the strengthening timbers have also been notched which has significantly reduced their capacity. These strengthening timbers should be removed and new timbers screwed to the side of the notched ceiling joists.

Photograph 5
Notching ceiling joists and strengthening

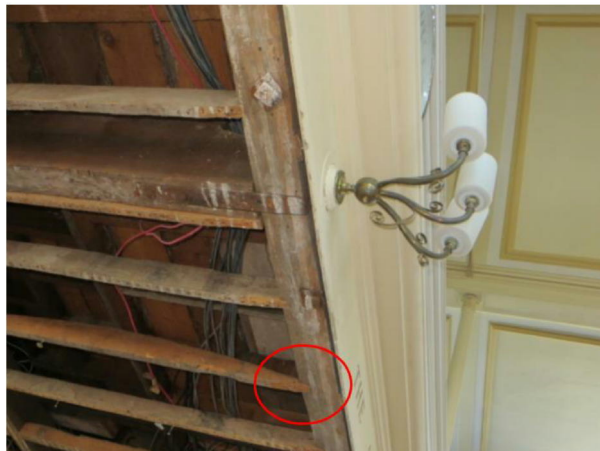
- 3.2.3 The ceiling joists appear to be original, and a variety of sections have been used. In some cases this means there is only a very small cross section at the end with little connection to the supporting beams. Some joists therefore have inadequate support and a new member should be inserted adjacent to the existing to pick up the laths. The original ceiling joists should be retained.

Photograph 6
Inadequate connectivity of ceiling joists

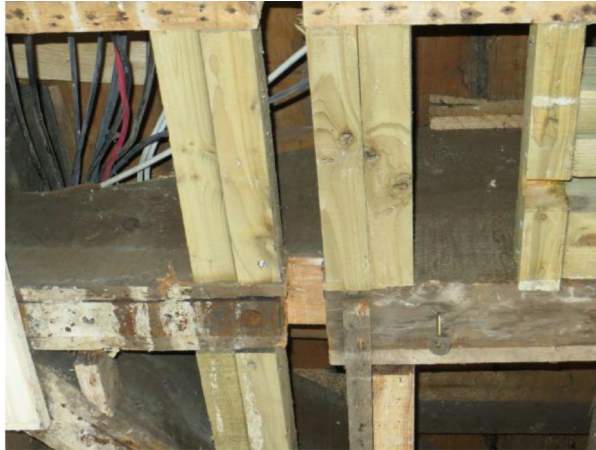
- 3.3.1 The bottom chord (tie member) of the two trusses which connect into the columns have been notched near the column head. This has reduced the section capacity but there was no evidence of excessive deflection or failure of the trusses.
- 3.3.2 Holes have been drilled through the centre of the diagonal member of the trusses. This will have reduced the capacity of the member, but as these are generally slightly above the centre they are likely to be within the compression zone, so capacity could be reinstated by infilling these holes.

Photograph 7
Notching through tie beam

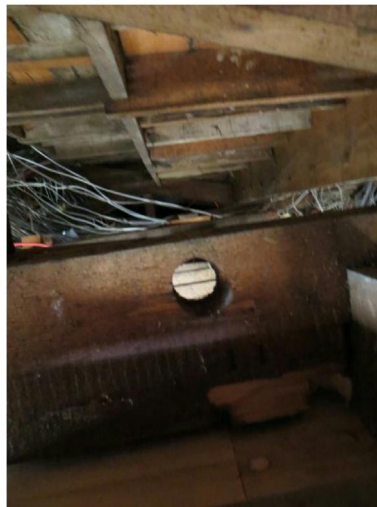
Photograph 8
Hole through tie beam

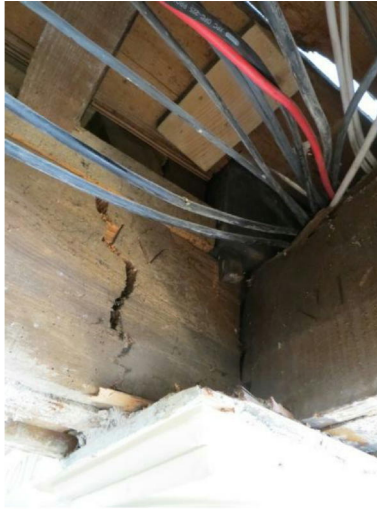
- 3.4.2 There is a significant crack at the eastern end of the transverse beam, amounting to a full failure at the bearing over the column. The crack pattern could be indicative of either bending failure of a continuous member at this point or shear failure of a simply supported member. Due to the tight nature of incoming beams it was not possible to determine if the beam is continuous or not.

Photograph 9
Crack to bearing of transverse edge beam

- 3.4.3 While the crack appears to be old, and there does not appear to be new deflection to this member, it was recommended to immediately prop under the support at this location as a safety precaution.

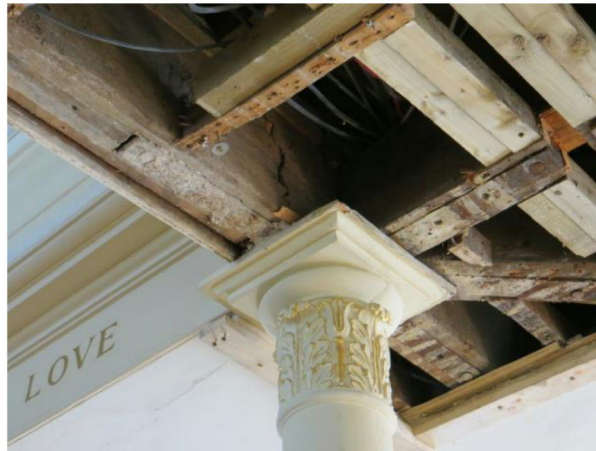
- 3.4.4 The edge beam appears to now be supported on a metal strap projecting over the top of the column, which is not an adequate bearing in the long term as the strap is likely to eventually fail.

Photograph 10
Column head with incoming cracked edge beam

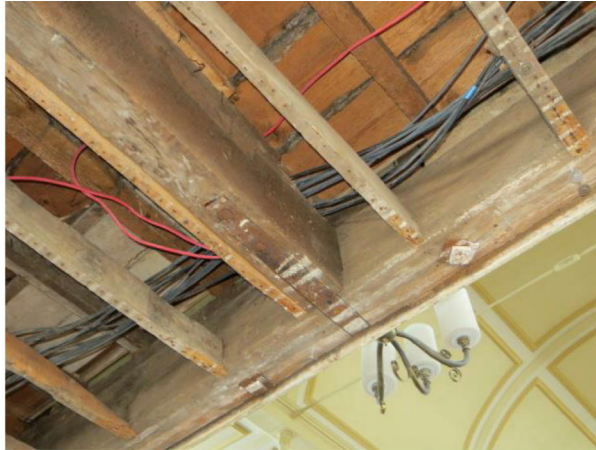
Photograph 11
Centre of transverse edge beam with incoming tie beam

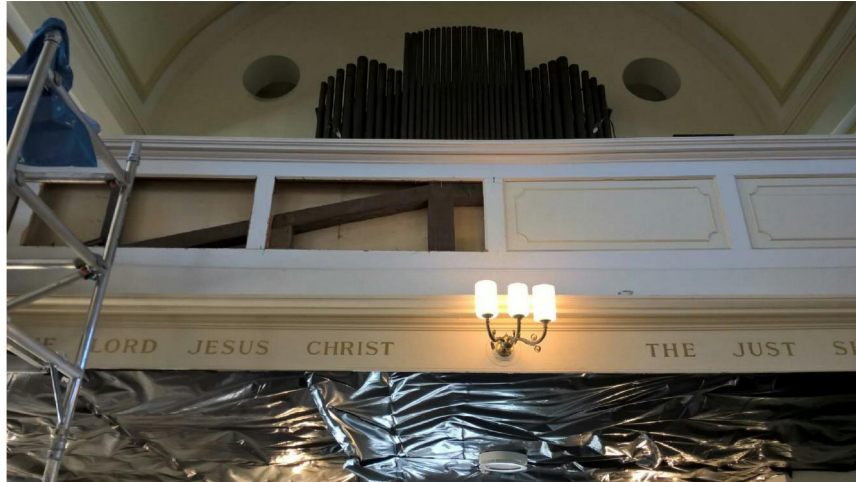
- 5.2 As anticipated, the leading edge of the balcony is formed of a timber truss, with two primary diagonal members, a top chord beam and a bottom chord beam. Bolts are visible in two locations at the underside. The truss arrangement is shown in SK005.

Photograph 12
Opening up to external face of balcony showing truss

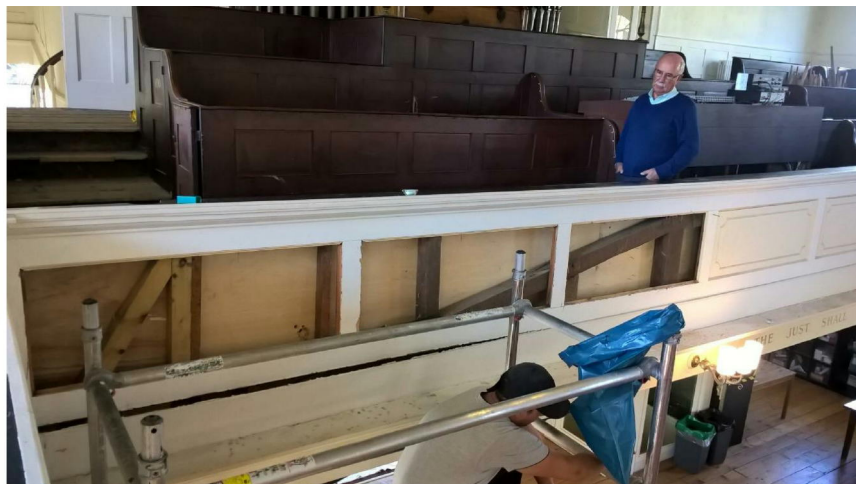
- 5.3 The truss has been strengthened in the recent past (estimated to be within the past 20 years) by the addition of a plywood sheath to the inner face of the truss. This measured around 24mm thick and appeared to well glued and screwed to the primary truss timbers.

Photograph 13
Opening up to external face of balcony showing original truss members (dark) and new strengthening timbers (light)

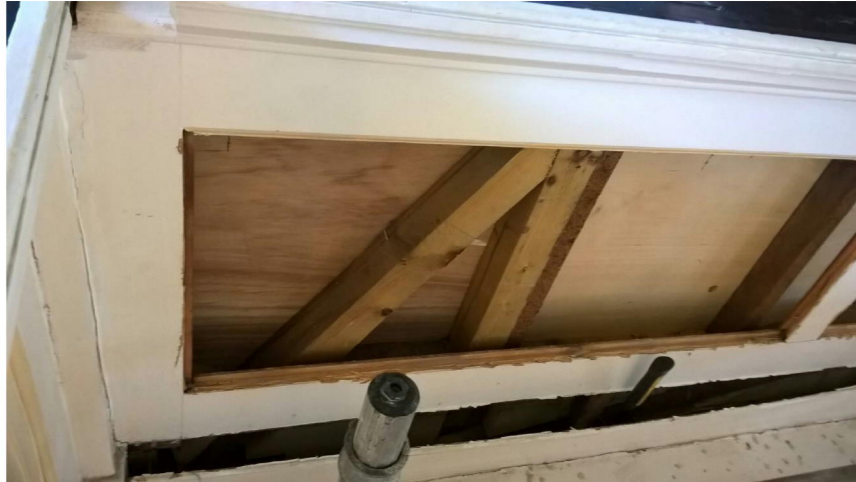
Photograph 14

- 5.4 In addition, over the support, an additional vertical and diagonal timber member have been introduced, also glued and screwed to the plywood.
- 5.5 The arrangement is consistent with strengthening to reduce deflection of the truss, and also to resist shear at the support. The age of the crack implies it is several years old, and the ply installation could not have been carried out without revealing this crack. The new arrangement implies that strengthening of this joint was considered, and the arrangement makes it unlikely that the crack would have occurred after the ply was installed.

Strengthening timbers glued and screwed to plywood sheath

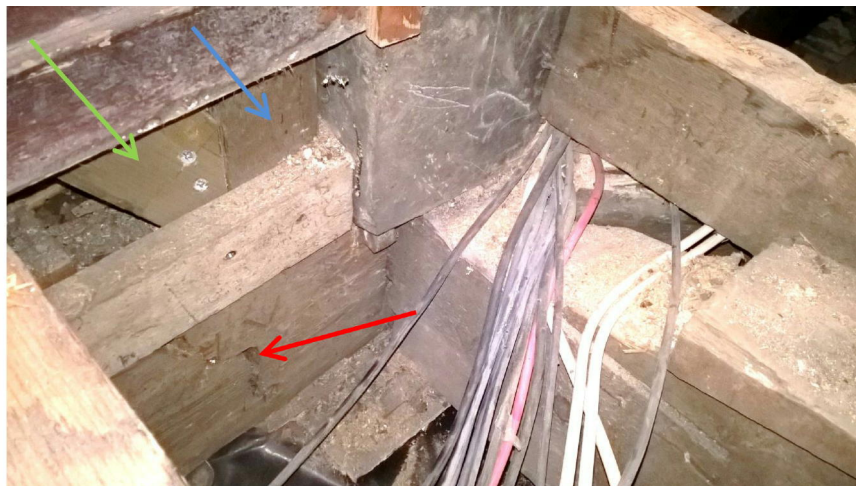
Photograph 15

Connection over column head viewed from balcony internal. Crack to beam (red), strengthening diagonal timber (green), original vertical (blue)

- 6.1 It is considered that the installation of the plywood sheath and additional timber strengthening is providing adequate shear capacity to the beam at the support. Temporary propping and access restrictions to the balcony are therefore no longer required.
- 6.2 The cracking to the plaster ceiling is deemed to be due to notched timbers failing. The repair works outlined in 4.4-4.7 should be carried out and the lathe and plaster ceiling reinstated.
