**BEECHWOOD, HAMPSTEAD LANE – FORMER SQUASH COURT REFURBISHMENT
APPENDIX A: Photographs (November 2015)**

Appendix A: Existing Photographs

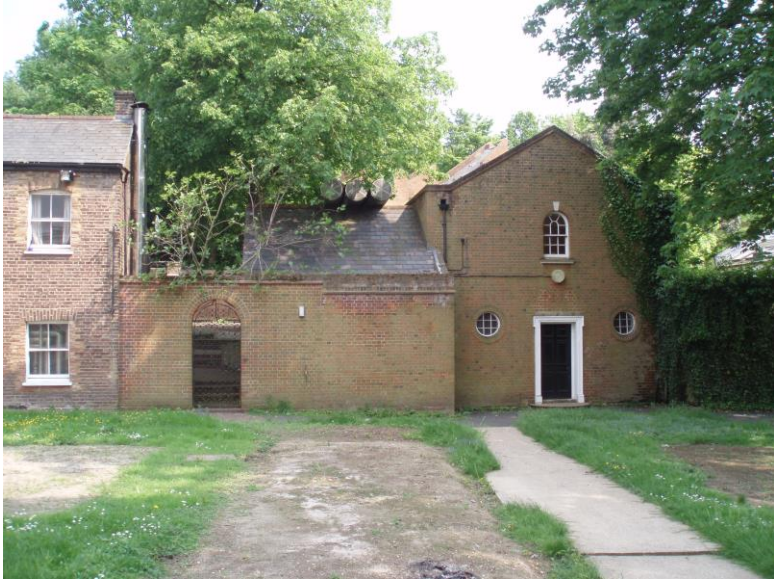
Fig.1 Squash Court in May 2008

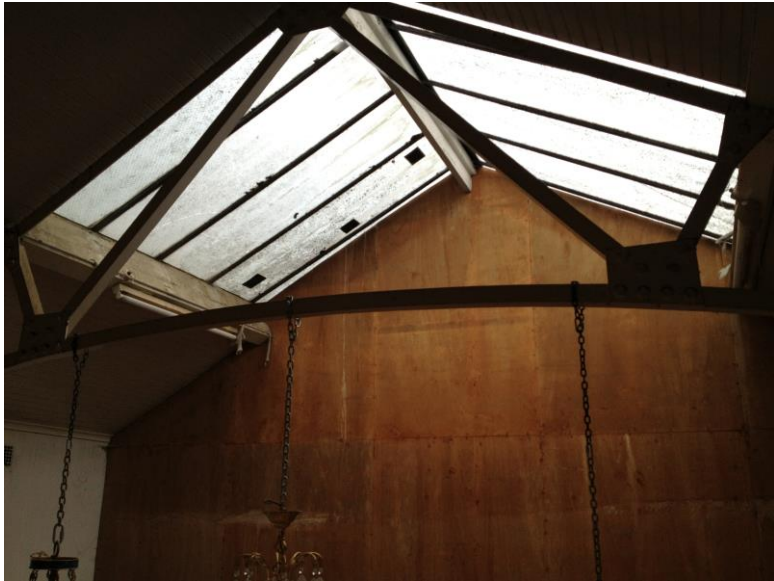
Fig. 2 Dividing wall in former squash court.

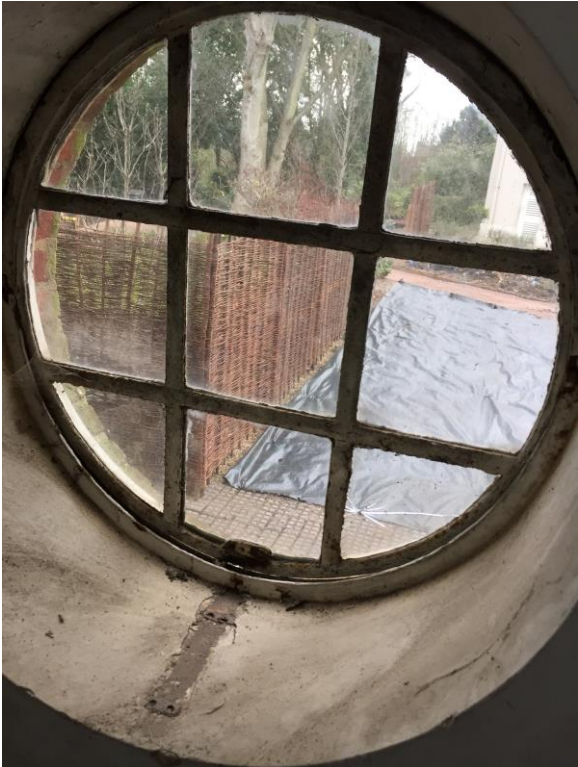
Fig. 3 Corroded metal 'Bullseye' window.

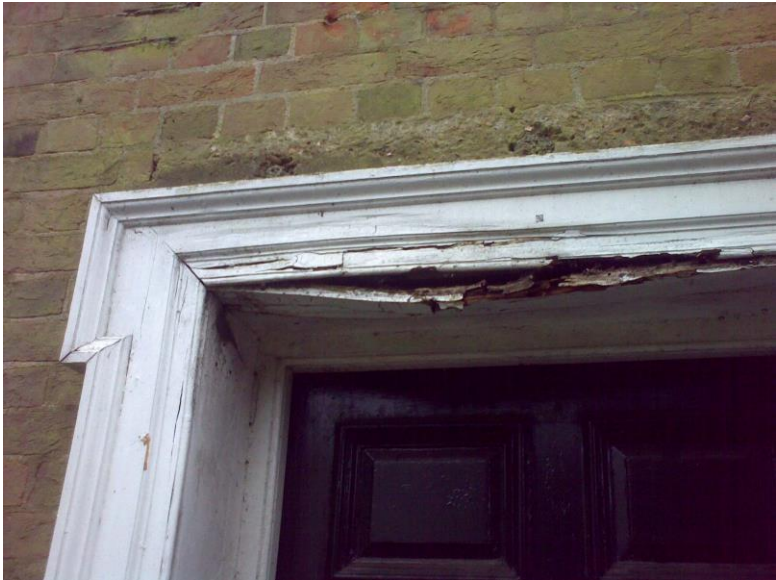
Fig 4 Decayed Entrance door surround

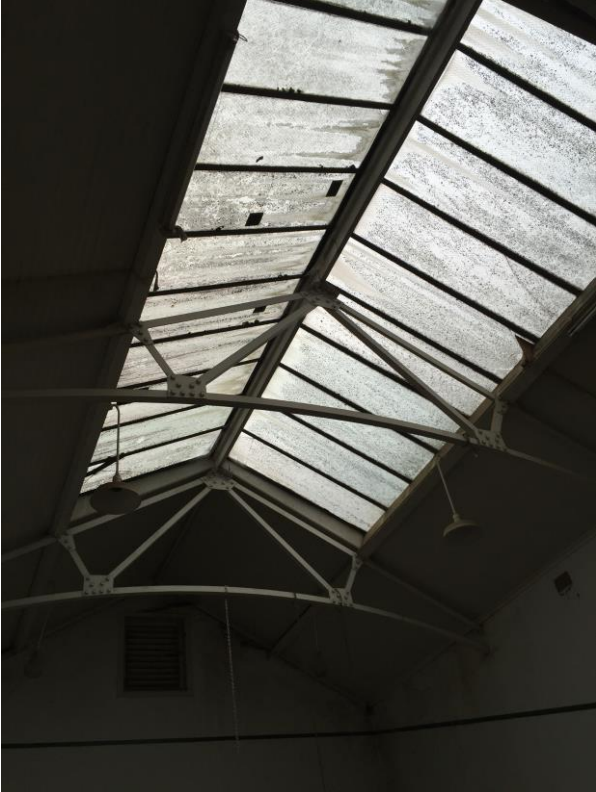
Fig. 5 Cracked & patched single glazed roof light.

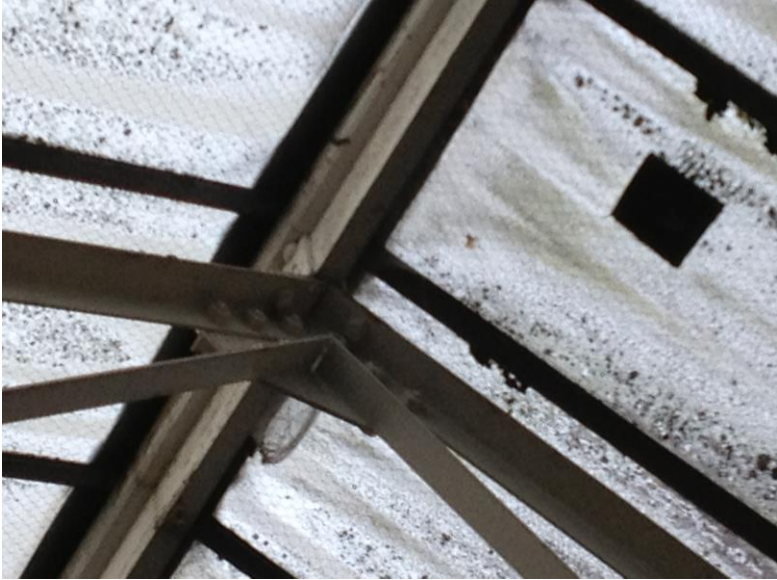
Fig. 6 Detail of roof structure.

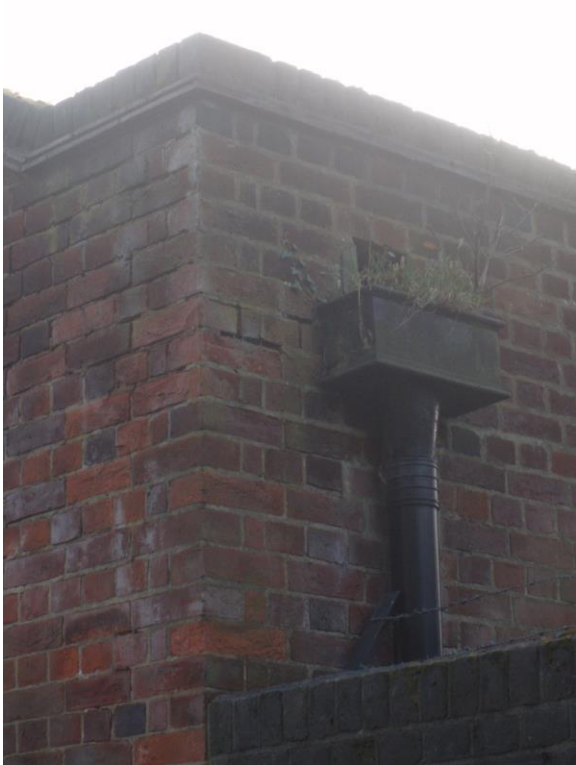
Fig. 7 Weathered parapet and defective rainwater goods.

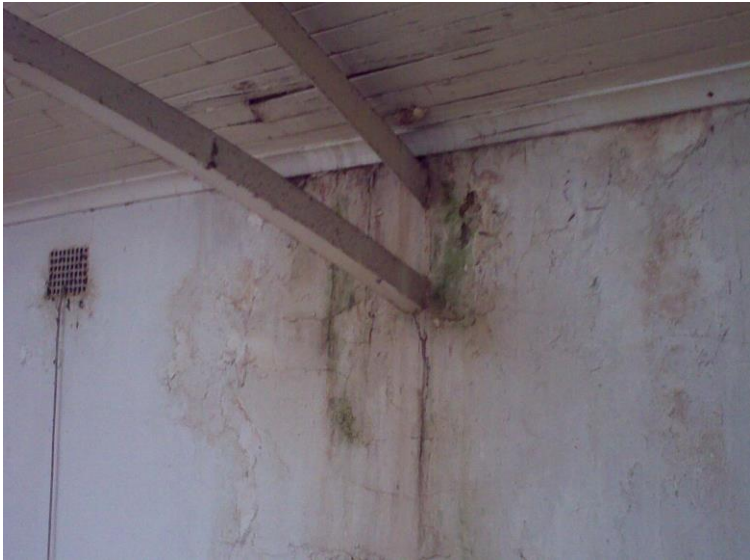
Fig. 8 Water ingress from leaking parapet gutters over truss.

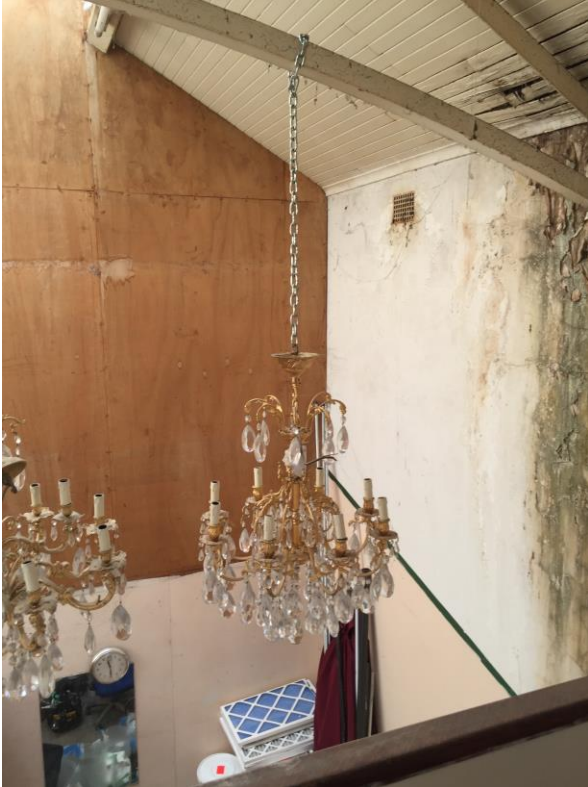
Fig. 9 Previous sub-division of court space by previous owners (present 2008).

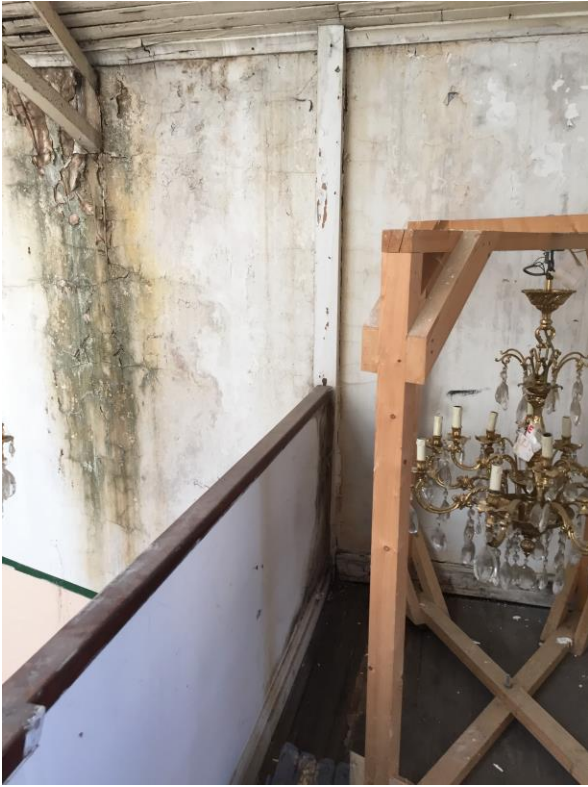
Fig. 10 Damage evident from leaking parapet gutter.

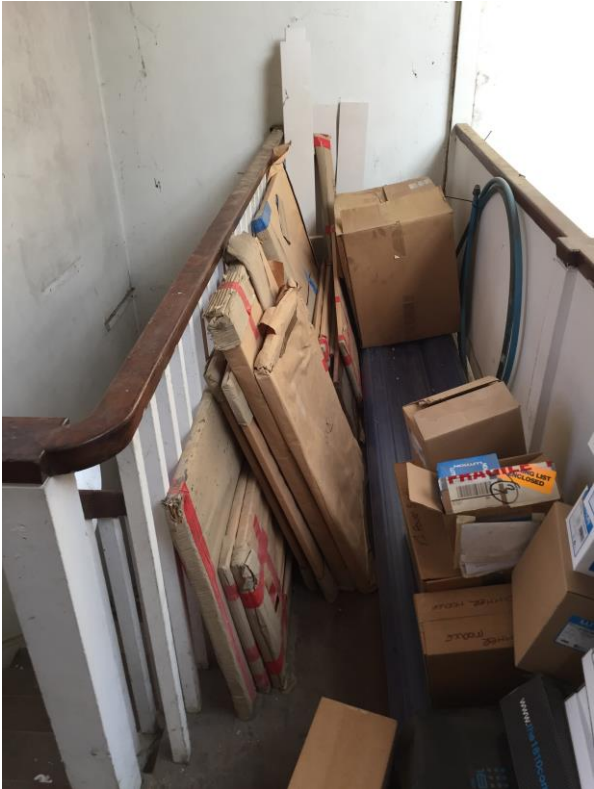
Fig. 11 Viewing Gallery and access stair.

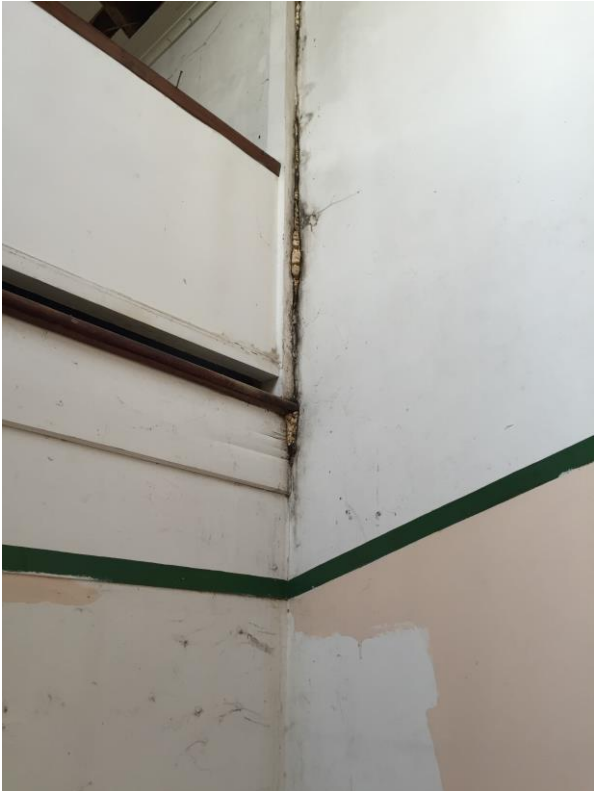
Fig. 12 Fungal decay along gallery boarding.

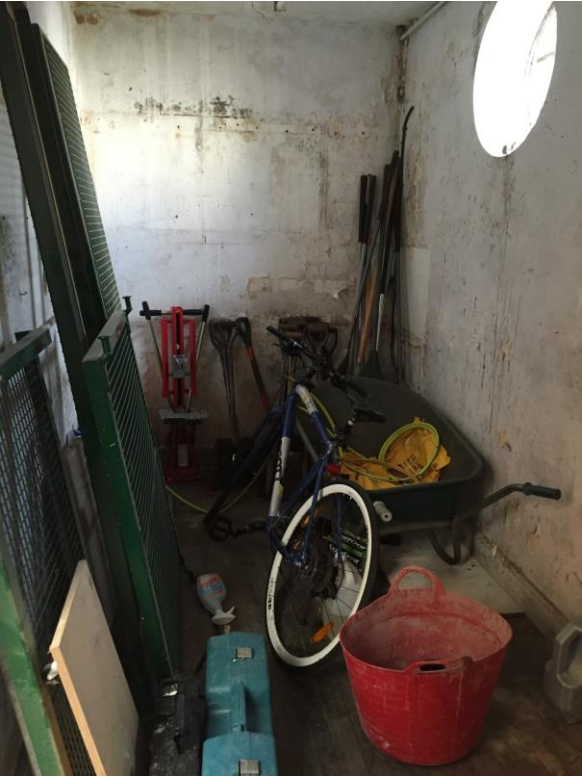
Fig 15. Lobby and former Kitchenette area.

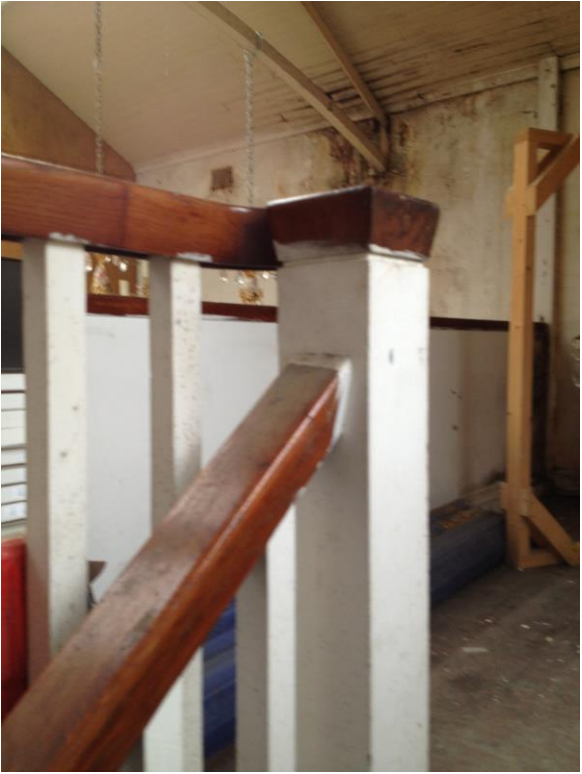
Fig. 16 Gallery and access stair.

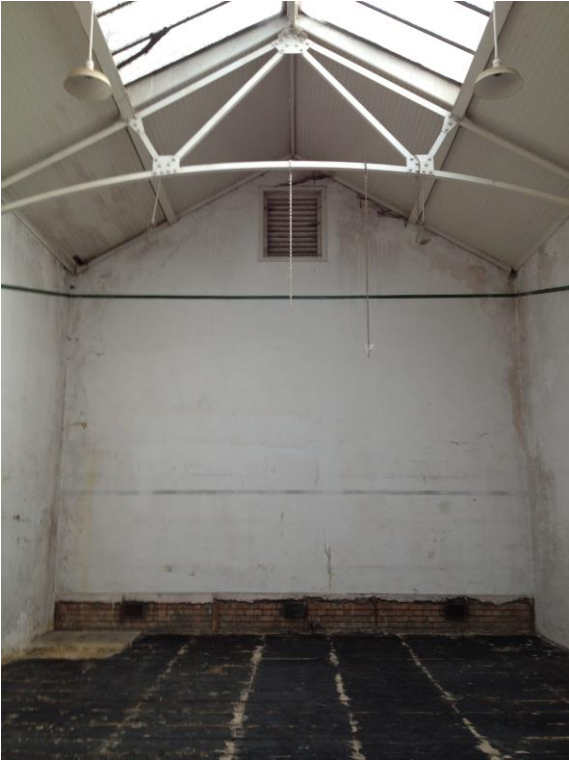
Fig. 18 View looking east following asbestos removal (Dec 15).

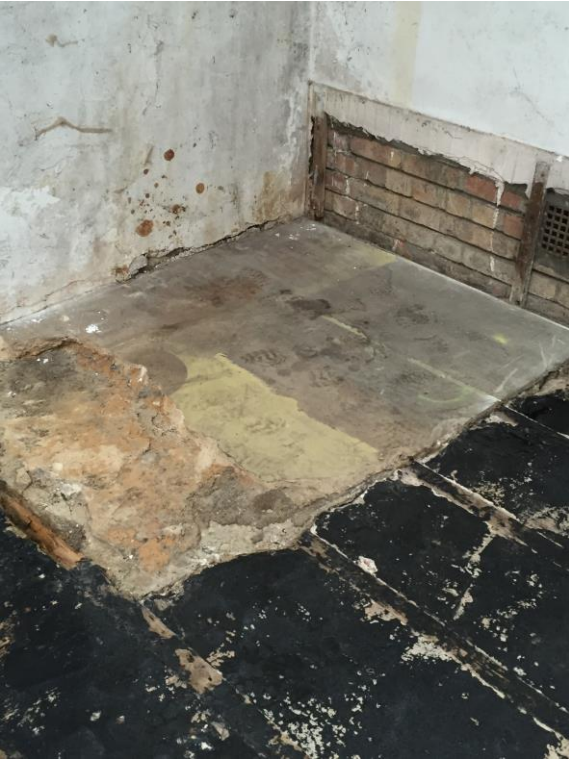
Fig. 19 Area of patched flooring in NE corner.

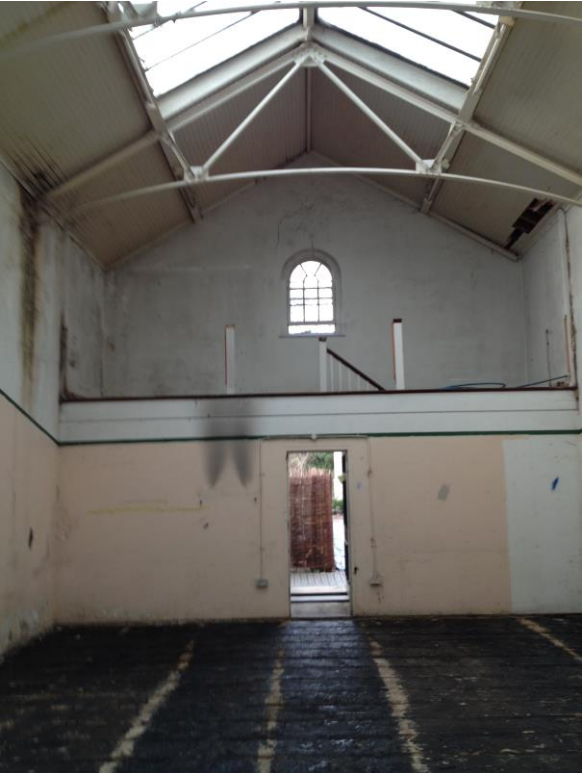
Fig. 20 View looking west following asbestos removal (Dec 15).

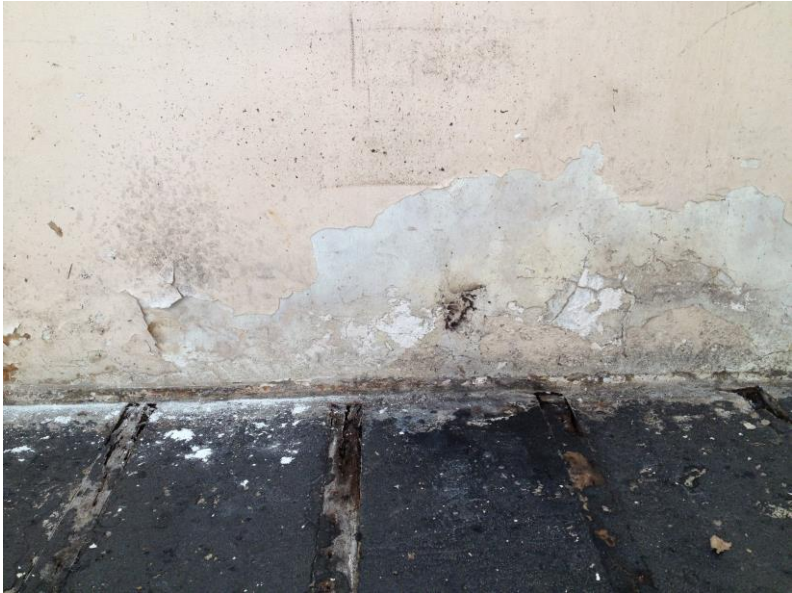
Fig. 21 Decayed timber battens revealed following asbestos removal (Dec 15).

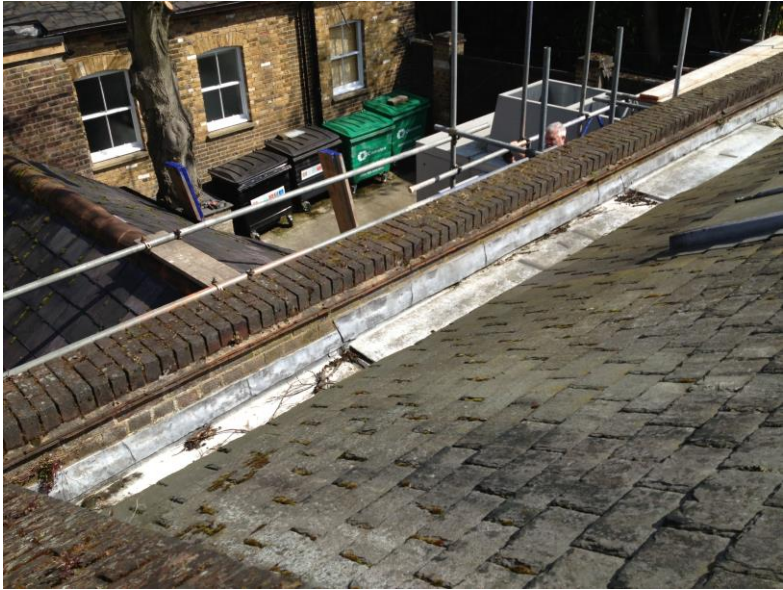
Fig. 22 North roof slope with patched lead parapet gutter.

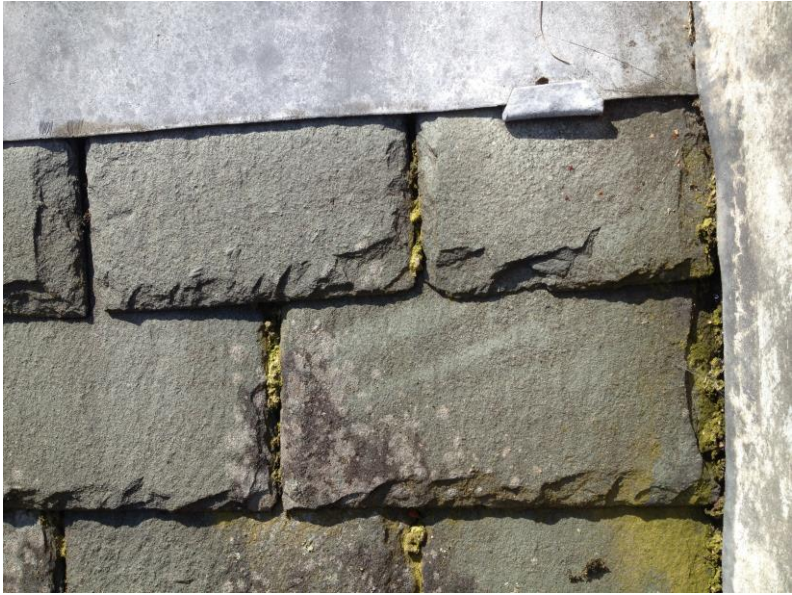
Fig. 23 Existing Westmoreland slates (re-used).

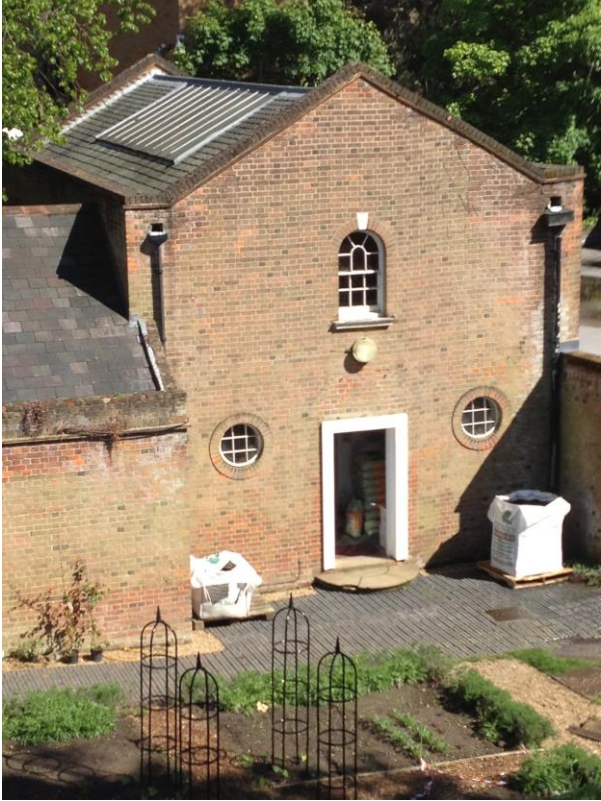
Fig. 24 West elevation from Beechwood House

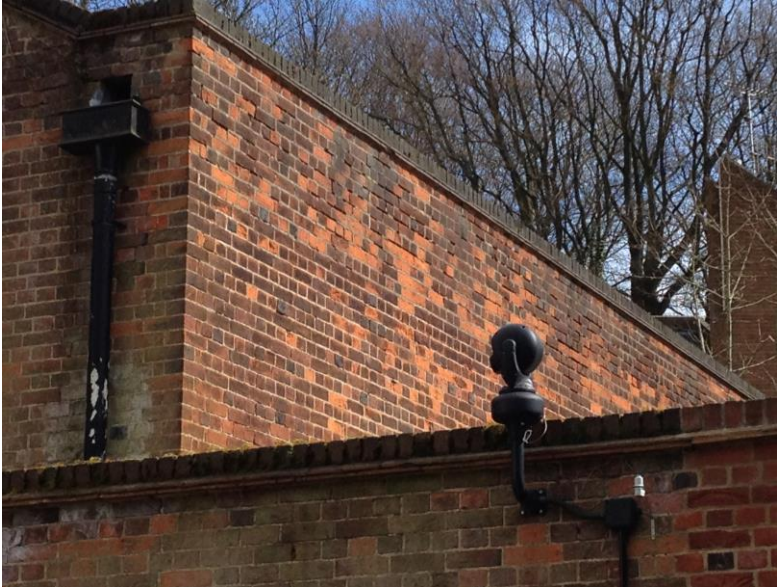
Fig. 25 South elevation from Kitchen Garden.

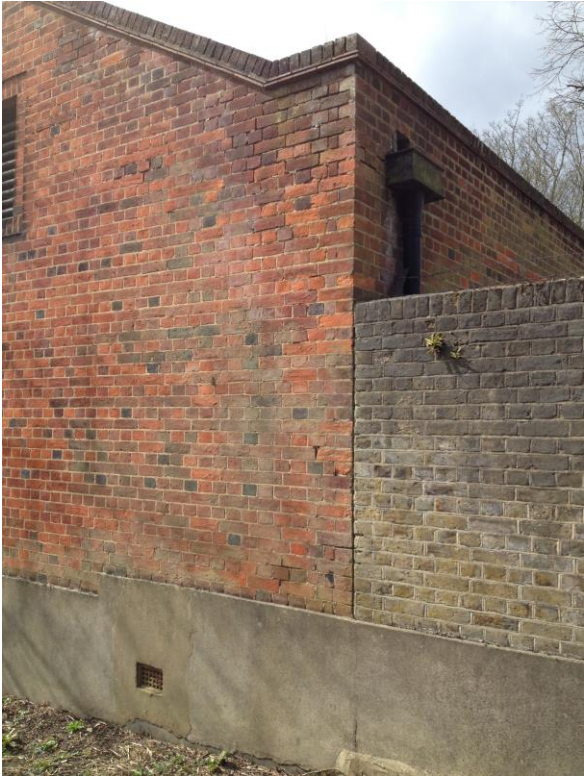
Fig. 26 East elevation with render band.

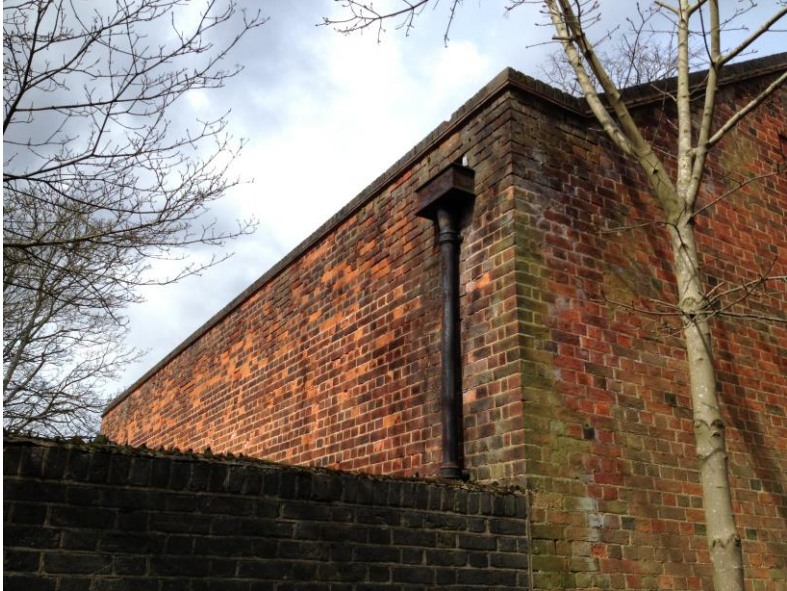
Fig. 27 South elevation from Fitzroy Park

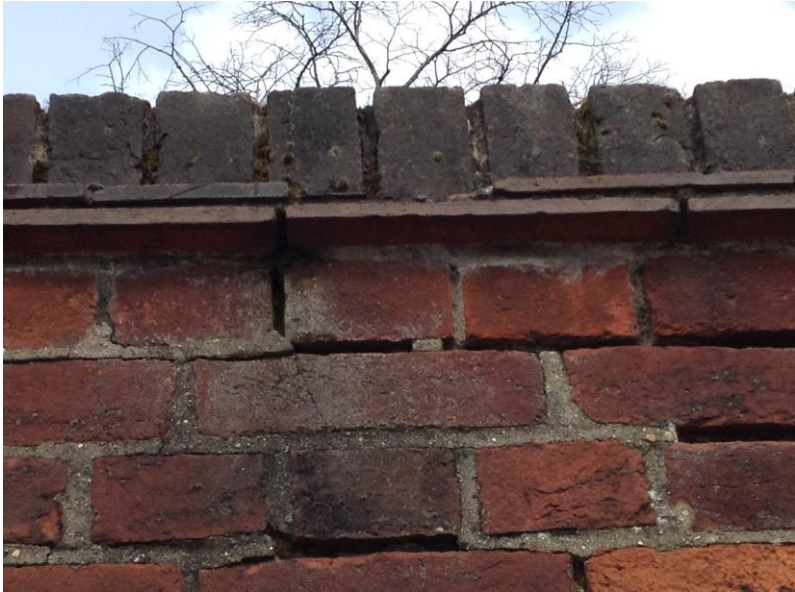
Fig. 28 Brick-on-edge and creasing tile parapet wall.

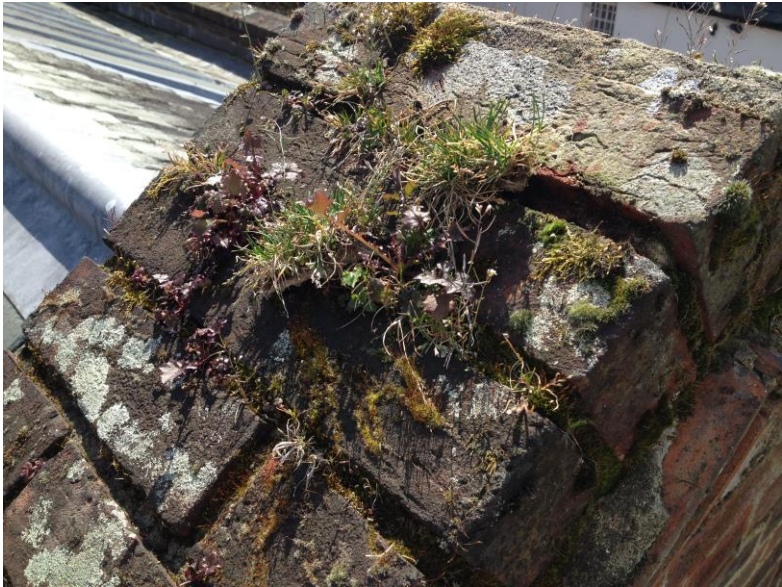
Fig. 29 Vegetation on parapet open brickwork joints.

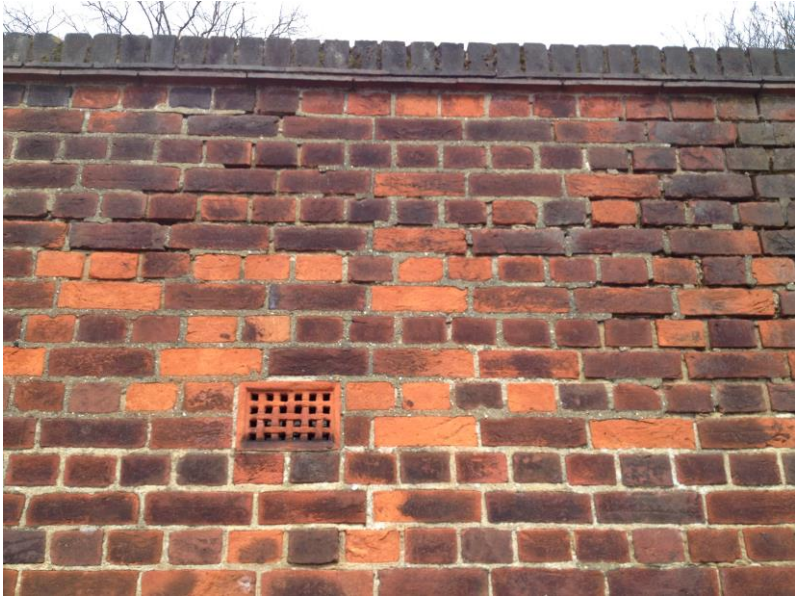
Fig. 30 South Elevation weathered brickwork.

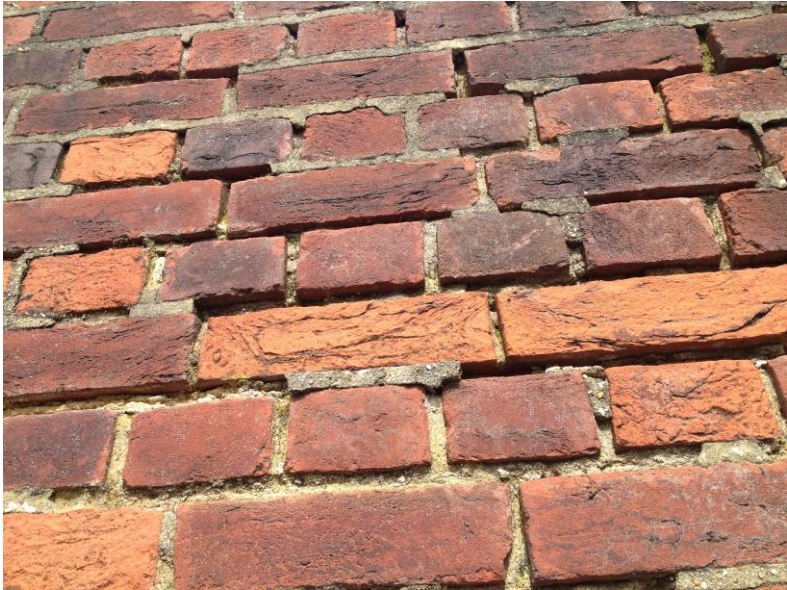
Fig. 31 Detail of weathered brickwork pointing.

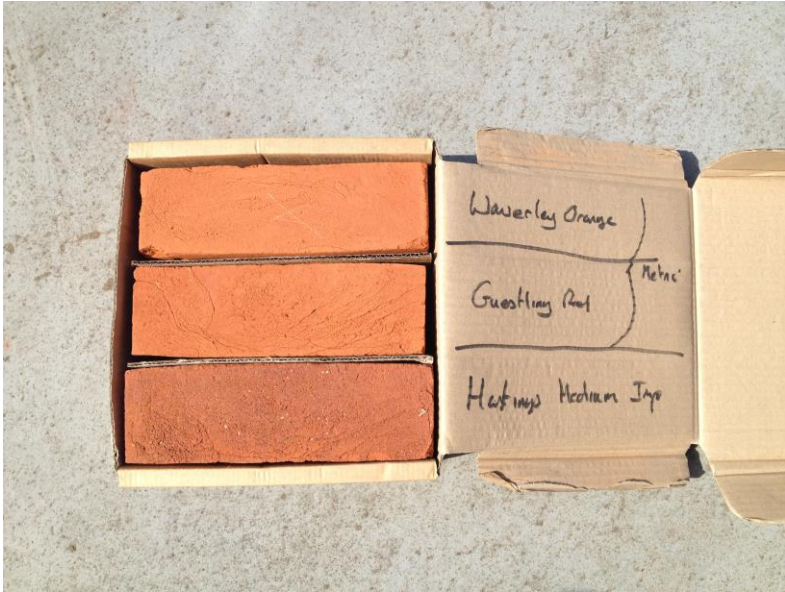
Fig. 32 Samples of replacement facing bricks (April 16).

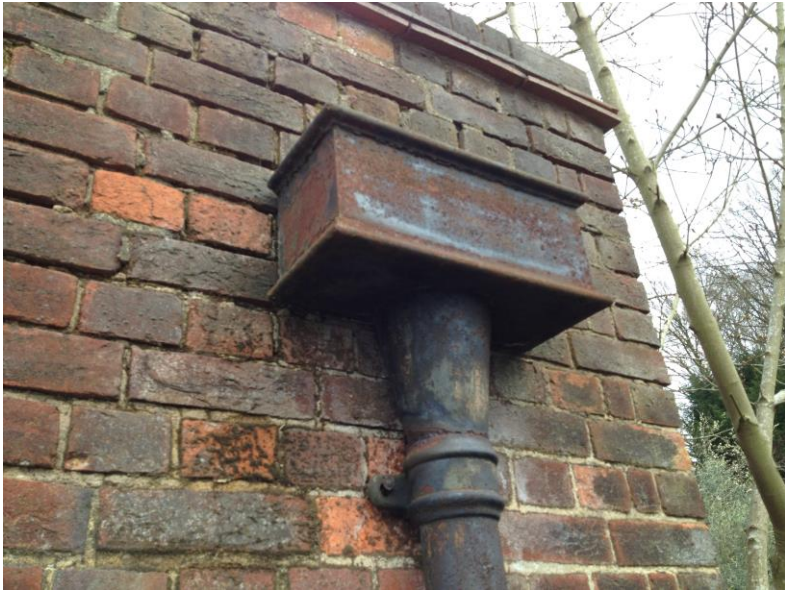
Fig. 33 Existing cast iron hopper head on SE corner.

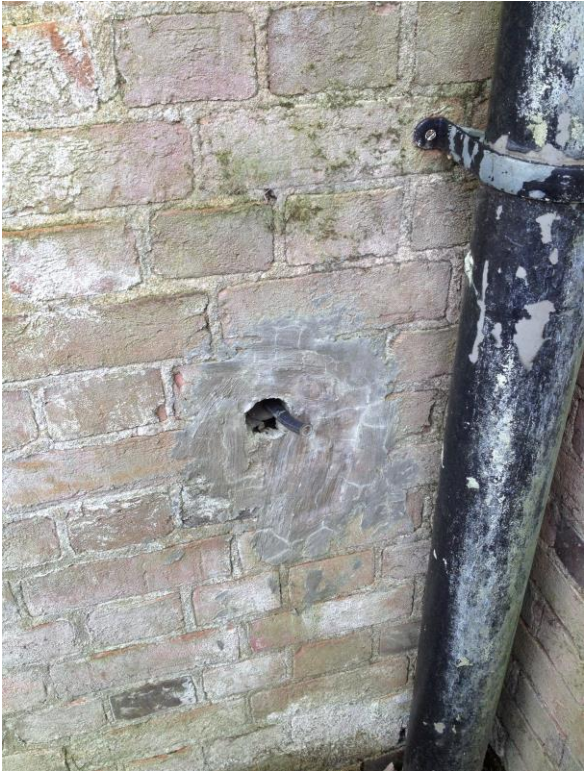
Fig. 34 Former waste pipe hole requiring making good.

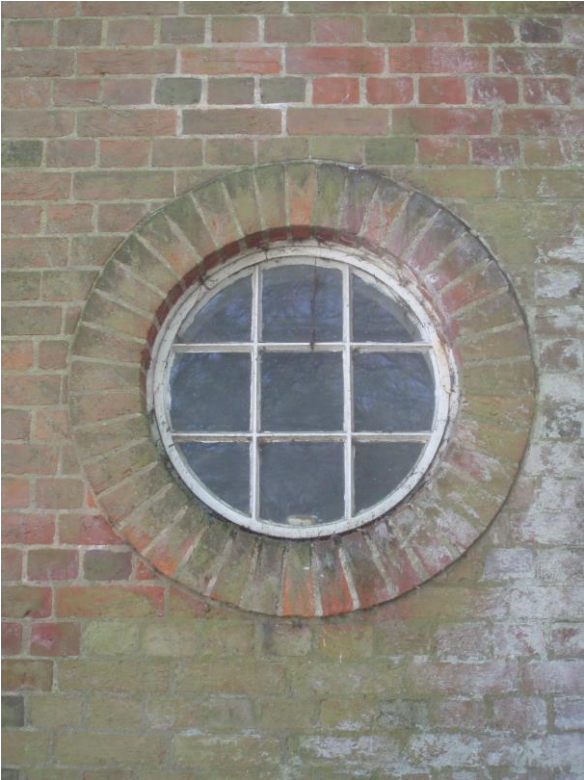
Fig 35. Corroded and 'seized' Bullseye window

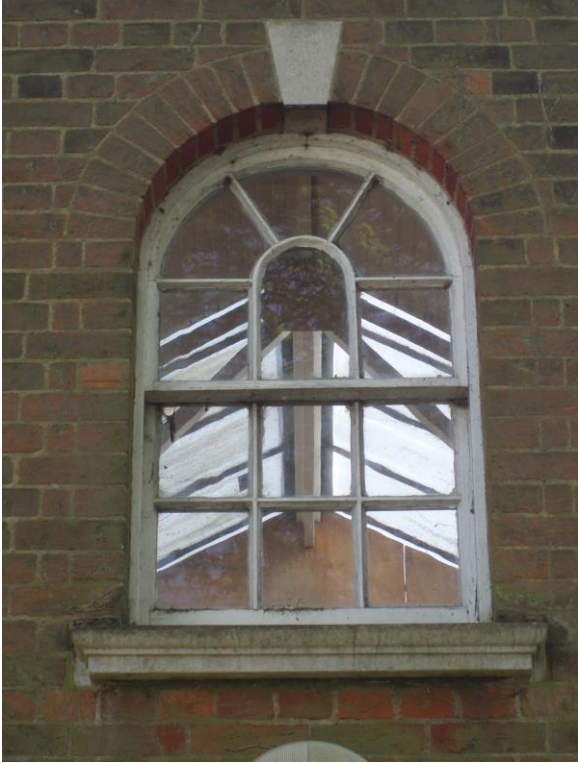
Fig. 36 Arched headed timber sash window at first floor.

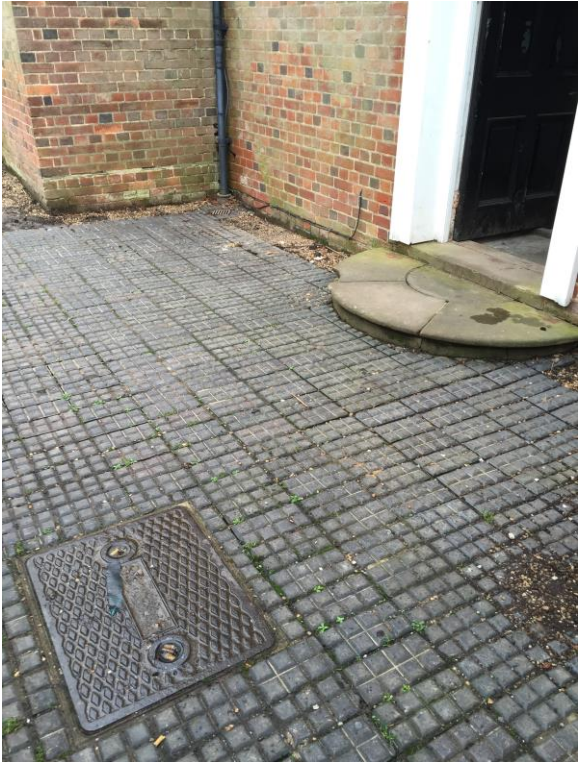
Fig. 37 Former yard paving and existing manhole connection.

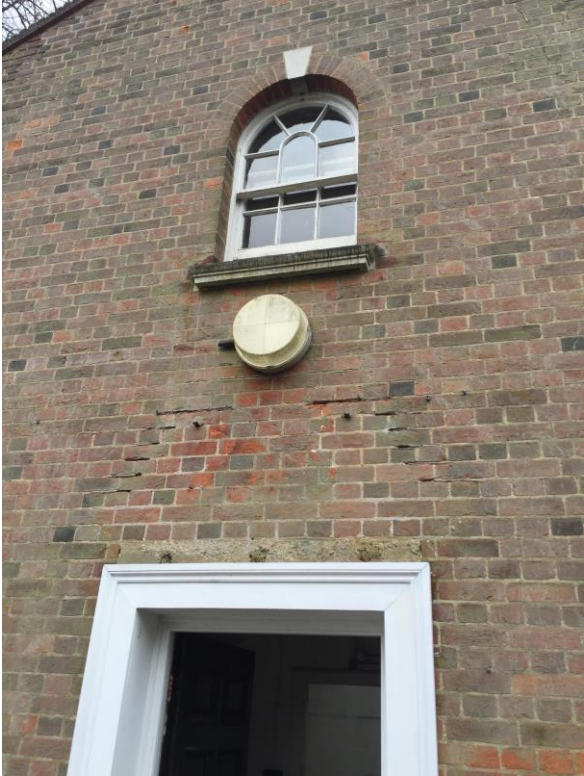
Fig. 38 Bulkhead light fitting and former canopy outline (Dec 15).

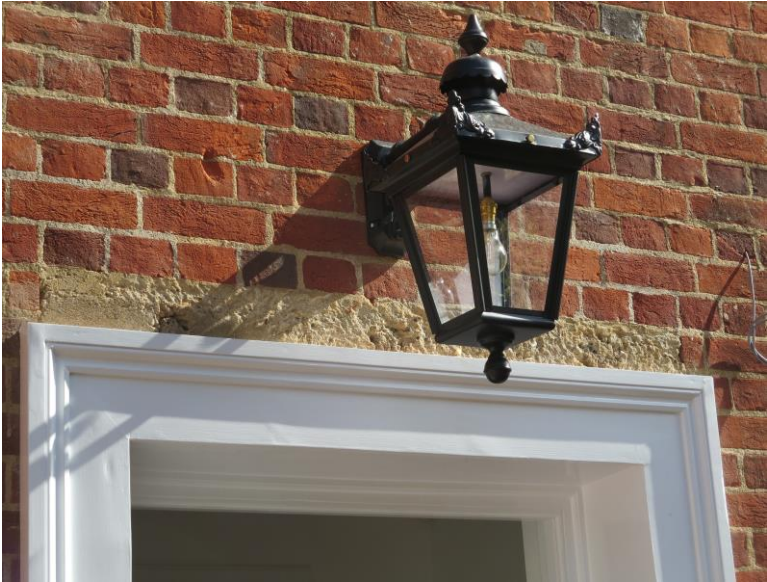
Fig. 39 Replacement cast iron lantern over entrance door (July 16).

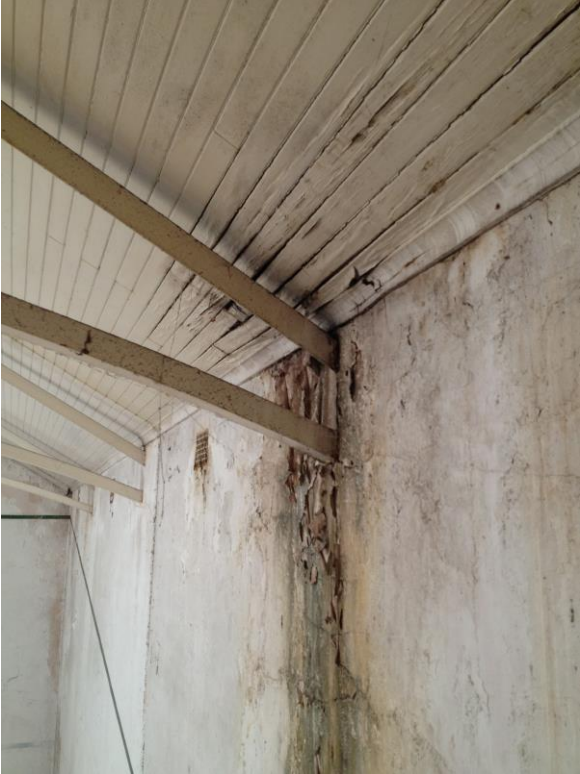
Fig. 40 Decayed soffit boarding and water ingress from parapet gutter.

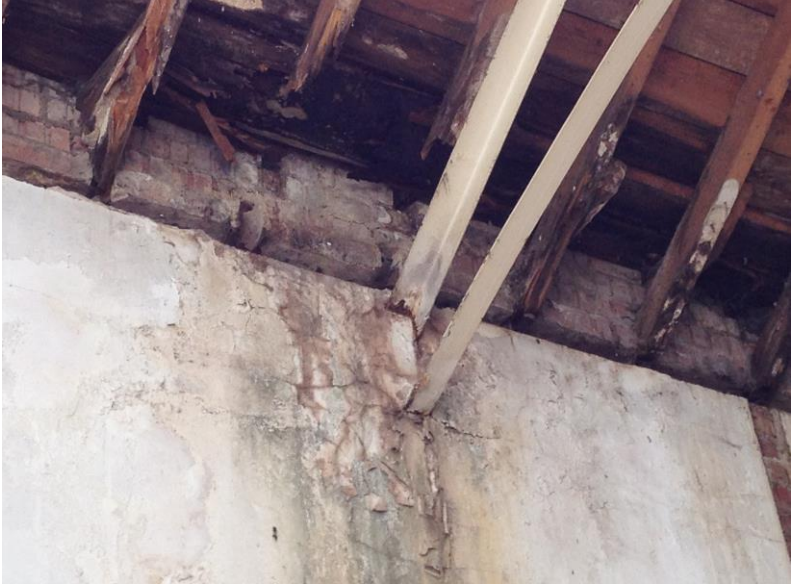
Fig. 41 Decayed wall plate, rafter feet and gutter lining (April 16).

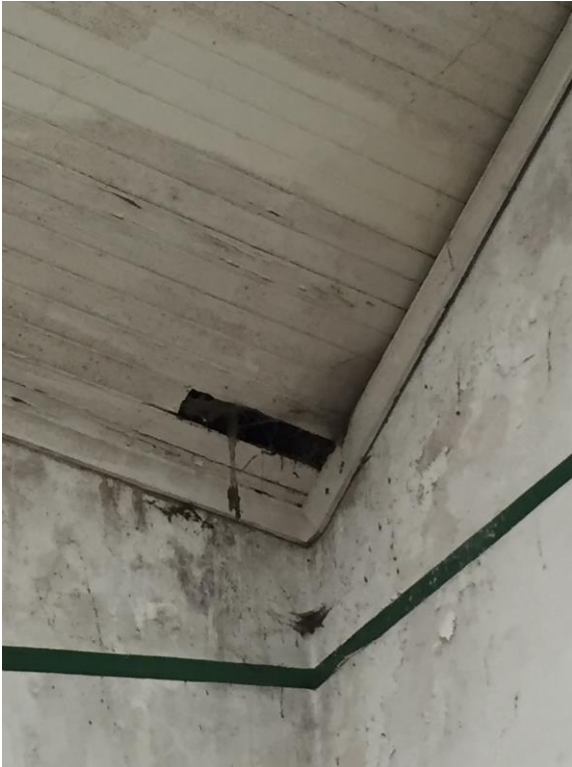
Fig. 42 Water ingress and damage (Dec 15).

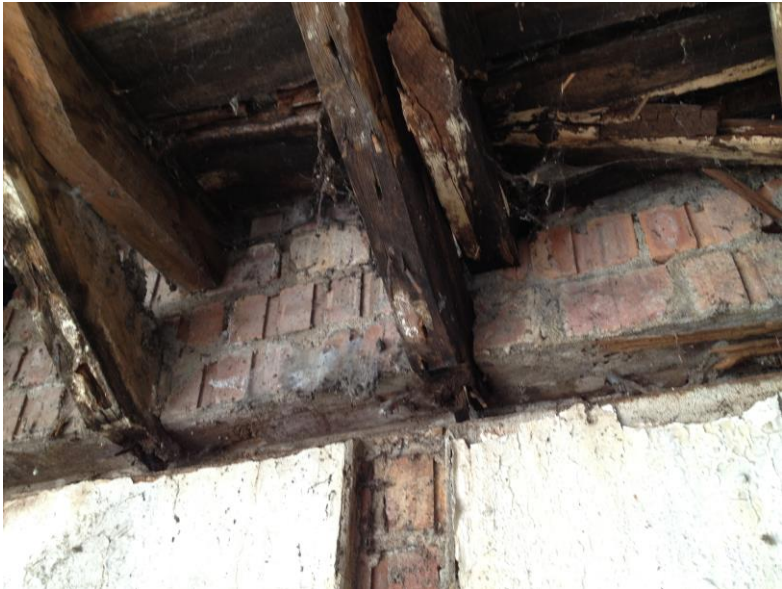
Fig. 43 Decayed wall plate, rafter feet and gutter lining (April 16).

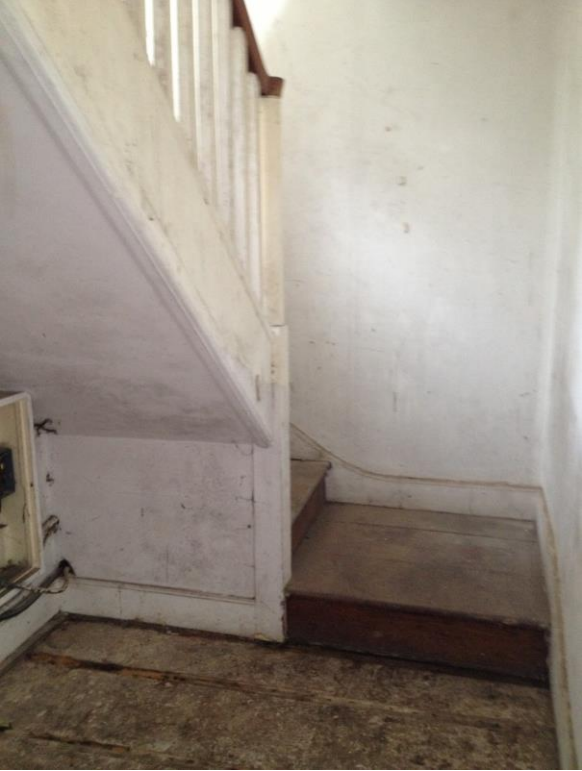
Fig. 44 Access stair to viewing gallery (Dec 16).

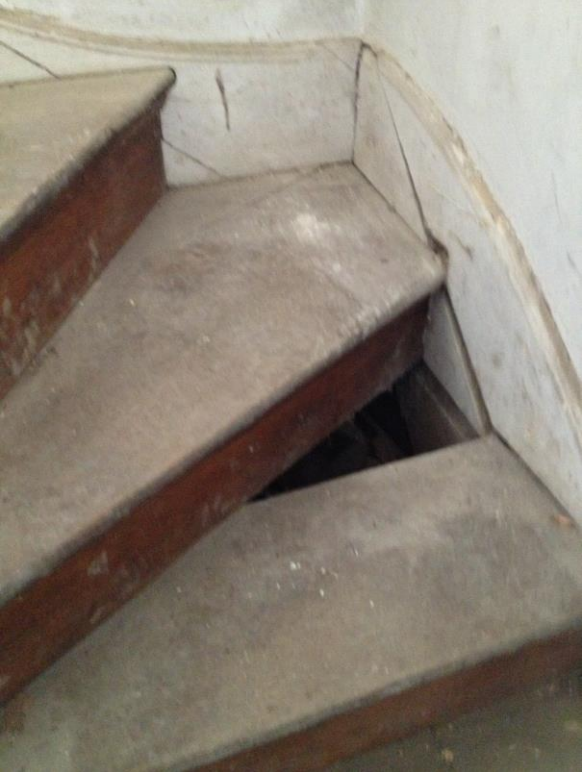
Fig. 45 Defective timber stair treads (Nov 15).

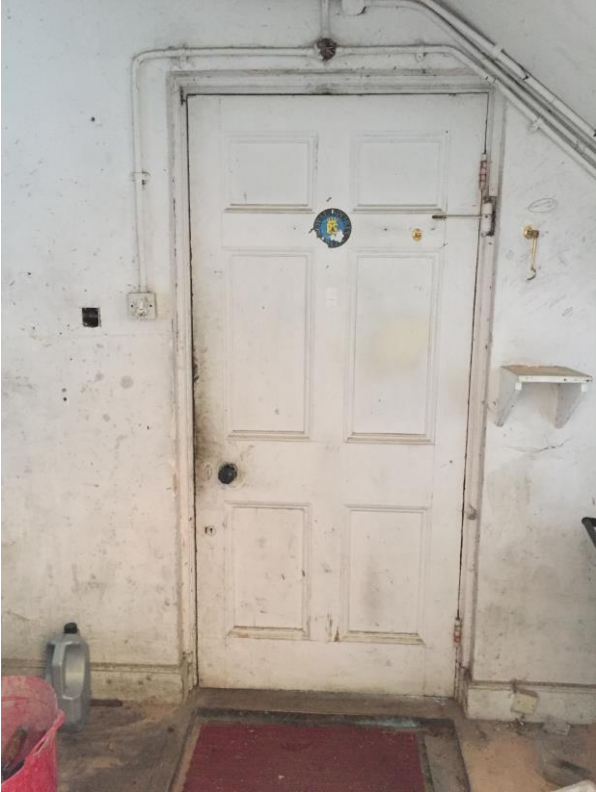
Fig. 46 Panelled entrance door & surface run conduits (Nov 15).

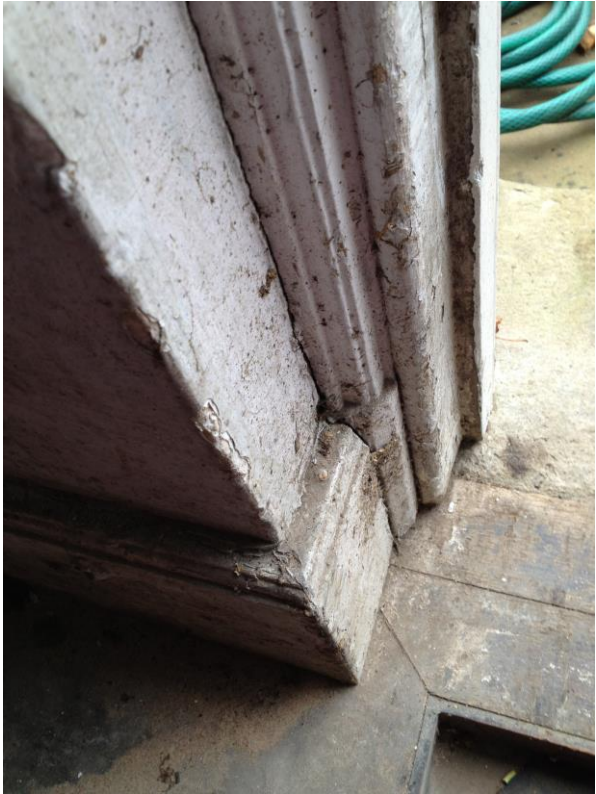
Fig. 47 existing skirting and architrave joinery details (Nov 15).
