Arboricultural Appraisal Report

Subsidence Damage Investigation at:

1 Torriano Cottages
 Torriano Avenue
 London
 NW5 2TA

CLIENT: Davies Group Ltd
 CLIENT REF: [REDACTED]
 MWA REF: [REDACTED]
 MWA CONSULTANT: George Peters BSc. (Hons), M.Arbor.A
 REPORT DATE: 18/07/2019

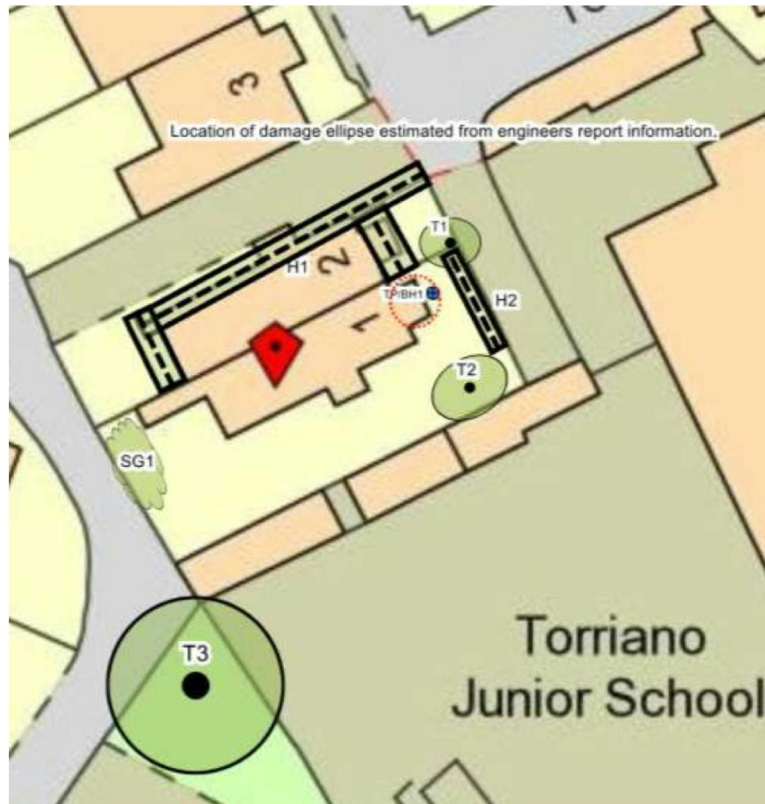
Site Plan

Approximate areas of damage

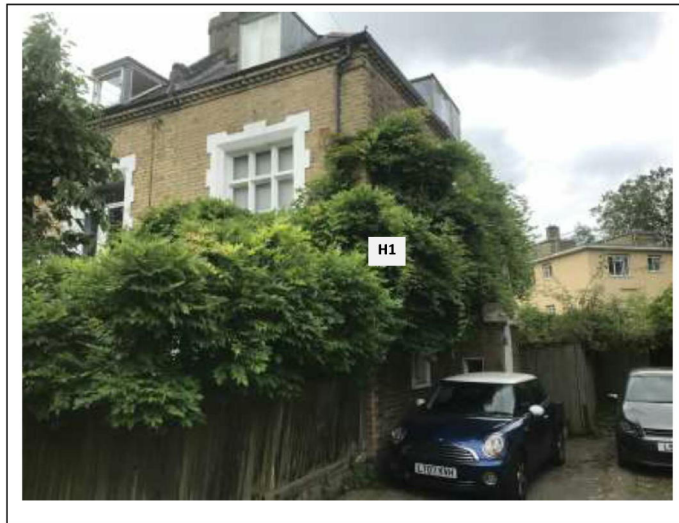
Irrespective of the identification of recovered root samples, the roots T2, H1 (Wisteria) and H2 are also likely to be present in proximity to the area of movement/damage and influencing soil moisture and volumes.

Based on the technical reports currently available, engineering opinion and our own site assessment we conclude the damage is consistent with shrinkage of the clay subsoil related to moisture abstraction by vegetation. Having considered the information currently available, it is our opinion that T1 the principal cause of the current subsidence damage, with a possible contribution from T2, H1 and H2.

View of H1 Wisteria, current claim.

We recommend that T1 and T2 are removed in the first instance and H1 is cut back to the main scaffold branches along its entire length and H2 reduced.

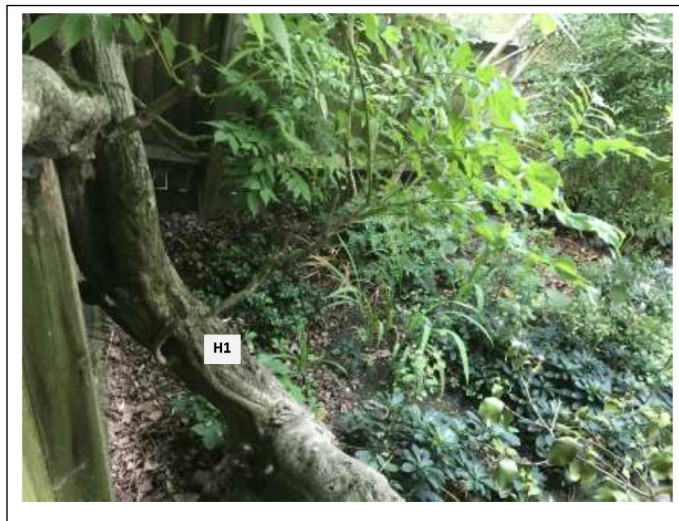
View of H1 Wisteria stem, current claim.

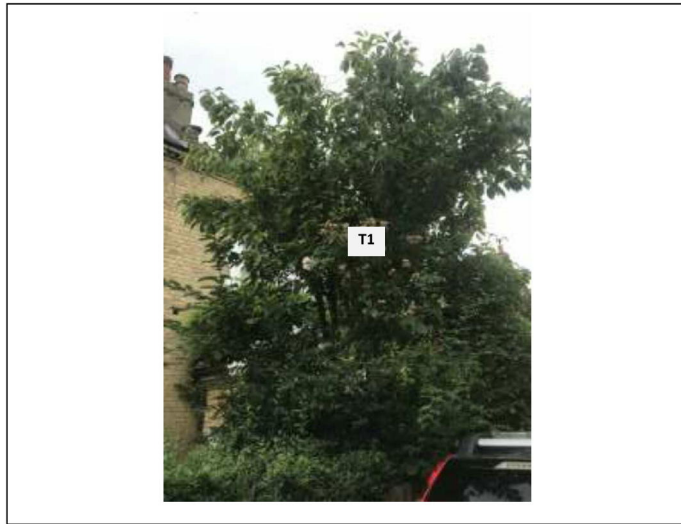
Roots were observed to a depth of 1000mm bgl in TP/BH1 and recovered samples have been positively identified (using anatomical analysis) as Prunus spp., the origin of which will be T1 Cherry confirming its influence on the soils below the foundations.

View of T1 Cherry, current claim.

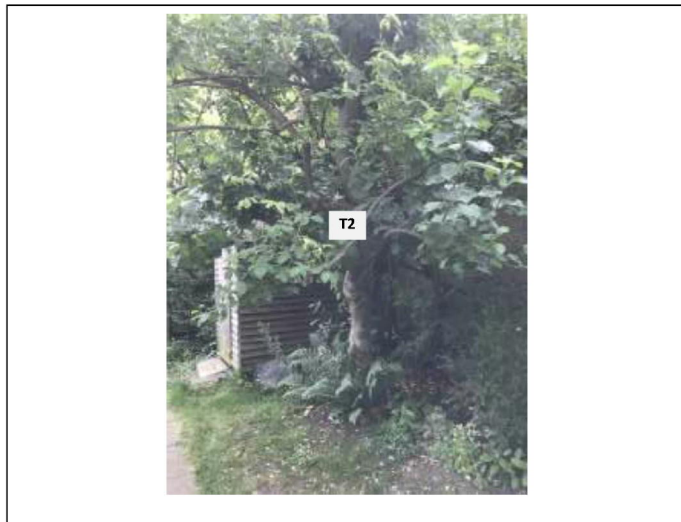
View of T2 Apple, current claim.
