# ARBORICULTURAL REPORT

to BS 5837:2012 at:

**99 South End Road,  
London  
NW3 2RJ**

Date: *April 2019*

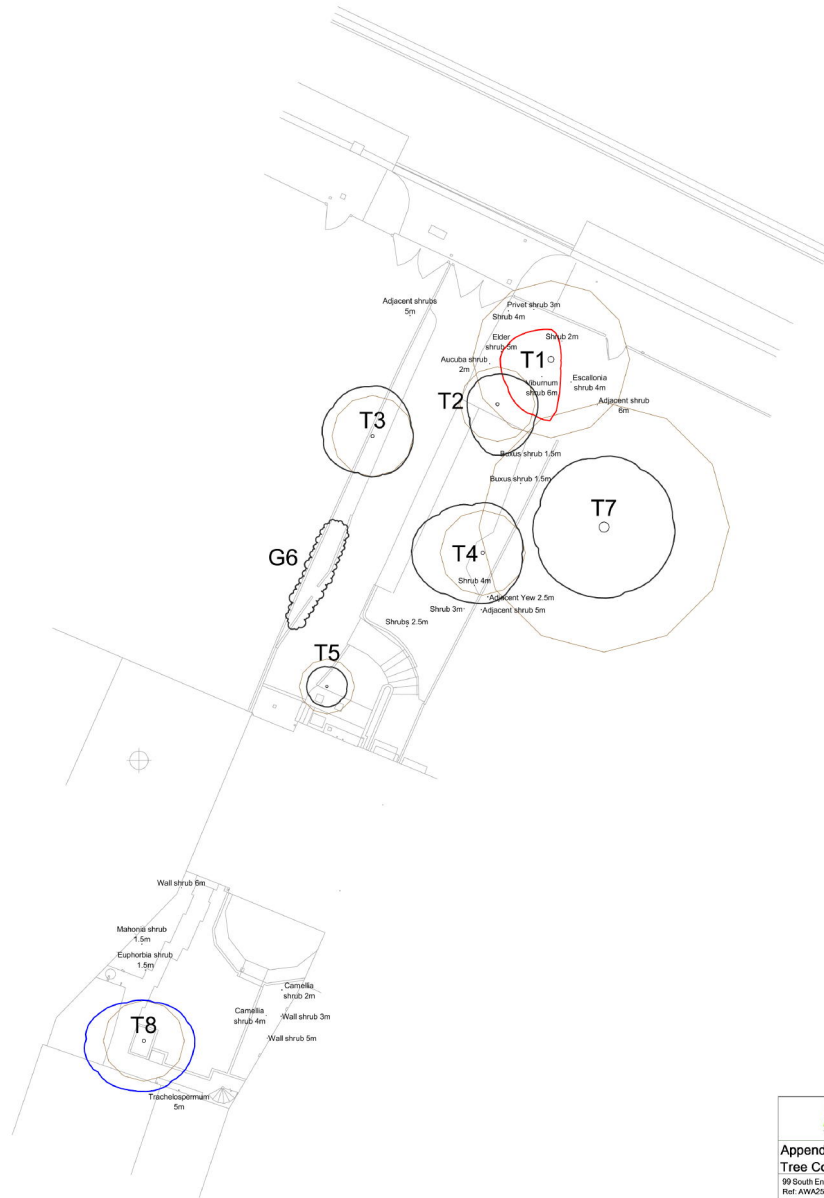
**Appendix 5:**  
**Tree Constraints Plan**  
99 South End Road, London  
Ref: AWA202

- 3.2.3 The site's most significant tree is the Magnolia T8, in the property's rear garden, which is in good overall condition and provides moderate amenity value to the site. The crown of the tree is in contact with a neighbouring property to the south; it is recommended to reduce the tree's southern and western crown by around 1m to 1.5m, selectively pruning to suitable points. The pruning works should be undertaken between mid-summer and early autumn, as pruning wounds can bleed if pruned in late winter or early spring. The tree appears to have had minor reduction works to its northern and eastern crown in the past; the recommended reduction works to the tree's southern and western crown would therefore also create a more balanced, even crown form.

- 3.2.5 The Yew hedge G6 provides some screening between the site and the neighbouring property to the west but has been poorly pruned in the past which will likely limit its future prospects. The hedge is of very low value and should not pose a constraint on development at the property; the limited screening it currently provides can be easily replaced.

- 3.2.6 T1 appears to have been dead for some time and is recommended for removal regardless of development at the site.
- 3.2.7 The Cherry T7 is situated in the front garden of a neighbouring property to the east of the site and so was only given a cursory inspection with measurements estimated and condition values indicative only.
